STAFF REPORT: MARCH 12, 2025, REGULAR MEETING
APPLICATION NUMBER: HDC2025-00048
ADDRESS: 1817 LEVERETTE
HISTORIC DISTRICT: CORKTOWN
APPLICANT: ELISE DECHARD, END STUDIO
PROPERTY OWNER: ALLENSON, THOMAS E & MAUREEN T
DATE OF PROVISIONALLY COMPLETE APPLICATION: FEBRUARY 5, 2025
DATE OF STAFF SITE VISIT: FEBRUARY 28, 2025

SCOPE: DEMOLISH REAR PORCH, ERECT REAR ADDITION

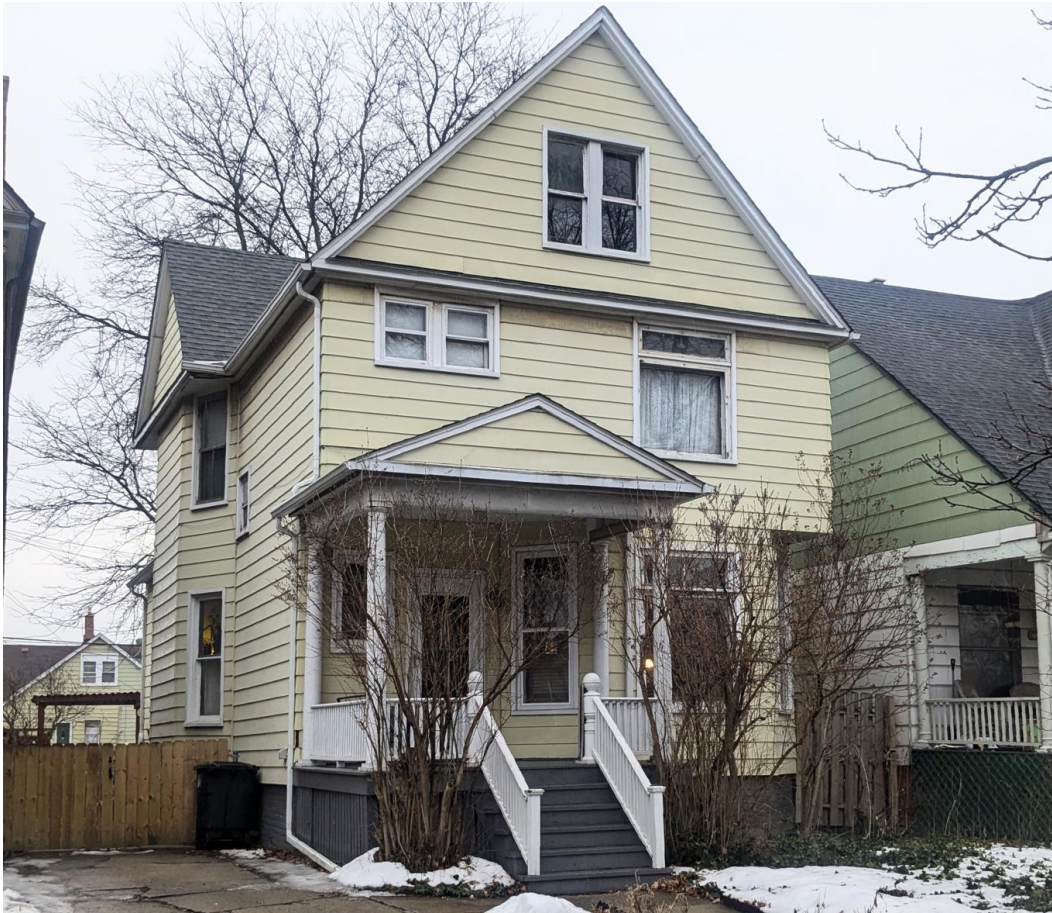
1817 Leverette viewed from the north. February 2025 photo by staff.

1817 Leverette is a two-and-a-half-story house built in 1903. An overall Queen Anne massing includes an asymmetrical façade with northwest cutaway corner, a gable-roof front porch, and a front-facing, projecting gable at the attic story. Tuscan columns with pronounced entasis are a Free Classic element. Aluminum siding (installed prior to the designation of the historic district) obscures any other decorative details that may have once existed.

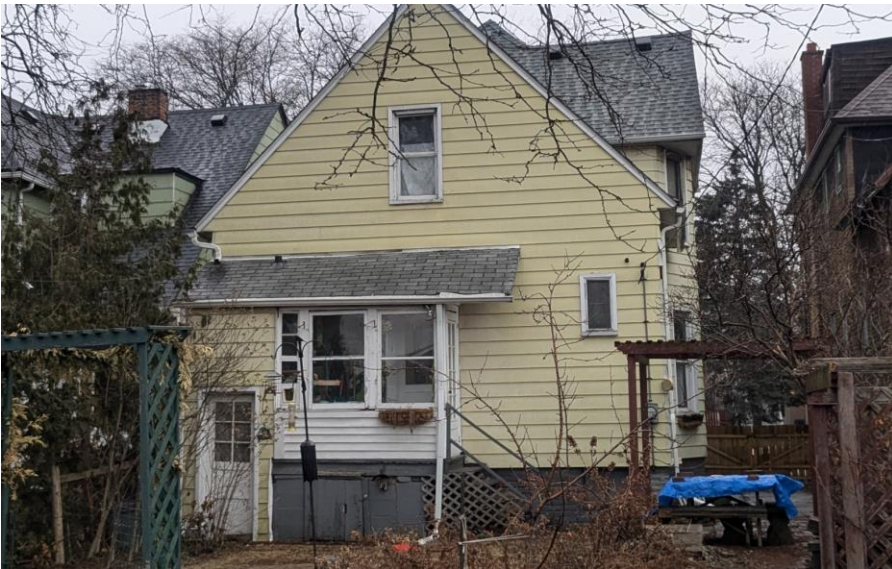
Rear of house viewed from the alley, showing the porch proposed for demolition. February 2025 photo by staff.

Subject of this application is a rear porch, described as an “unconditioned sunroom” in application materials. The enclosed area has a shed roof, two different types of siding, wood windows, and non-matching doors. It also contains a basement access stair.

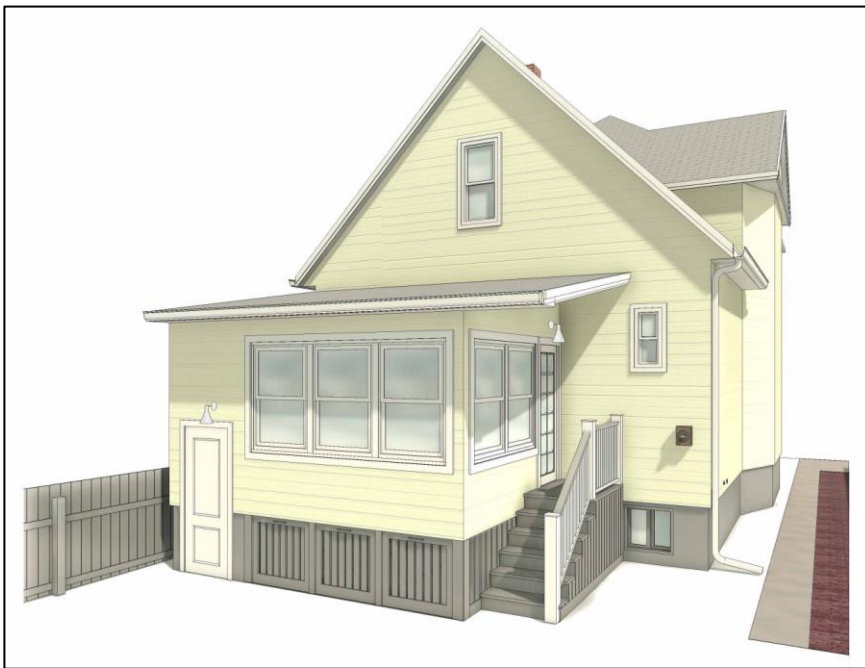
Rendering of proposed work. Image from application.

The proposal is to demolish the rear porch and build a new rear addition in the same location and slightly wider than the current porch.

Specifications for all materials are provided in the application documents. They include aluminum siding, Marvin Signature Ultimate double-hung aluminum-clad wood windows in Stone White color, Medium-density-fiberboard (MDF) doors (the basement door a solid panel door appearance, and the first-floor door glazed with twelve true divided lites), and two conical wall sconces.

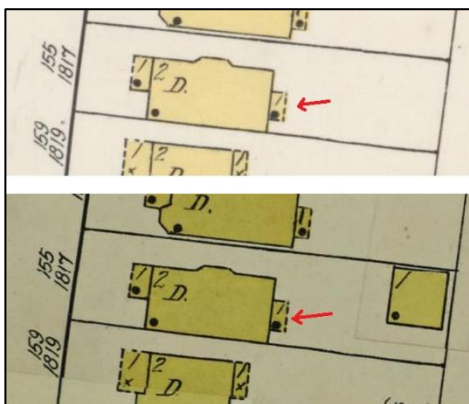
Sanborn Map Company images from 1921 (above) and 1950 (below) with arrow added to show porch location. The dotted line indicates an open porch.

- The Corktown Historic District was established in 1984. The Final Report for the district states “its diversity of architectural styles is representative of working class housing from the late 1840s to the early 1900s,” implying a period of significance.
- Sanborn maps show that the rear porch was originally an open porch, enclosed some time after 1950 and therefore outside of the period of significance.

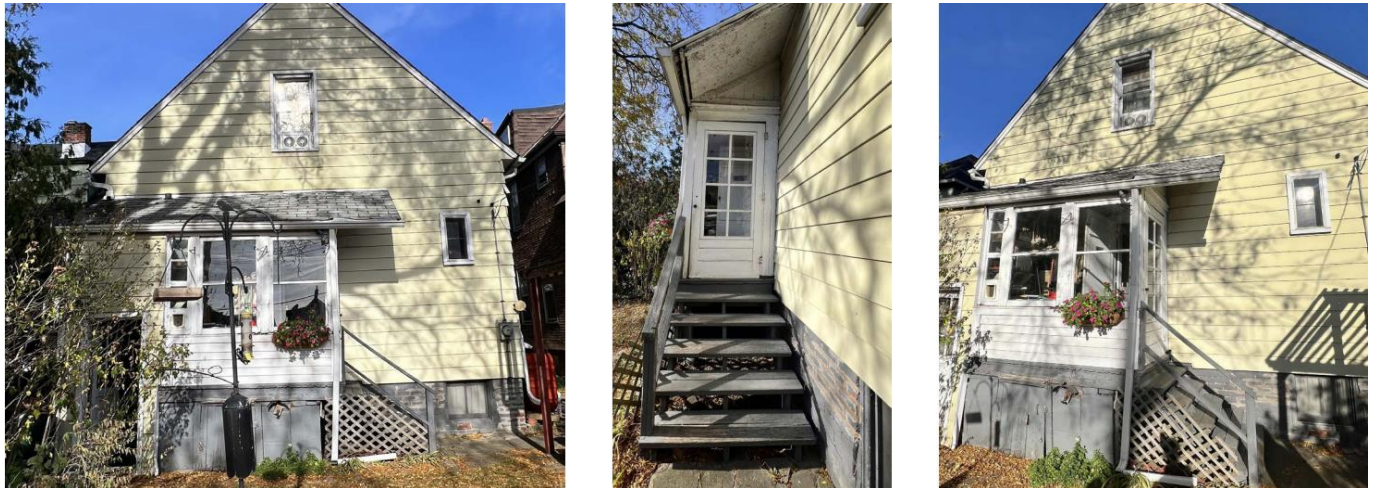
Additional rear porch photos from submitted application materials.

- The historic and character-defining features of the porch appear to have mostly been lost when the porch was enclosed after 1950. An original balustrade or other historic details are not present. The doors, windows, siding, and skirting are mismatched and do not appear to be original to the house. It is possible that the porch roof is original or historic, but staff suggests that a hip roof would have been a more likely treatment for a Queen Anne house from the era. The decking may be original, but contributes minimally to the building’s character. In conclusion, staff opinion is that the porch is not a character-defining feature and may be removed. The primary concern is that any new work should satisfy Standard #9: “The new work shall be differentiated from the old and shall be compatible with the massing, size, scale, and
