STAFF REPORT: 04/09/2025 MEETING
ADDRESS: 3964 W. LAFAYETTE
APPLICATION NO: HDC2025-00087
HISTORIC DISTRICT: HUBBARD FARMS
APPLICANT: JAMIE PEREZ

SCOPE: ERECT CARRIAGE HOUSE

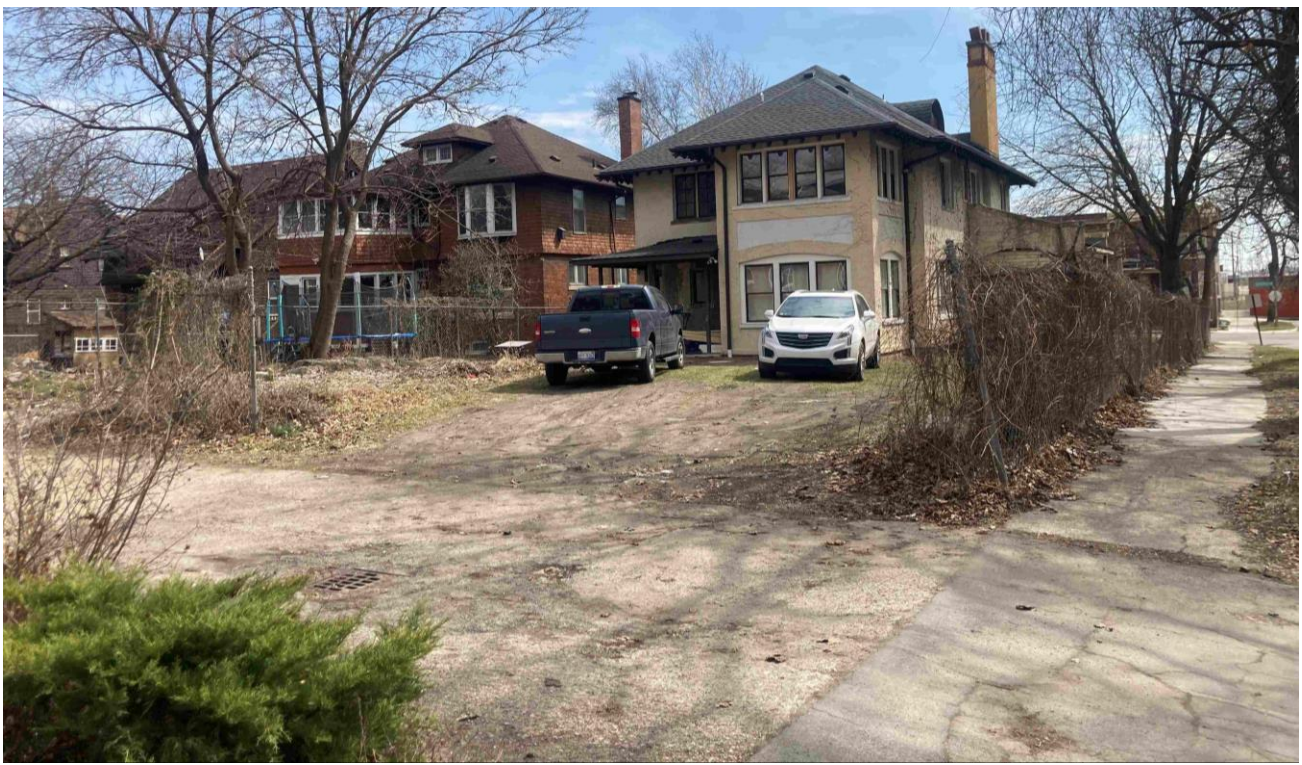
3964 W. Lafayette. Current conditions of rear yard. Photo by staff on 3/25/2025

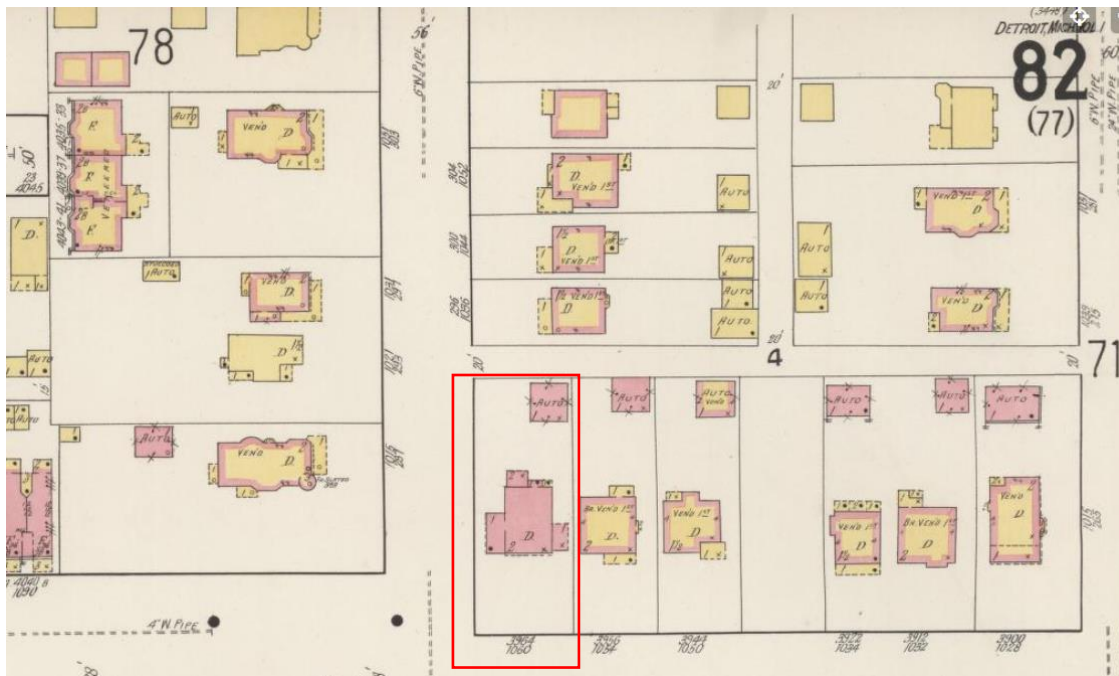
Sanborn Fire Insurance Map, 1921. 3964 W. Lafayette (outlined in red). Note that the parcel included a one-story masonry garage at the time.

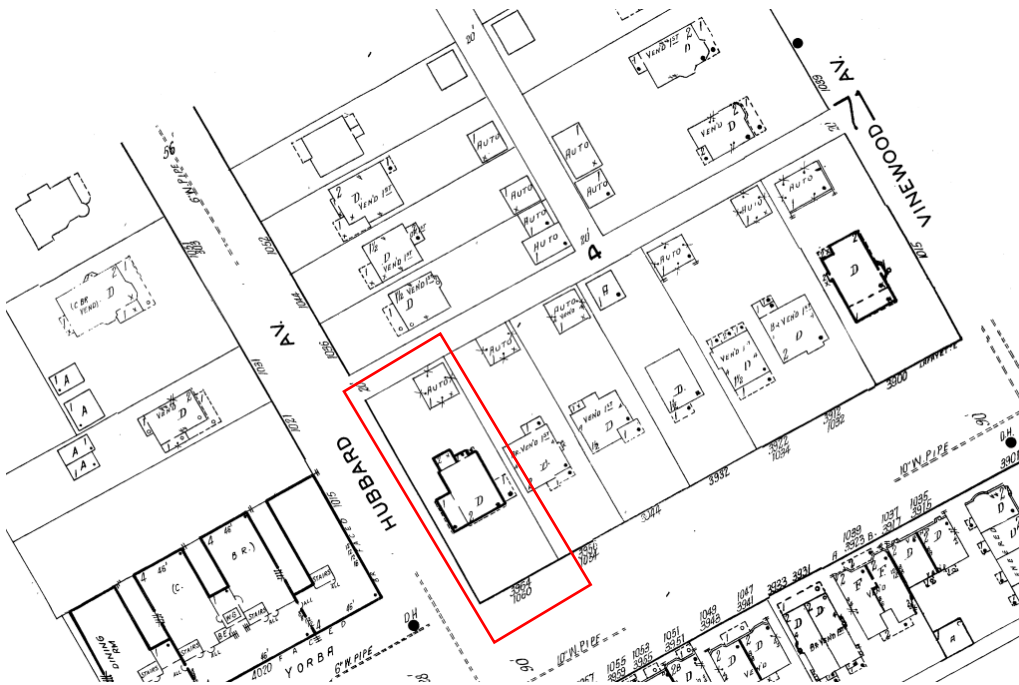
Sanborn Fire Insurance Map, 1971. 3964 W. Lafayette (outlined in red). Note that the one-story masonry garage was still extant

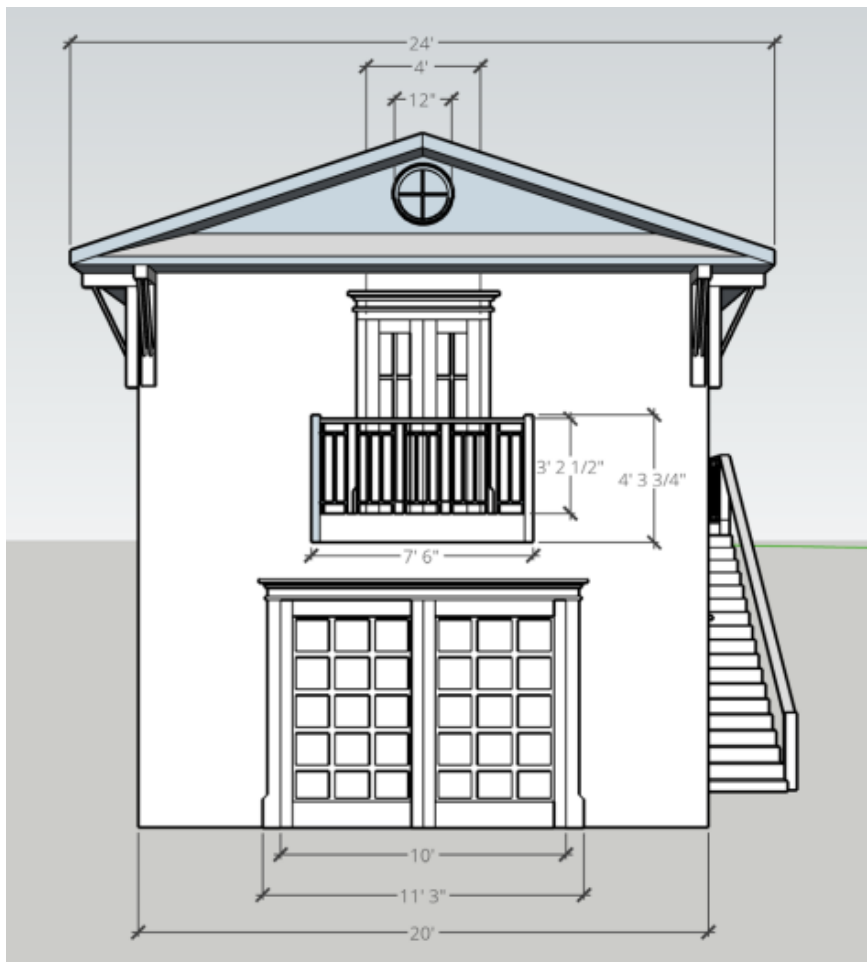
Proposed south (front) elevation

The applicant is seeking the Commission's approval to erect a two-story carriage house in the rear yard, per the submitted materials. The new building will be 24'-0" in height and will feature a gabled roof with deep, overhanging eaves. Exterior walls are proposed to be clad with lapped cement fiber siding and windows will be wood casement units with wood trim. The exterior doors will be wood. A wood balcony will be located at the building's south façade, second story, while a set of wood stairs leading to the second story will be located at the east wall. The building's front/primary façade (south façade) will face the house's rear wall. A paved area of stone, brick pavers, and concrete will be added. See the below and drawings and renderings which depict the proposed new carriage house building.

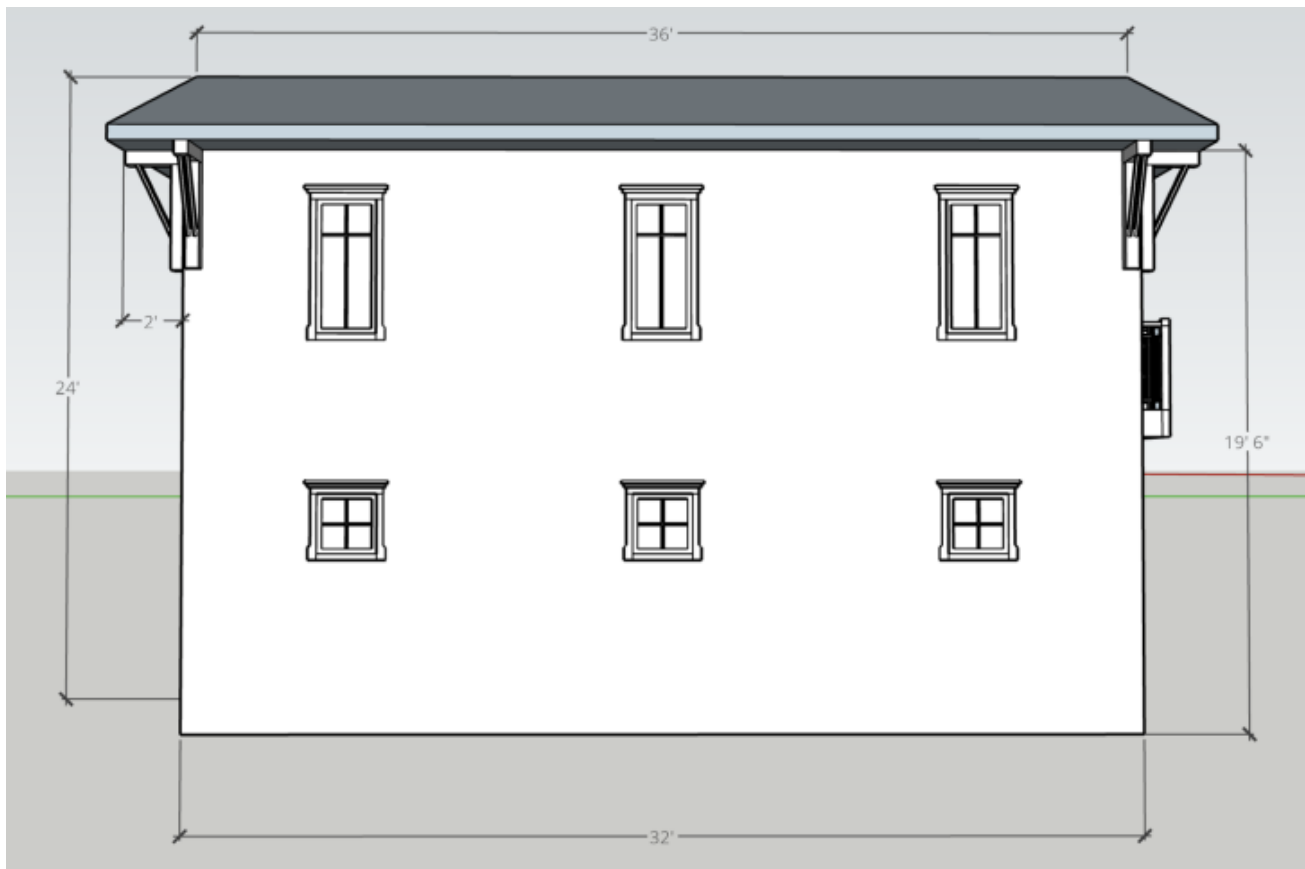
Proposed west (side) elevation

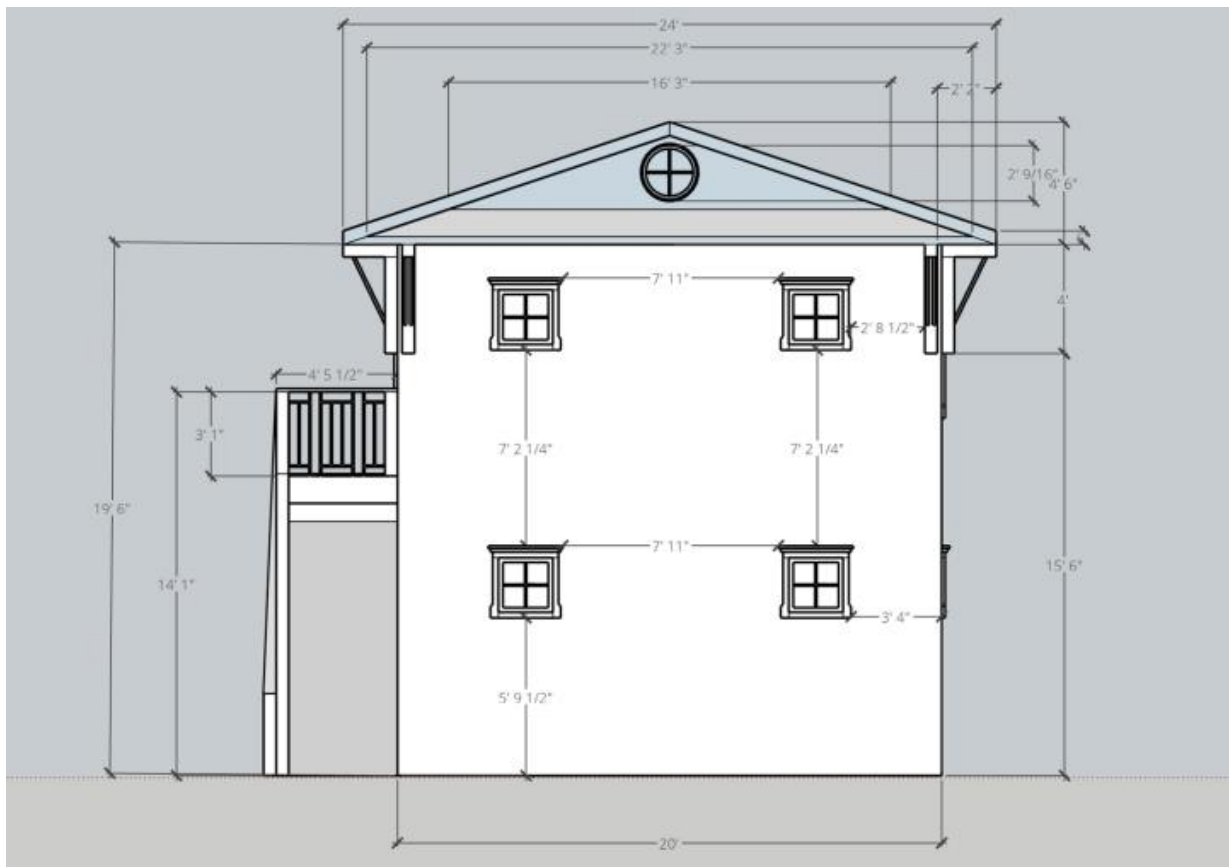
Proposed north (rear) elevation

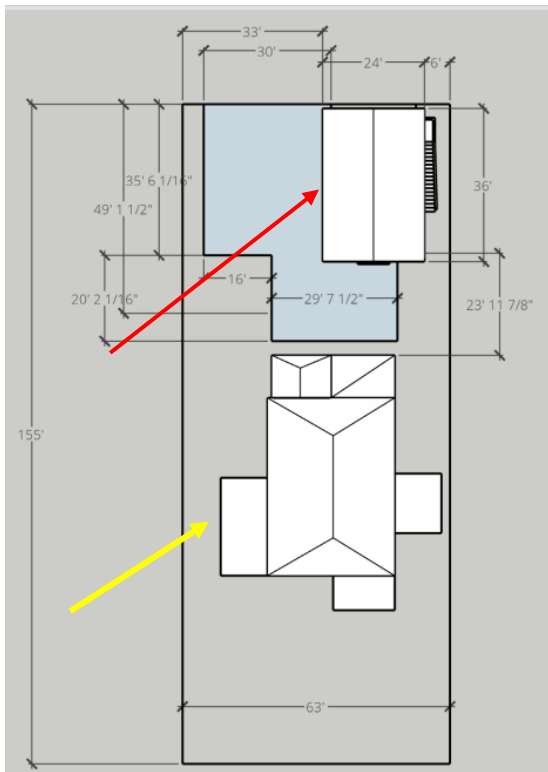
Site plan, showing new carriage house (indicated by red arrow) and hardscape. The historic house (indicated by yellow arrow) is to the south of the new building.

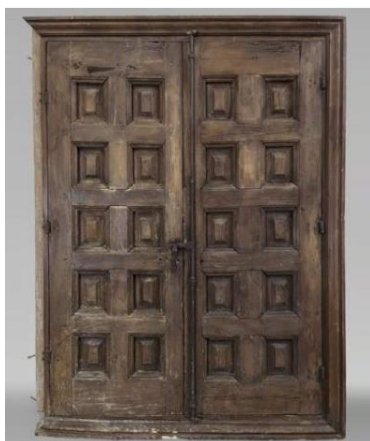
South/front façade auto doors will be custom made to resemble these doors submitted by applicant

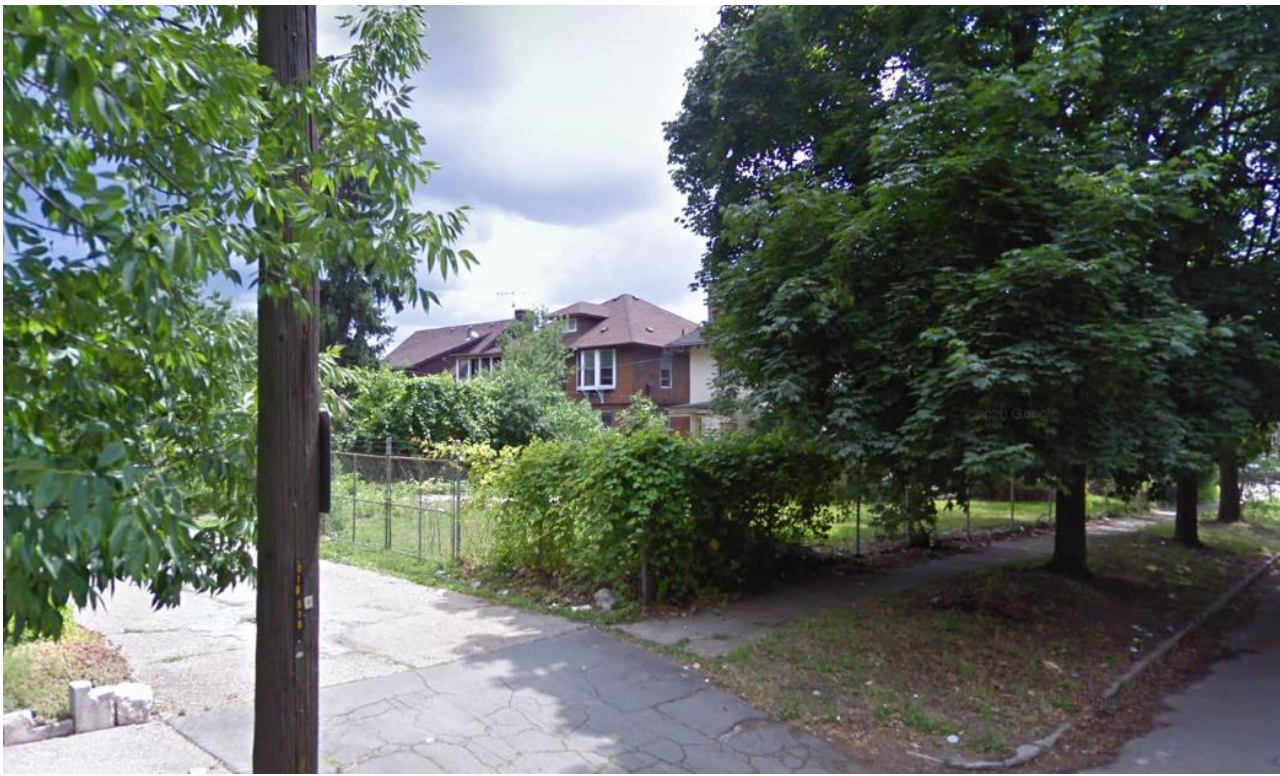
Google Streetview image of the backyard at 3964 W. Lafayette. Image dating from 2009. Note that the garage is no longer extant
