STAFF REPORT: MAY 14, 2025 MEETING 5/13 Correction made on page 9

APPLICATION NUMBER: HDC2025-00193

ADDRESS: 2012 WABASH

SCOPE: ERECT SINGLE-FAMILY DWELLING, INSTALL ROOFTOP SOLAR PANELS

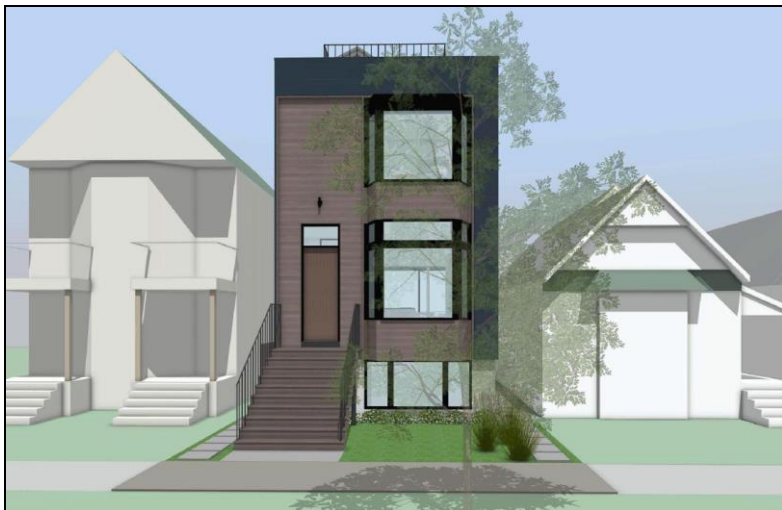
Applicant's renderings and site plan of the proposed dwelling.

Top left: Façade facing Wabash.

Top right: Site Plan, oriented east/west – Wabash is at the bottom and the alley at the top. 2012 Wabash is outlined in red.

Middle: View looking southeast of the façade and north-side elevation.

Bottom: Rear/east elevation.

Per the submitted drawings and documents, the applicant proposes to erect a two-story, with basement, single-family house. The dwelling will feature thermal modified wood siding, metal shiplap siding and a metal standing-seam roof. Solar panels are proposed for the south-facing roof. The site plan shows the rear yard tree will be retained.

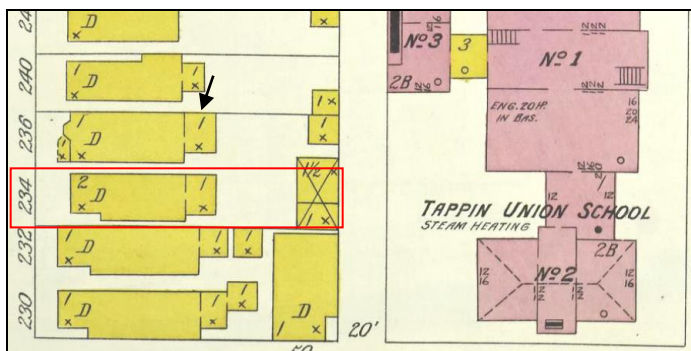
Vol. 1, 1897 Vol. 1 Sanborn map.

The number in the top left corner of each wood-framed (yellow) dwelling indicates the number of floors.

- The Sanborn maps show the now-demolished dwelling at 2012 Wabash was a two-story house and centrally located amongst single-story houses; the dwelling was demolished in 1935. The maps also show changes were made to the house directly north at 2014-2016 (236) Wabash, as it went from a single-story house to a two-story house between 1897 and 1921.

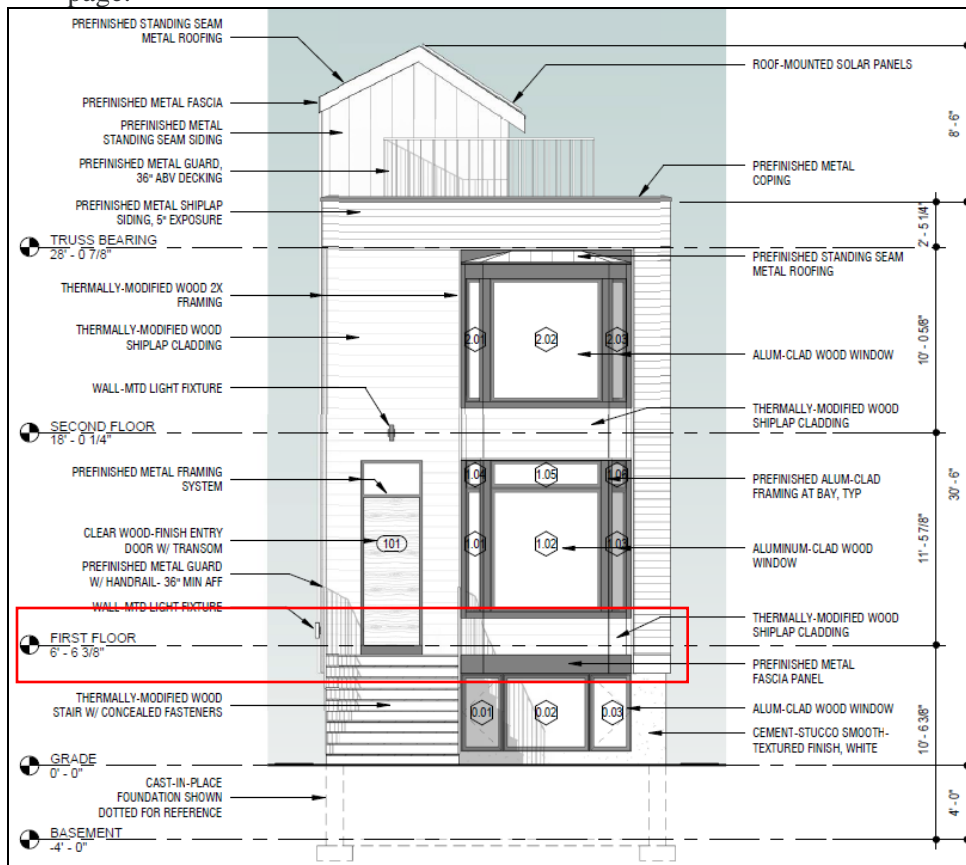
The applicant's dimensioned drawing shows how the exterior wall of the bay window extends below the interior's finished floor height, allowing for visual alignment with the first floor (and exterior porch floor) at 2014 Wabash.

- The three historic houses all have raised basements, but the basement at 2014 Wabash is the tallest, allowing for large window openings. This creates a slightly higher first level floor height in contrast to the 1-½ story houses to the south. However, the top of the first floor bay window at 2014 Wabash is aligned with the top of the exceptionally large window at 2006 Wabash, minimizing the height different of the first floor.
- As shown below, the new dwelling's first floor exterior cladding of the bay window extends below the finished floor, thus creating visual alignment with the floor height of 2014 Wabash. However, the impact of the raised basement and increased ceiling heights of the interior rooms, causes the window openings to be out of alignment with the neighboring houses, as outlined in the photo at the bottom on the previous page.

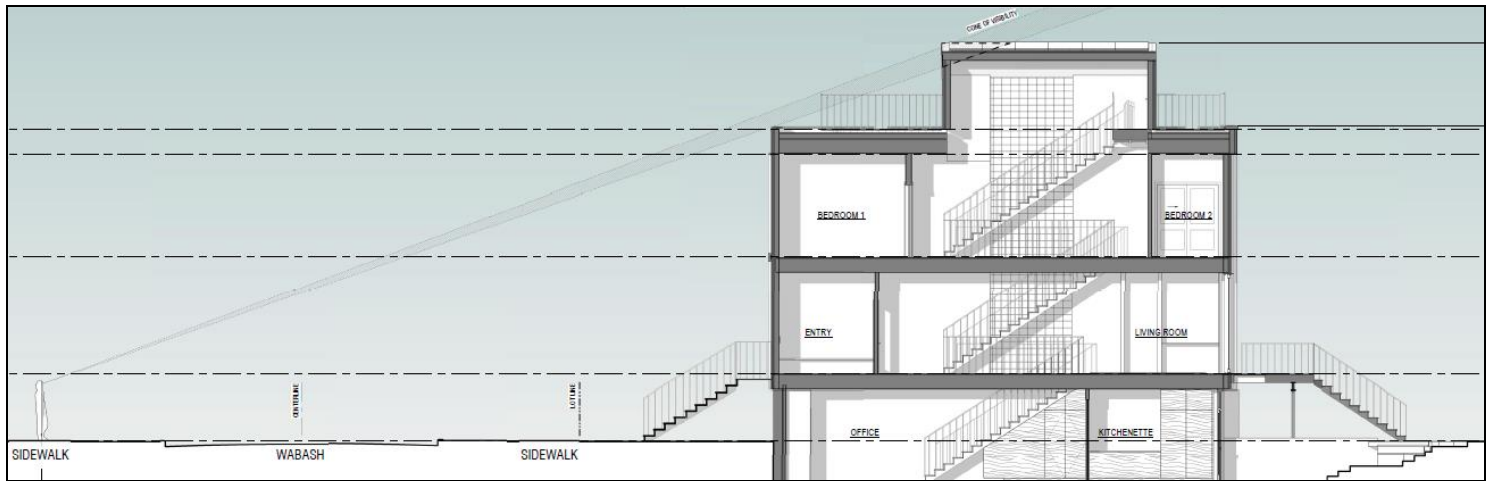
Above: Applicant visual study. Right: Detroit Parcel Viewer

- The applicant supplied this visual study to show the portions of the rooftop patio railing and penthouse that will be visible from the west side of Wabash. Staff believes additional studies should be submitted for the Commission to understand how visible these elements will be from north, south and east views. The east view will be highly visible as Mullett Park is behind this lot.

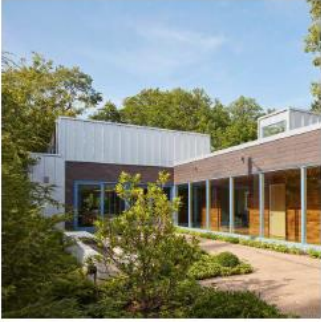
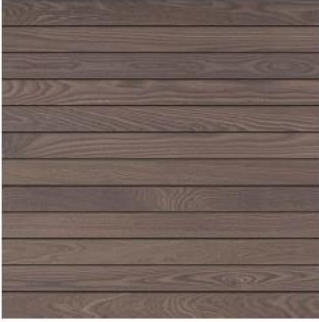
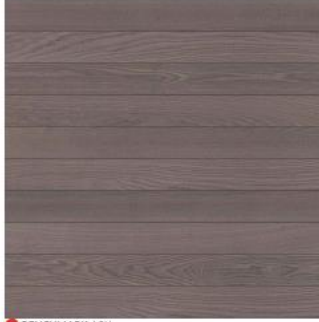
Excerpt from the applicant's materials page of the application.

<p>24" ON STANDING SEAM METAL PANELS MANUFACTURER: PAC-CLAD TOP PANEL: SMOOTH MIDCH: KYNAR-COATED COLOR: WEATHERED ZINC</p>

<p>BENCHMARK ASH SERIES MANUFACTURER: THERMORY DECKING: 1-1/4" GROOVED WITH CONCEALED FASTENERS FRAMING: 2x4x8 TRIM FINISH: UNGLUED</p>

<p>VESTA 5" Plank - Solid 5PS12 Steel 0.020"</p> <p>VESTA SERIES MANUFACTURER: QUALITY EDGE PROFILE: 5" STEEL PLANK SIDING FINISH: MENDOTA BLUE SMOOTH</p>
SIZE	THICKNESS	WEIGHT	FINISH																				
1-1/4"	1/2"	1.2	Smooth																				
1-1/2"	1/2"	1.5	Smooth																				
1-3/4"	1/2"	1.8	Smooth																				
2"	1/2"	2.1	Smooth																				
STANDING SEAM METAL PANELS	THERMALLY MODIFIED WOOD DECKING & FRAMING	THERMALLY MODIFIED WOOD SIDING	PREFINISHED METAL SIDING

- These elements discuss the relationship of materials, textures and colors.
- Staff will refrain from discussing the materials selected for the structure until physical samples of each cladding material are submitted for review. Staff offers hesitation on the thermally-modified wood siding (product information on the following page), as the visual shown on the manufacturer's website has a defined wood grain pattern, which traditional wood siding does not. Staff also would like to see how the two different horizontal cladding materials work together as they will be adjacent each other on the front and rear walls, as well as the third cladding material (vertical prefinished metal standing seam) specified for the patio penthouse.

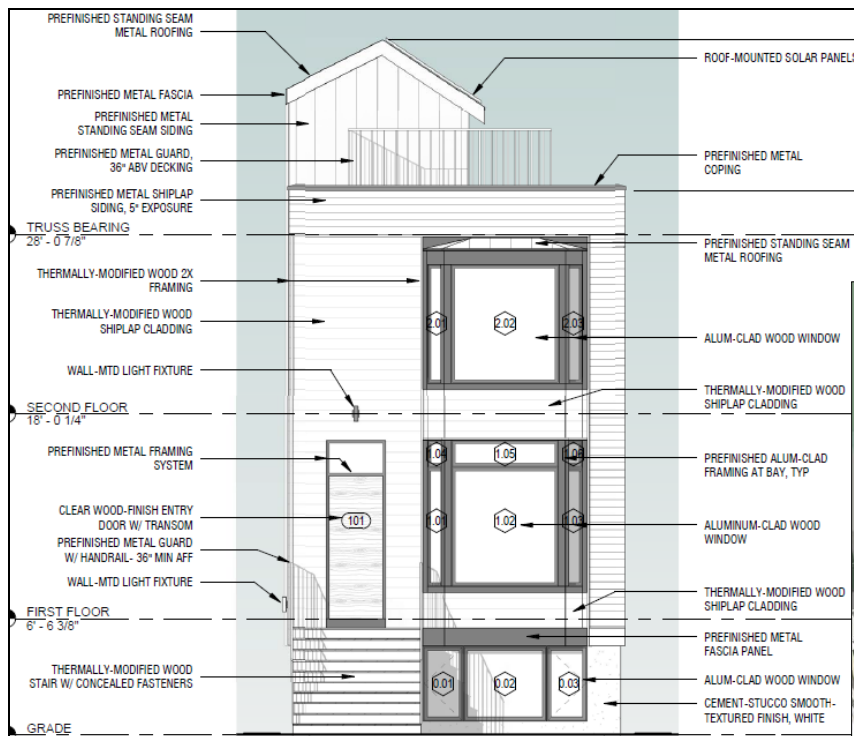
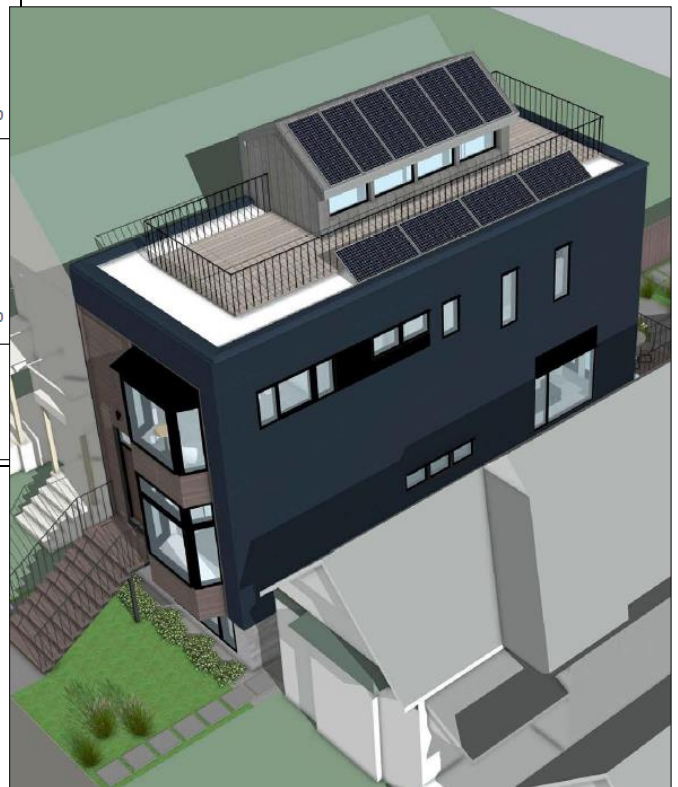
Applicant documents. Above: Elevation of façade.

Right: Rendering looking northeast from above.

- Solar panels are proposed for the third floor. The roof plan and elevation shows panels on the south-sloping roof, however the rendering shows an additional array on the flat roof, between the patio and roof edge.

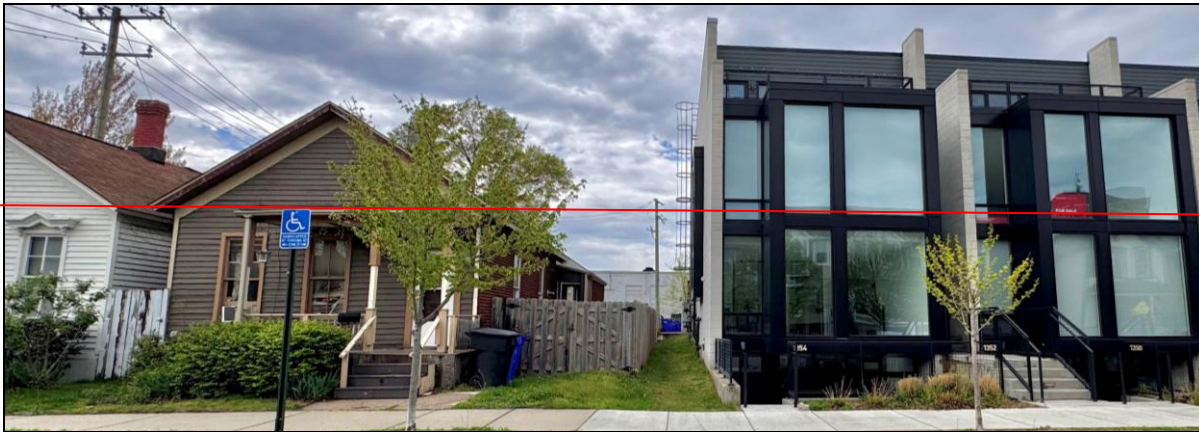
These one-story vernacular houses are at the west end of the new development. The condos have three floors, but the third floor is recessed from the street (with a repeating flat roof) which minimizes the visibility of the upper porch railings so the dominant, and mostly transparent façade walls, read as a two-floor structure. The basement is accessible from the street by stairs leading to a lower patio; this allows the first floor to be only slightly above grade and in alignment with the adjacent historic dwellings. The entrances are recessed, which offers a similar secondary effect (i.e., letting the building read as the dominant element) as the adjacent historic house whose entry door is accessed by a covered porch, which extends forward from the primary wall.

1336 – 1354 Bagley – condominium development. It is located between 19th century dwellings and across the street from a multi-family development that was erected in 1997. The height of the condominiums are not out of scale with the buildings on the south side of Church, where the ridge of the gabled roof is similar in height to the townhouses.

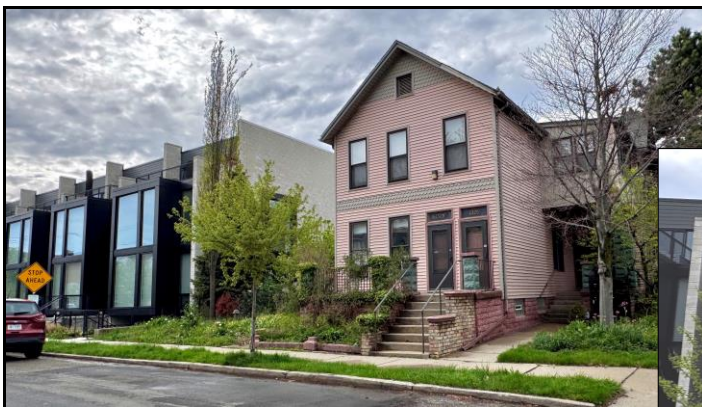
This is the east end of the condominium development. The new building's roofline remains at, or under, the ridge of the two-story historic house (which is a bit taller due to its slightly raised basement). The mostly transparent façade of the contemporary building subdues its modern and unornamented design, allowing the textured walls of the 19th century houses to remain a dominant architectural expression on the north side of the street.
Staff photos, May 2025.
