STAFF REPORT: 09/10/2025 REGULAR MEETING

APPLICATION NUMBER: HDC2025-00539

ADDRESS: 1724 SEYBURN

SCOPE: REMOVE EXISTING CANOPY, ERECT NEW FRONT PORCH ROOF AND COLUMNS, ALTER REAR PORCH, ALTER DOORS/WINDOWS, OTHER REHABILITATION WORK

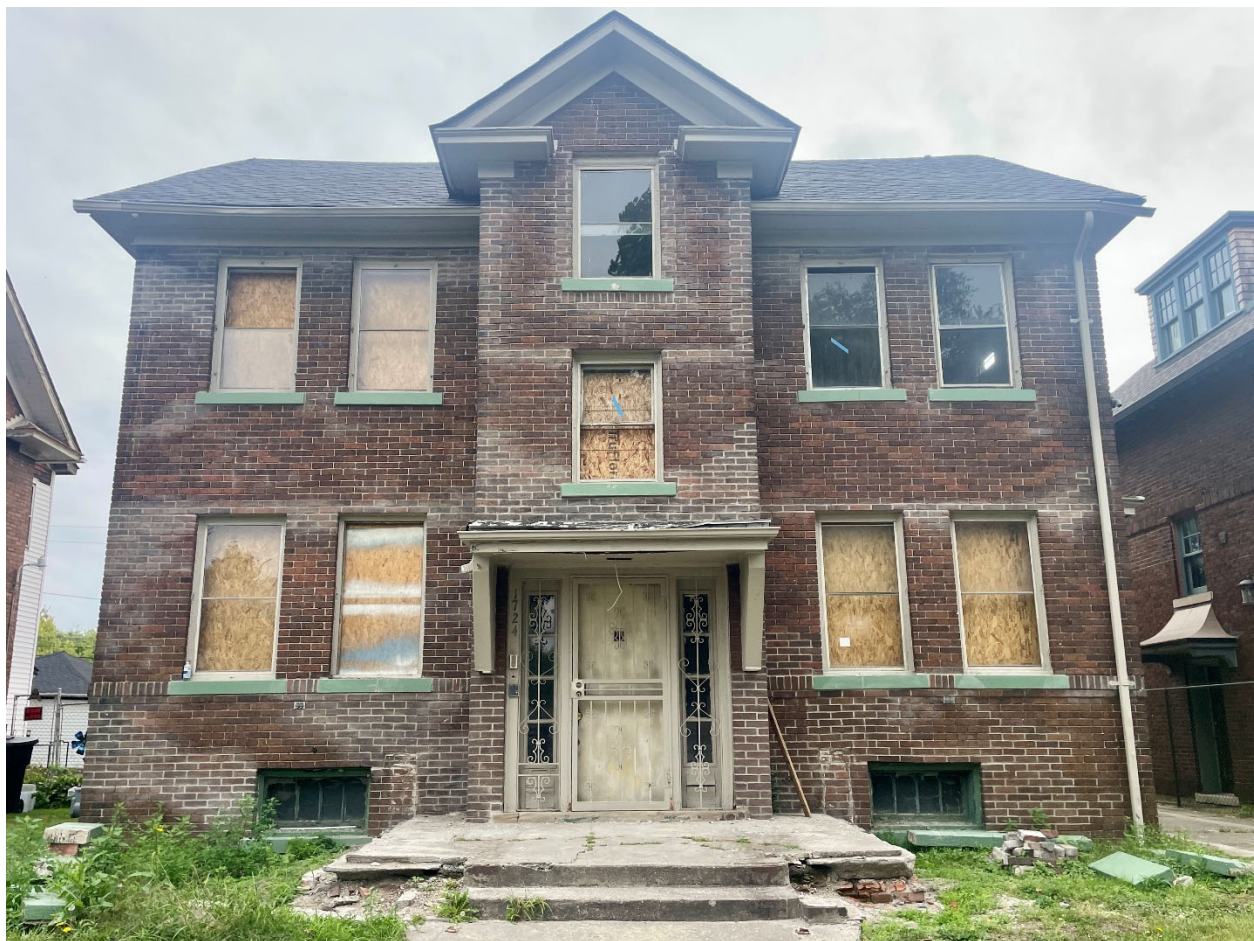
The dwelling located at 1724 Seyburn in Detroit, built in 1912, is a brick Colonial Revival with Craftsman-style influences. The house is two-and-a-half stories and features a side-gabled roof with a centered, front-facing gable, creating a symmetrical façade. The Craftsman influence is evident in the multi-pane upper sash windows over single-pane lower sashes. This blend of styles reflects early 20th-century architectural trends that combined traditional forms with emerging modern details.

Staff photo, 08/28/2025

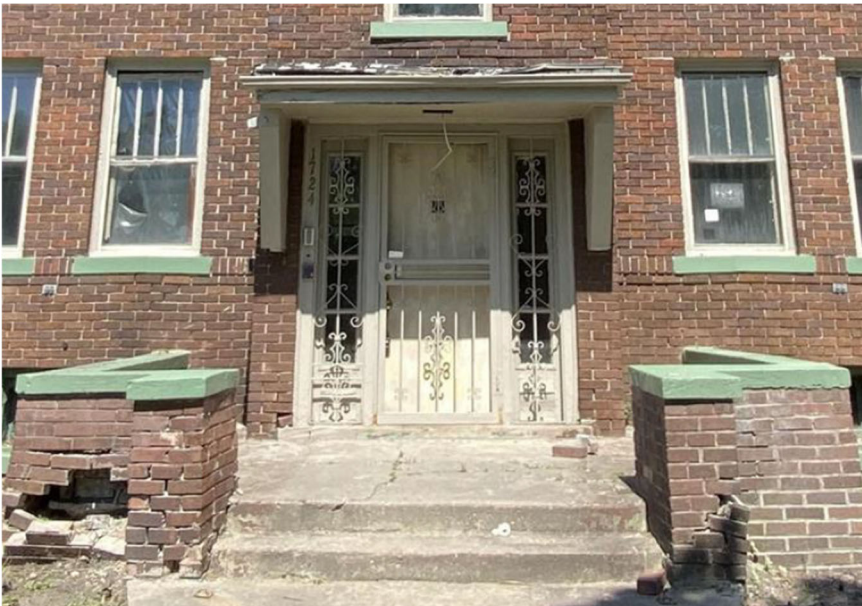
Photo from application of existing condition

- The existing roof canopy, with its angular supports, flat roof, and minimalist design, appears to reflect a design that would be more typical of a mid-century build, contrasting with the more colonial and detailed entrance canopies of surrounding properties.

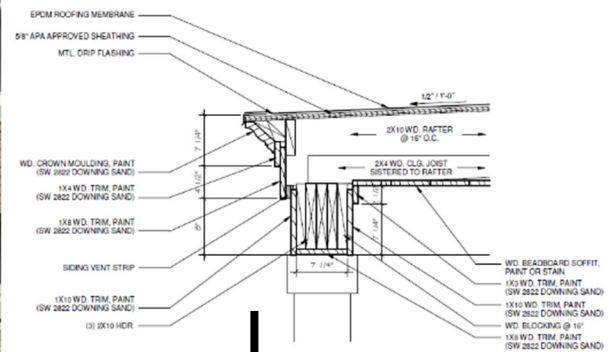
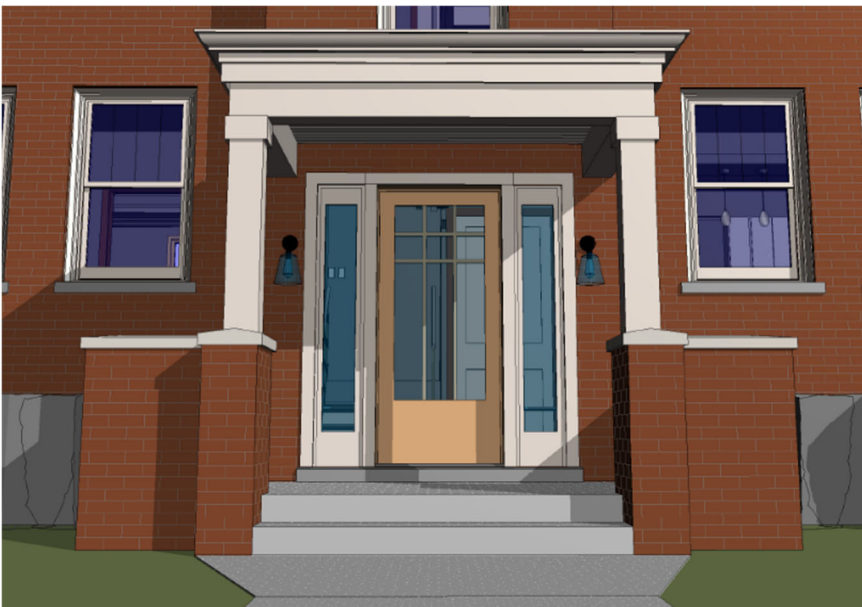
Rendering from application of proposal

- Considering the existing porch canopy is likely not original, it is staff's opinion that the massing, style, and materiality of the proposed front porch canopy/roof is appropriate.

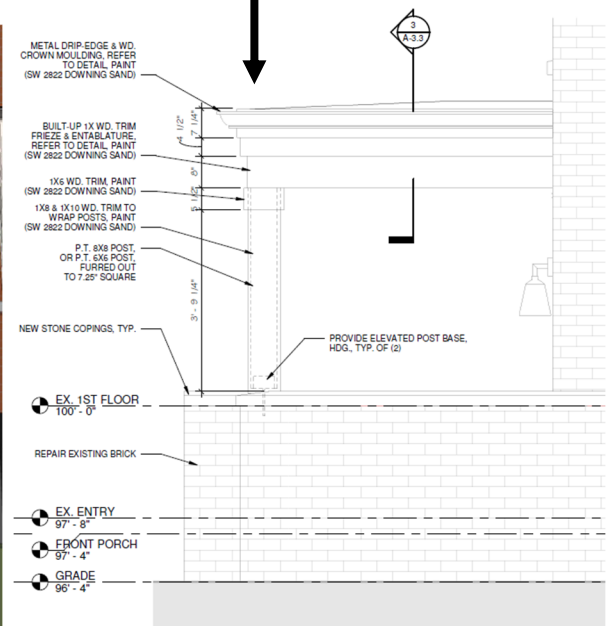
Drawings from application

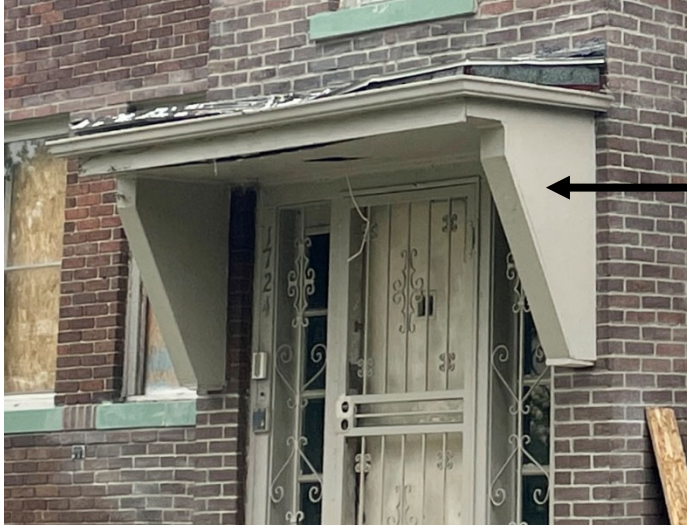
Staff photo, 08/28/2025

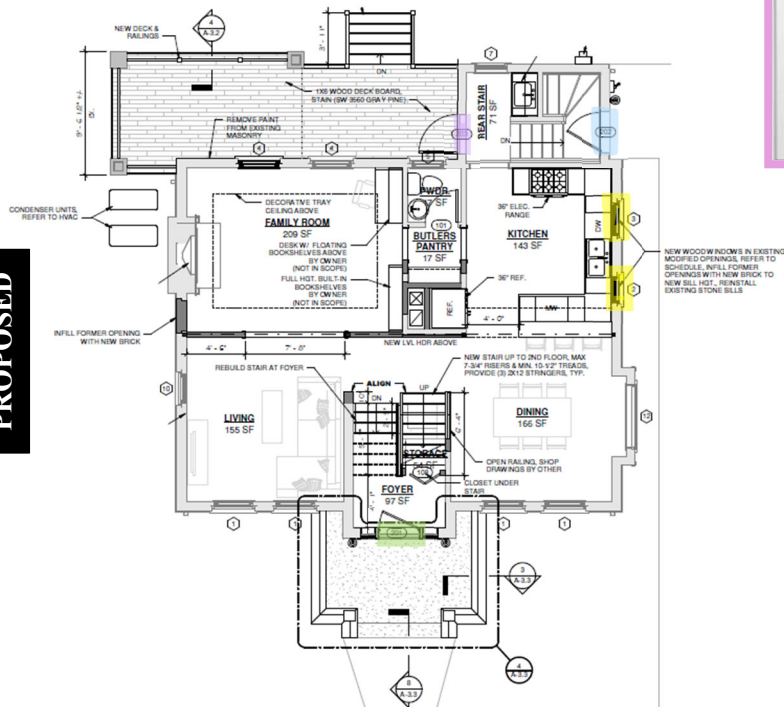
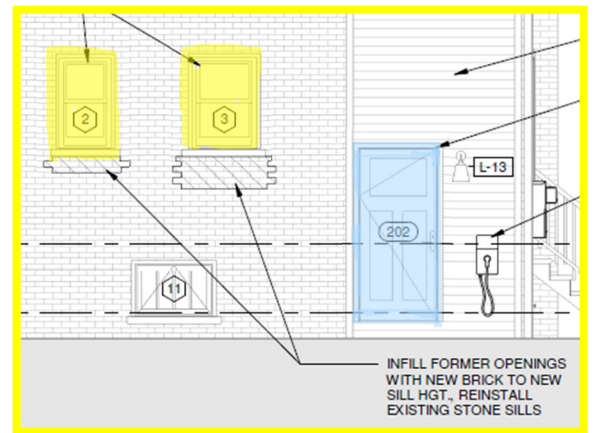
PROPOSED

New windows to be wood double-hung

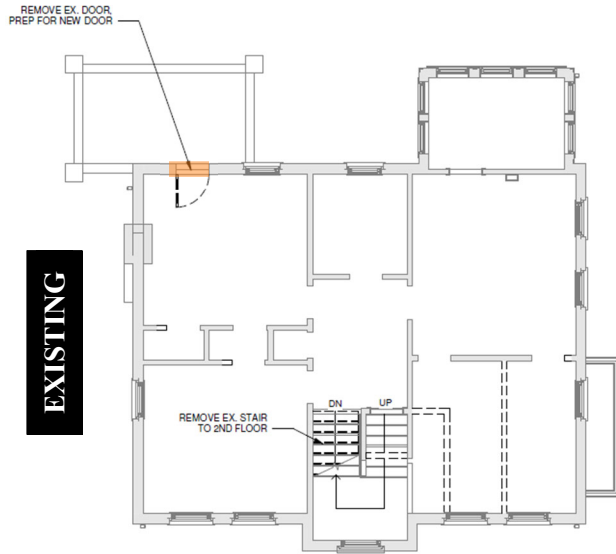
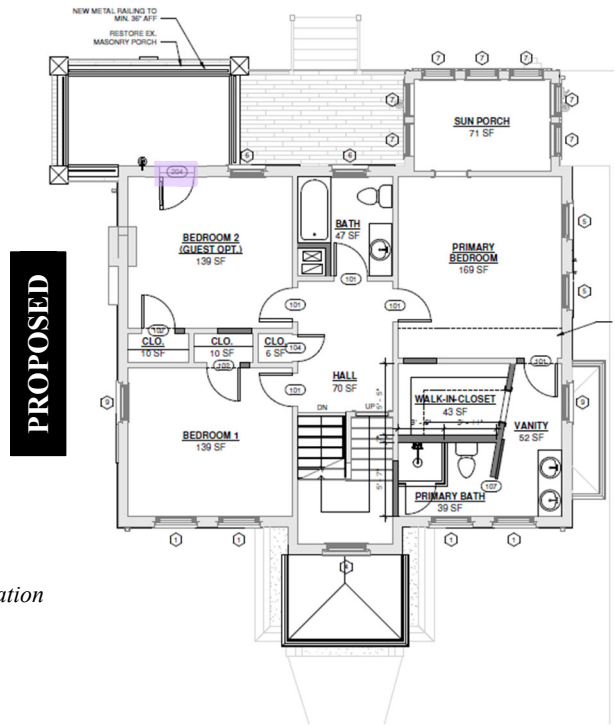
SECOND FLOOR

Drawings from application

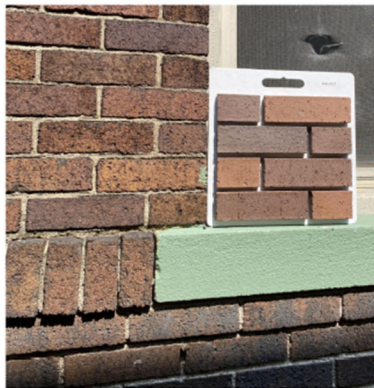
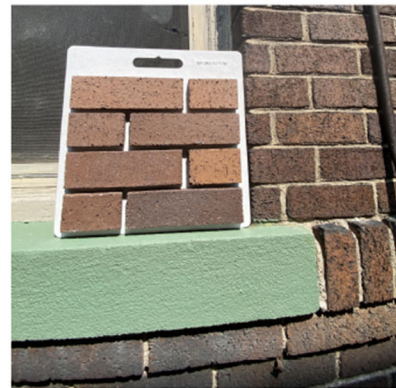
INTERSTATE BRICK - WALNUT

INTERSTATE BRICK - BRONZESTONE

INFILL BRICK TO MATCH EXISTING
INTERSTATE BRICK - BRONZESTONE & WALNUT BLEND - SHOWN IN SAMPLE BOARDS

Photos from application

- In areas where infill brick is proposed, a mix of Interstate Brick in the Walnut and Bronzestone colorways will be used. This infill brick combination was already previously approved for masonry repairs with HDC2025-00443.

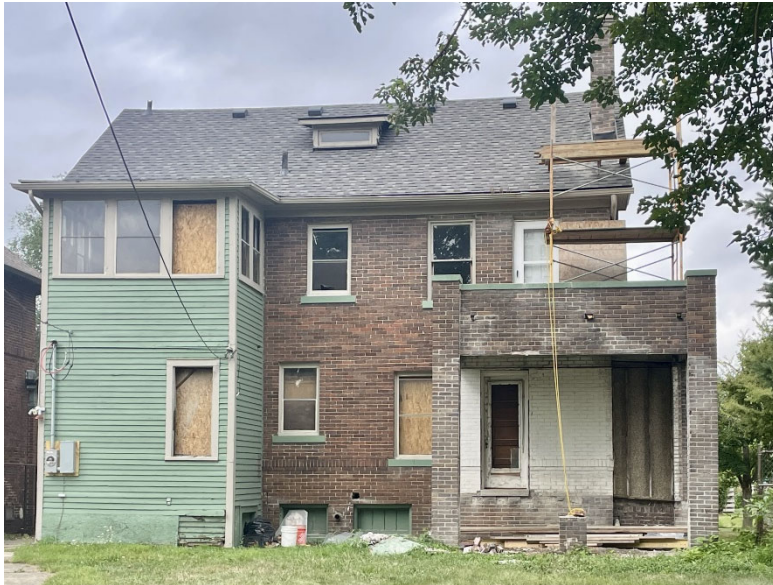
Staff photo of existing condition, 08/28/2025

- The applicant states that “the rear masonry porch has failed at its concrete slab.”

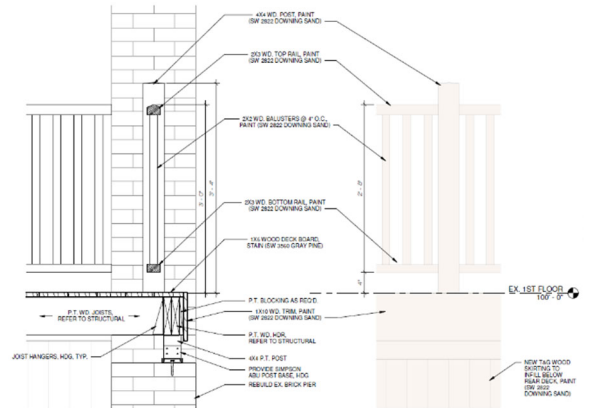
Elevation drawing from application

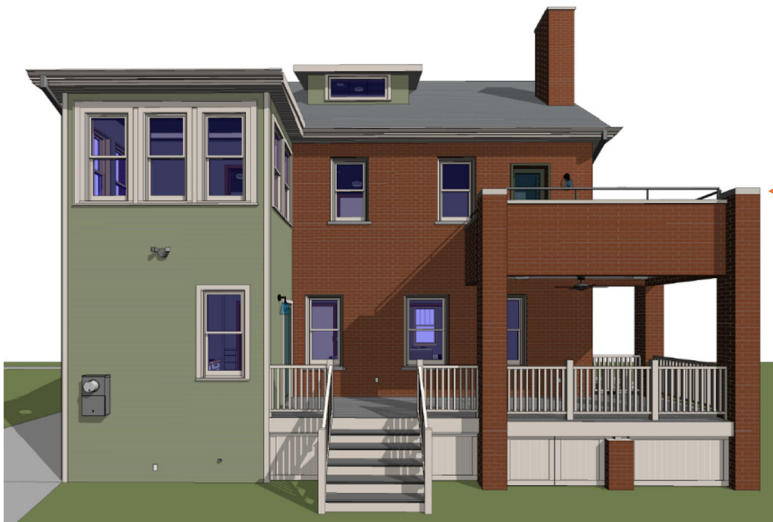
Rendering from application of proposal

1-1/2" Diam pipe, painted black, 12" H to be installed/fastened on top of the existing coping

Wood railing, 36" H

Tongue and groove wood skirting

- Staff finds the proposed scope of work for the rear porch to be appropriate but would like to note that the second level of the existing porch does not appear to be historic. The 1915 Sanborn map, as shown on page 2 of this report, and a 1951 Sanborn map indicate that the rear porch was historically only one level.

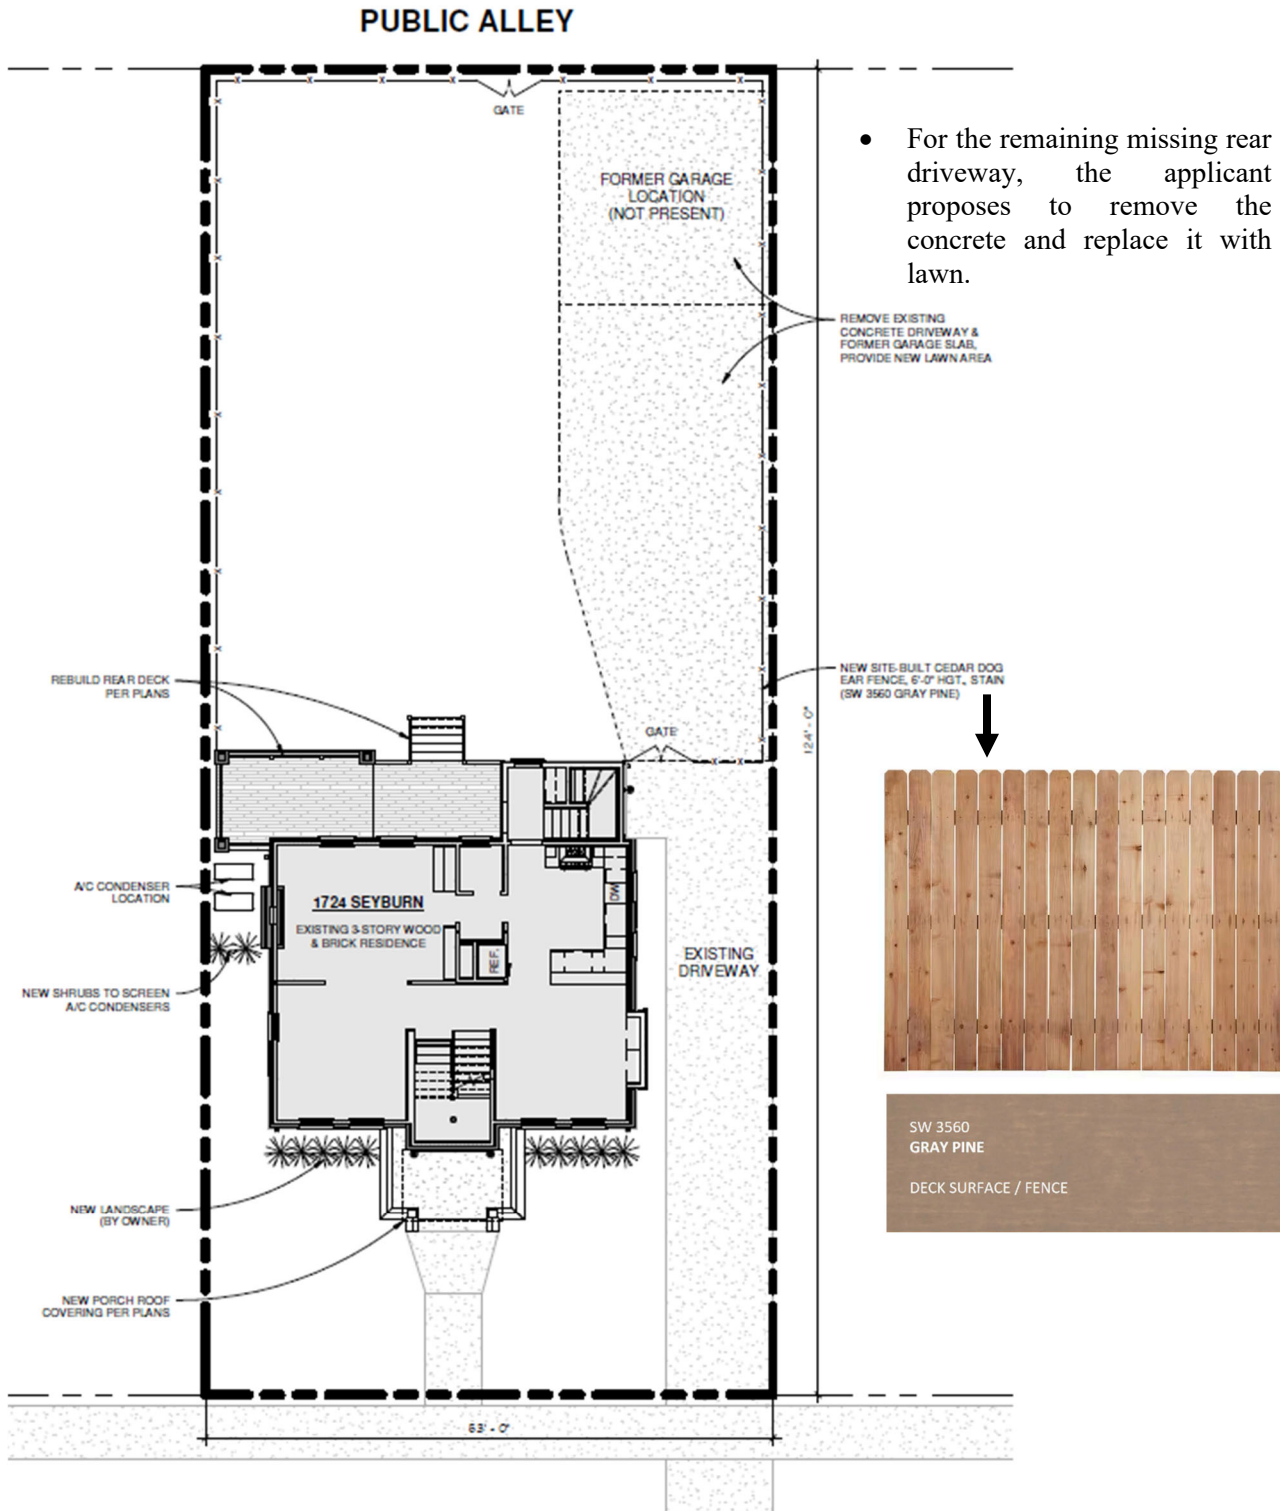
Materials from application

- Staff finds that the proposed fencing complies with the Historic District Commission's Fence and Hedge Guidelines, and that the landscape alterations, including the removal of the rear driveway, the addition of shrubbery, and the installation of AC condenser units, do not alter the historic character of the property, nor damage any historic features.

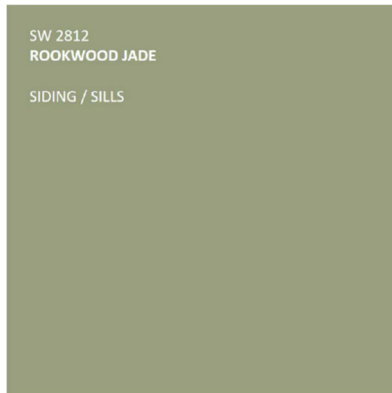
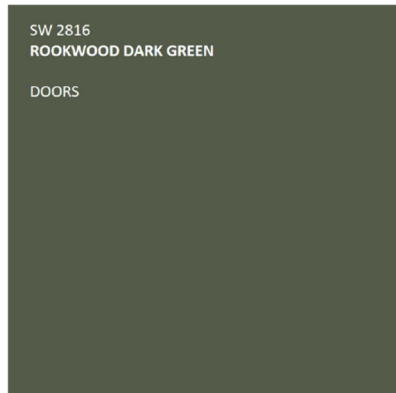
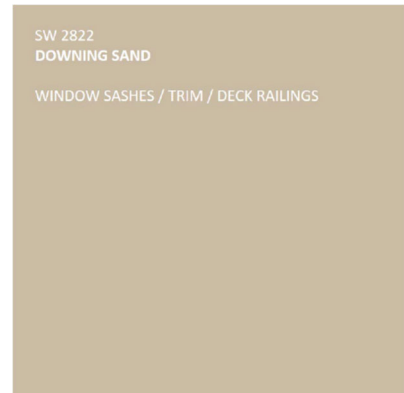
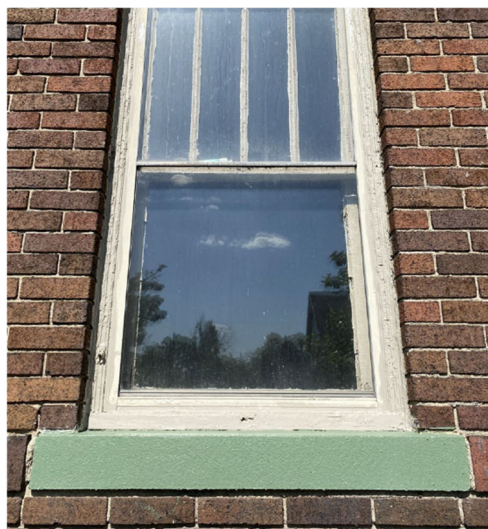
Photo from application

- The proposed colors generally follow the Historic District Commission's Color System E.
- The application proposes to re-paint the window sills. Since limestone window sills were historically not painted, it is staff's opinion that the existing paint should be removed.
