STAFF REPORT: 10/08/2025 MEETING

ADDRESS: 264 WATSON

APPLICATION NO: HDC2025-00592

SCOPE: ERECT PORCH AT FRONT AND SIDE

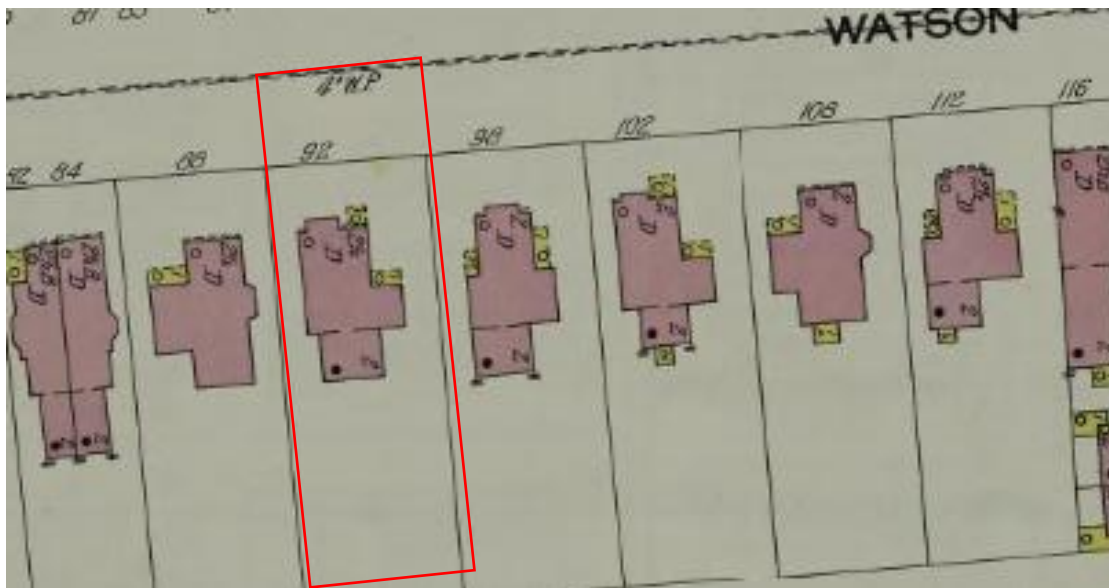
Sanborn Insurance Fire Map, 264 Watson, 1887. Note that the building is addressed as 92 Watson at this time

- The above Sanborn Maps indicate that the building had a distinct east side and a front porch as early as 1887. This condition continues to the current day.
- With respect to the current front porch, a review of HDC records revealed that the house was rehabilitated in 1981 under a City-funded, home repair program. Exterior work items included the installation of a new asphalt shingle roof, the addition of the current ornamental woodwork/vergeboard at the front facades gable end, the addition of new columns at the front porch to match those present at the historic east side porch, and the removal of the rooftop rail at the front porch (see the below).

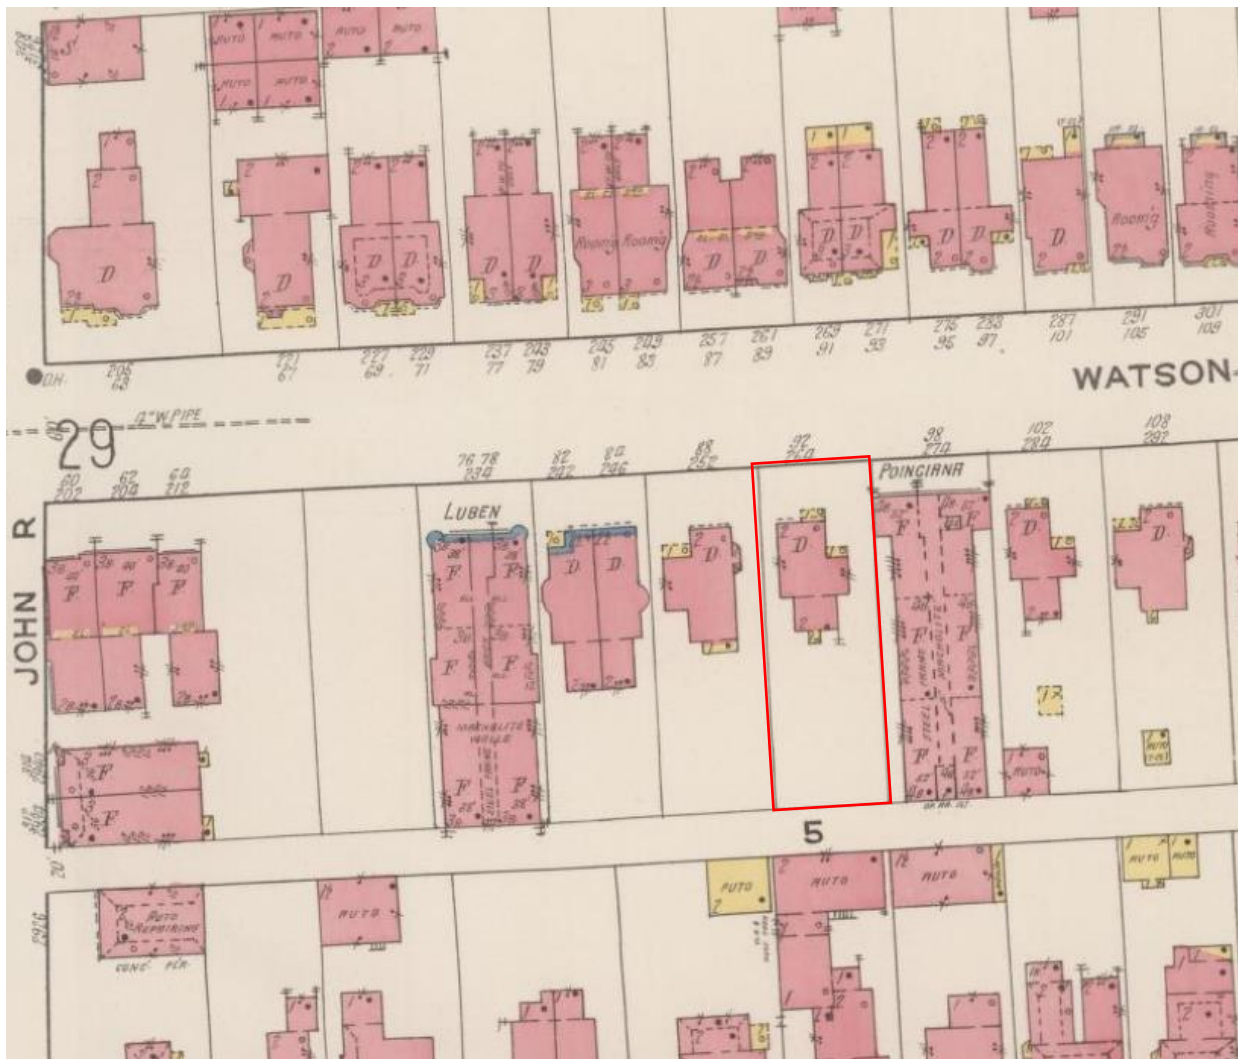
Sanborn Insurance Fire Map, 264 Watson, 192

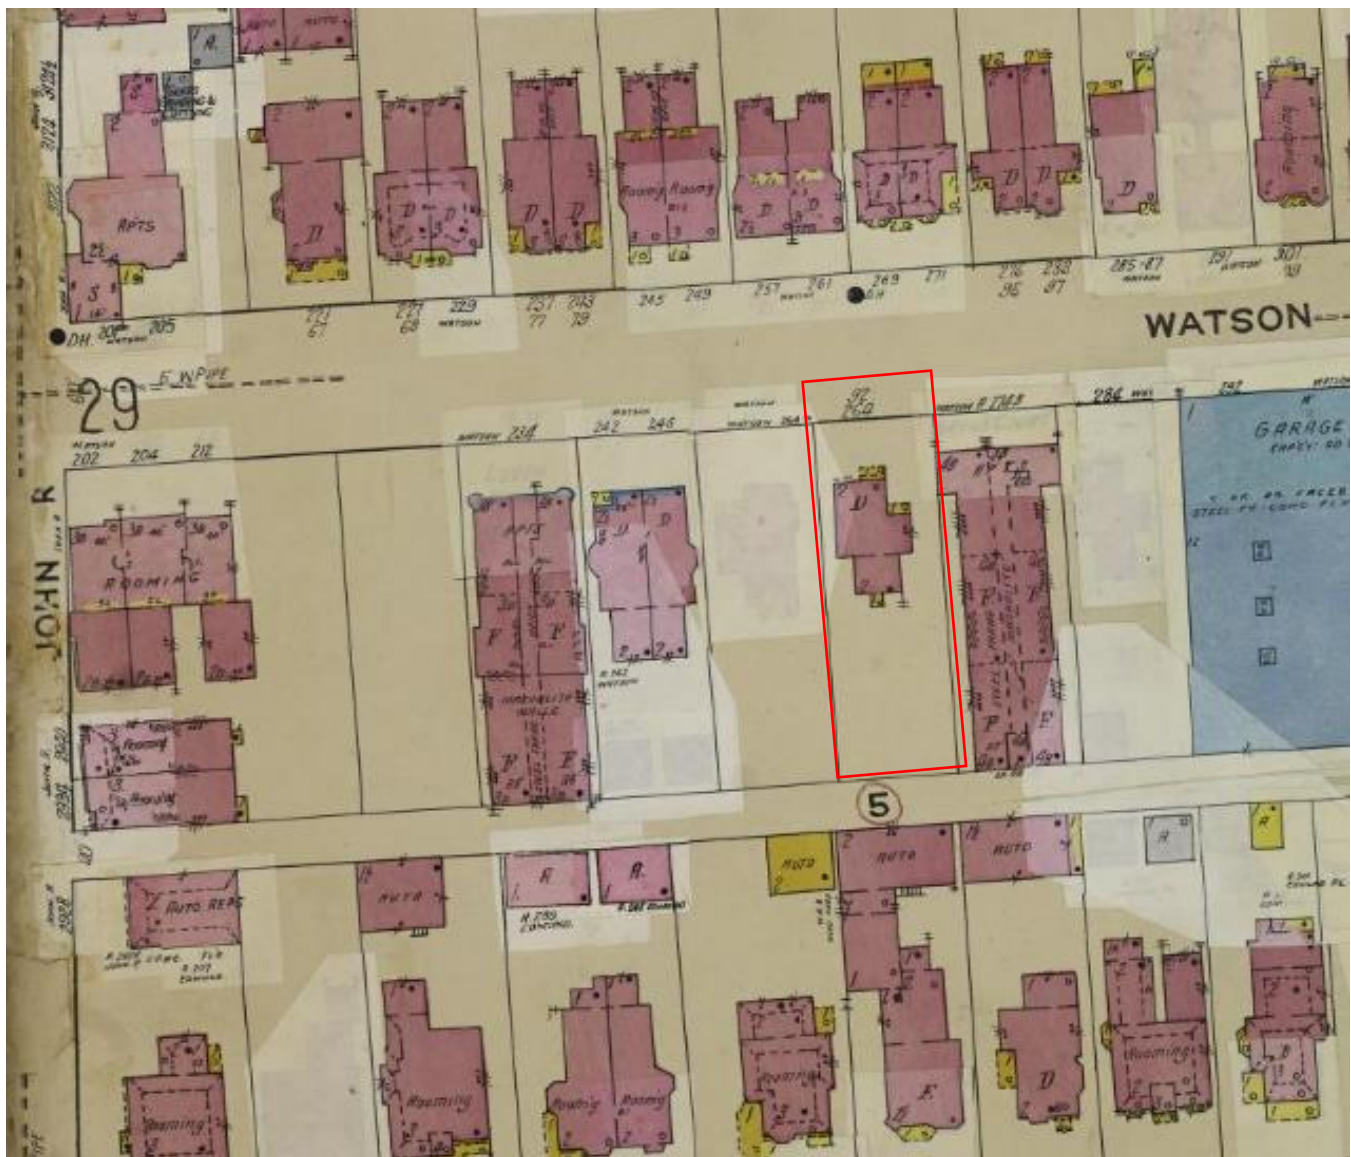
Sanborn Insurance Fire Map. 264 Watson, 1950

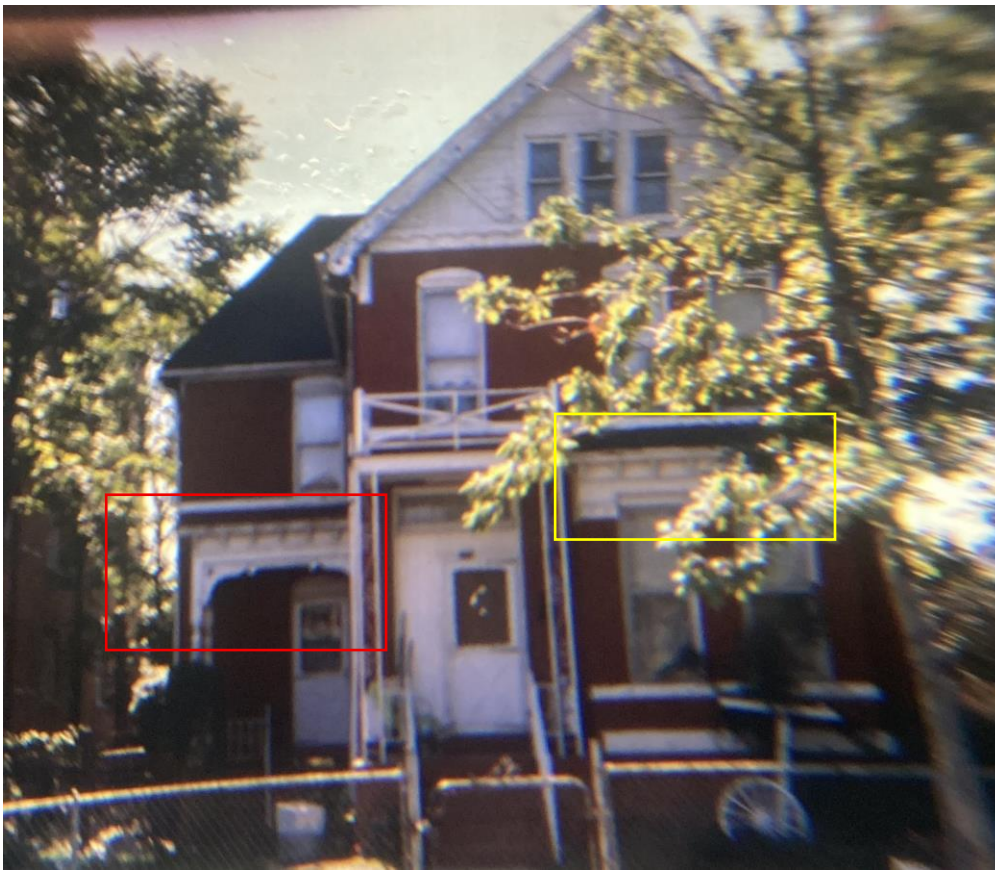
264 Watson, designation slide dating from 1980. Note that the side porch displays decorative detailing (outlined in red) which is consistent with the detailing at the front façade's bay (outlined in yellow)

- See the below photo of the house, taken in 1980 at the time of the district's local designation to note the following:
 - The east side porch was present and appears to be of historic age/original to the date of the house's construction. Note that the side porch displays decorative detailing (outlined in red) which is consistent with the detailing at the front façade's bay (outlined in yellow)

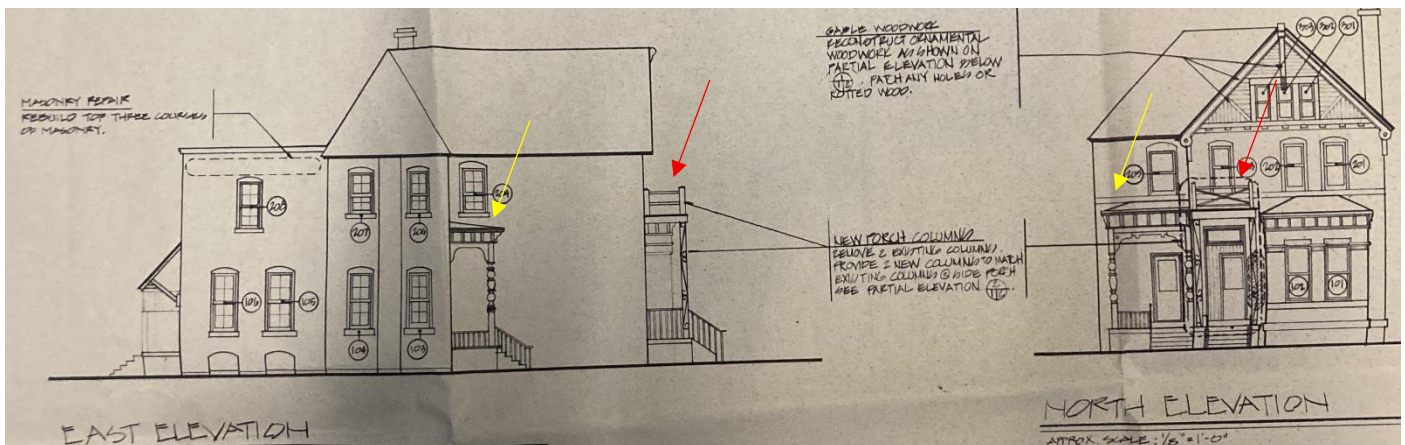
Rehab drawings from 1981 showing the front (yellow arrow) and side porch (red arrow) conditions at that time. The project proposes to replace the non-historic front porch with a new porch which takes design cues from the historic east side porch. Note that the side porch was not proposed for repair, likely because it was in good condition and retained elements that were consistent with the building's historic character.

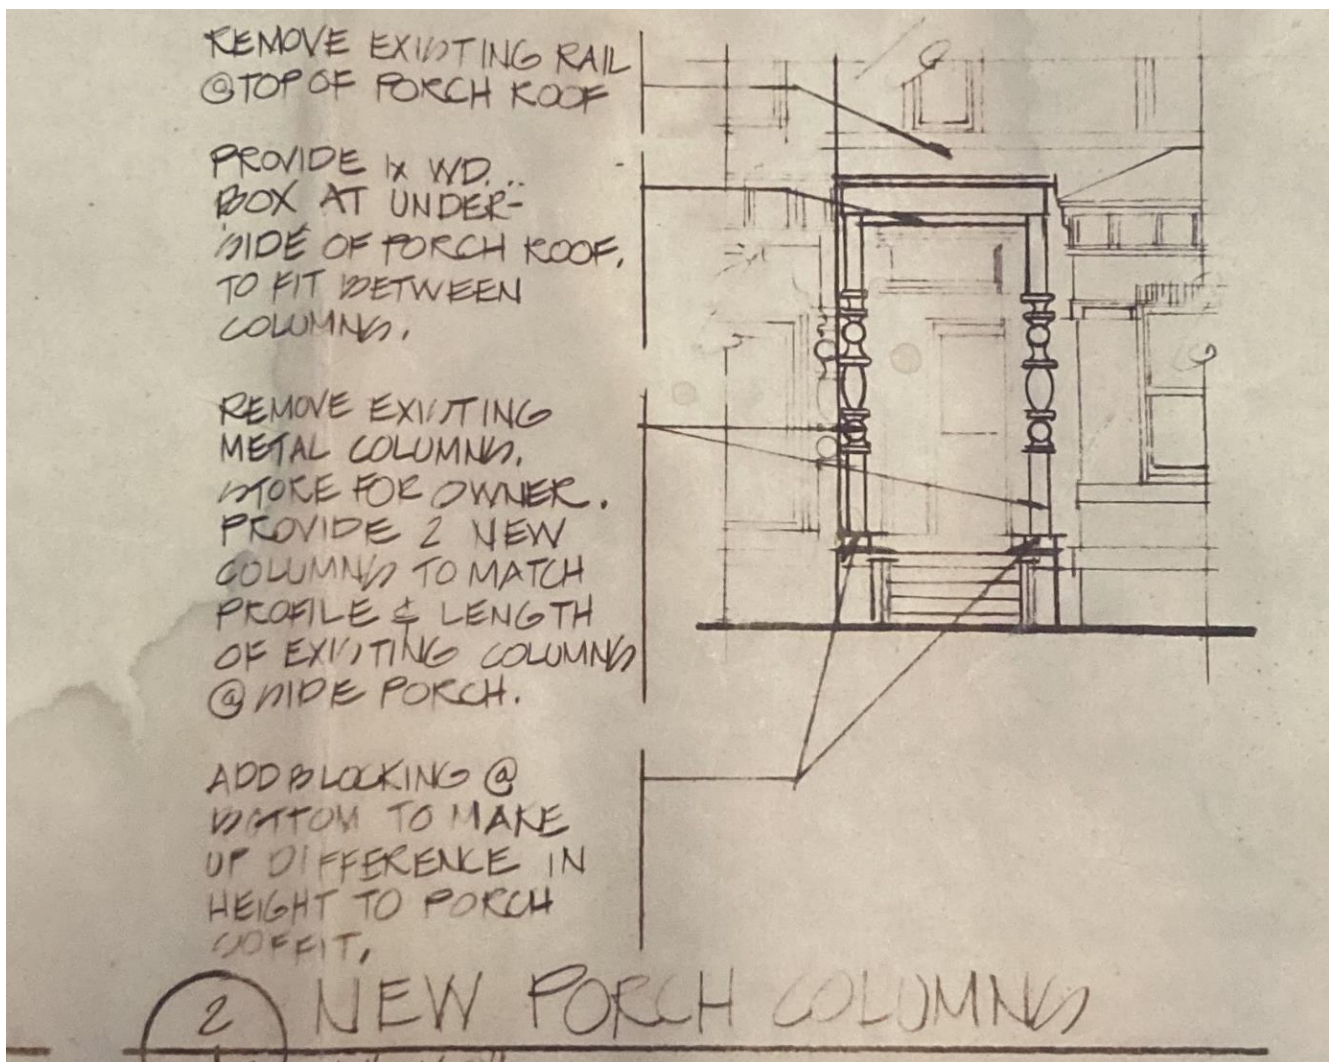
Rehab drawings from 1981, showing the proposed design of the new porch, which takes cues from the historic east side porch.

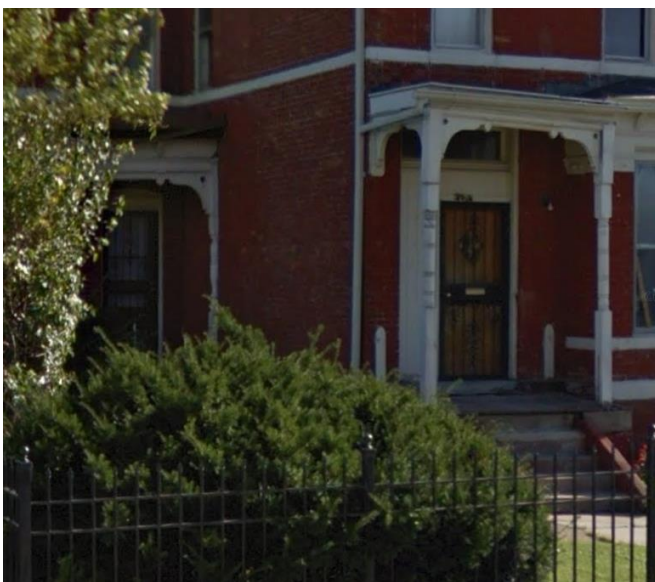
Google Streetview image, 2011. Showing the front porch which was added in 1981

- Google Streetview images indicate that the later, non-historic front porch which was added in 1981 was removed sometime between 2011 and 2013 without HDC approval, leaving the masonry steps. The current front porch columns, roof, and railings were installed in 2021 without HDC approval (see below). Staff supports the proposed removal of the current front porch as it is not of historic age and does not contribute to the property's historic character.

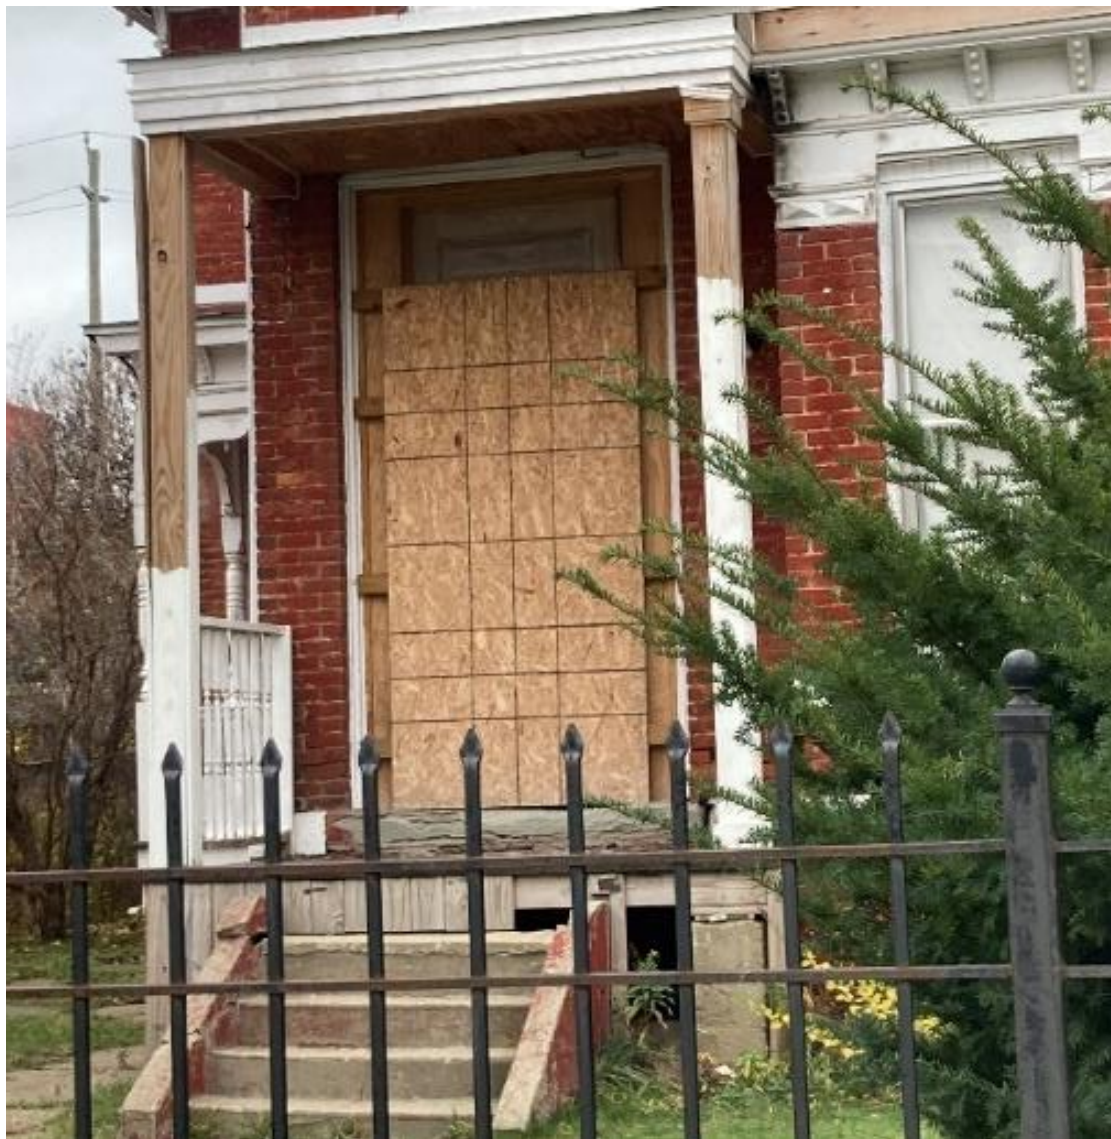
Front porch, current conditions. Photo by staff, 11/25/2024

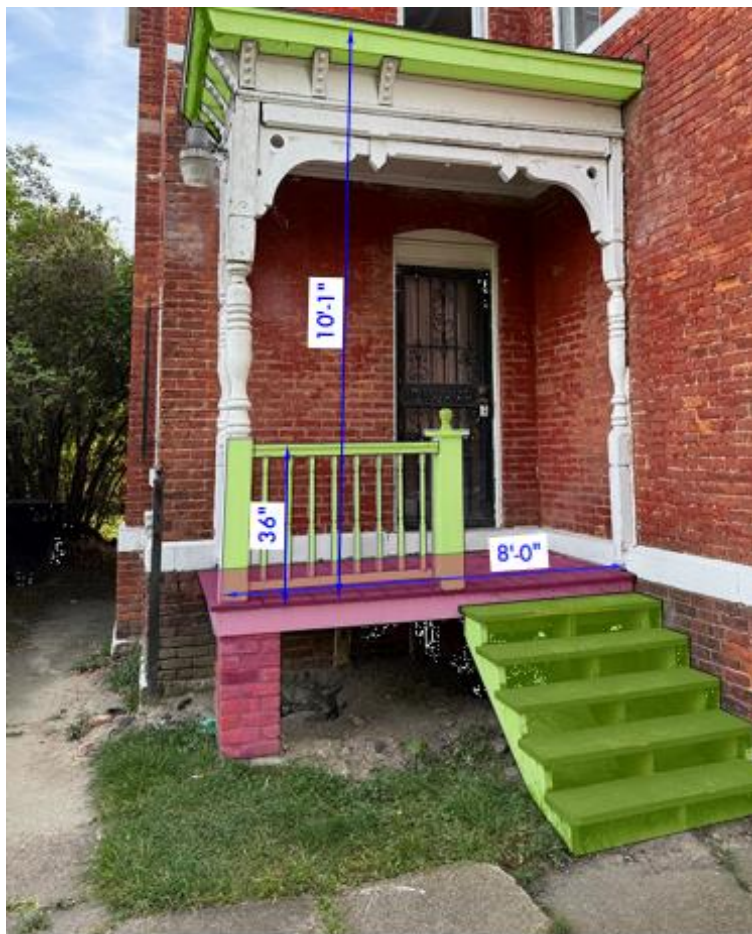
Existing historic side porch. Diagram by applicant

- With respect to the historic east side porch, staff notes that it currently appears much as it did at the time of local designation/when the building was identified as Contributing to the historic district. It is staff's opinion that the side porch is a distinctive character-defining feature of the building as it displays historic-age details which are associated with the Queen Anne style and are reflective of decorative detailing elsewhere on the building. A review of Sanborn maps (provided above) indicates that the porch has been extant since 1887. Also, note that the Commission determined that the east side porch was a distinctive, character-defining feature of the property at their 12/11/2025 regular meeting. The Commission upheld this position at their 02/12/2025 meeting. The porch also appears to remain in relatively good condition and therefore should be kept and, where deteriorated, repaired using in-kind materials. The below indicates the the areas/elements of the porch that are in poor condition and the elements that do not date from the building's original construction as noted by the applicant.

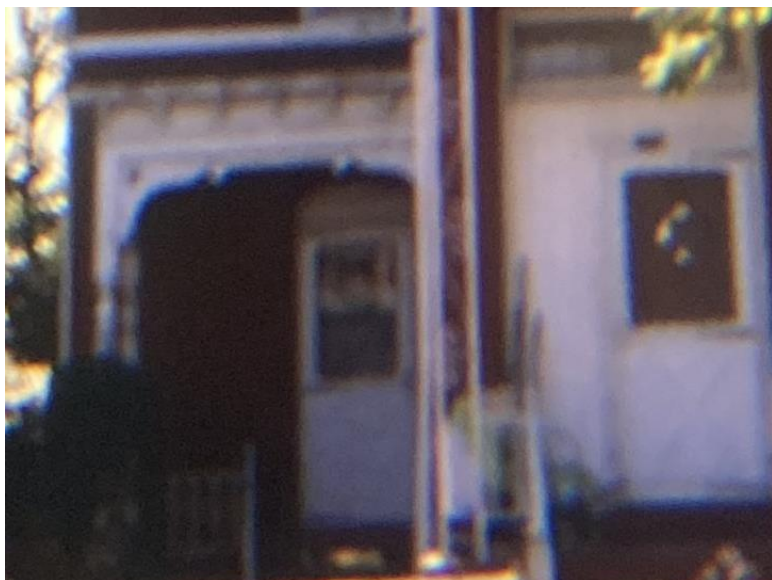
Appearance of east side porch in 1980, at time of local designation. Photo provided by HDAB
