STAFF REPORT: OCTOBER 8, 2025 REGULAR MEETING PREPARED BY: B. SALIE

APPLICATION NUMBER: HDC2025-00566

ADDRESS: 76 W. ADAMS

SCOPE: INSTALL STOREFRONT DOORS* & FLOOR TILES*, REHABILITATE ROOF CANOPY

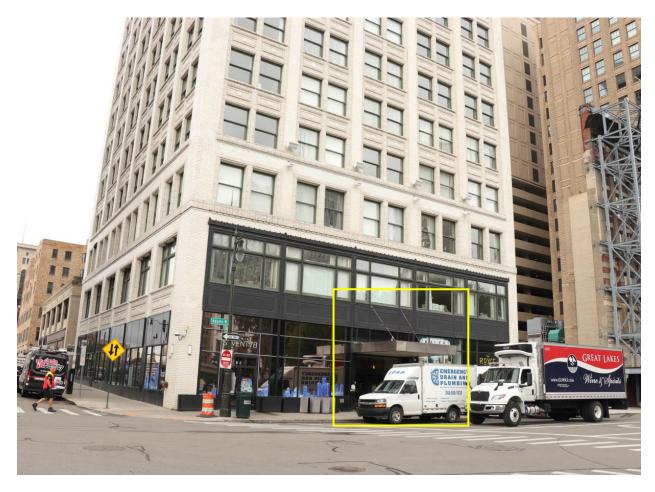
The Kales Building. 76 W Adams – Grand Circus Park Historic District. Photo taken by staff on 09/24/2025.

The Kales Building, formerly known as the Kresge Building (named after founder S.S. Kresge) is an 18-story skyscraper located adjacent to Grand Circus Park. The building features storefronts on the first and second floor, and apartment units from the third floor and above. The building underwent extensive rehabilitation in 2004, and still sits as one of Detroit's most prominent historic skyscrapers today.

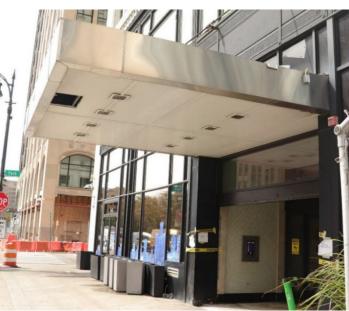
76 W Adams, storefront current appearance. Photos taken by staff on 09/24/2025.

- The district's designation report provides a description of the building's storefront in 2002: "The first floor retail storefronts have been reconstructed with brown granite piers and aluminum surrounds for plate glass. A bulkhead of brown granite continues to the ground. The original overhanging marquee awning recently fell from the building and was removed."

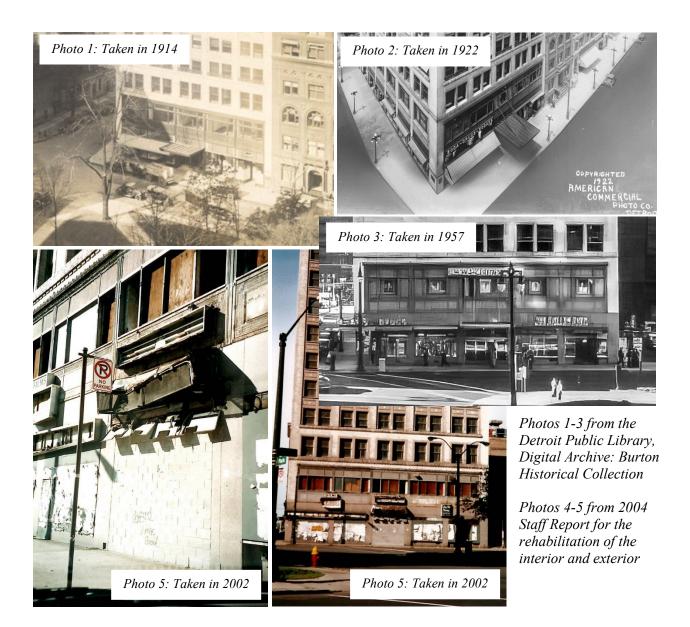
- The compilation of historic photos show that the first level storefront has undergone multiple alterations since opening in 1914.
- Also, the below elevation drawing indicates that the most recent storefront, to include the extant canopy, as well as the aluminum doors, sidelites, transom and floor tiles which were recently removed without HDC approval, were installed in 2004.

- Grand circus Park was designated as a historic district in 2002
- Grand Circus Parlk was listed on the National Register of Historic Places in 1985
- Sanborn Map shows the roof canopy as an original feature of the historic building; which is also visible in the historic photos shown on the next page.

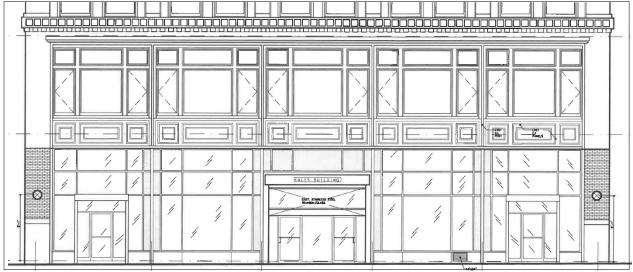
Elevation drawing of new aluminum storefront and canopy, approved by HDC in 2004.

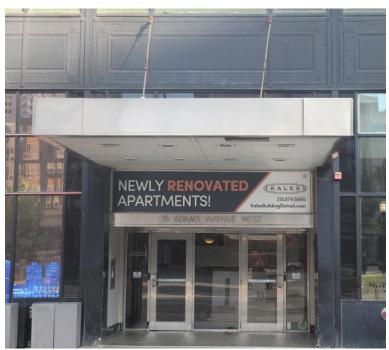
Storefront, canopy, and floor tiles that were installed in 2004. Photo provided by applicant. As noted previously, the transom, doors, sidelites and floor tiles captured in this photo were recently removed and replaced without HDC approval.

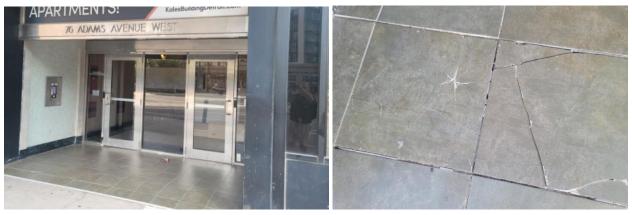
Non-historic, ca. 2004 floor tiles which were recently removed without HDC approval. Photos provided by applicant.

• The tiles that were removed without HDC approval were not of historic age and had no impact on the historic integrity of the building.
