**STAFF REPORT: 11/12/2025 MEETING**

**ADDRESS: 1427 EDISON**

**APPLICATION NO: HDC2025-0065**

**SCOPE: DEMOLISH GARAGE, ERECT GARAGE**

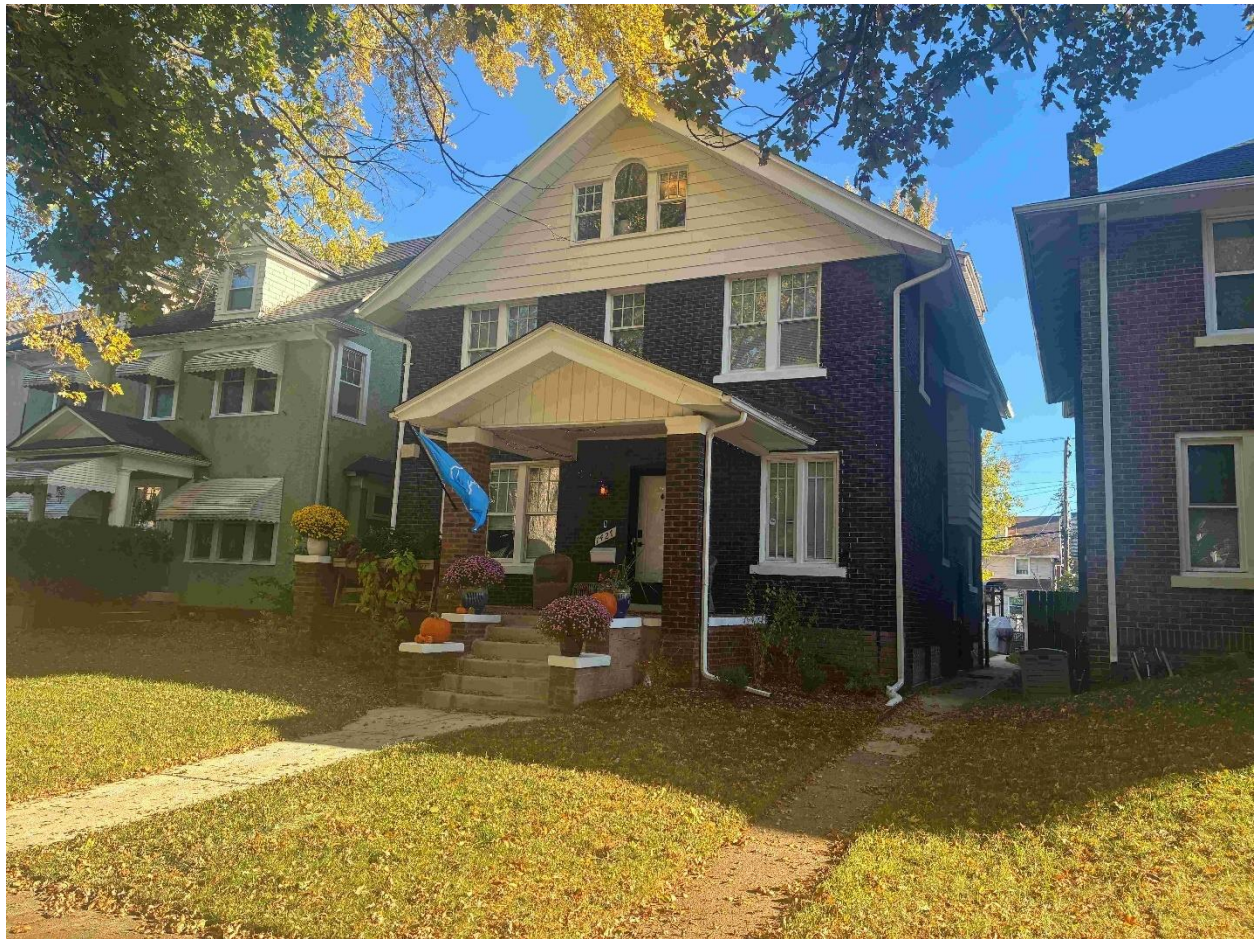
**1427 Edison. Photo by staff, taken 10/27/2025 showing current conditions**

The building located at 1427 Edison is a two-story, single-family dwelling that was erected ca. 1910. The building features a front-gabled roof with a lower, front-gabled porch at the façade. Aluminum currently encloses the roof's eaves. Exterior walls are primarily brick, while lapped aluminum siding is found at the gable ends at the front and rear walls. Windows are double-hung, aluminum-clad, wood units, installed in 2006. The rear yard includes a concrete foundation where a garage once stood.

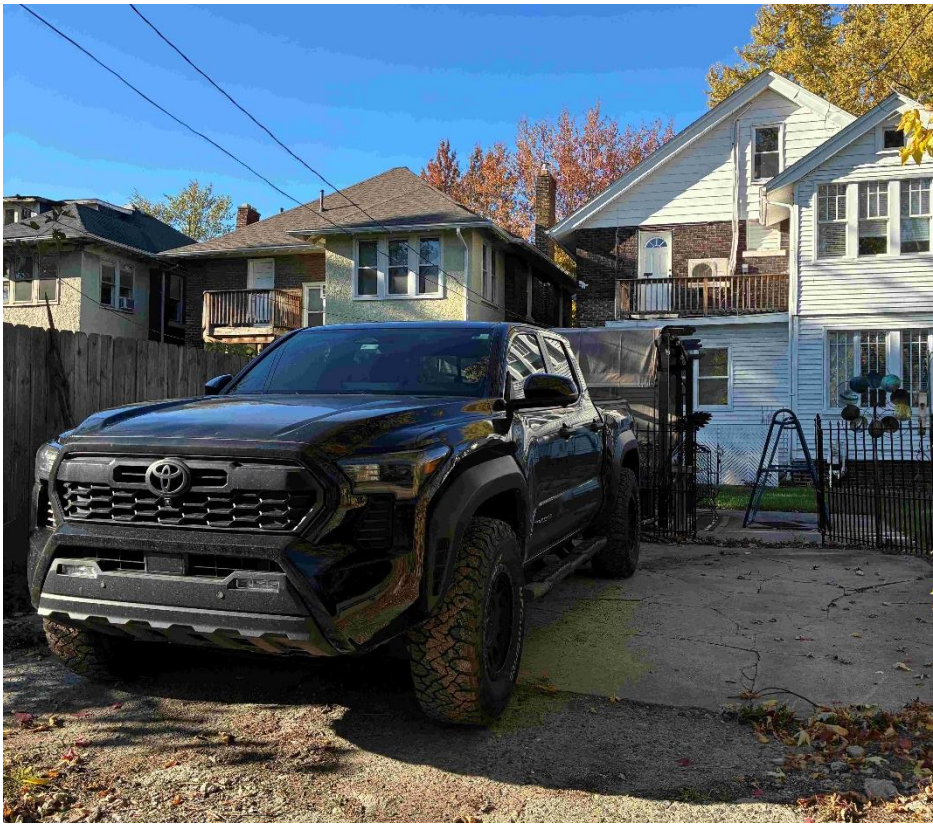
**1427 Edison. Photo by staff, taken 10/27/2025 showing current conditions at rear yard**

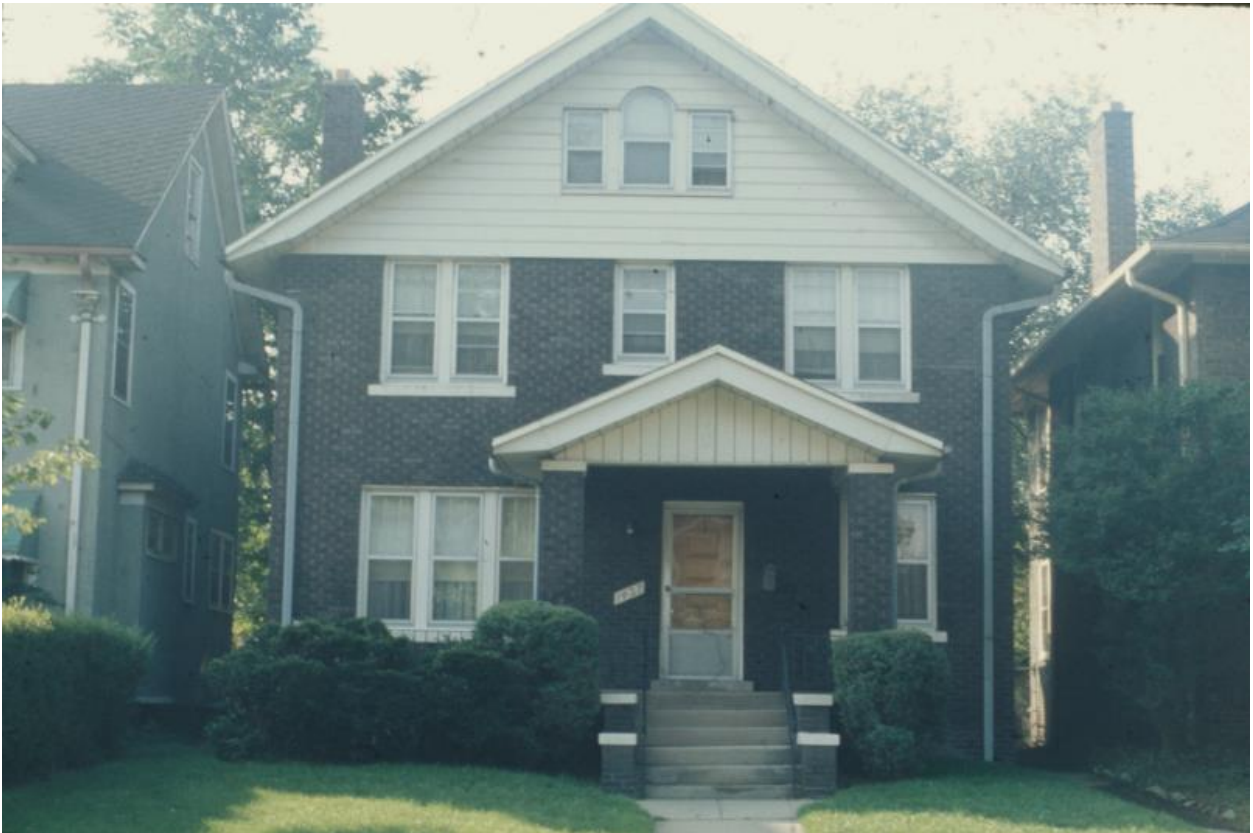
**Photo taken by HDAB in 1974, at time of the district's designation. Note aluminum siding in main roof and porch gable ends.**

- The Boston Edison Historic District was designated in 1974
- Per the above designation slide, taken in 1974 by the HDAB, the current aluminum siding located in the building's gable ends was present at the time of the district's designation

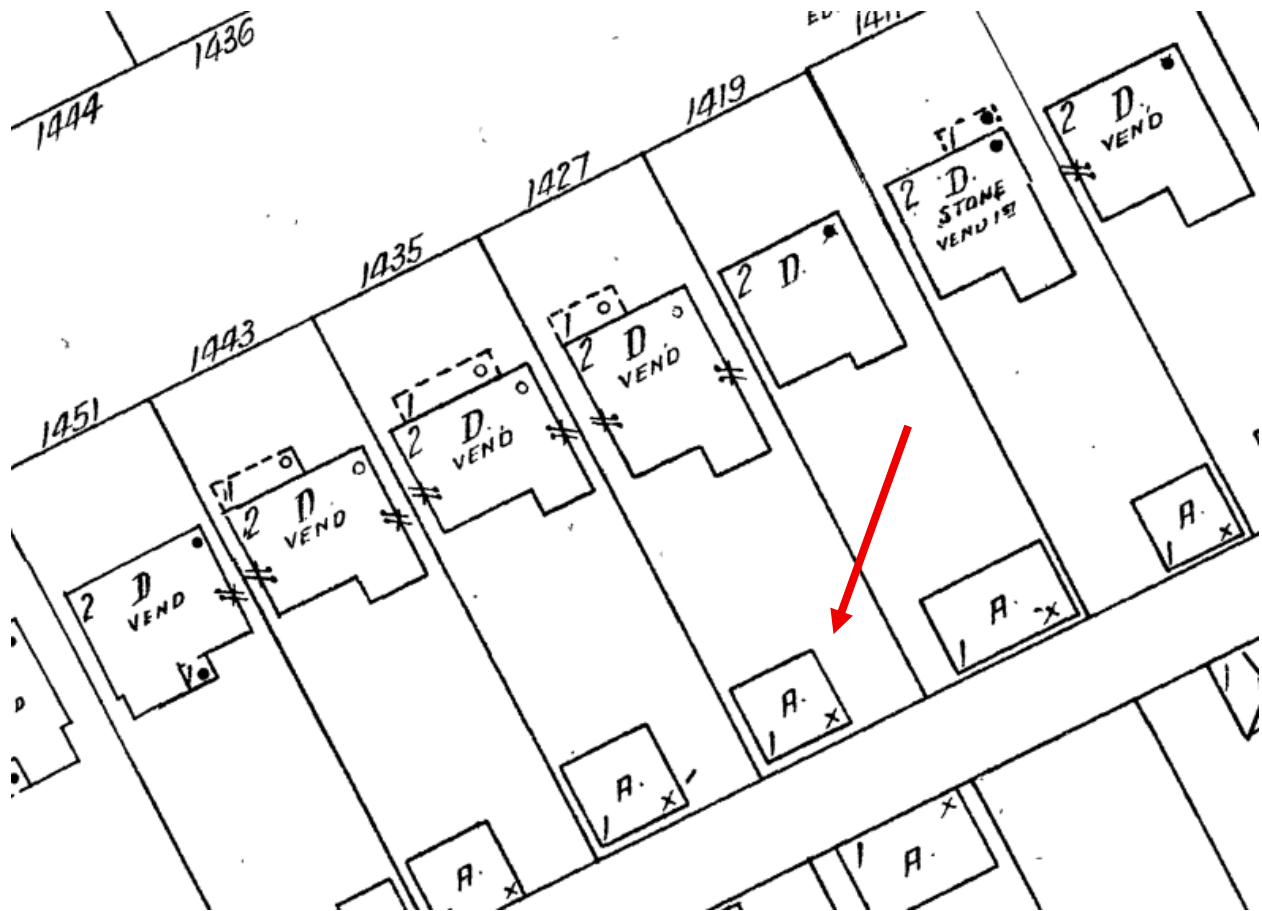
Sanborn Fire Insurance Map, 1969. Garage at rear yard indicated by red arrow.

- Per the above Sanborn Map, a small garage was present at the same location as the proposed new garage/current concrete slab in 1969. A review of birds eye images of the property (see below) indicates that this garage was demolished sometime between 2006 and 2011. Staff notes that the HDC does not have a COA on file for the garage's demolition. Staff therefore reached out to the applicant to note that the current application would be considered incomplete unless the demolition of the garage was added to the current scope. This was required because a new garage cannot be built at the location of the old garage without a legal/HDC-approved removal of the previous structure. The applicant is therefore seeking the Commission's "after-the-fact" approval for the removal of the property's garage. Staff acknowledges that the current owners purchased the property in 2025/the unapproved garage demolition was completed by a previous owner. However, note that existing violations remain with the property until legally addressed.

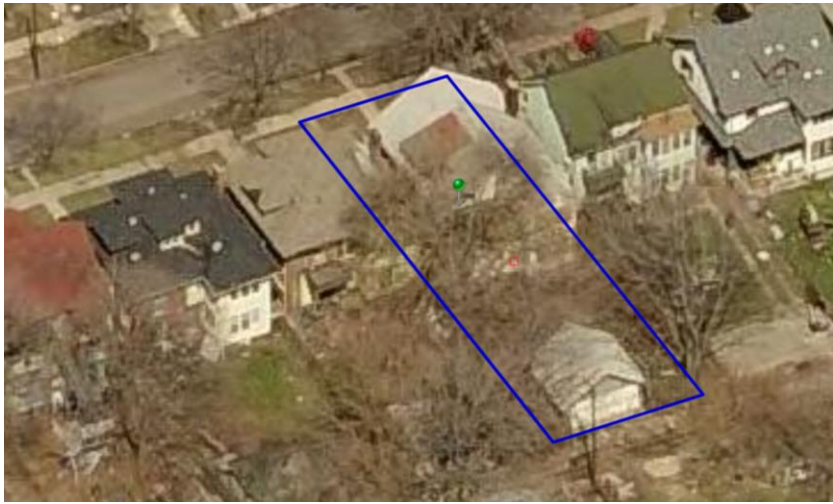
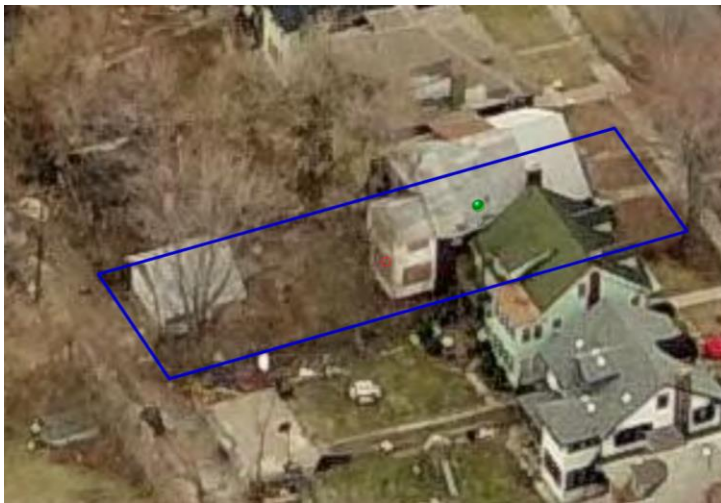
**1427 Edison outlined in blue. Bird's eye view, 2006. Note that the garage is present to the rear of the house**

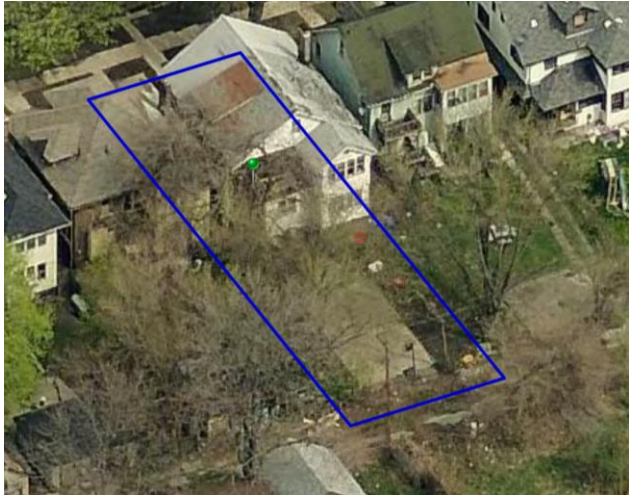
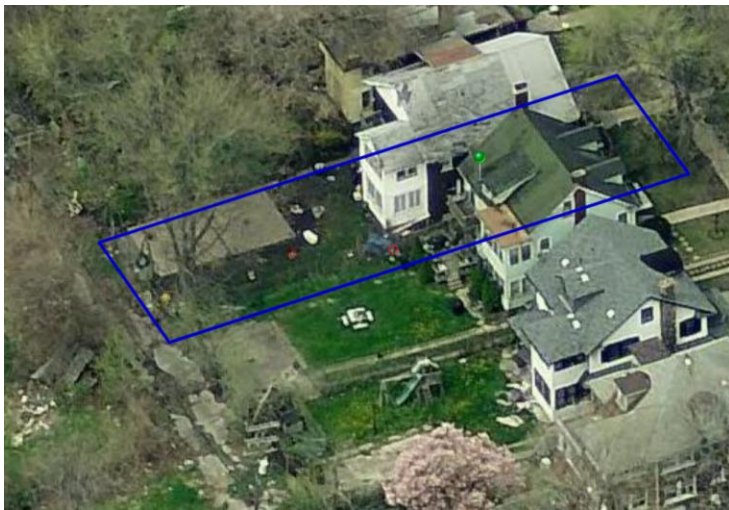
**1427 Edison outlined in blue. Bird's eye view, 2011. Note that the garage has been demolished at this point, leaving only a concrete pad**
