STAFF REPORT: NOVEMBER 12, 2025 MEETING

APPLICATION NUMBER: HDC2025-00642

ADDRESS: 2725 W. BOSTON

SCOPE: MASONRY WORK AND BUILDING REHABILITATION, INCLUDING NEW ROOFS (NOT CLAY TILES), DOORS, AND LIGHTING.

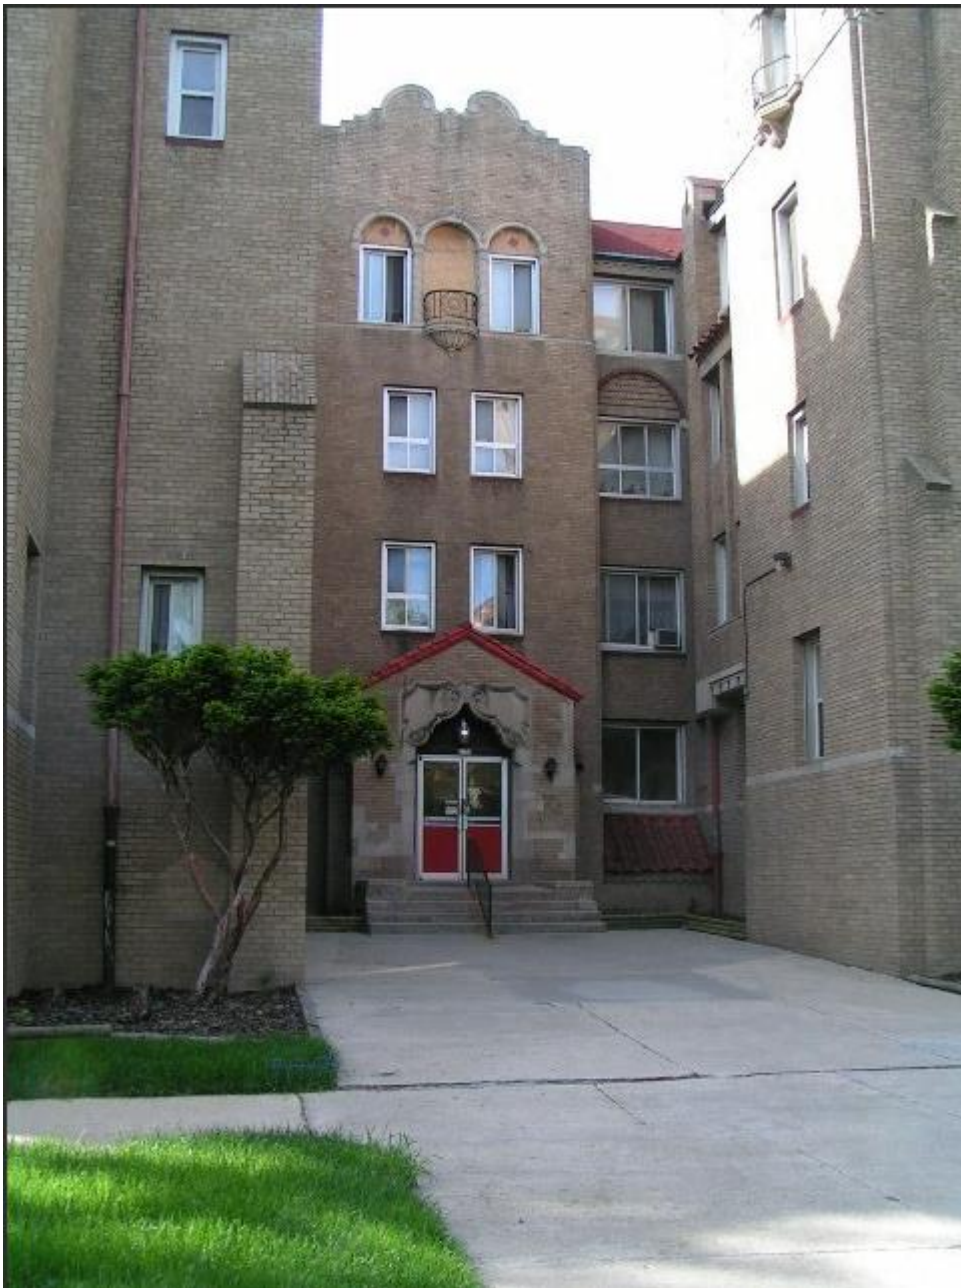
2725 W Boston, HDAB designation slide, c. 2006. Pictured are some of the inappropriate changes the report referred to, including slider windows. These inappropriate windows shown have since been replaced with double-hung vinyl windows.

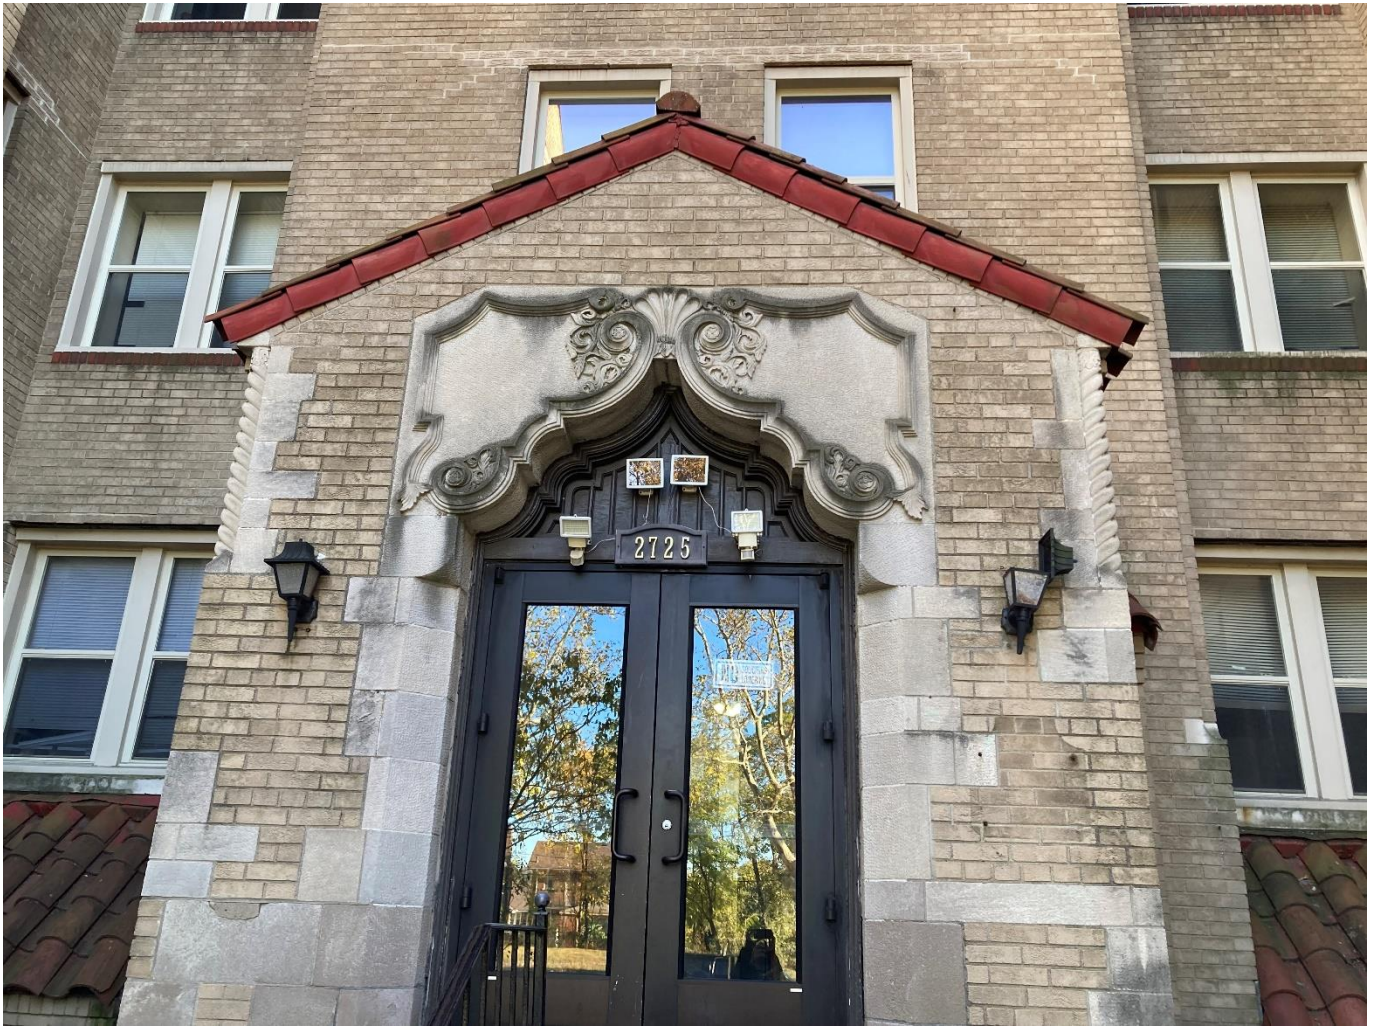
2725 W Boston, north (primary) façade, detail of main entrance. Staff photo, October 2025. The building's main doors, shown here, are proposed for replacement.

- None of the existing doors are historic.
- Staff finds the in-kind proposed replacements for the current simple, black storefront doors at the main entrance compatible with the building, and notes that hardware on the doors should remain understated to preserve compatibility.

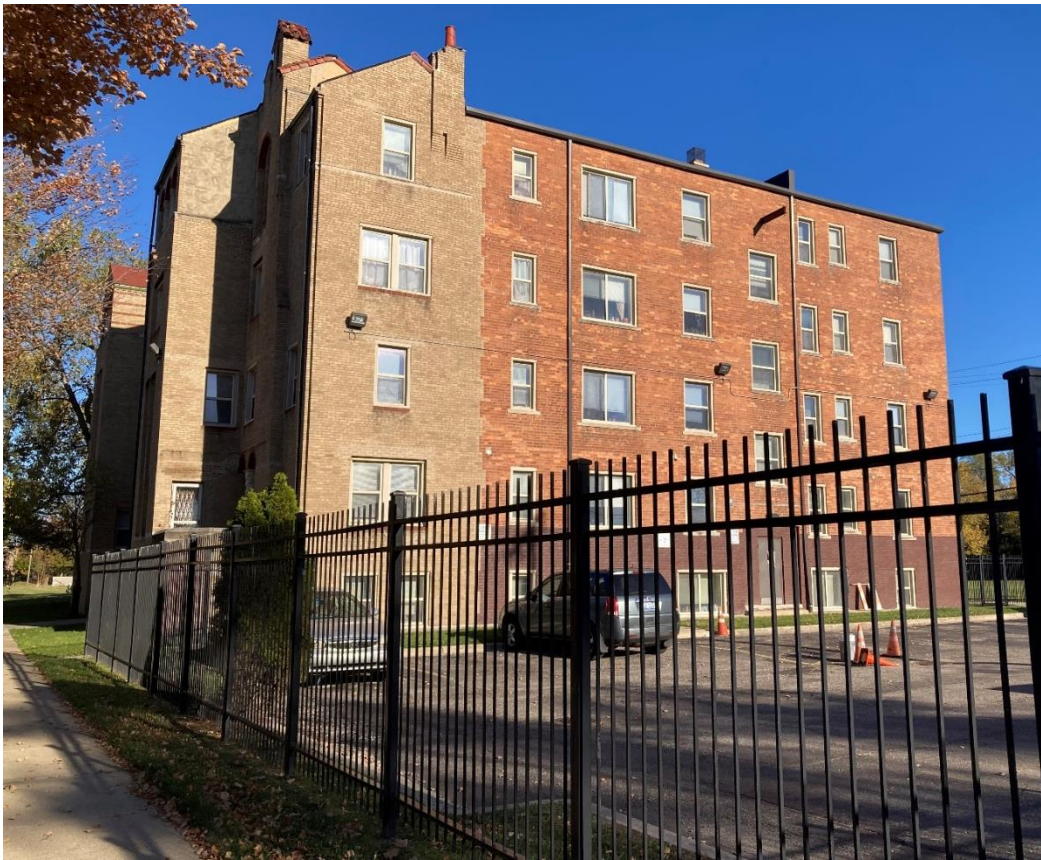
2725 W Boston, west side and parking lot with metal fence. Staff photo, October 2025. The transition from buff brick to red brick is visible here. The door on the first floor at the northwest corner and the door near the center of the west side are both proposed for replacement.

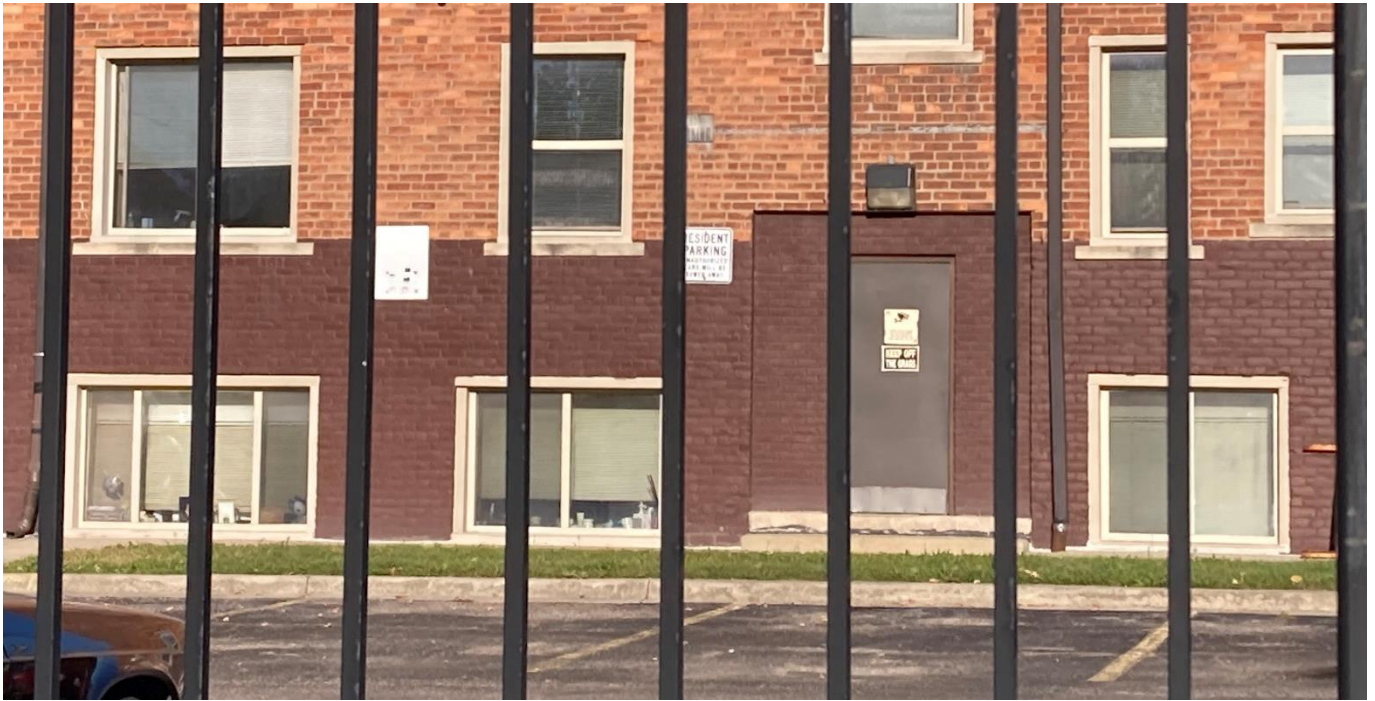
2725 W Boston, west side detail through metal fence. Staff photo, October 2025. The exterior door shown here is proposed for replacement.

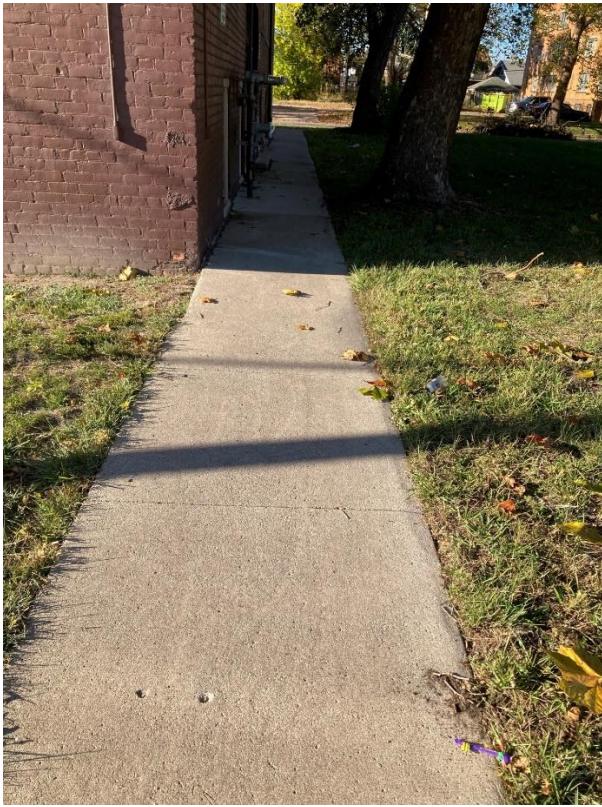
2725 W Boston, southeast corner and east side of building with narrow walkway along building that is proposed for replacement as needed. A similar walkway exists on the west side of the building. Staff photo, October 2025.

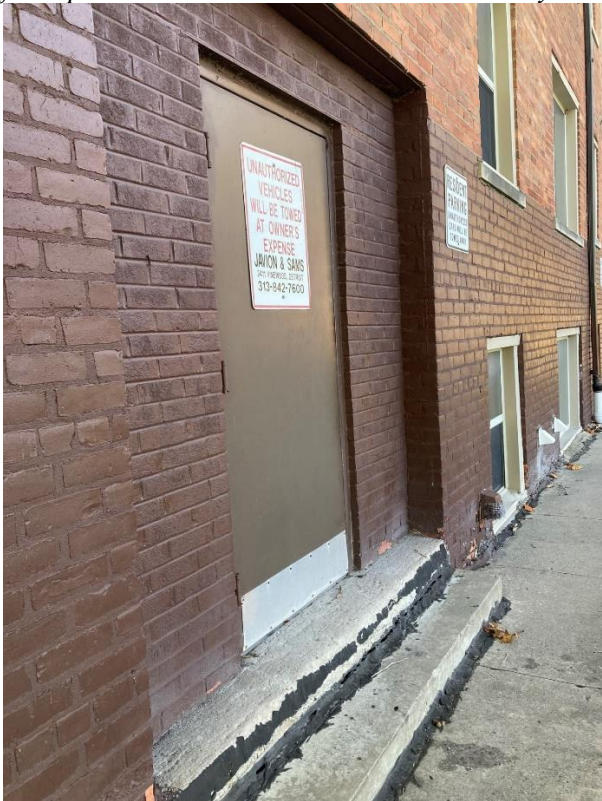
2725 W Boston, east side of building, exterior door proposed for replacement. Staff photo, October 2025.

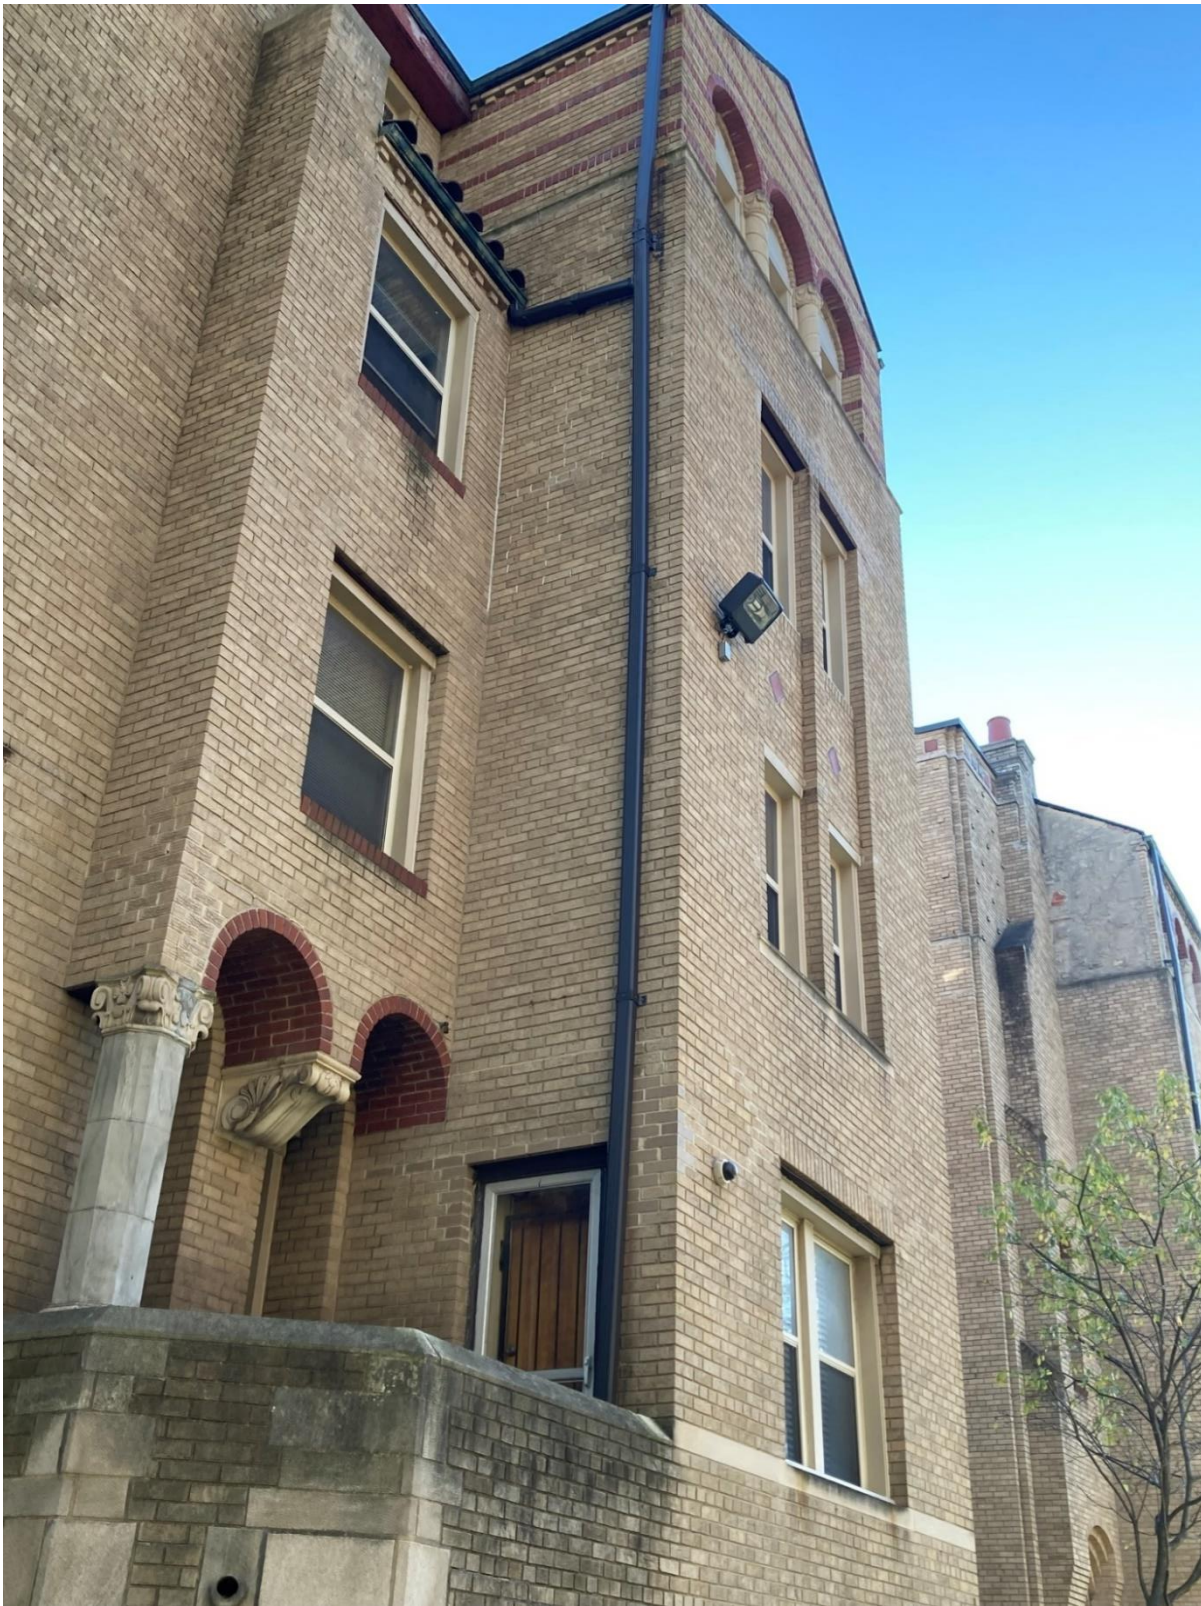
2725 W Boston, detail at northeast corner. The door shown is proposed for replacement with a door and storm door. Its corollary at the northwest corner is also proposed for replacement. Also shown are character-defining features including arches, a bracket, and a marble column. The brick staining here would likely be included in the proposed masonry cleaning. Staff photo, October 2025.

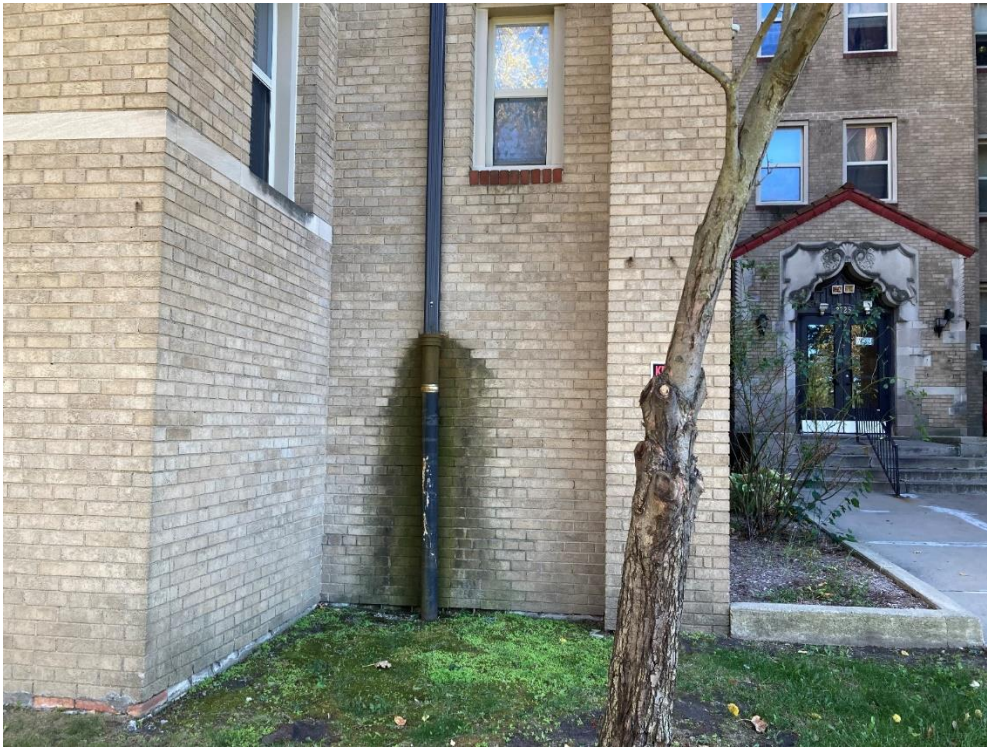
2725 W Boston, detail of east tower at its base, near the central courtyard and main entrance. Water staining from the downspout is visible, and is likely one of the areas slated for masonry cleaning. Staff photo, October 2025.

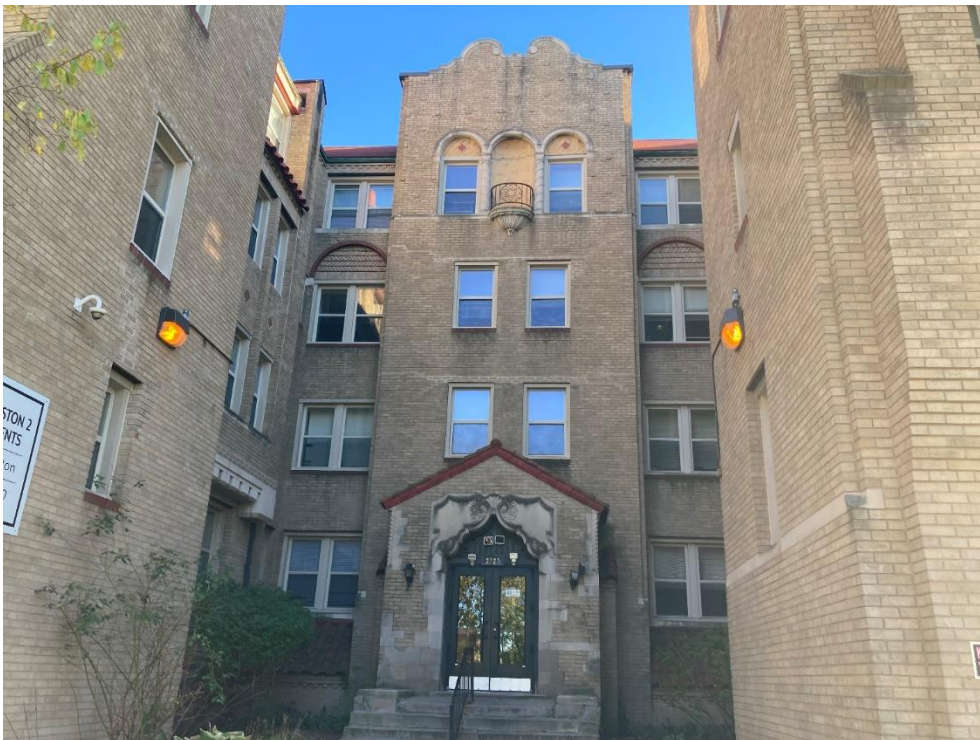
2725 W Boston, central courtyard and main entrance. Some of the building's rich architectural features are visible, including the balconette or Juliet balcony centered on the fourth floor between stone columns, the herringbone masonry in the arch over the windows on the third floor, and the ornamented masonry Arabesque arch over the main entrance. Staff photo, October 2025.

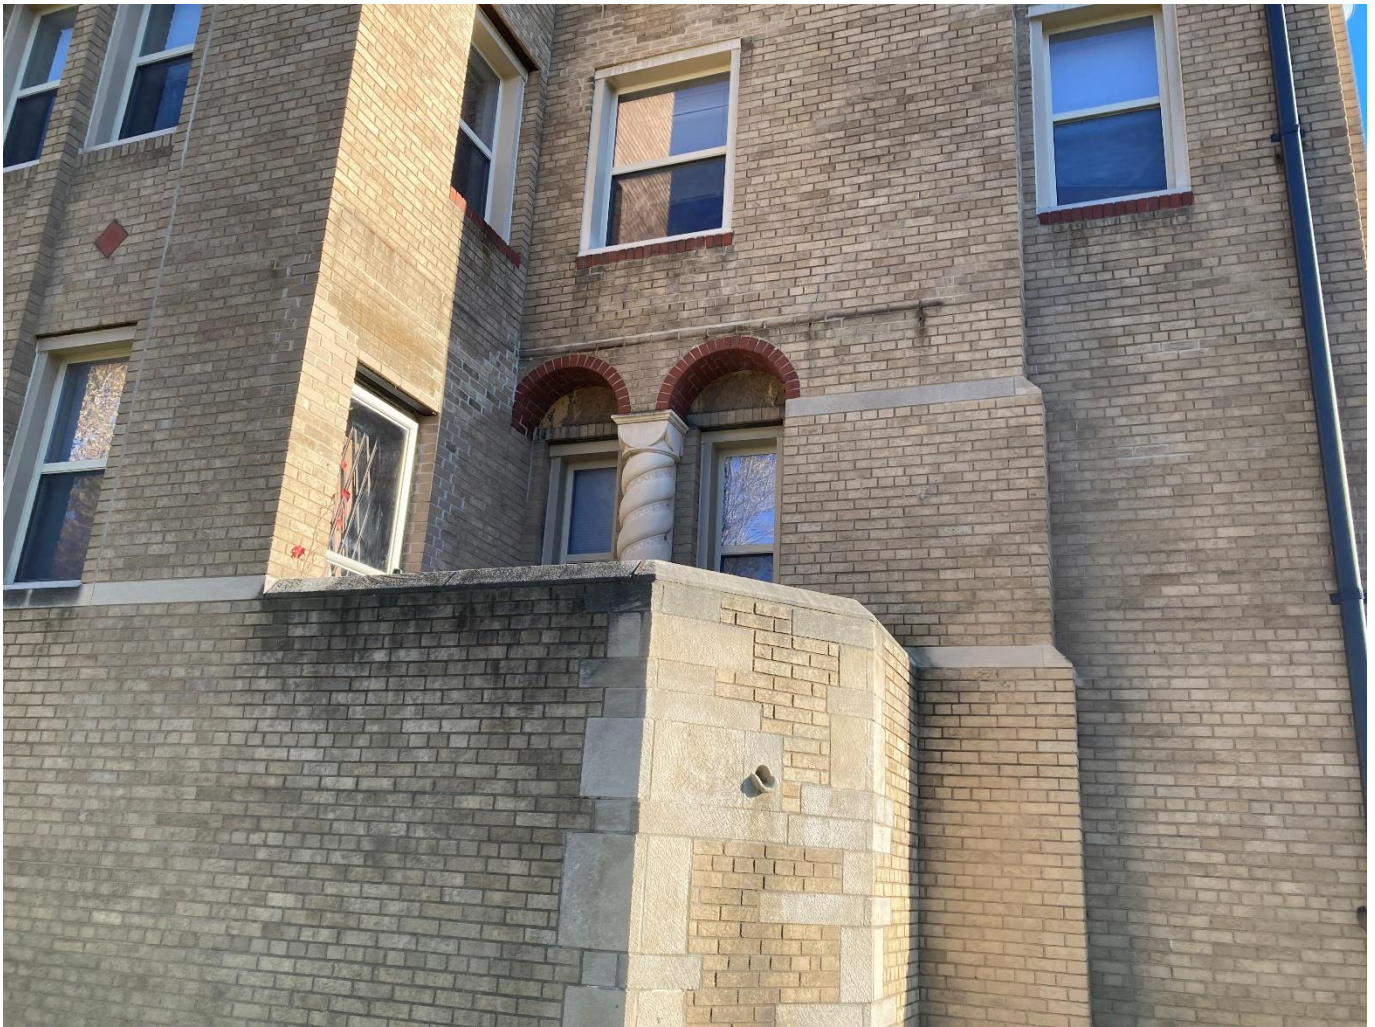
2725 W Boston, detail at northwest corner. The door shown is proposed for replacement with a door and storm door. Its corollary at the northeast corner is also proposed for replacement. Also shown here are the arches over windows, defined by red bricks, and an ornate stone column. Staff photo, October 2025.

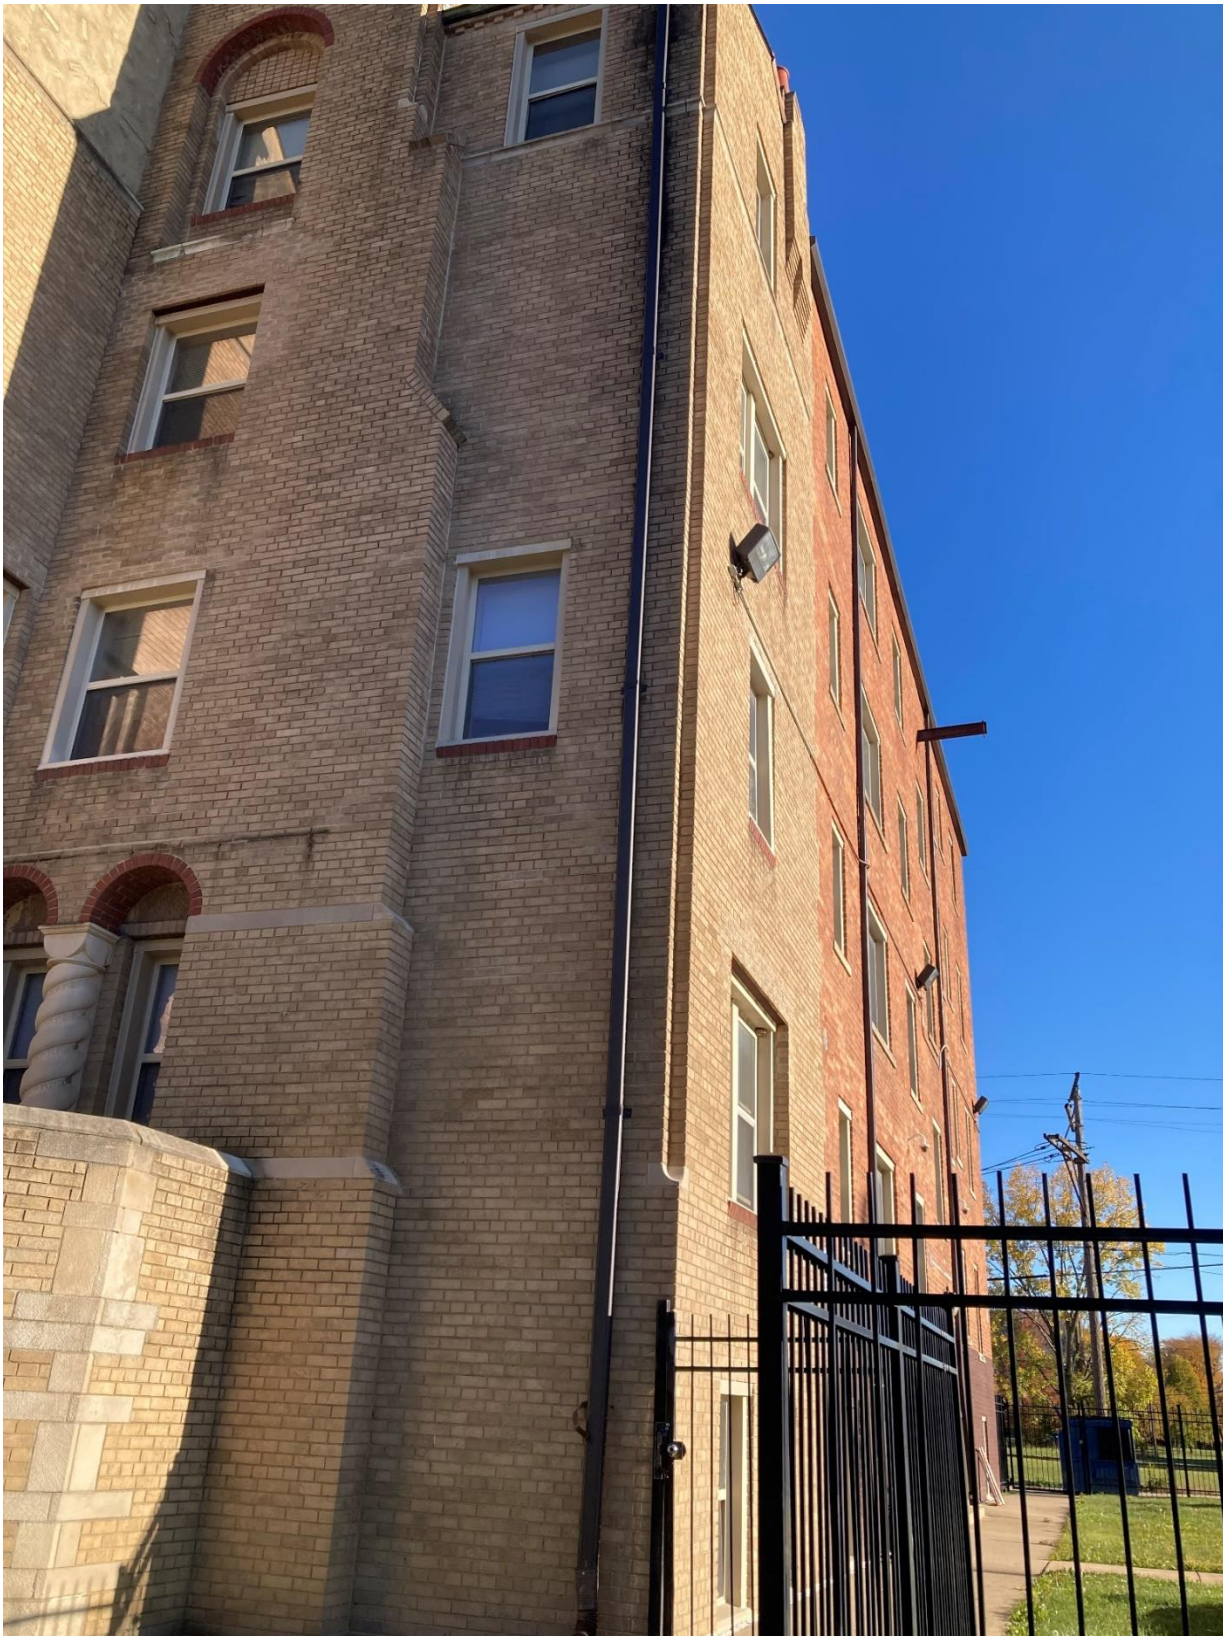
2725 W Boston, northwest corner. A downspout is shown and all of these are proposed for replacement. Staff photo, October 2025.

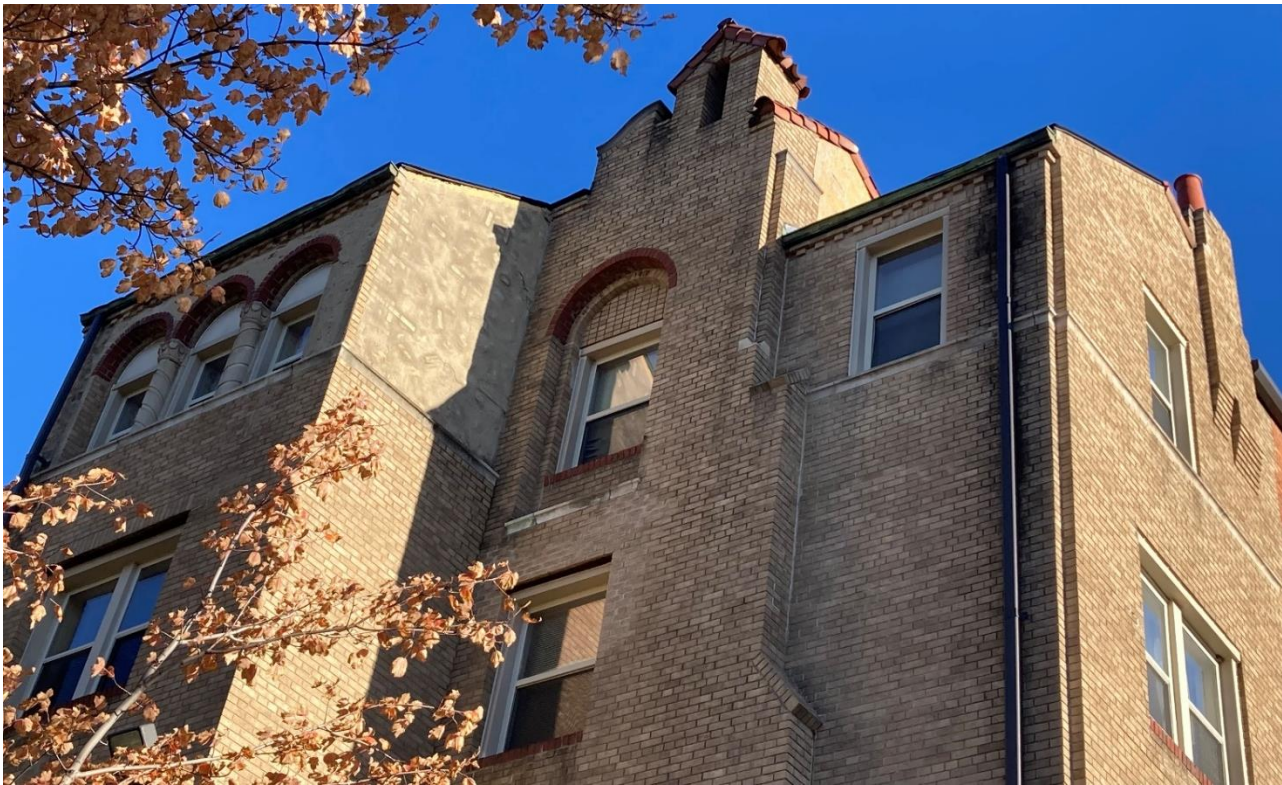
2725 W Boston, north side of west tower and northwest corner. Copper gutters and a nonhistoric downspout are shown and all of these are proposed for replacement. Some of the building's rich architectural features are also shown, including the tripartite arched window with columns, patterned masonry inset above the window in the arch, dentil molding, and the clay tile and varied roofline. Staining behind the downspout here would likely be targeted in the proposed cleaning efforts. Staff photo, October 2025.

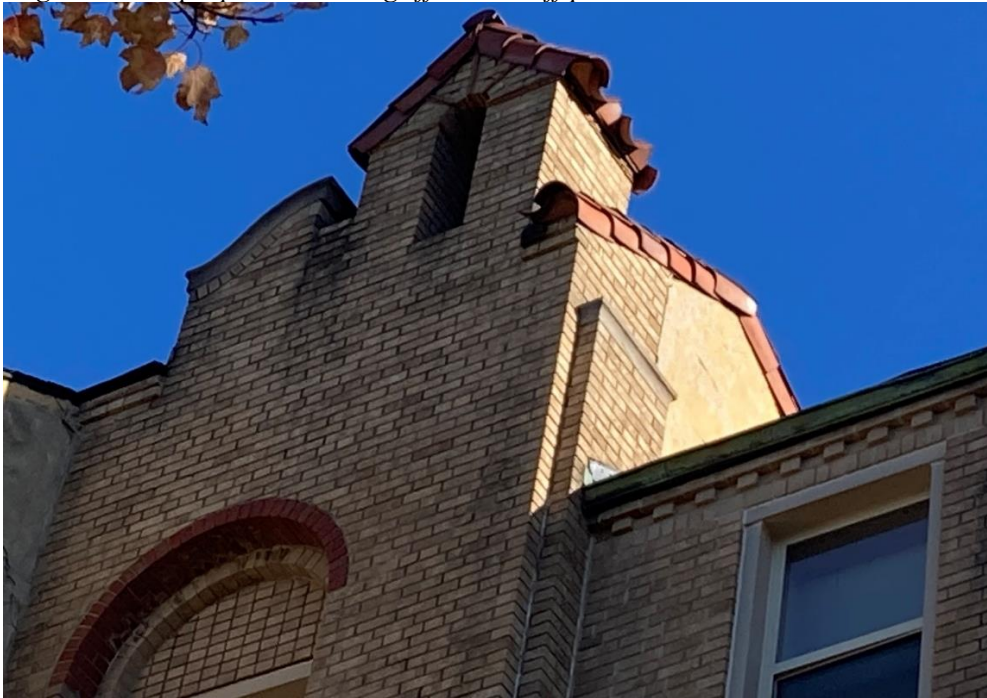
2725 W Boston, north wall of west tower, detail. Shown here is a detail of some dentil molding, copper gutter, the patterned masonry inset in the arched opening, the varied roofline, and some of the clay tile. Staff photo, October 2025.

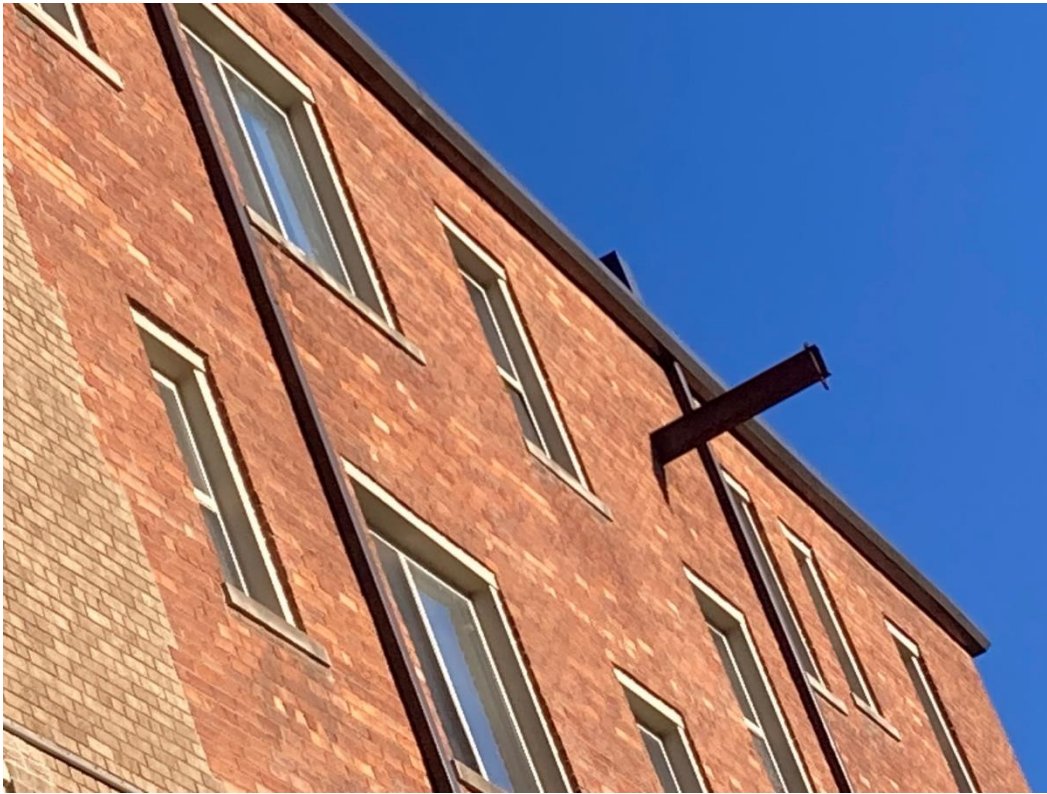
2725 W Boston, west wall, detail of gutter and downspouts. All gutters and downspouts are proposed for replacement. Nonhistoric gutter and downspouts appear brown here. Staff photo, October 2025.

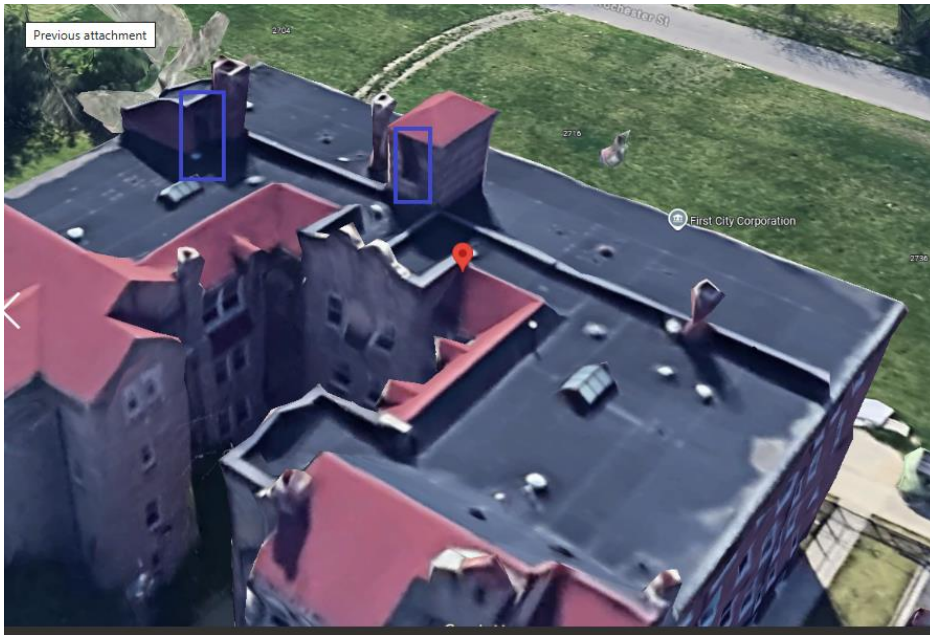
Applicant provided this picture showing the flat roof that is proposed to be white and the roof access doors outlined here in blue. Historic skylights are also visible.

- Regarding the flat roof and the existing, historic-age skylights, the applicant explained to staff that they leak and fog up. The skylights are not visible from the ground, and staff does not find them to be character defining.

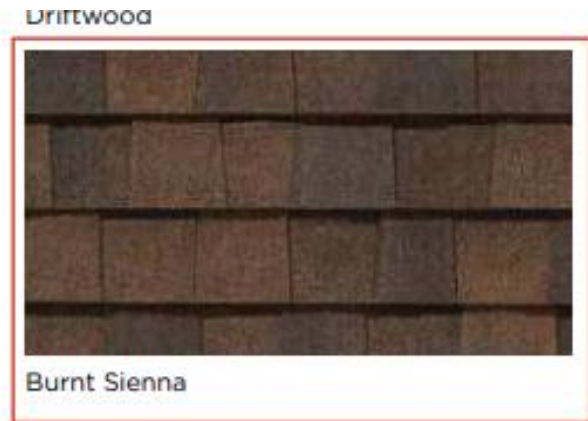
Staff requested product specs for the new asphalt shingles; proposed are Certainteed Landmark shingles in Burnt Sienna:

- On the high, sloped roofs, retaining the red color that matches the remaining historic clay tiles is important to the Spanish Revival style of this building, as noted in the Elements of Design. Staff notes that the current, pre-designation three-tab asphalt roof has a similar appearance to flat tiles and the red color matches the clay roofing and accent wall tiles. The proposed asphalt roof shingles, in contrast, are dimensional and so look more like wood shingles and the proposed color does not match the clay as well as the current shingles do.

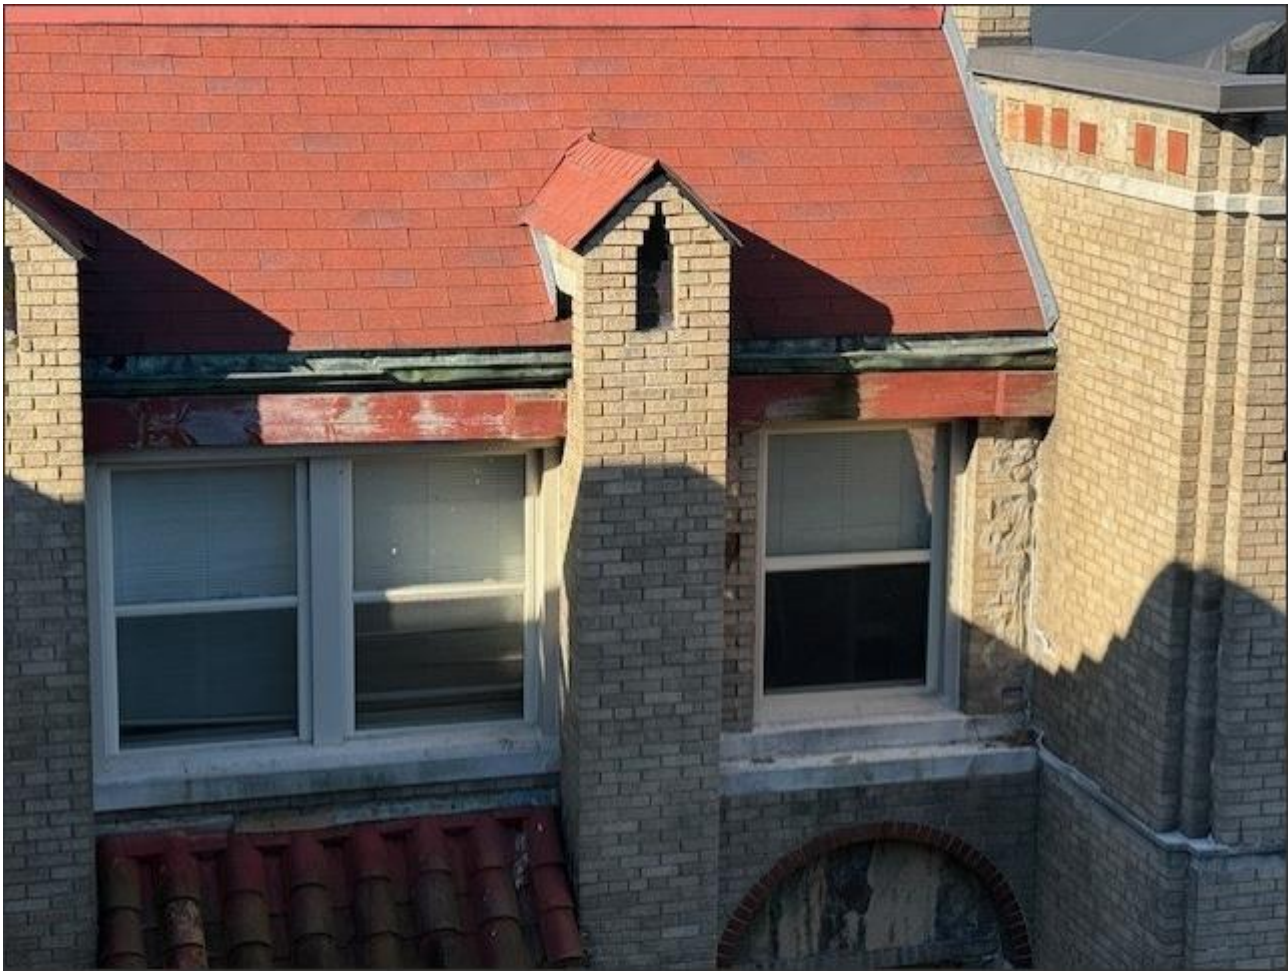
The applicant provided the photo below of the existing asphalt roof and a fascia board to be replaced. This photo shows how well the asphalt roof matches the clay tiles and so the board is also painted to match both.

This applicant-provided photo shows how well the existing asphalt shingle matches the color of the clay tile roof and how the fascia board is painted to match both. The proposed roof won't match the clay so closely and is intended to look more like shingles and less like flat tiles. The paint color for the new fascia boards is unknown.

- Staff notes that the current three-tab asphalt roofing that replaced the clay tiles on the pitched roof areas has a similar appearance to flat tiles, like slate, and the red color matches the clay tiles.

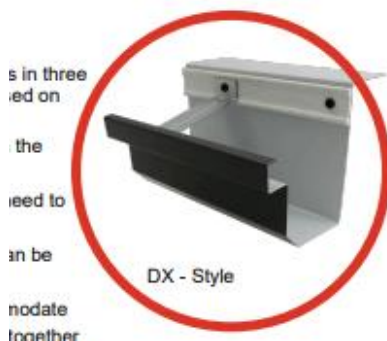
Proposed new gutters in black with matching black corrugated downspouts (3" x 4"). The downspouts are to be installed in existing locations. Image from applicant's materials.

- The paint color for new fascia boards needs to be specified.
- Gutters and downspouts are distinctly character-defining elements. Where historic copper gutters remain, they should be retained—either repaired or replaced in kind if necessary. Matching copper downspouts should be specified as well where the historic gutters remain. In areas where gutters and downspouts were replaced prior to designation, they should be brown or a shade of green.

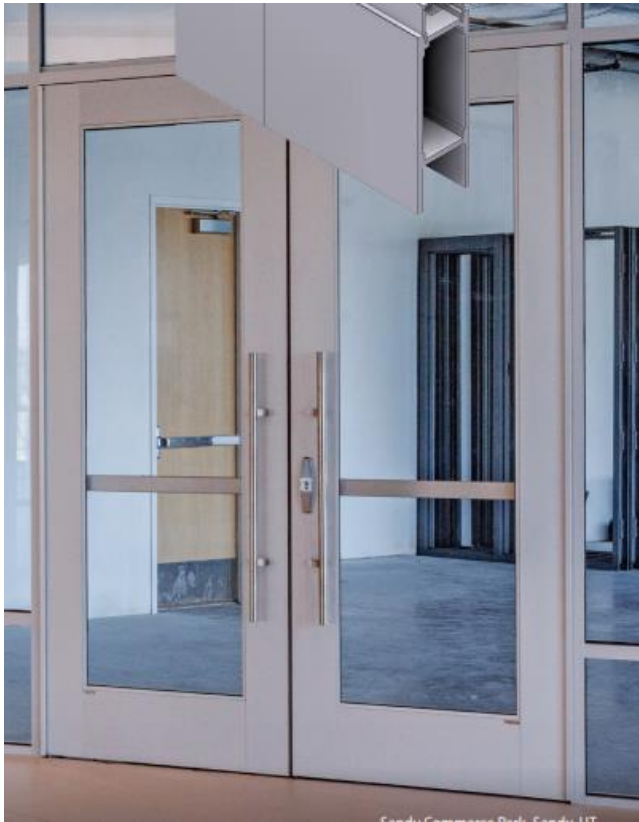
Sample Tubelite storefront door provided by applicant. Similar doors in black are proposed for the main front doors, and hardware style and color were not specified.

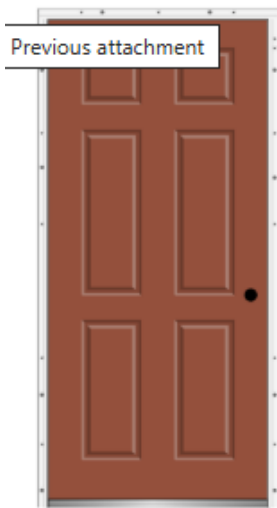
Proposed steel side and roof doors, in Clay Hearth. Hardware was not specified.

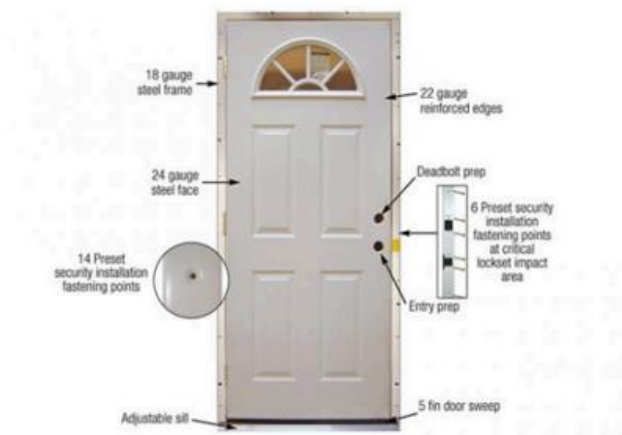
Proposed white steel and black storm doors (below) at the northeast and northwest corners, first floor. Any window in these doors has not been clarified/confirmed. Images from applicant's materials.

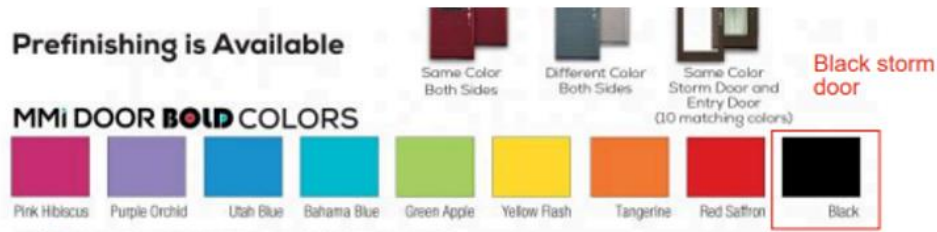
Black storm door proposed to complement the white steel door above, for the northwest and northeast corners.

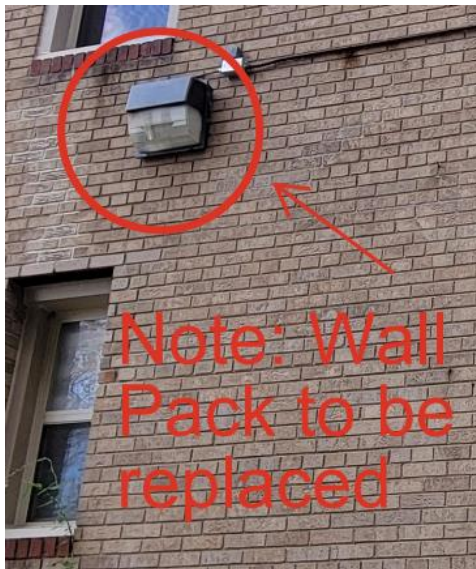
Existing typical security lights.

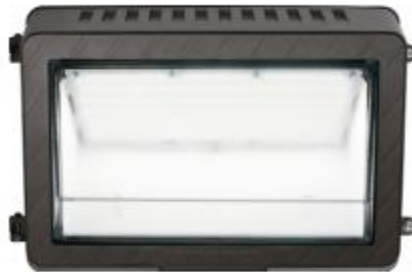
Proposed replacements.

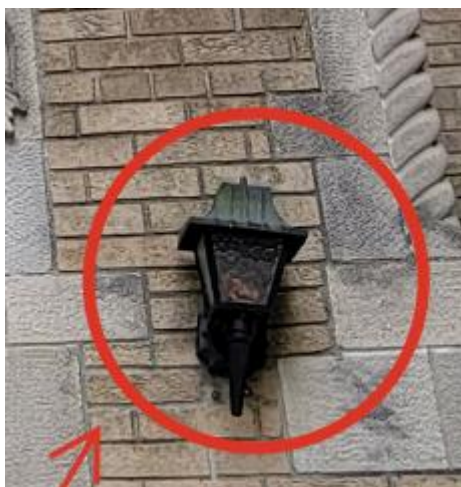
Existing non-historic wall sconces flanking the main entrance doors (left) and proposed LED replacements (right).

All security lights (wall packs) around the property are proposed to be replaced in kind and the existing, non-historic black wall sconces that flank the main entry are also to be replaced. Security cameras are also proposed but product specs/cut sheets were not provided.

- None of the existing light fixtures are historic.
- As long as the lights are installed so that they do as little damage to historic material (like masonry) as possible, they do not destroy historic materials, and they seem to staff to be compatible with massing, size, and scale to protect the integrity of the property and its environment.

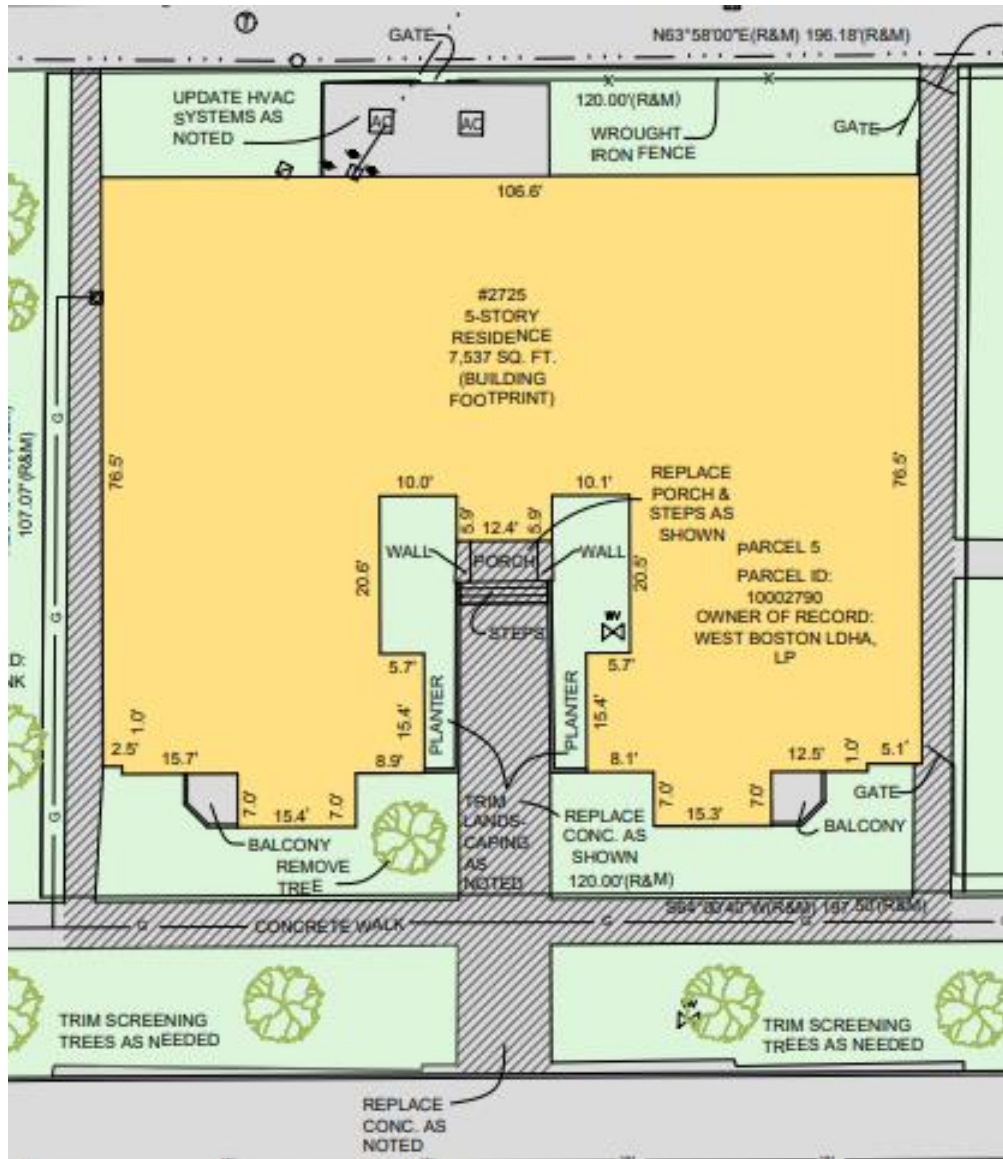
2725 W Boston, portion of site plan from applicant's materials. Gray striped sidewalk in front of building, walkways along both sides of building, the courtyard, and the steps, stoop, and low walls at the main entrance are proposed for damaged concrete to be replaced with new concrete.

- Replacing damaged concrete on walks, courtyard, front stoop, low wall on stoop, and front steps.

- Replacing damaged concrete in the courtyard, around the front steps and stoop, and along the walks around the building would not destroy historic materials that characterize the property, but untinted "bright white" concrete should not be used. Because there are stone details and buff-colored bricks on the building's primary façade, and an absence of bright white, the concrete for the courtyard, new steps, stoop, and low walls should be tinted to match the color of the stone surrounding the entry (see photos below).
