STAFF REPORT: NOVEMBER 12, 2025 MEETING

APPLICATION NUMBER: HDC2025-00642

ADDRESS: 2725 W. BOSTON

SCOPE: MASONRY WORK AND BUILDING REHABILITATION, INCLUDING NEW ROOFS (NOT CLAY TILES), DOORS, AND LIGHTING.

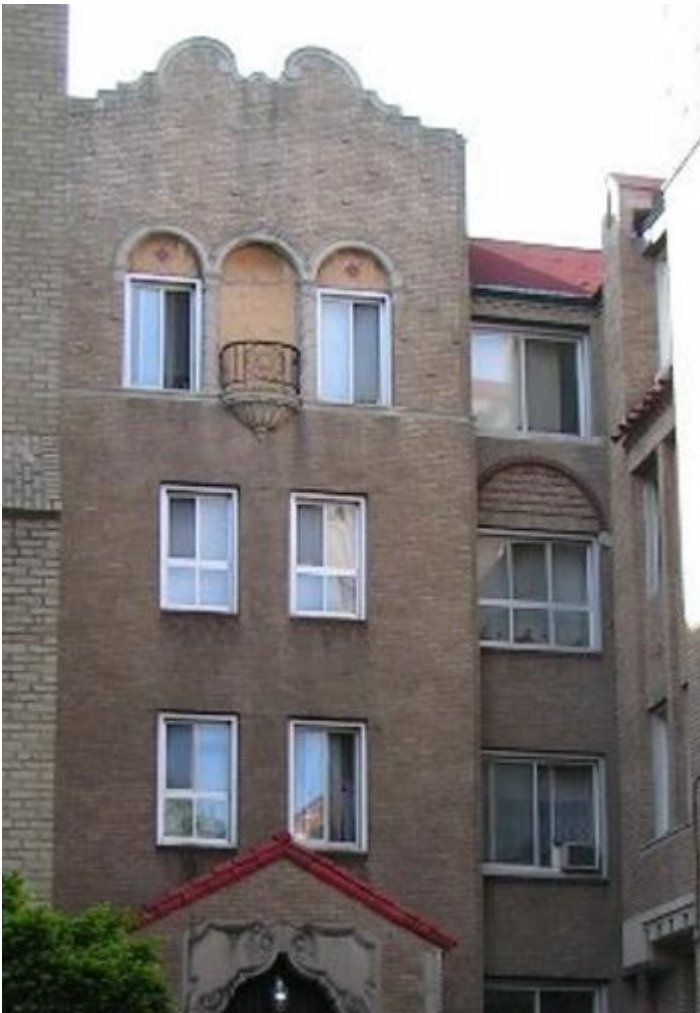
The designation slide photo from c. 2006 shows the red asphalt roofing, echoed by the red diamond tiles in the arches and red clay tiles on the right and again below, over the front entrance.

- Staff notes that the current three-tab asphalt roofing that replaced the clay tiles on the pitched roof areas has a similar appearance to flat tiles, like slate, and the red color matches the clay tiles.

- On the high, sloped roofs, retaining the red color that matches the remaining historic clay tiles is important to the Spanish Revival style of this building, as noted in the Elements of Design. Staff notes that the current, pre-designation three-tab asphalt roof has a similar appearance to flat tiles and the red color matches the clay roofing and accent wall tiles. The proposed asphalt roof shingles, in contrast, are dimensional and so look more like wood shingles and the proposed color does not match the clay as well as the current shingles do.

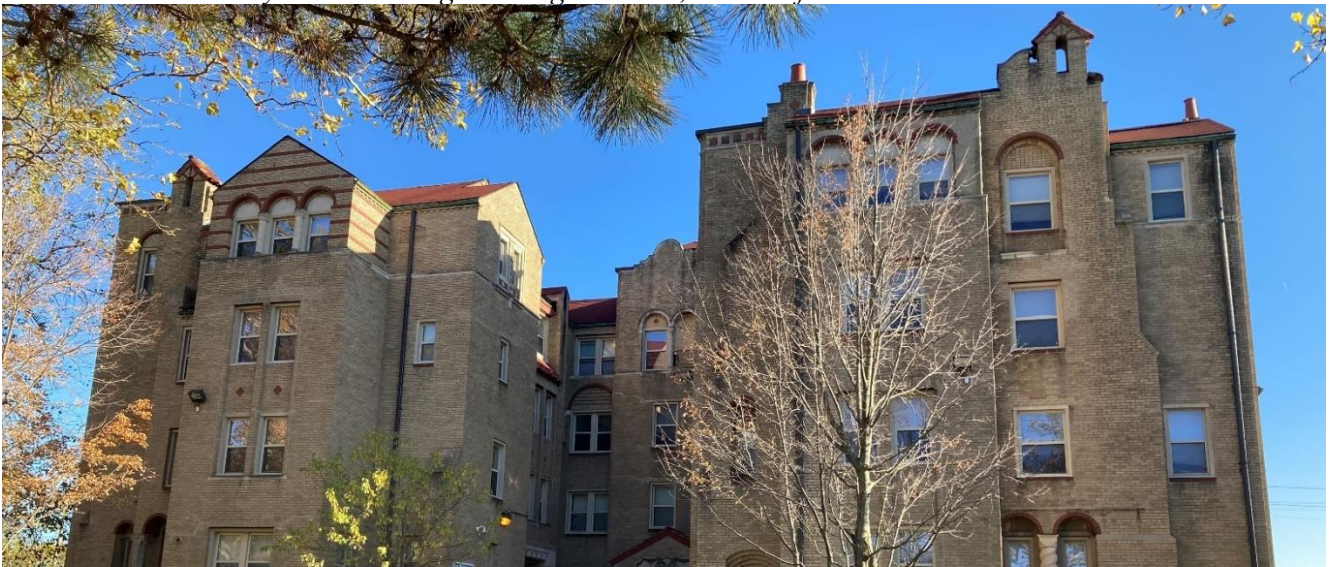
The red on the sloped roof is repeated on the bricks that top the arches above some of the windows, in the red brick stripes on the east tower, on the clay roofs on the assorted pent roofs, and on the clay roof over the front entrance.

- The district's Elements of Design 7, 8, 9, and 10 convey the importance of this building's rich and varied character-defining architectural details, the importance of texture in the building's design, and the key relationship among the elements with the color red. For example, Element of Design 9 states, "The Andorra Apartments building features a light beige brick contracting (*sic*) with light stone trim. Red clay roof tiles, red brick used as sills and lintels, red decorative tiles, and black metal railings contribute to decorative coloristic effects."

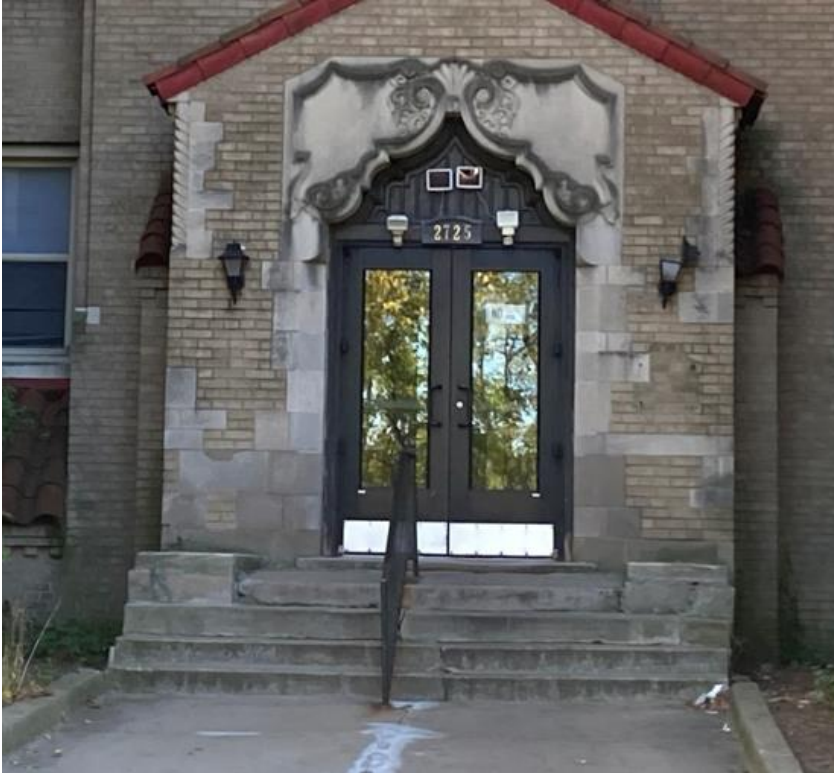
The steps and low walls that form the stoop in front of these main entry doors match the stone details around the doors. If the concrete for the steps and low walls were bright white, the harmony of these historic features together would be diminished.

- Replacing damaged concrete in the courtyard, around the front steps and stoop, and along the walks around the building would not destroy historic materials that characterize the property, but untinted "bright white" concrete should not be used. Because there are stone details and buff-colored bricks on the building's primary façade, and an absence of bright white, the concrete for the courtyard, new steps, stoop, and low walls should be tinted to match the color of the stone surrounding the entry (see photos below).

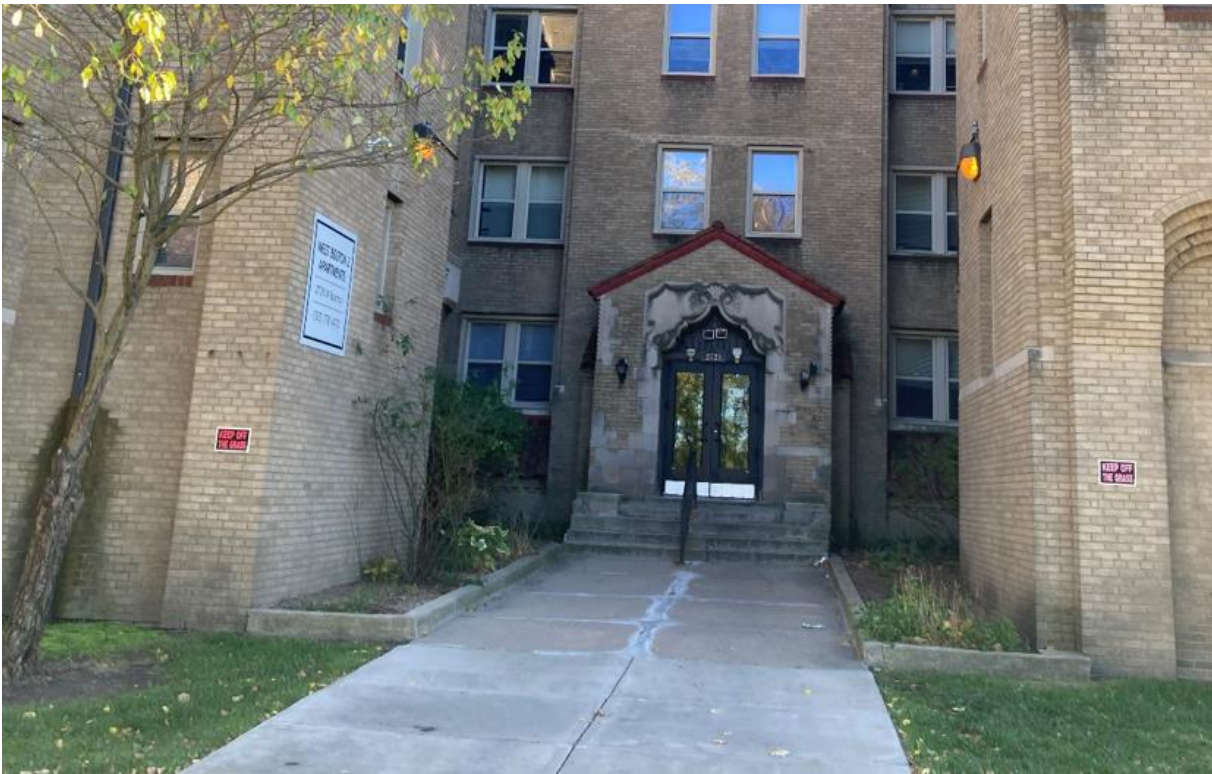
The gray or beige of the sidewalk in this court, the entry steps, and the stone surround of the entry all work together to create a harmonious whole with the buff bricks of the building. Bright white concrete would negatively impact the composition.
