STAFF REPORT: DECEMBER 10, 2025 MEETING PREPARED BY: E. THACKERY

**APPLICATION NUMBER: HDC2025-00674**

**ADDRESS: 761 WHITMORE**

SCOPE: ERECT A TRASH ENCLOSURE, ERECT A FENCE, INSTALL AIR CONDITIONER UNITS, AND

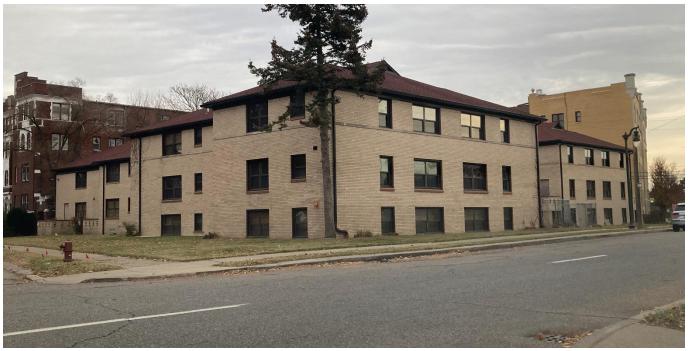
761 Whitmore Road at the southeast corner of Whitmore Road and Third Avenue. Shown are the north and west sides of the building. The low porch enclosures toward the left of the photo (along Whitmore) at the building's northeast corner is a repeated and historic, character-defining feature. The courtyard opens midway down the building's west facade, along Third, where a chain link fence currently stands. Proposed is a 6-foot-high black steel fence near the sidewalk along Whitmore and Third with gates where there are building entrances. Air conditioning units are proposed for installation in front of the apartments along Whitmore. (Staff photo, November 2025)

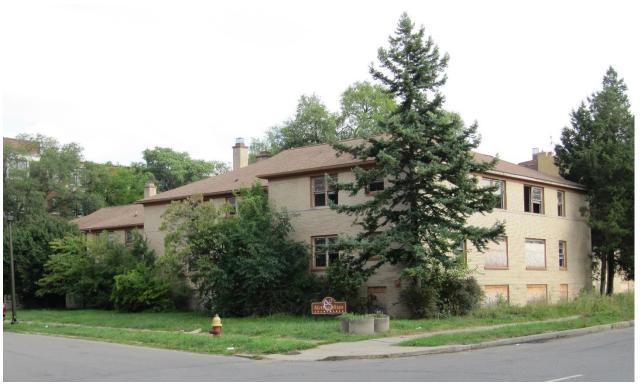
Designation photo, 2012. As compared with its current appearance, the building had a lighter-colored asphalt shingle roof and its former windows had light brown trim and more transparent glass. Shallow lawns along both Whitmore and Third are evident, where fences are proposed.

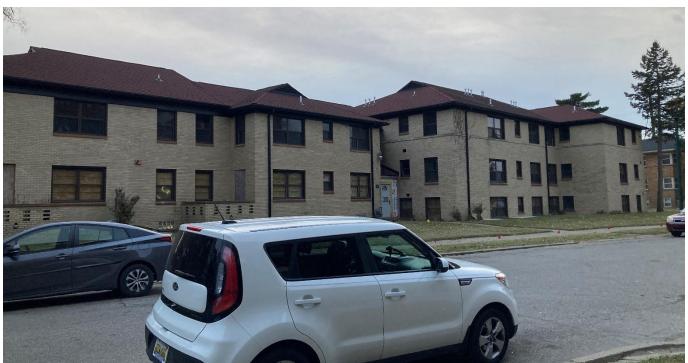
North side of 761 Whitmore, along Whitmore. The door centered here was replaced without approval and will be replaced with a rebuilt entry door that matches the historic design. The low porch walls toward the northeast corner are historic, character-defining features of the building. The chimneys that were visible in the designation photo have since been replaced with short, metal exhaust pipes. Air conditioning units and a 6-foot-high black fence are proposed along Whitmore. (Staff photo, November 2025)

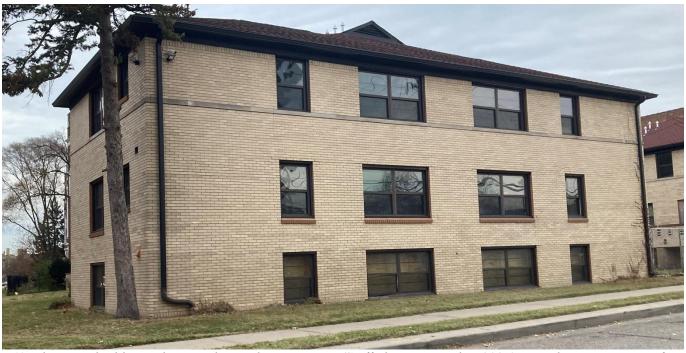
761 Whitmore, building volume at the northwest corner. (Staff photo, November 2025) Note the narrow strip of grass between the building and the sidewalk where a 6-foot-high black fence is proposed.

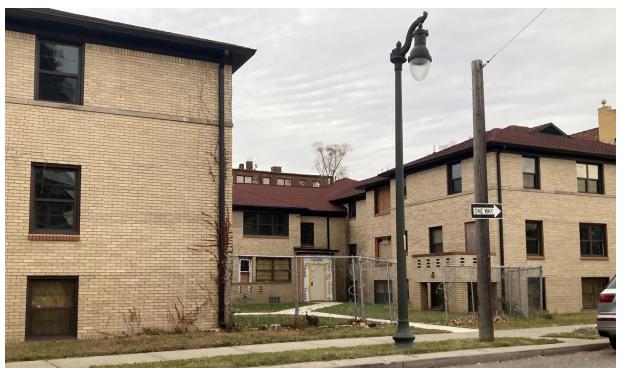
761 Whitmore, west side of the building, along Third. The northern portion of the building's west side is to the left of the photo, the courtyard is at the center, and the southern portion of the west side is visible to the right of the photo. The entranceway visible here will be replaced with an entranceway that matches the historic design. The proposed black fence would have a gate across the walkway to the building entrances. (Staff photo, November 2025)

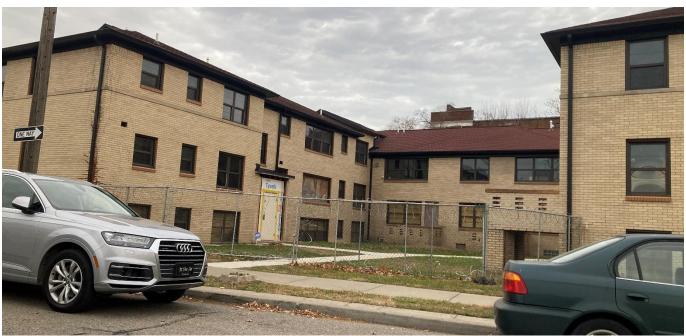
761 Whitmore, west side of the building, along Third. The building's volume at the northwest corner is to the left of the photo, the courtyard is at the center, and the volume toward the southwest corner is visible to the right of the photo. The entranceway visible here will be replaced with an entranceway that matches the historic design. A 6-foot-tall black fence is proposed near the edge of the grass along the sidewalk, with a gate across the entry walkway. (Staff photo, November 2025)

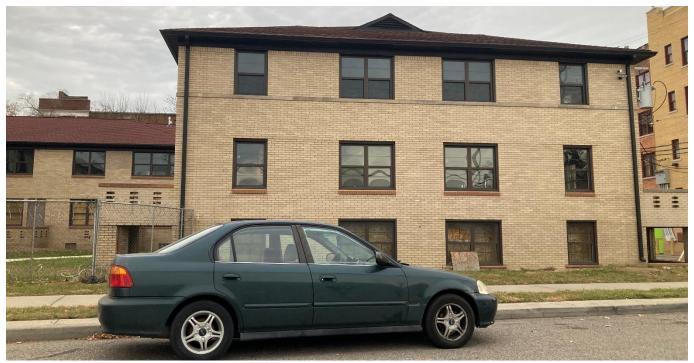
761 Whitmore, west side of the building along Third. Shown is the building's southernmost portion of the west side. Two of the historic, character-defining porches are visible as is the shallow lawn where a fence is proposed. (Staff photo, November 2025)

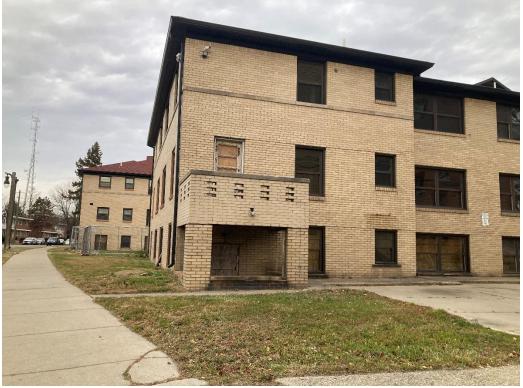
761 Whitmore, building's southwest corner from the south looking north toward Whitmore. A low-walled raised porch with a patio under it, below grade, is visible, and the narrowness of the strip of grass along Third is evident. A 6-foot-high black fence is proposed to enclose this grass strip and run northward to the corner at Third Avenue. The concrete at the bottom of the photo is the alley, and the concrete parking lot for the building is visible just off the alley, next to the building. (Staff photo, November 2025)

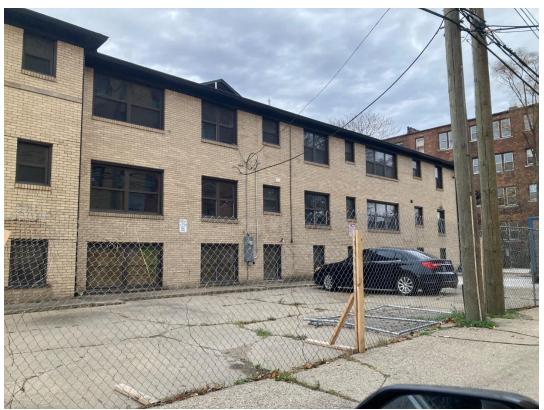
761 Whitmore, south side of the building is shown from the alley. The concrete lot off the alley is pictured here. The proposed transformer will be positioned between the building and the two utility poles shown. No fence is proposed along the building's south side. (Staff photo, November 2025)

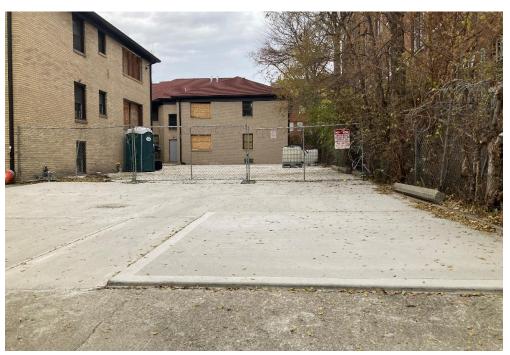
761 Whitmore, the building's southeast corner is to the left, a driveway runs along the east side of the building, and the concrete pad shown to the right (east) is where the proposed trash enclosure will be erected. A black steel double gate is proposed to be installed approximately from the rear of the concrete pad across the driveway. Three parking spots are planned in that gated area. (Staff photo, November 2025)

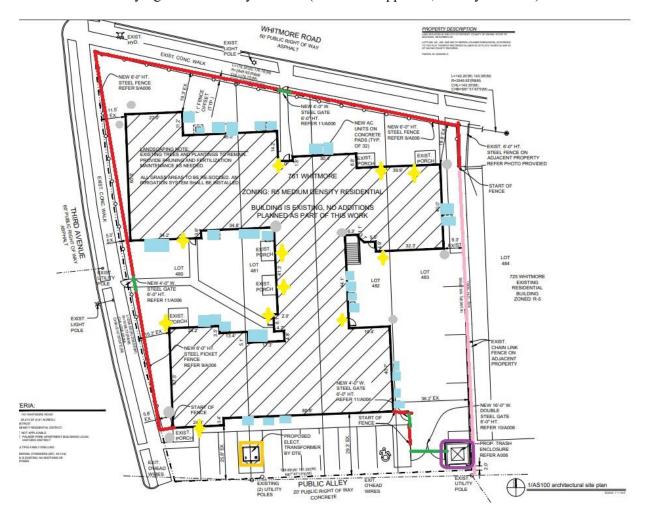
Proposed conditions, plan provided by applicant and color-coded by staff

Gray: Security lights and cameras Pale blue: Air conditioning units Yellow star: Exterior light fixture

Purple: Trash enclosure

Gold: DTE transformer

Red: Proposed 6' black steel picket fence

Green: Proposed gates

Pink: Existing chain link fence

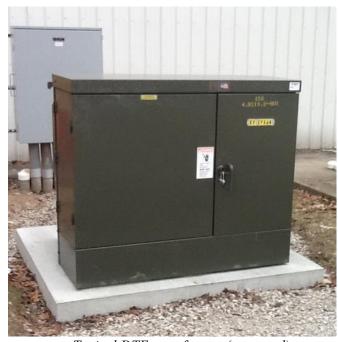
Typical DTE transformer (proposed)

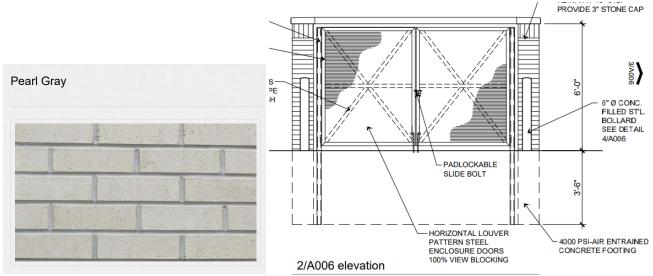
Proposed trash enclosure: Concrete block wall with pearl gray brick facing to match building, 6' tall with a 3" stone cap, steel enclosure doors with louvers, and 3' 6" concrete footings.

- Regarding the trash enclosure, staff believes that it too meets the Standards and Guidelines and the Elements of Design. It is proposed to be constructed of a material that is compatible with the historic building's exterior cladding, is sufficiently subordinate to the historic building in scale, and will be placed at the rear of the parcel, in the most unobtrusive location the property offers.

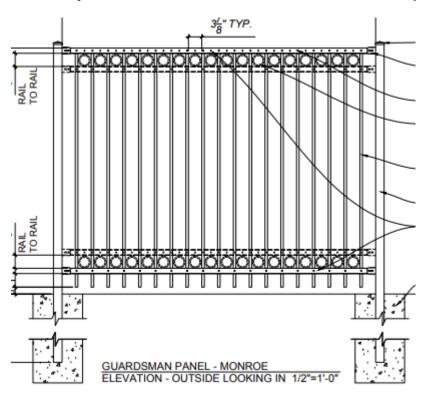
Proposed fencing and gates: Black 6-foot-high steel fence proposed for north and west sides of property, along shallow grass lawns, with matching gates for walkways to entries and matching double gate for driveway near southeast corner of building.

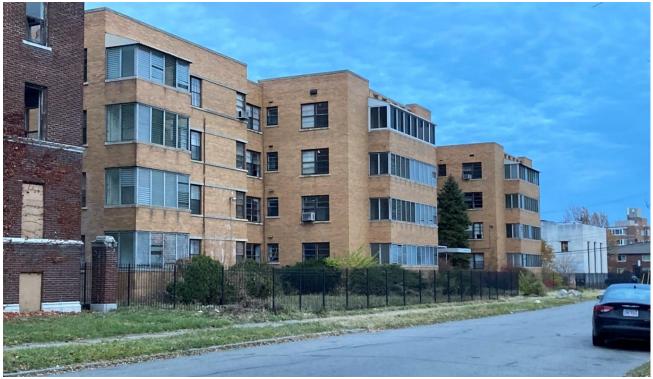
The next large apartment complex to the east on Whitmore, 660 Whitmore, has almost full perimeter fencing. The fencing is not historic. The white building to the east just visible here is the Unity Temple and that building only has its parking lot fenced in.

- There are, however, two instances of perimeter fencing in the neighborhood of 761 Whitmore. The property immediately to the east (725 Whitmore) and a property four buildings to the east and across the street (660 Whitmore) both have full perimeter fencing around their properties. Neither is on a corner, as 761 Whitmore is. (Please see the photos below the "Recommendations" section.) Unity Temple, at the corner of Whitmore and Second (17505 Second), has its parking lots fenced in, but the front of the church is unfenced.

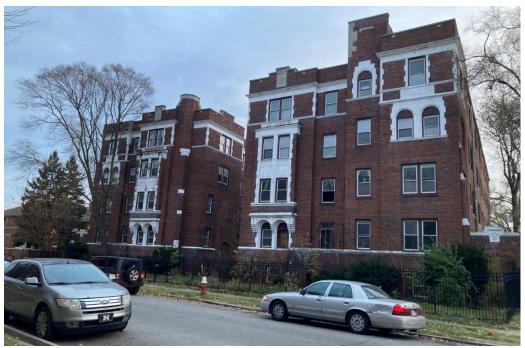
Apartment complex (725 Whitmore) immediately next to 761 Whitmore to the east. It has a full perimeter fence. Staff believes this fence to be contemporary.

- Regarding 725 Whitmore, the subject property's immediate neighbor to the east, staff notes that it is an older building than the subject property

and is a taller, more traditional, more symmetrical building with a more formal relationship with its lot. Its perimeter fence is not historic but is designed to look similar to a historic, wrought-iron fence. Staff notes that this fence style, and perhaps this fence placement along the sidewalk, may be appropriate for 725 Whitmore, but may not be for 761 Whitmore. The Modernist, lower-slung, garden-style apartment buildings like 761 Whitmore, which are scattered throughout the district, have a different appearance and a different relationship with their lots than higher-style, more formal apartment buildings do. The garden-style apartments tend to be only a few stories tall, have an irregular footprint, and they tend to sprawl across their lot. A perimeter fence at one property does not mean that a similar fence at another property would be appropriate, even if the properties are adjacent to one another.
