STAFF REPORT: DECEMBER 10, 2025 REGULAR MEETING PREPARED BY: B. SALIE

**APPLICATION NUMBER:** HDC2025-00666

**ADDRESS: 2984 IROQUOIS**

**SCOPE**: INSTALL GATE

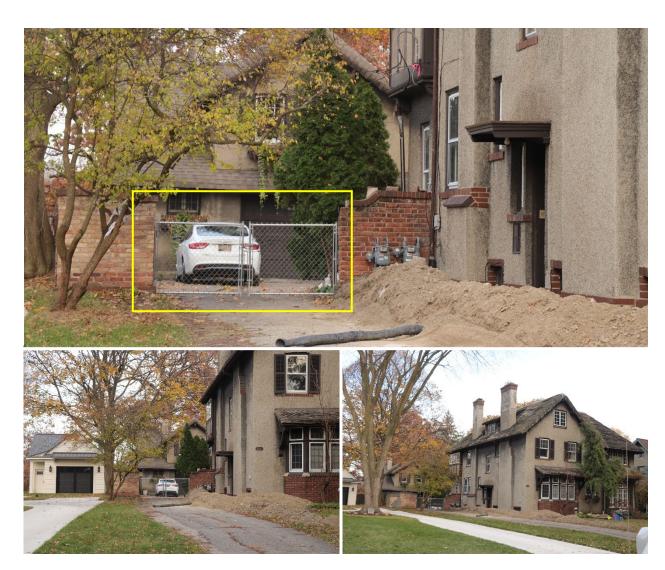
Photo taken by staff on 11/21/2025. YELLOW: Chain-link gate (subject of this application).

- Install a chain-link gate
  - O The current chain link gate was installed as a temporary gate in 2023 with a two-year allowance. The property owner is returning to the Commission to request a permanent extension for the chain-link driveway gate.
    - The applicant notes, "DHDC 23-8401 allowed a traditional wire mesh driveway gate to contain my dogs; it was temporary for two years. This was a result of my appeal that the HDC proposed wood gate required wheel support due to wide span, and would require manual clearing of snow in winter to operate. I am now 70 years old. I have had numerous health problems with my legs... The current gate can be cleared with a self-propelled snowblower, the wood gate area cannot. I request a permanent HDC extension to accommodate my disability."

The existing wall is largely parged with concrete or stucco, though some of this material has detached. Staff suggests that the street-facing plane of the wall, now showing exposed brick, was once similarly parged. The use of common brick, combined with the rough nature of the mortar joints, implies that the brick was intended to be concealed, consistent with the other elevation of the wall.

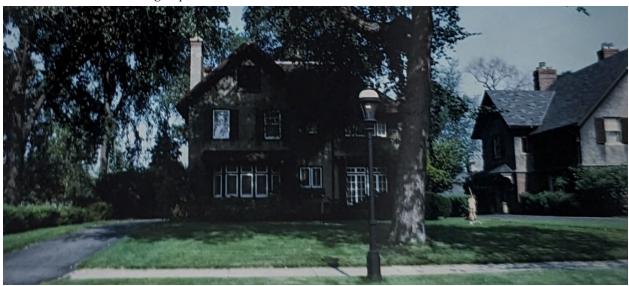
Designation photo taken August 1971

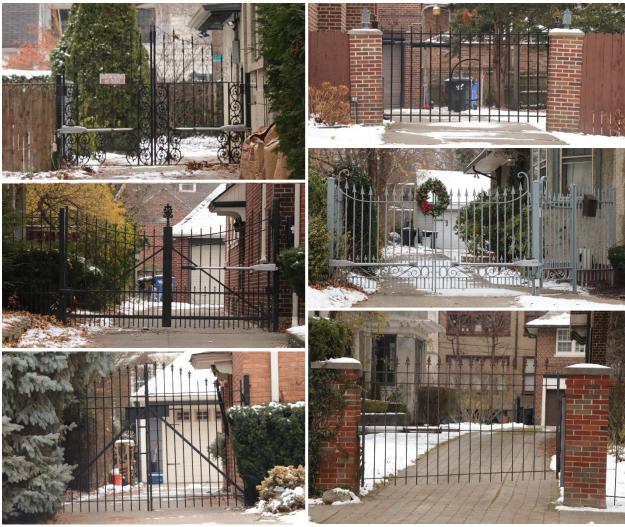
Examples of wrought iron or wrought iron style aluminum gates within Iroquois Street, some enclosed by masonry

• Staff observed a consistent pattern of wrought iron or wrought iron style driveway gates at the houses surrounding 2984 Iroquois, including gates abutting masonry walls or piers. Based on Google Street View Images from 2019, the houses directly next to and across from the property, all have wrought iron style gates. This includes 2970 Iroquois, 2965 Iroquois, 2961 Iroquois, 2924 Iroquois, 2910 Iroquois, 2971 Iroquois, 3020 Iroquois, 3015 Iroquois, and 3031 Iroquois.
