SR-2 – ADVISORY STAFF REPORT (03-06-2026)

ADDRESS: 1656 W BOSTON BOULEVARD

APPLICATION NUMBER: HDC2026-00006

SCOPE: ENCLOSE REAR PORCH (WORK COMPLETED), PARTIALLY DEMOLISH REAR PORCH ENCLOSURE, INSTALL DECK

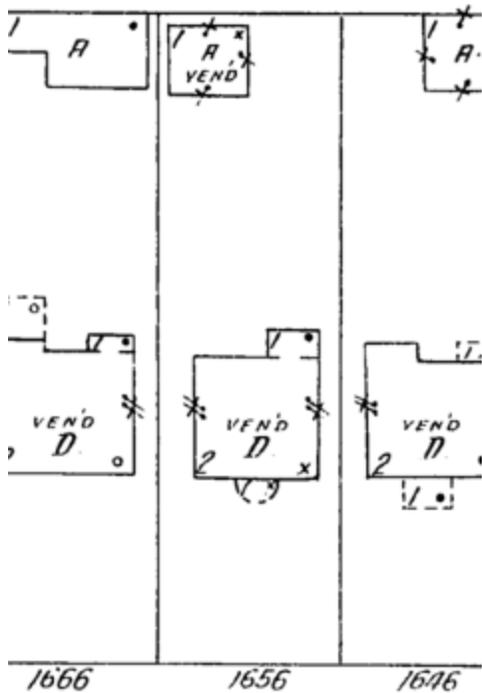
Sanborn map, 1925. 1656 W Boston Blvd is shown with the one-story rear wing at the house's northeast corner, but the centered rear porch is not shown.

- **The first proposed scope item is the retroactive approval for an enclosure of a rear porch.**
- The rear porch is centered on the rear of the house, and it is not known when it was built or when it was enclosed. (BSEED records do not document either event.)
- The 1925 Sanborn map for Boston-Edison shows no center addition/porch on the house's rear.

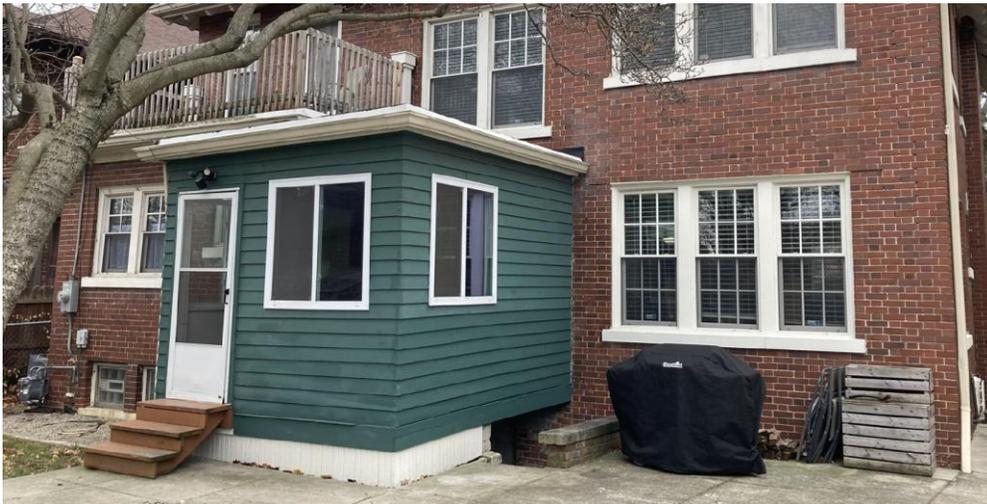
From application materials. The one-story brick wing with a guardrail above is shown to the left of this image. This is the one-story rear wing shown on the Sanborn at the northeast corner of the house. Also visible here is the centered enclosed porch addition, which is a focus of this proposal. The centered addition does not appear on the Sanborns and the date of its construction and enclosure is unknown, but it does appear as an open porch in 2005-2006 satellite images.

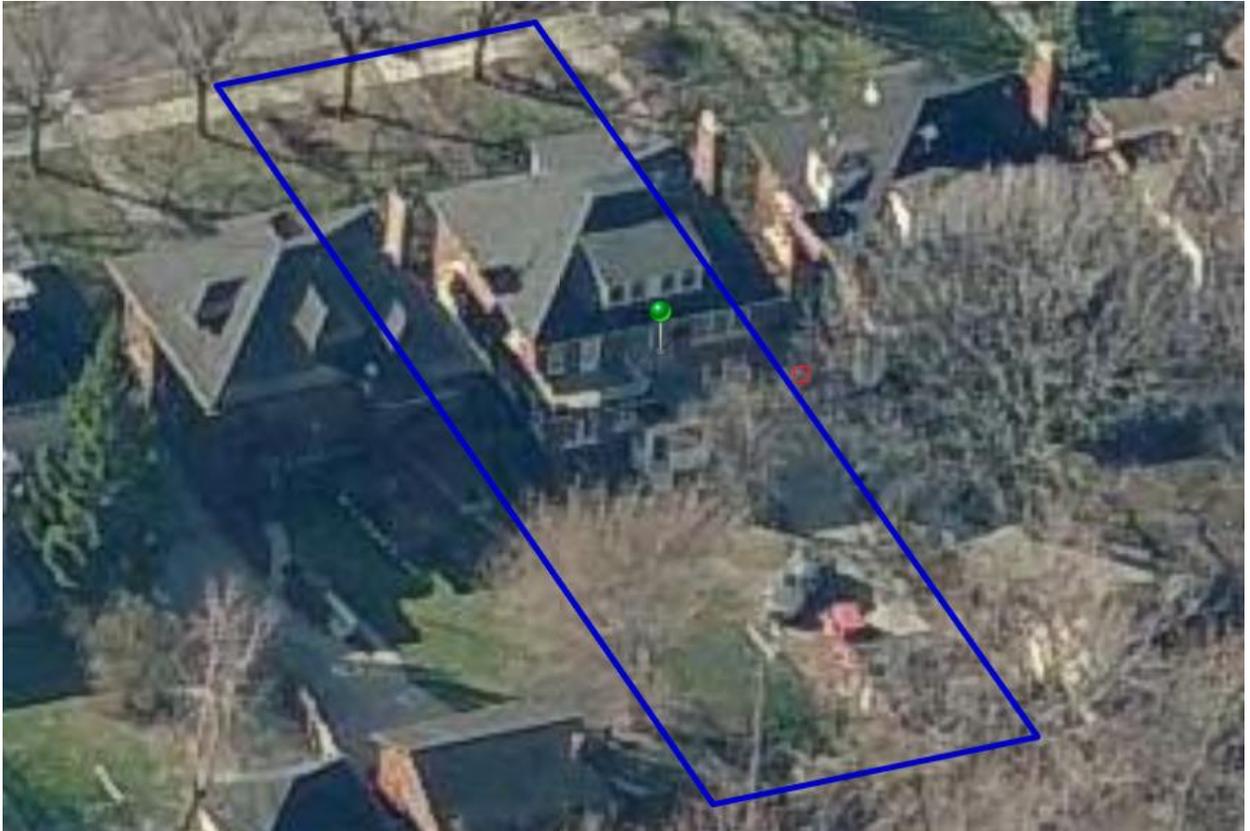
1656 W Boston, ConnectExplorer image, dated November 2005-April 2006, rear (north side) of the house. The centered, rear one-story open porch with white posts and railing is visible next to the one-story brick wing with guardrail above.

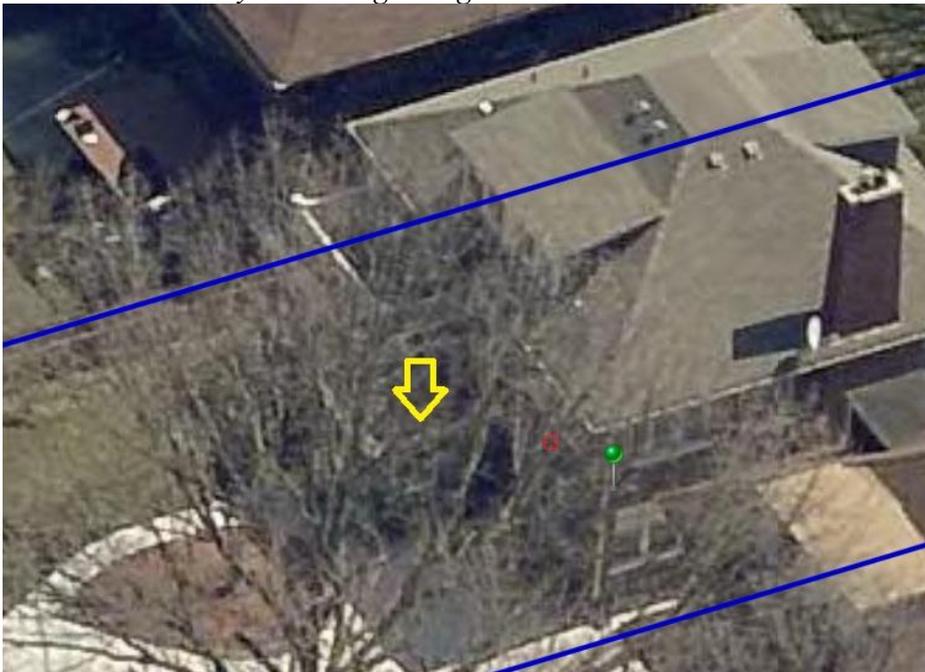
In this ConnectExplorer image taken between April and May 2016, the centered open porch has been enclosed. Staff added the yellow arrow to indicate a window visible through tree branches.

- In summary, it appears that the rear porch was enclosed by 2016 without HDC approval. The enclosure included wood siding, an aluminum storm door, and aluminum slider windows.

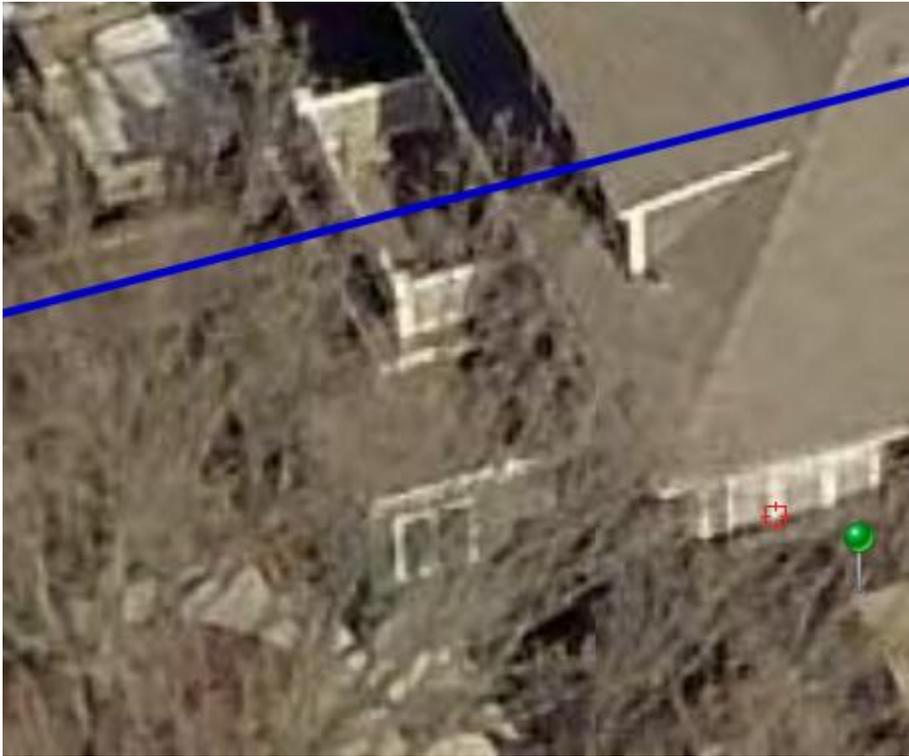
This ConnectExplorer image from March-April 2018 clearly shows that the centered porch has been enclosed. The guardrail on top of the one-story brick wing is visible as well.

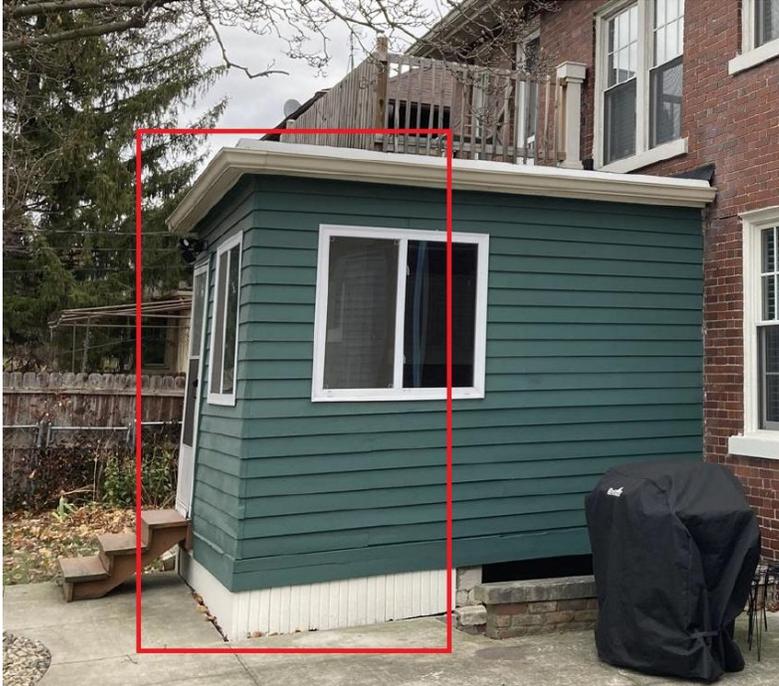
From applicant materials, with staff mark-up. The portion of the enclosed porch outlined in red is proposed to be demolished. Afterward, the remaining enclosure will generally align with the concrete foundation wall seen here and the rear wall of the brick wing. The brick wing and sided porch enclosure are proposed to be flush with each other once the work is complete. The resulting rear addition would only have one window, next to the exterior door. The other windows are proposed to be eliminated.

- **The second scope item is to demolish part of this now-enclosed porch.**
- Staff does not find this rear enclosed porch historic or character defining. As such, the Standards don’t compel preservation of the nonhistoric addition.

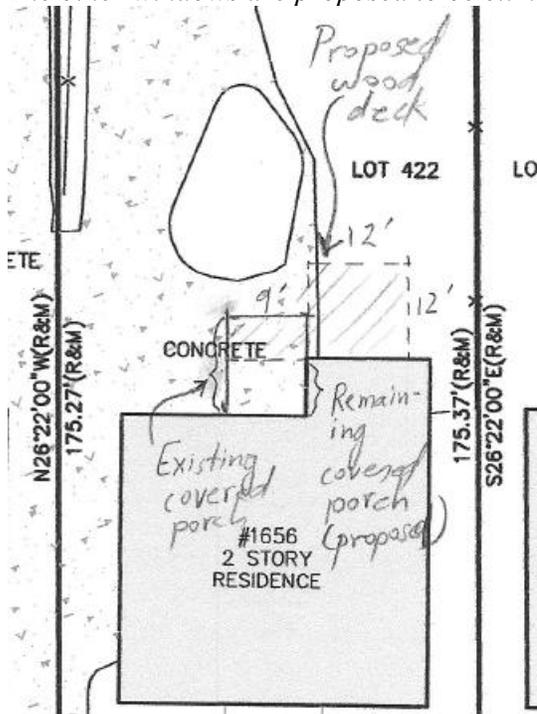
Plan view of proposal. The existing enclosed porch will be partially demolished and reduced in size. Then, a new proposed wood deck (shown in stripes) would be built. (From applicant's materials)

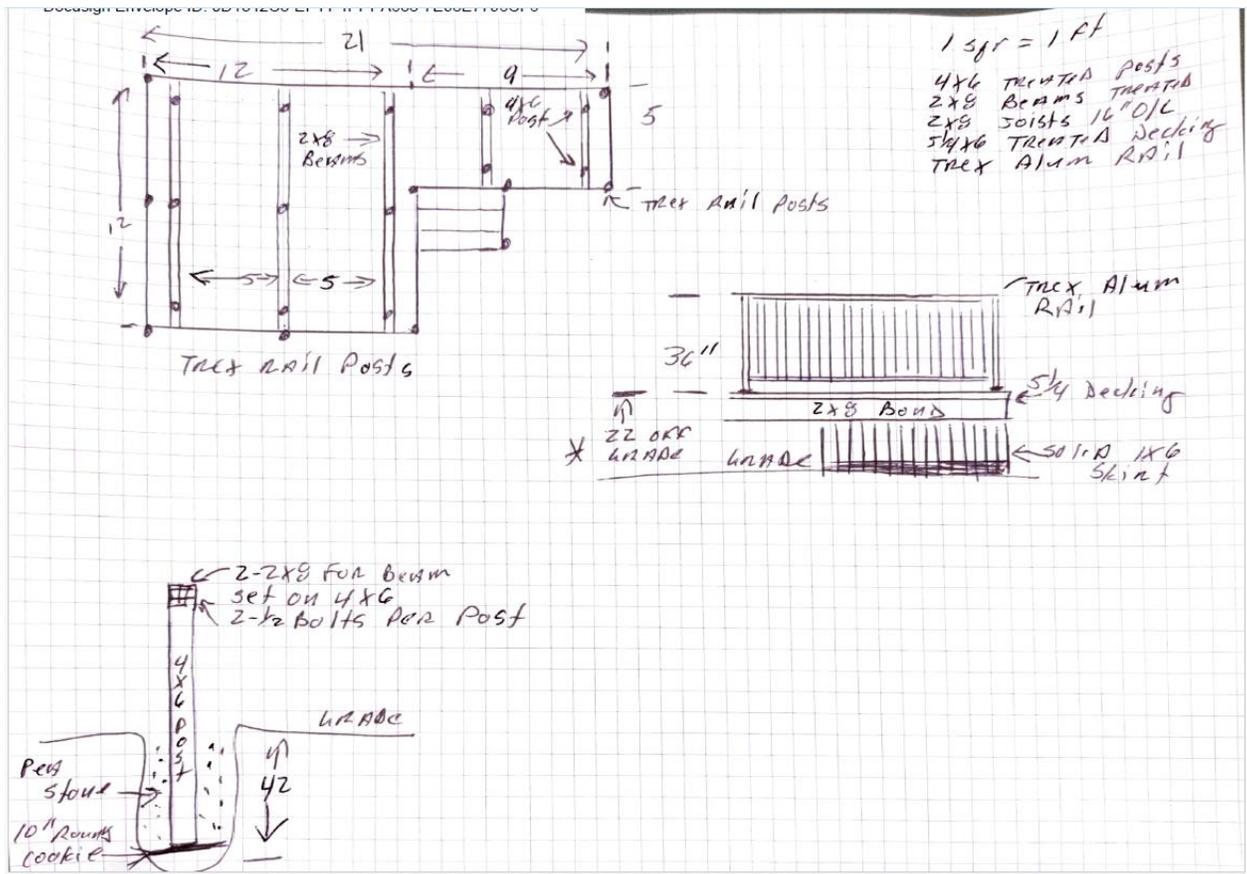
From applicant's materials. The smaller, rectangular portion of the deck is proposed to be the same size as the demolished part of the enclosed porch. The altered enclosed porch and the smaller portion of the deck would have the same footprint as the former enclosed porch. Additionally, a larger section of the deck would be built that would span across most of the brick rear wing as well, so the entire deck would span from the center of the rear wall almost to the eastern wall of the house.

- Staff finds the proposed deck compatible with the house in size, scale, and massing. Staff believes that the proposed black aluminum guardrail will be compatible with the historic house and the deck, and that the wood components of the deck structure should be stained or painted. The proposed skirting material was not provided and needs to be confirmed. It should be painted or stained wood. Staff believes that the proposed treatment composed of vertical boards forming a solid skirt under the deck is a contemporary treatment and would not be compatible with the historic house.
