SR-2 – ADVISORY STAFF REPORT (03-06-2026)

ADDRESS: 892 W BOSTON BOULEVARD (EDWARD FISHER RESIDENCE)

APPLICATION NUMBER: HDC2026-00039

SCOPE: INSTALL POOL, LANDSCAPING

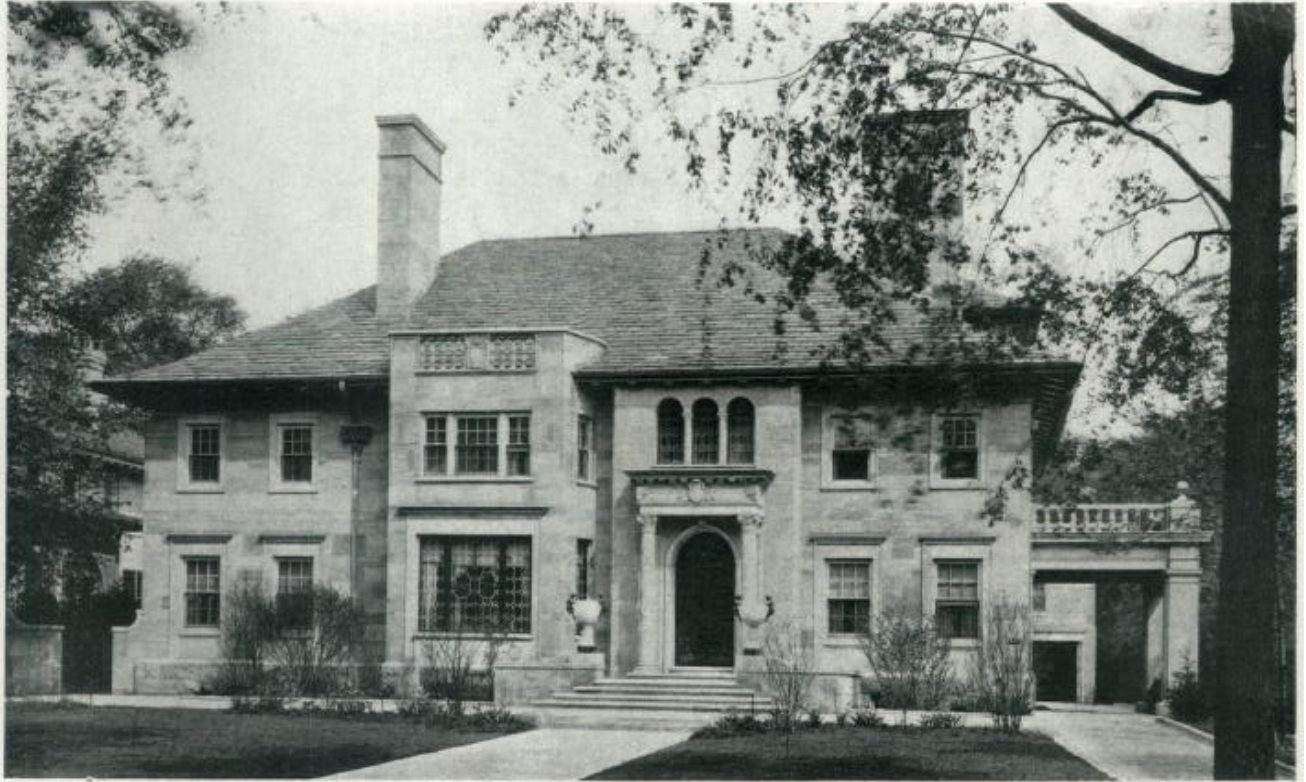
RESIDENCE OF EDWARD F. FISHER, ESQ., DETROIT, MICHIGAN

The house, featured in The Architectural Record (February 1926). The house remains the same. The shrubs have changed (evergreens are in their place) and the urns on the front terrace have been replaced.

- The Edward Fisher Residence was featured in *The Architectural Record* in February 1926, and the photos from that article show that the property retains a high level of integrity.

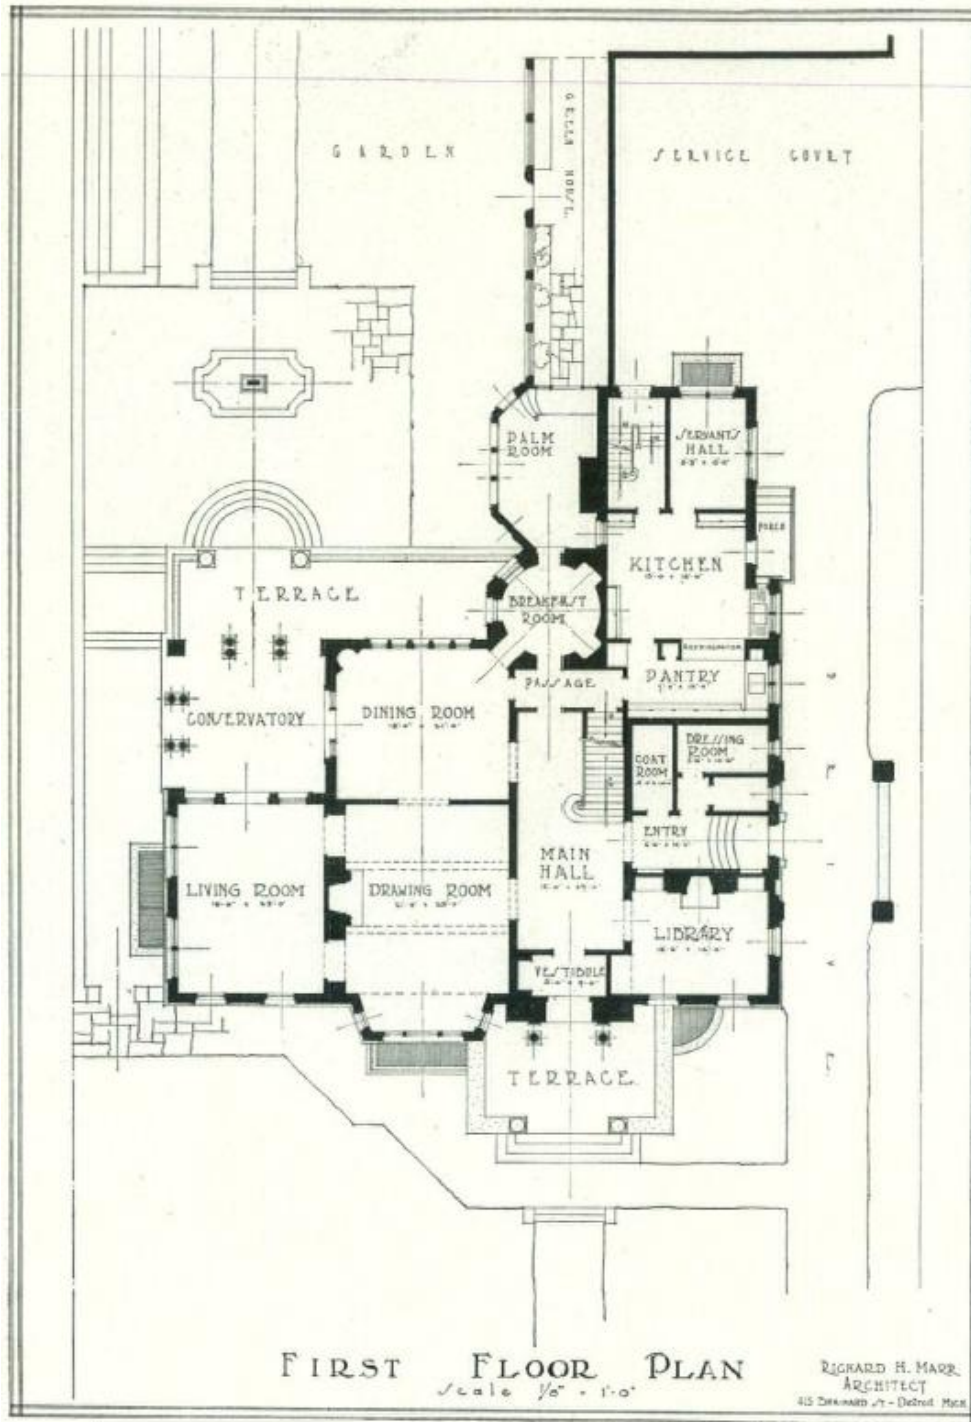
First-floor plan as shown in the February 1926 Architectural Record. The south water feature is shown, and the rear terrace, steps, south water feature, and paved path to the north water feature (north of this plan) create an axis and an intentional view. Shown is a greenhouse that connected the palm room to the garage. That connector has been removed, but staff has not been able to determine when. Also shown is the service court, small kitchen porch, porte-cochere, drive, and front entry walk. These spaces are all included in the proposed scope of work.

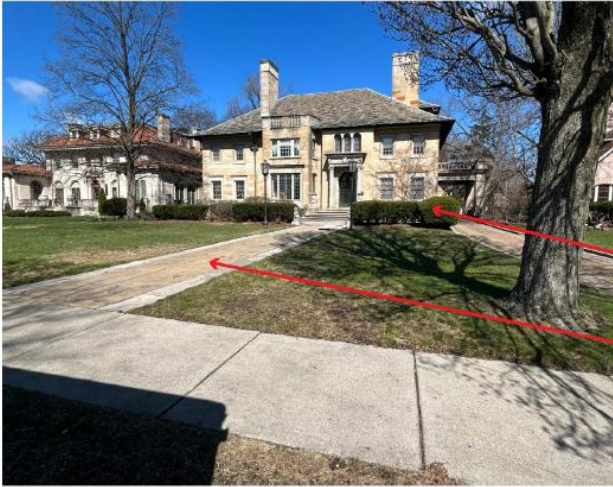
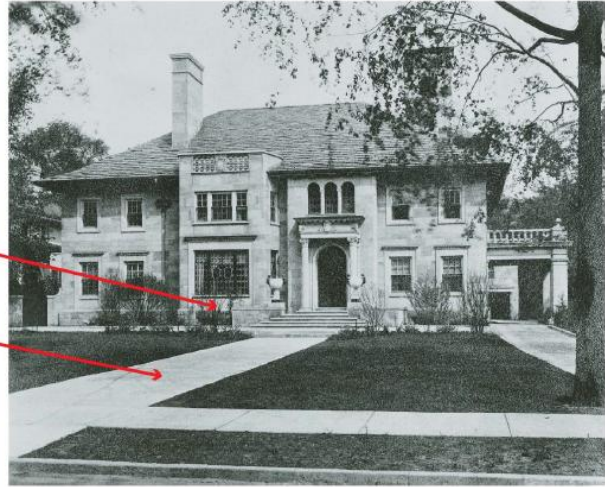
From applicant's materials. The existing dyed concrete and paver combination is shown on left. In the historic photo to the right, the entry walk looks like concrete, similar to the public sidewalk, but it is difficult to discern the material with certainty. The drive was brick in historic photos.

- **Staff Response:** Staff finds that the proposed concrete installation on the front entry walk is a restoration of a missing feature, meeting the Secretary of the Interior's Standards and Guidelines for Rehabilitating Historic Buildings.
- **Replace front yard lanterns on poles**
 - **Proposed:** Remove existing gas lanterns (installation date unknown)

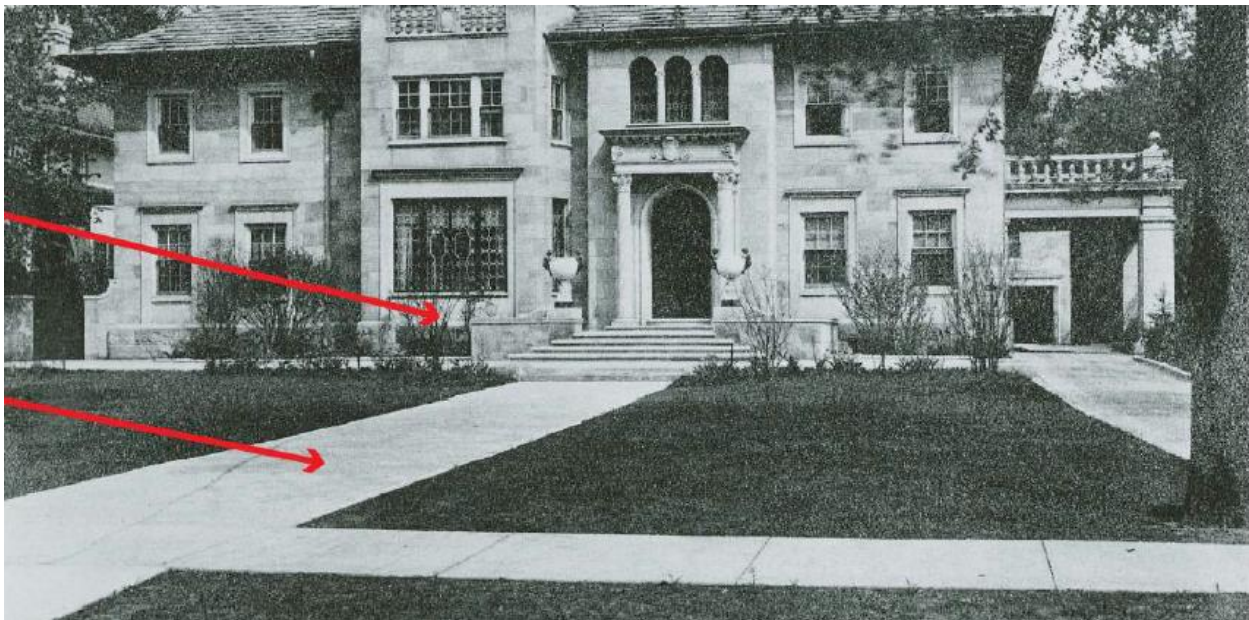
Detail of historic photo above. The front entry walk appears to have a long crack in it down through the sidewalk, which indicates to staff that it was concrete or stone and not brick pavers like the drive.

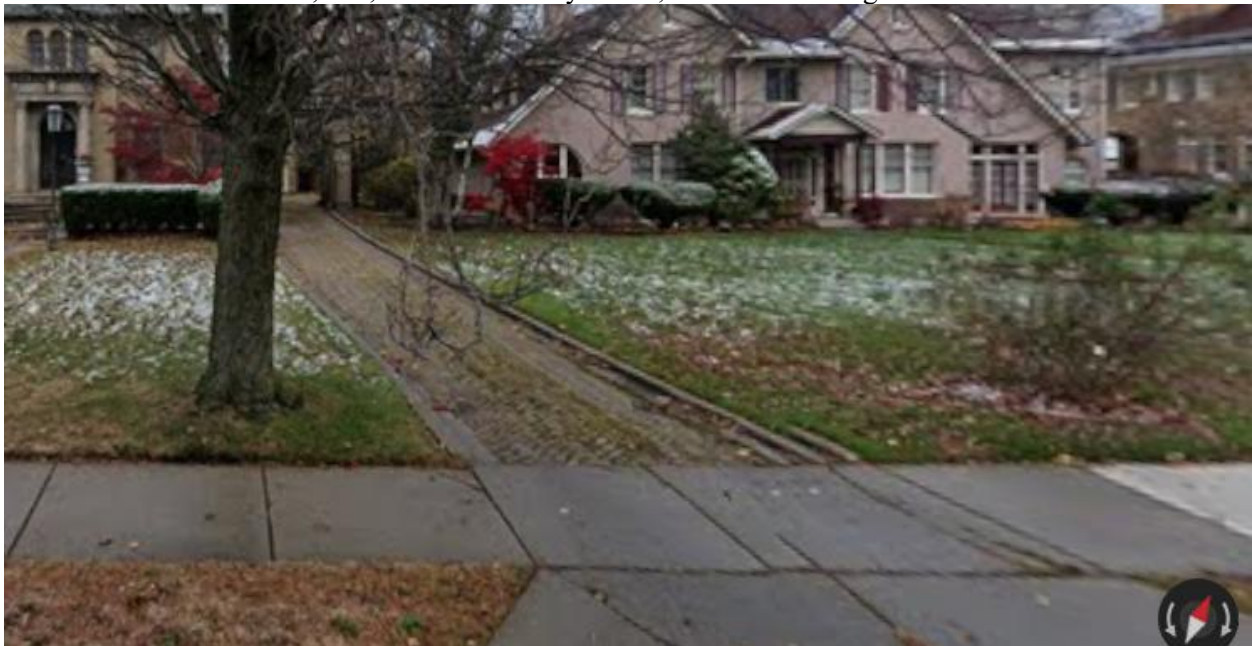
Google street view image from November 2024 that shows the historic brick drive with curbs and slight curve into the porte-cochere. The 2026 staff site visit photos do not show this feature well because of snow cover. The proposed new drive would align with the outer edge of the porte-cochere and follow a straight line south to the sidewalk.

- **Staff response:** Currently, the drive remains a consistent width along its length from sidewalk to porte-cochere. Once through the porte-cochere, the driveway begins to widen and by the house's rear wall, the service court reaches from the service court wall east to the property line, and from the kitchen porch steps to the front wall of the garage. There is currently a slight curve to the drive, along the front lawn, and this proposal keeps the curve on the west edge of the drive next to the house and lawn, but eliminates the curve on the east edge of the drive. Flattening this curve allows the driveway to widen 3' 4" from the beginning of that curve to the porte-cochere to 12' 8". Staff estimated the widths of 12 nearby driveways on both sides of W Boston between Hamilton and Third,

and all but four measured between 8 and 10 feet wide. Two were 11' wide, one was 12' wide, and the driveway next to 892 (Berry Gordy's residence) measured 15' wide. (The 1960s house across from Berry Gordy's residence has a very suburban form with a two-car garage and a wide, modern subdivision-type driveway that is atypical for the neighborhood, so it was excluded from this study.) 892 W Boston Boulevard's current driveway width is average for the neighborhood, and widening it to almost 13' makes it the second-widest on this block. It is staff's opinion, however, that the impact of the widening would be lessened by the fact that the drive wouldn't widen beginning at the sidewalk; instead, the new eastern curb would start where it is presently and it would stretch to meet the outer (eastern) edge of the porte-cochere. As long as there are enough salvaged bricks to use for this scope item (or matching bricks could be sourced) and the brick pattern remains the same, staff finds that this work (re-laying bricks and widening the drive) is compatible and meets the Standards. Boston-Edison's Elements of Style Element 13 states that "Straight side driveways leading from the street to rear garages are the norm..." and that "These driveways are paved in asphalt, concrete, or brick." Staff assesses that the brick driveway with its curbs is a very visible, historic feature.

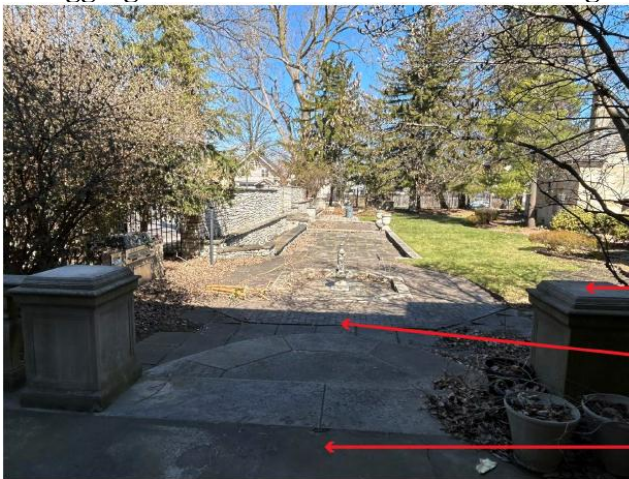
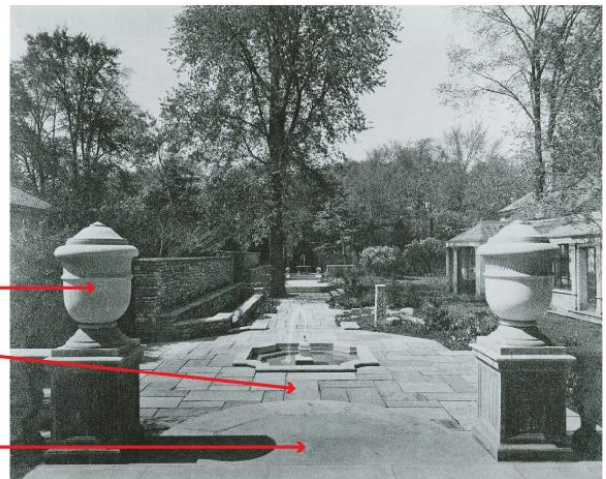
Photos from application materials. Current photo on left and historic photo on right. These views show some of the most important, character-defining elements in this rear yard designed by Fleming, including the terrace and pedestals (still intact), shallow fountain in an octagon border, pavers around the octagon (replacement pavers), west wall, and continued axial path with pavers to north water feature.

Staff response: Staff finds that the terraces with pavers, from the upper terrace to the north water feature and framed by trees, are central design elements in this work by significant and nationally renowned landscape architect Bryant Fleming. Large pavers were planned and installed, and they have since been replaced with smaller pavers and bricks; still, staff finds that the historic, character-defining elements remain and should be preserved. If the existing pavers and bricks are beyond repair, the pavers should be replaced in kind or, more faithful to the Guidelines, restored to their former appearance. Staff does not assess that changing the pavers to exposed aggregate concrete with limestone bands as shown in the sample above meets the Standards. Staff does not find that the proposed matches the existing in size, scale, color, texture, or materials.

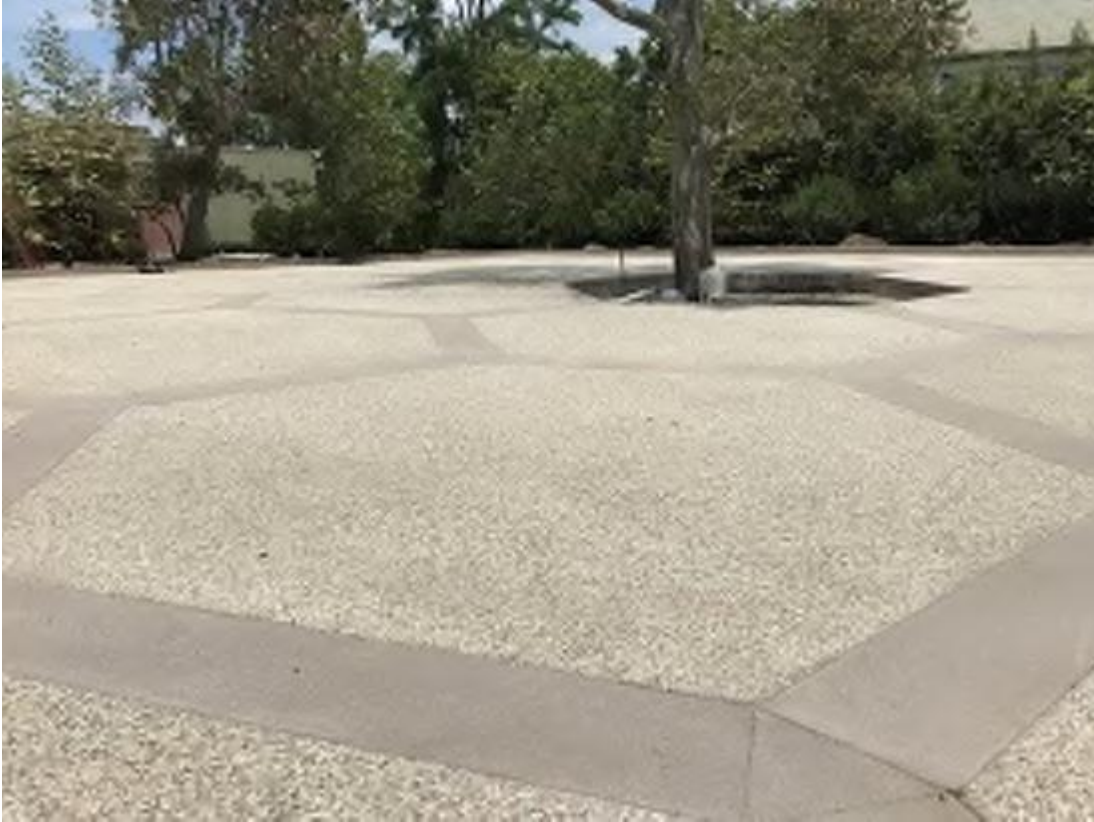
Proposed exposed aggregate concrete (sample) with limestone banding to replace the concrete and brick pavers around the octagon fountain.

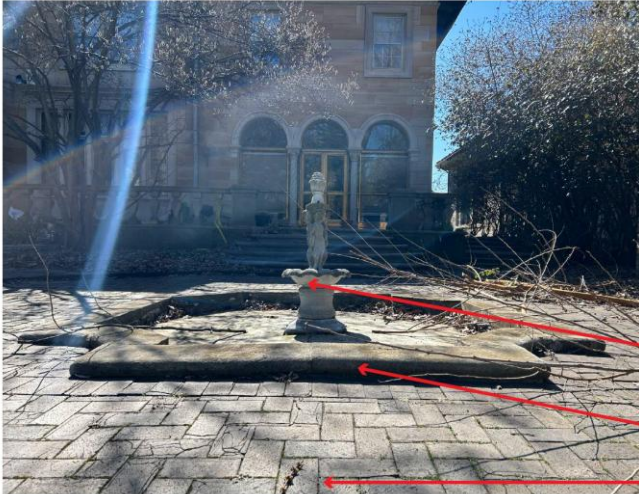
- **Rear yard, transition terrace: Remove existing fountain sculpture and bowl from existing fountain and replace with replicated limestone fountain from historic photos.** (South water feature)

- **Staff response:** The current fountain is not original to Mr. Fleming’s plan, and staff found no information suggesting that the existing sculptural fountain and bowl have acquired significance in their own right. Consequently, staff finds that removing the current fountain and replicating and restoring a missing significant feature to install instead would be encouraged by the Standards (6) and Guidelines.

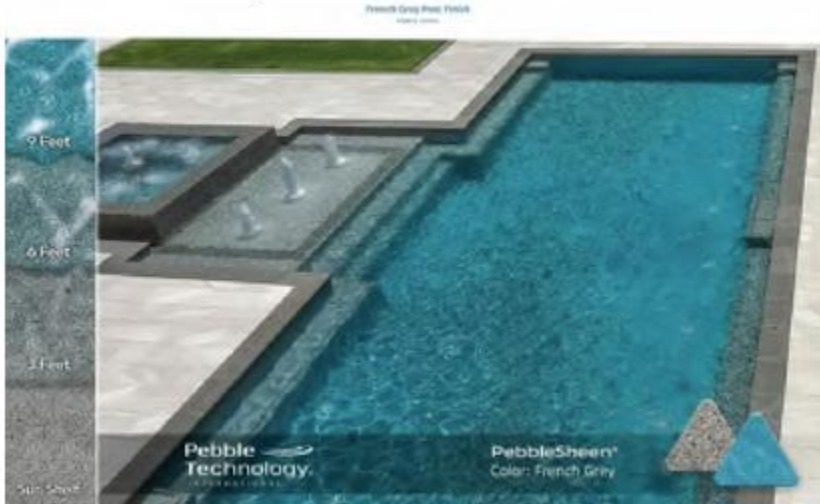
**Proposed Pebbletec Interior Pool
Finish – French Gray**

Proposed pool products, from applicant materials.

- **Staff response:** Staff finds that the terraces and axial path paved with geometric pavers, along with the west wall of uncut stones, are all significant, historic, character-defining features of this designed landscape and that the landscape features tie the Italian Renaissance house to its site. Mr. Fleming’s use of shrubs and trees, water features, walls, and pavers in formal, geometric ways organize this lot and integrate the yard with the Italian Renaissance house and its architectural details.

- Removing the pavers on this terrace, widening it, and replacing the pavers with concrete and a modern swimming pool would interrupt the axial path the landscape architect designed, and would significantly depart from his plan and diminish the formality and intention of the plan. The result would be the alteration of features and spaces that characterize this property. Consequently, it is staff’s opinion that the modern addition of a swimming pool in the proposed location conflicts with Standards 2, 5, and 6 in this case. Further, the proposed replacement of materials with exposed aggregate concrete would not uphold Elements of Design 7, 8, 10, and 14.

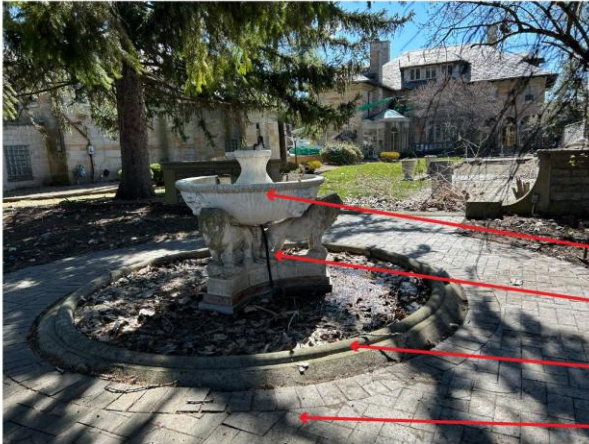
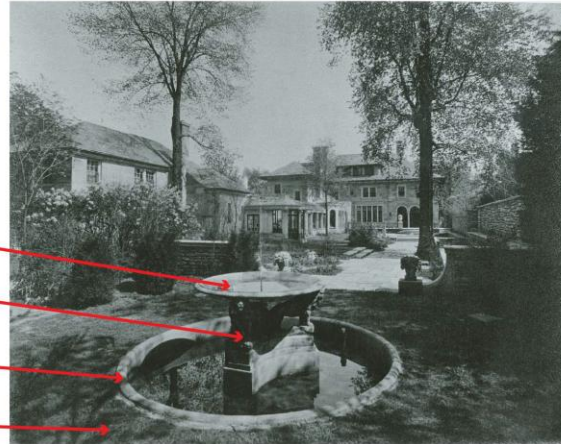
Rear yard, north water feature/fountain with lions base

- **Staff response:** Restoration of both water features is important to Mr. Fleming’s vision for the space and the design he implemented. The original bowl was shallower and simpler.

- Applicant confirmed in an email (2/26/26) that the plan is to retain the lions base as long as the base is structurally stable, and install a new Haddonstone bowl as specified in the application
- In the specifications included with the application, the bowl is shown on a pedestal, but the bowl can and would be purchased separately.

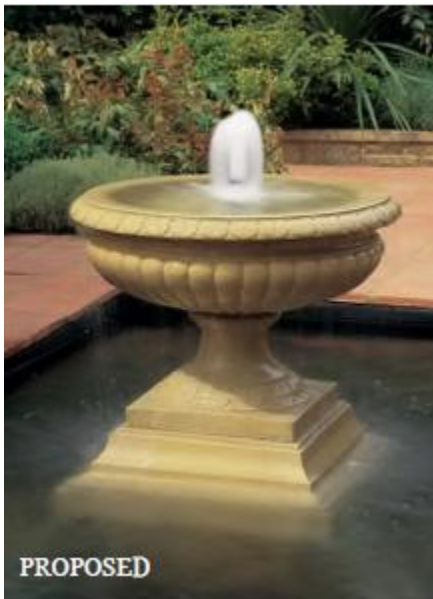
The bowl only (no pedestal) is proposed to replace the current broken bowl on top of the lions base. Then, the plan is to restore the fountain to working order.

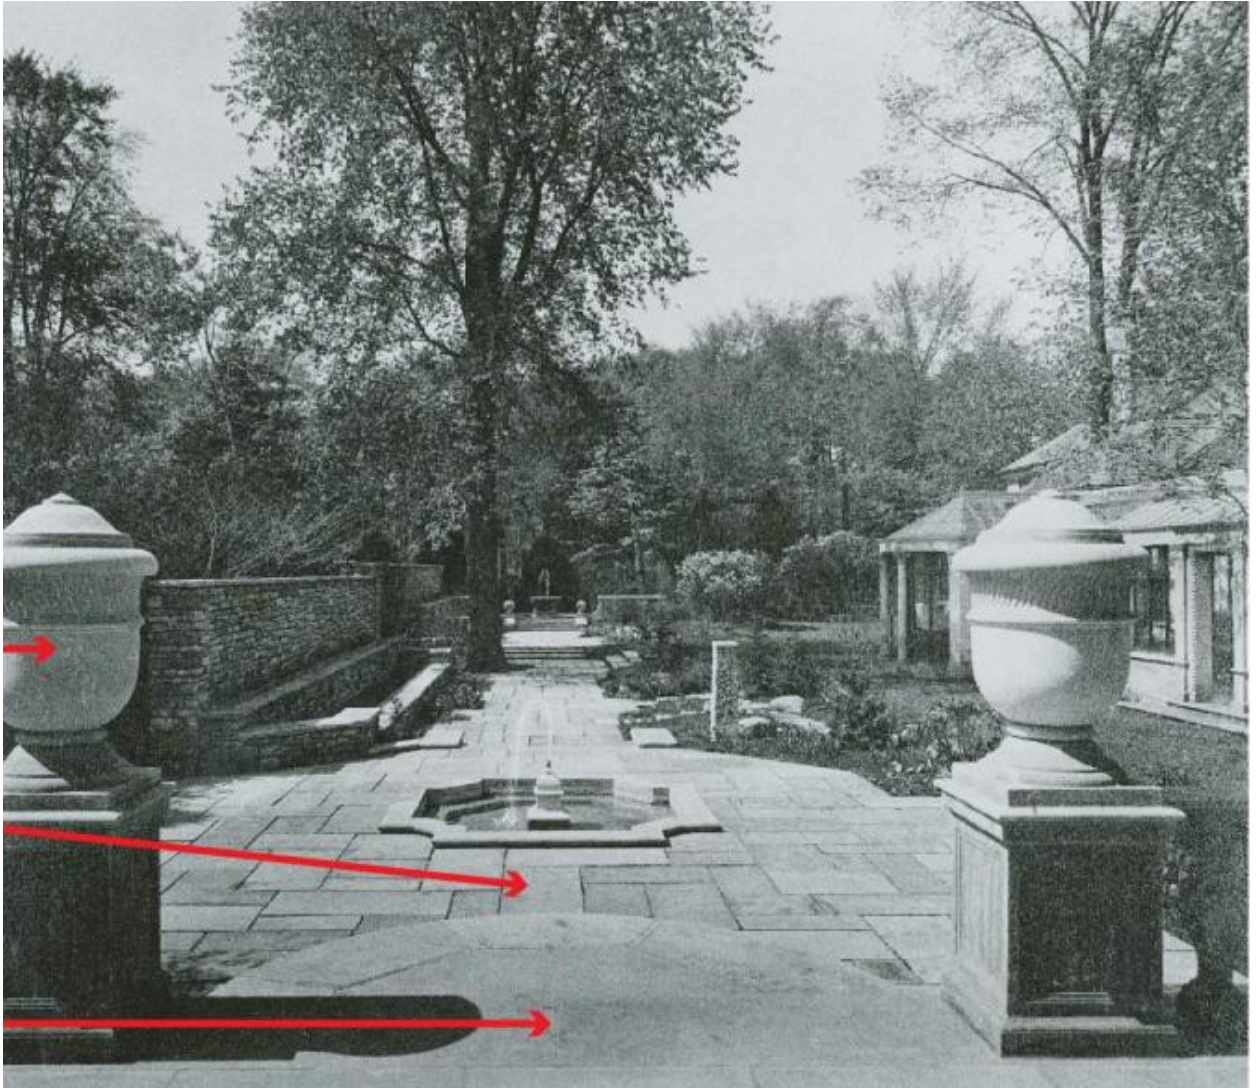
The historical photo shows the trees at the rear of the lot in Mr. Fleming's design. Also shown are steps up to that higher section of land where the expanded terraces would be. Would the topography be retained or would it all be flattened? It looks slightly lowered in the current photo below. (Applicant's materials)

- **Remove all spruces, maples, and a cottonwood at the rear of the yard. Replace with perimeter evergreen arborvitae.**
 - **Staff response:** An inventory is needed of the trees (and shrubs if any) proposed for removal, cross-referenced with historic photos showing the trees and shrubs that are planted per Mr. Fleming's historic design to ensure that historic landscape features are not lost.

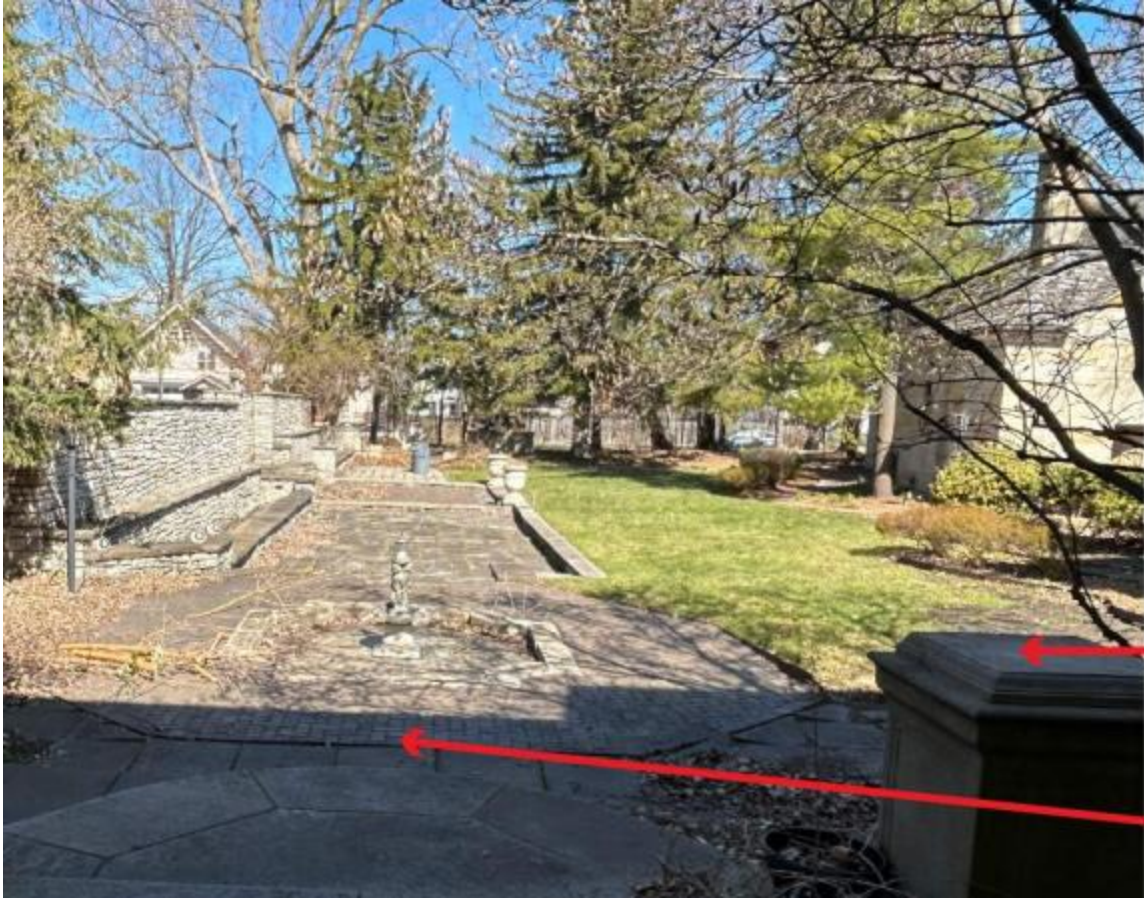
Applicant's photo shows trees present at the rear of the lot today. Staff does not know whether any of these are historic. An inventory of the trees to be removed cross-referenced with old photos of trees planted per Mr. Fleming's design is necessary.
