Re: Residential Redevelopment

240 Mack

Detroit, Michigan

The existing 3 story multi-family residential property at 240 Mack Ave, Detroit, MI is intended to be redeveloped as a 21 unit apartment building including the addition of 4 new units on the third floor of the existing 2 story concrete block portion of building.

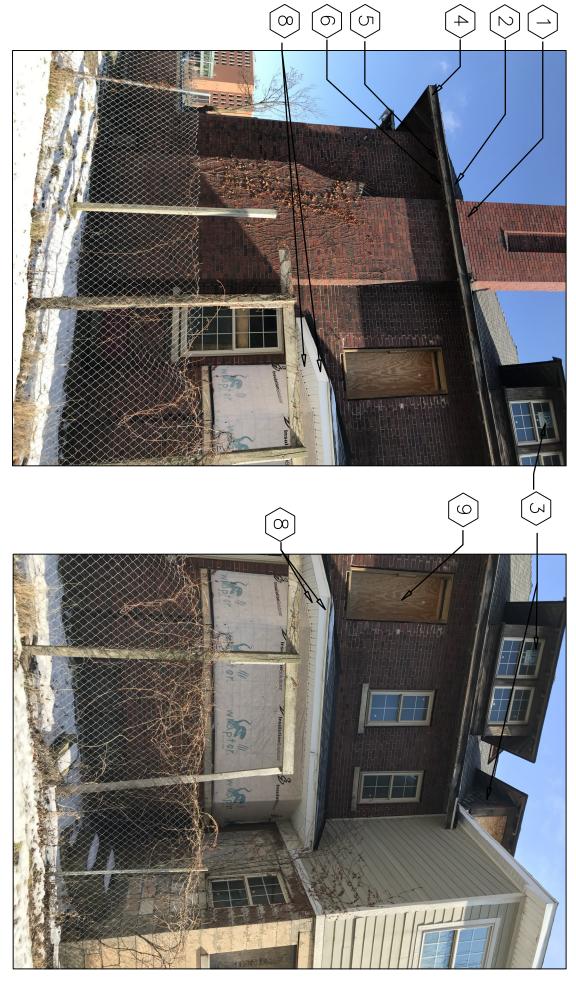
WEST ELEVATION, CON'T

- 1. All existing lap siding is to be removed complete with all corner and window trims.
- 2. The existing shed roof will be removed complete with all finish roofing, rafters, soffits and fascias. A new low slope, nearly flat roof will be installed per detail A/A5.2

- Existing walls will be trimmed with 1 x wood trim and painted to match original porch walls as closely as possible. See detail A/A5.2
- 4. The existing portion of the wall shown as shaded below will be removed, and setback 24" from it's current location in order to restore the 3 sided massing of the original second floor porch (see attached photo)

5. The vinyl windows currently installed on the front (historic portion) of the west elevation will be removed. New aluminum clad wood windows (Pella architect series) with 6 over 1 muntin pattern to match the original windows.

- 6. Wood crown trims at line of first floor are to be restored with new crown. See detail A/A5.2 for profiles.

7. All existing windows at historic porch section shown are to be removed and replaced with new aluminum clad wood windows (Pella architect series) with 6 over 1 muntin pattern.

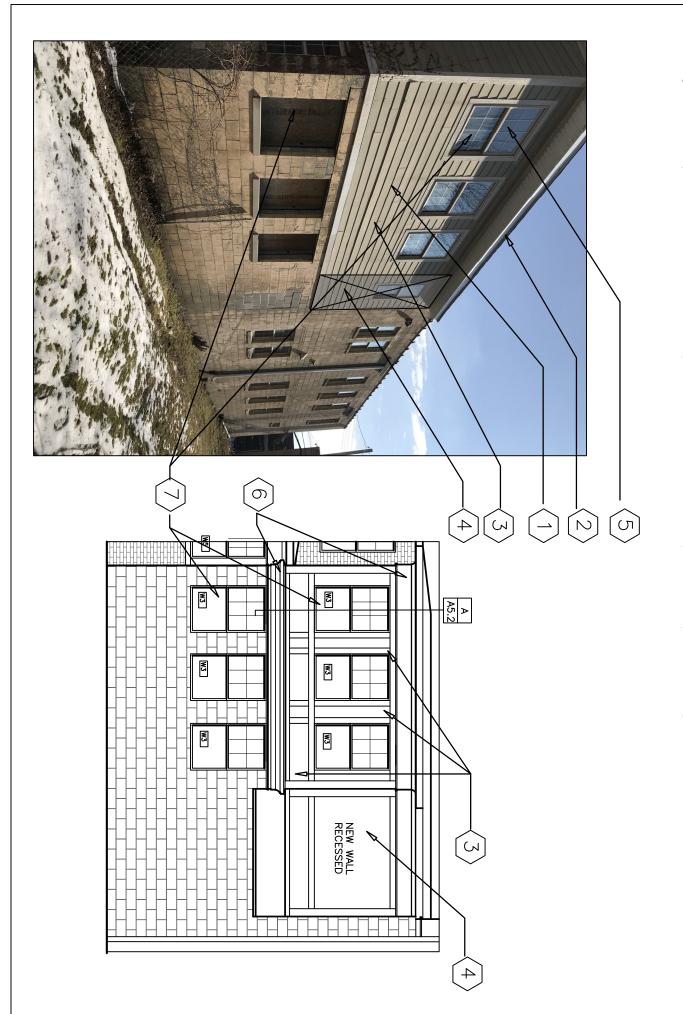
WEST ELEVATION, SOUTH ELEVATION

- 1. All existing lap siding is to be removed complete with all corner and window trims.
- . The existing shed roof will be removed complete with all finish roofing, rafters, soffits and fascias. A new low slope, nearly flat roof will be installed per detail A/A5.2

- The existing portion of the wall shown as shaded below will be removed, and setback 24" from it's current location in order to restore the 3 sided massing of the original second floor porch Existing walls will be trimmed with 1 x wood trim and painted to match original porch walls as closely as possible. See detail A/A5.2

- 8. The existing ADA access ramp will be removed and replaced. See detail 1+2 A/A5.3
- 5. The aluminum windows currently installed on the concrete block portion of the west elevation, shown below will remain.

6. Existing concrete block walls are to be scraped and painted.
 7. a new hipped roof structure will be built over the existing concrete block wall section to match slope of existing historic roof. see detail A/A5.1
