Addendum to HDC Project Review Request for 2485 Burns St.

Part 1: Second floor sleeping porch

Part 2: First floor screen porch

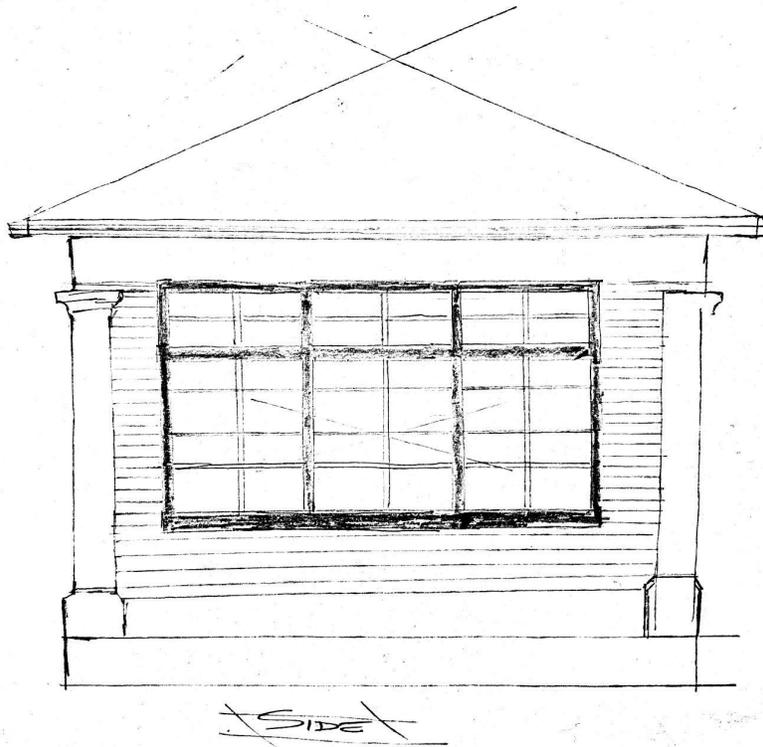
Sketch 1: South Face

My original sketches for the enclosure are included here. Some changes to the sketches were made based on actual availability of materials.

- Remove inoperable aluminum sliding doors and tracks
- Keep fascia board below gutter and repaint white
- Keep corner columns and replace same wooden trim at top of column
- Build knee wall to match existing sill height
- Build side walls to enclose room around new windows
- Install Marvin Signature wood windows
- Install Thermatru fiberglass door and Provia steel storm door
- Install 7" Hardie Board siding to match siding on rear
