3964 W Lafayette - Scope of Work

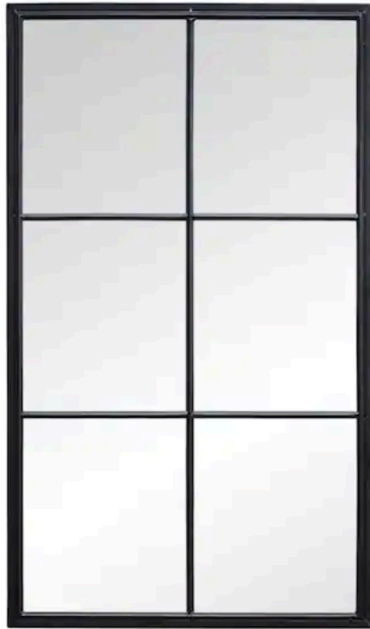
The window units themselves will look like this:

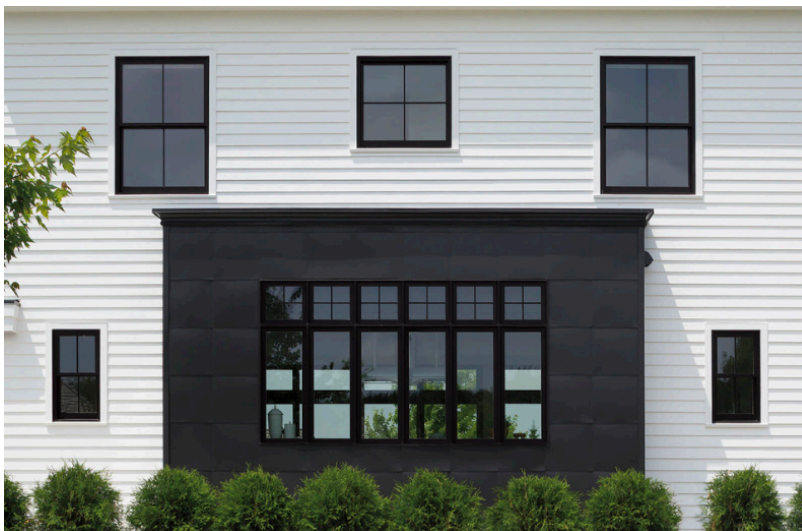
The window trim will be very minimal in order to blend with the siding. This will create a more seamless transition between the kerfed windows set in stucco, and the new windows installed alongside lap siding of the new addition. This “look” is captured well here:

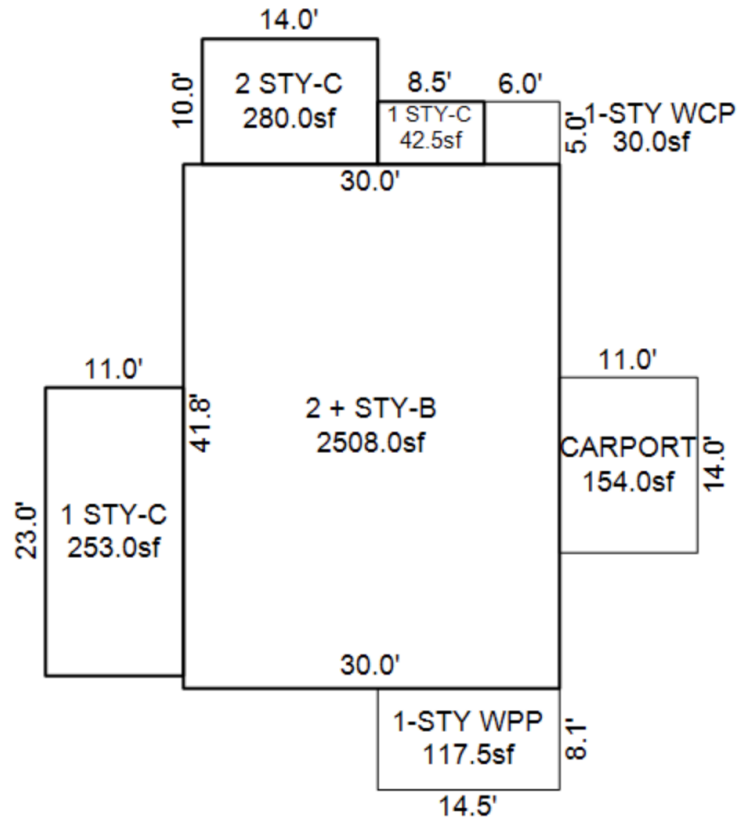
The addition in question is located in the south western corner of the home, measuring 23' x 11'. The floor plan is depicted here:

Our plan is to demolish this addition and rebuild one of the same footprint as the last. I'd like to fully demolish it so that I can have the opportunity to properly rebuild the foundation. We will be framing the room with wood studs instead of block, which will greatly reduce the final load on the walls. This helps ensure longevity of the new construction, and allows us to insulate the walls to a greater extent. The sun-room-like character of the addition will be captured in the new design by including multiple six large 6-lite windows to mimic the style of the historic windows present on the home, as discussed above. The windows will be picture windows, and trimmed in a very minimalistic fashion from the exterior. The roof line of the addition will extend to create an 18" overhang, giving ample weather protection to the exterior walls. There will be a circular dormer added to the center of the addition's roof to mimic those found on the main house roof. The roof of the addition will be the same product installed on the main roof of the home, which is the Timberline UHDZ Pewter Grey shingle. The siding will be a cement board siding that will be lapped to create a tight reveal found on historic homes throughout Hubbard farms and the Michigan as a whole. I am choosing to install this siding product instead of stucco for two reasons. First, building science proves that stucco over wood framing is not a resilient installation. Installed over a block wall face it works perfectly, due to the solid nature of the substrate. However, wood tends to move through temperature changes and causes
