# HISTORIC DISTRICT COMMISSION APPLICATION FOR WORK APPROVAL

Stabilization of existing 6 story apartment building, including masonry repairs, cleaning and/or repainting of facade, roof replacement, new gutters & downspouts, reboarding of existing windows, and entry modifications.

PROJECT NAME: ALHAMBRA APARTMENTS STABILIZATION  
ADDRESS: 100-112 TEMPLE ST., DETROIT, MI 48201  
PROPOSED USE: N/A - PROJECT SCOPE IS LIMITED TO BUILDING/FACADE STABILIZATION AND ROOF REPLACEMENT ONLY.

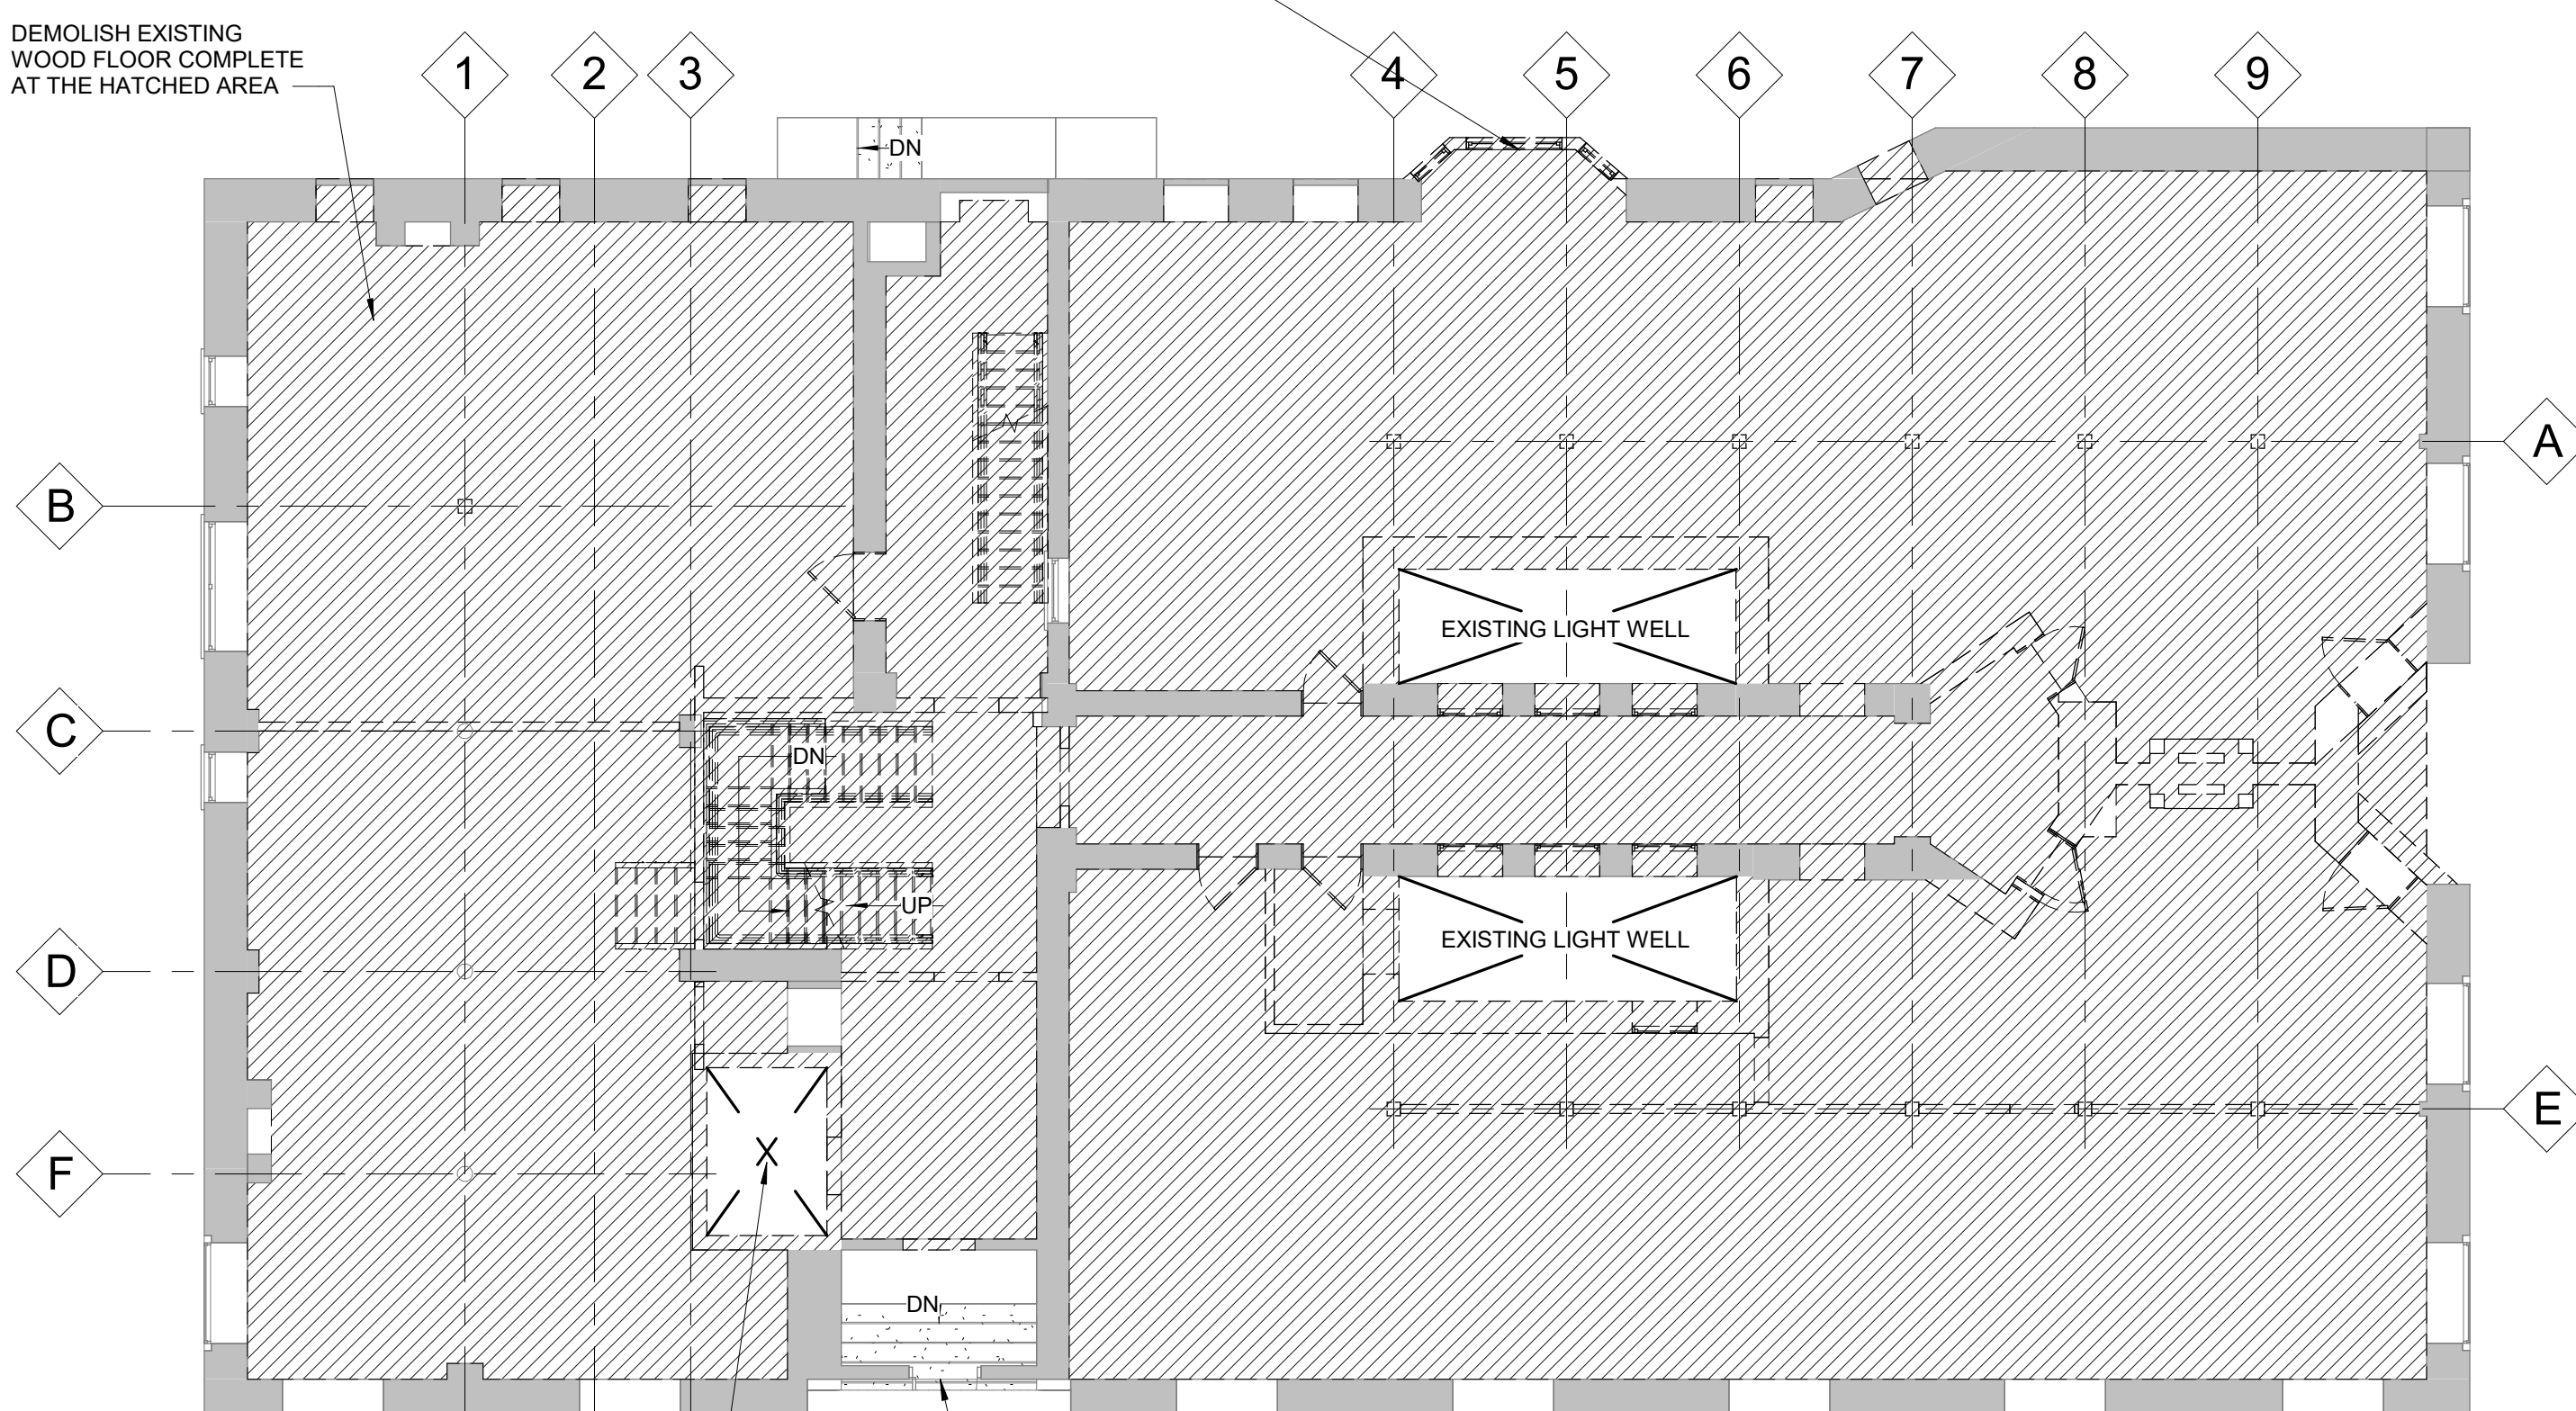
01 Level - Demolition  
1/8" = 1'-0"

DEMOLISH EXISTING  
WOOD FLOOR COMPLETE

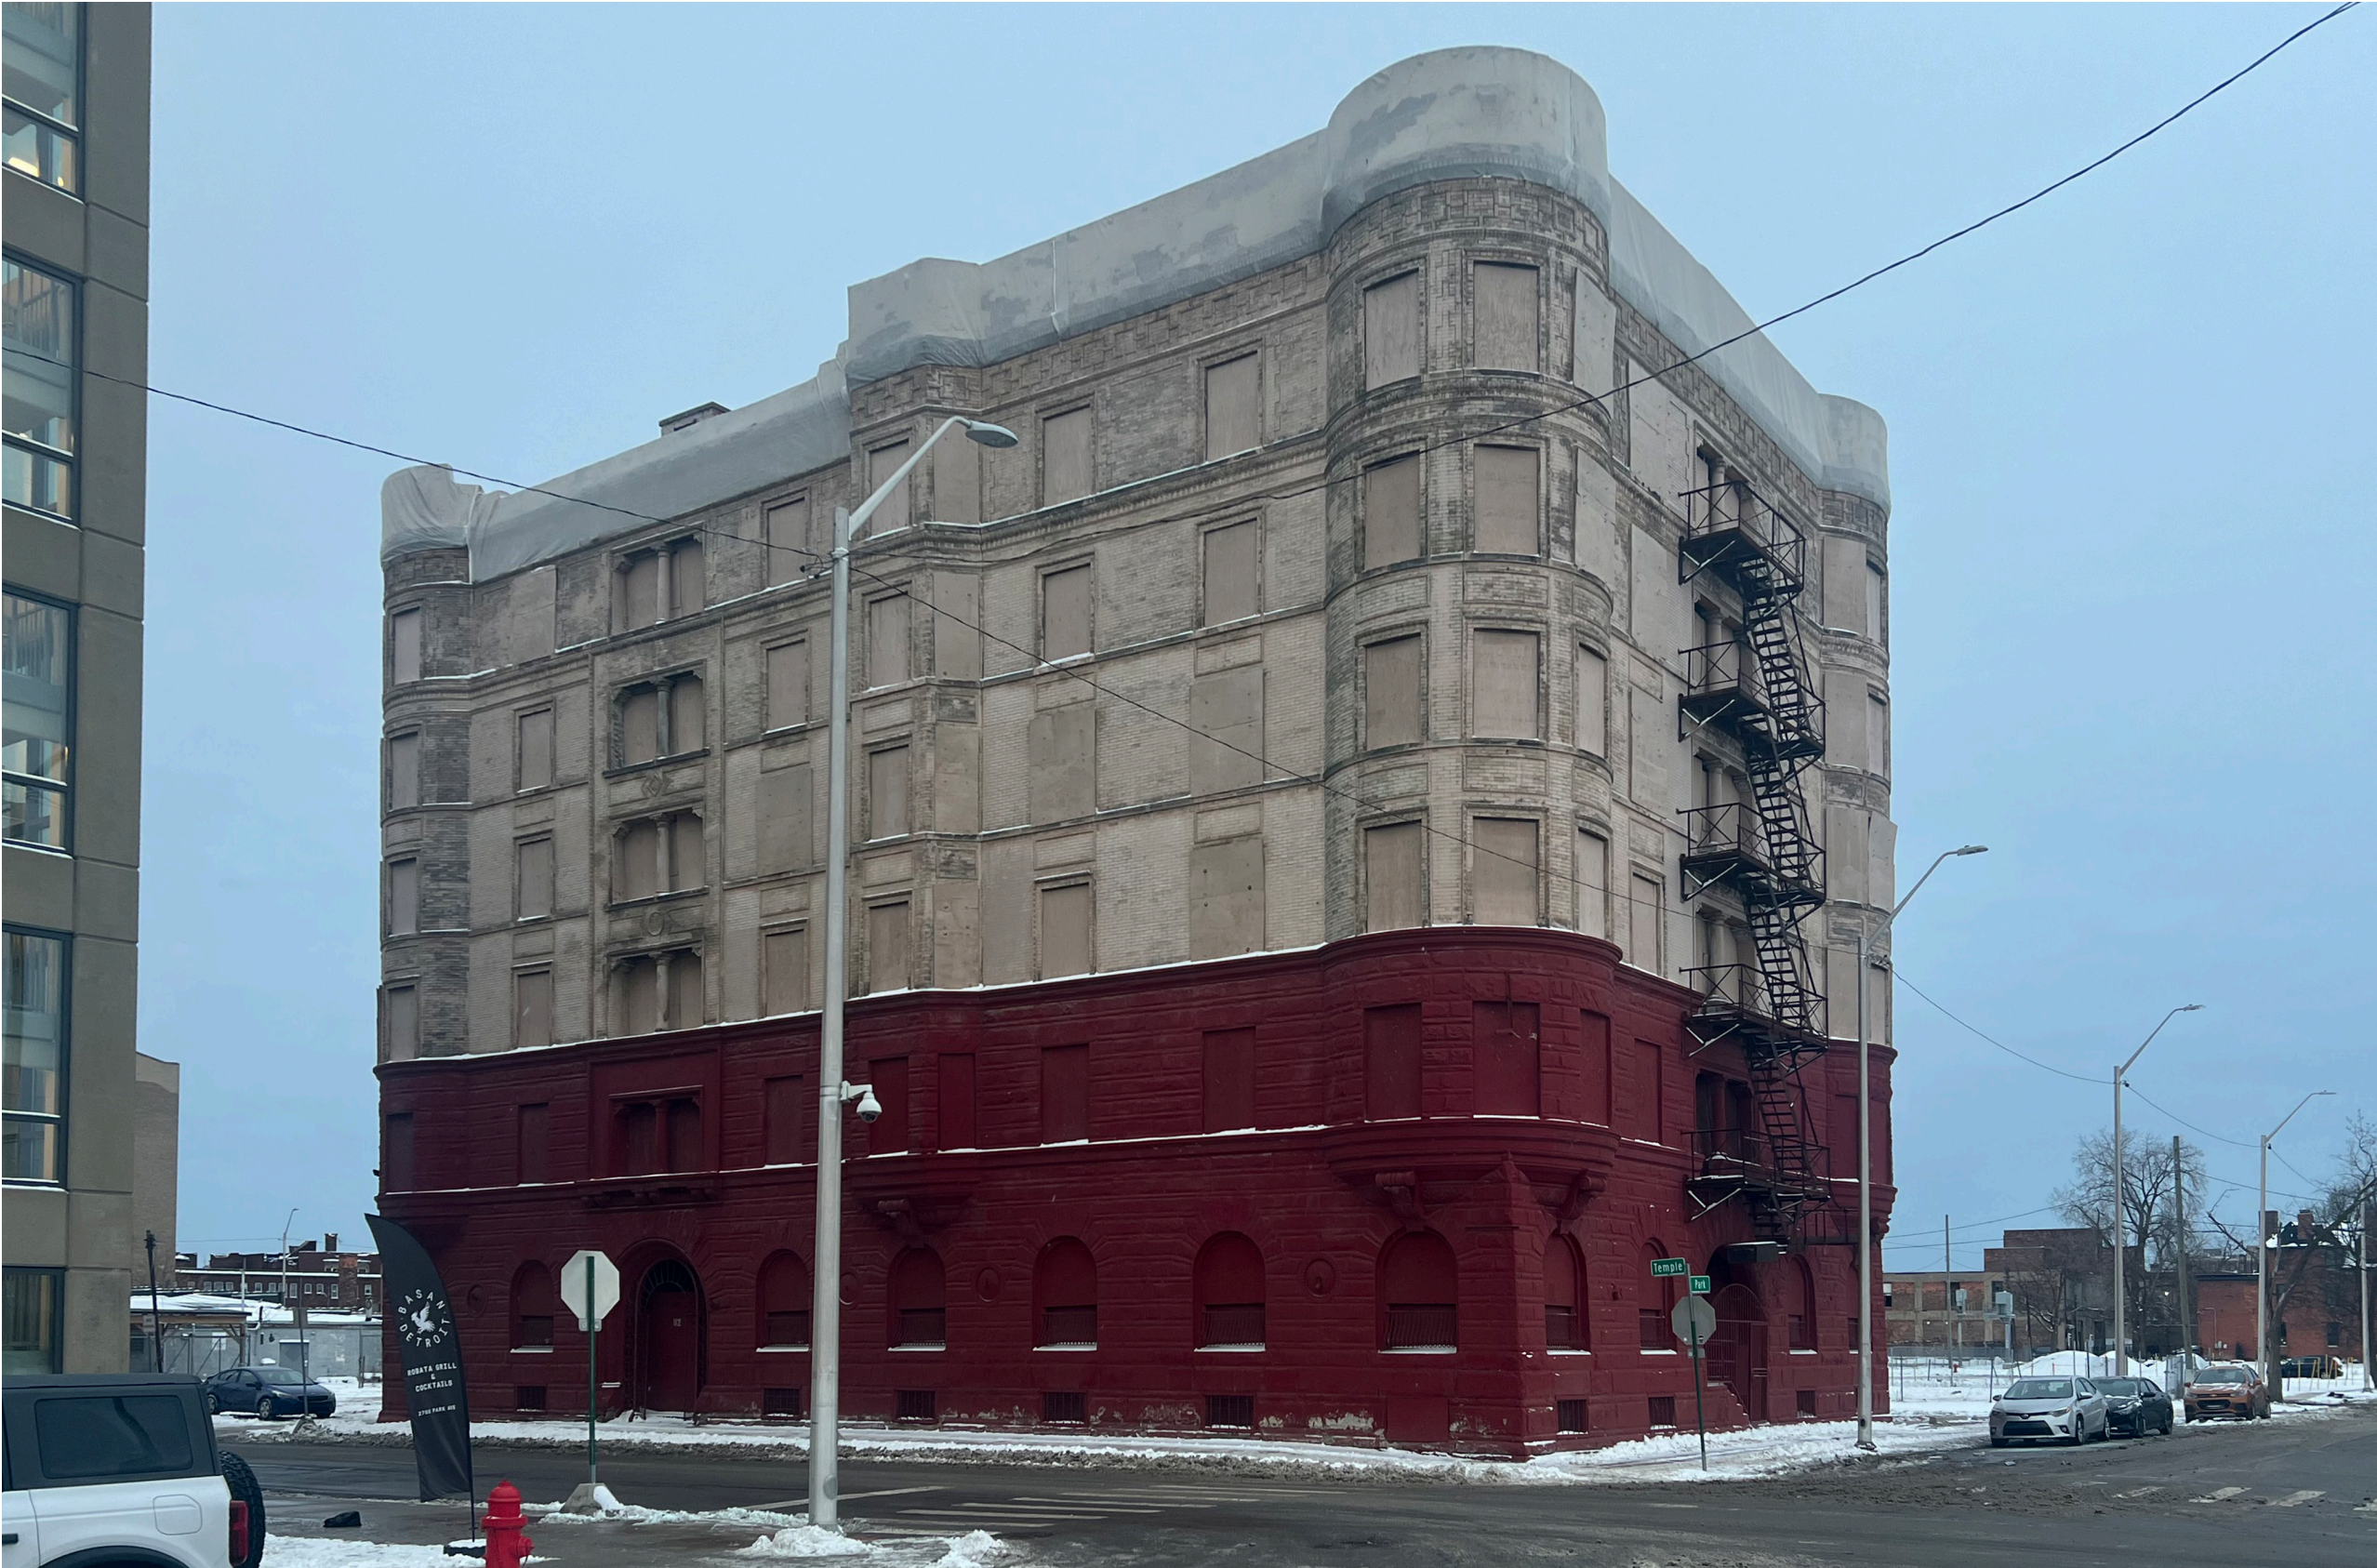
**EXISTING CONDITIONS** (VIEW STANDING AT PARK AVE. & TEMPLE ST., LOOKING NORTHWEST)

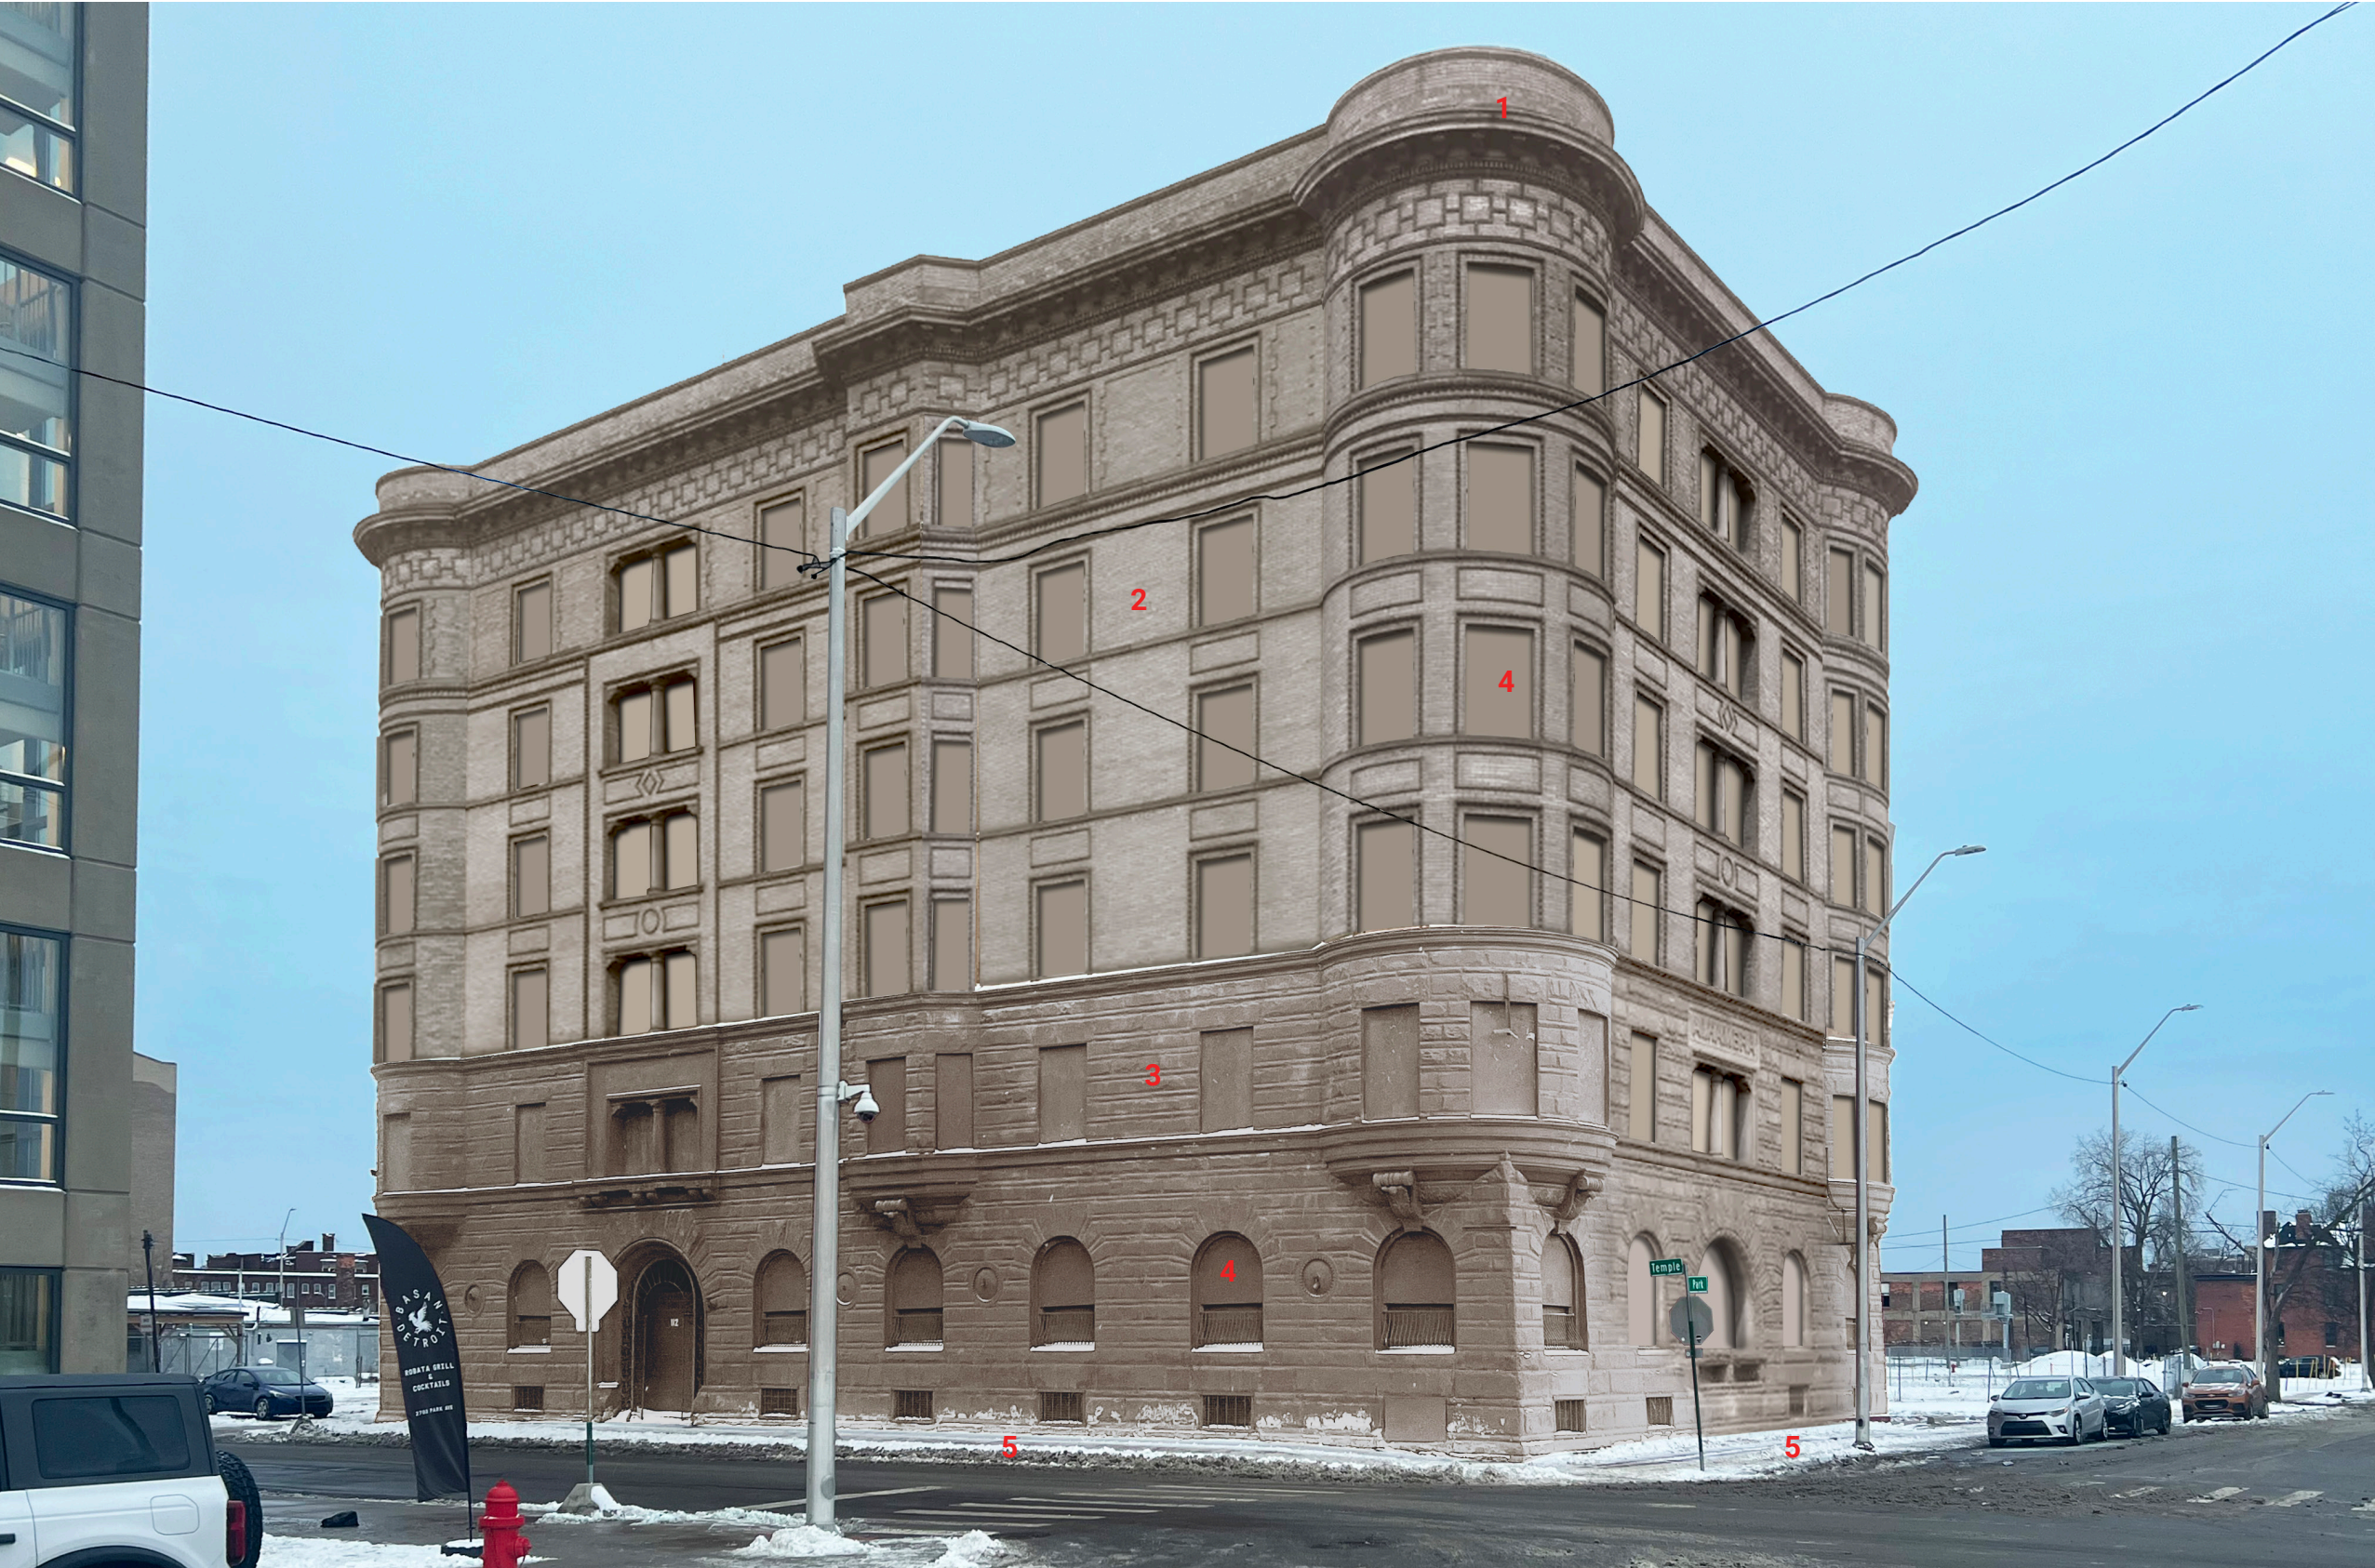
**PROPOSED RENOVATION SCOPE**

**FACADE RENOVATION SCOPE**

- 1. STABILIZE & REPAIR EXISTING PARAPET STRUCTURE & RECREATE ORIGINAL CORNICE DETAIL WHERE NECESSARY
- 2. CLEAN / RESTORE UPPER FACADE (FLOORS 3-6)
- 3. CLEAN / RESTORE LOWER FACADE & REPAINT FOR PRESERVATION (FLOORS 1 & 2)
- 4. REPLACE WINDOW BOARDING WITH NEW PAINTED PLYWOOD
- 5. REPAIR / REPLACE SIDEWALKS ON TEMPLE STREET & PARK AVENUE AS REQUIRED
