STAFF REPORT 10-09-2019 REGULAR MEETING APPLICATION NUMBER: 19-6453 ADDRESS: 2085 ATKINSON STREET HISTORIC DISTRICT: ATKINSON AVENUE APPLICANT: BRECK CRANDELL, BRECK CRANDELL LLC DATE OF COMPLETE APPLICATION: 09-16-2019 STAFF SITE VISIT: 09-25-2019

SCOPE: DEMOLISH EXISTING SUN PORCH, CONSTRUCT NEW PORCH

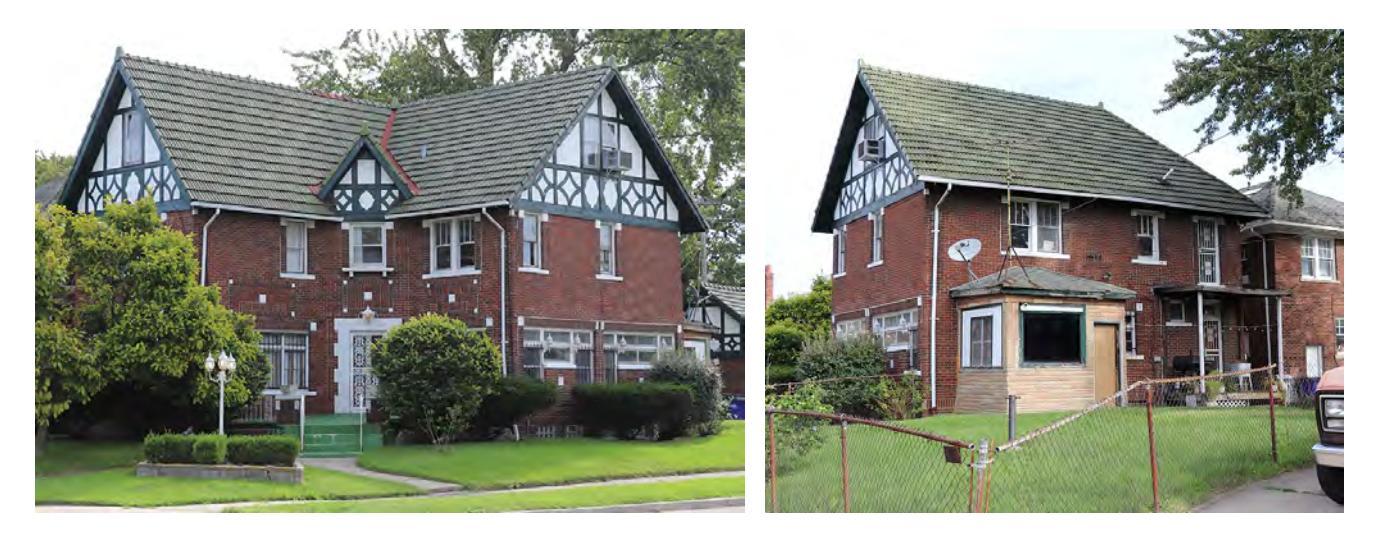
The building located at 2085 Atkinson Street is a 2 ½-story single-family residence constructed in 1924. The structure is clad in variegated red brick and features cast stone details as well as stucco and decorative half-timbering in the roof gables. The massing of the house is L-shaped with the front entrance located at the intersection of the two wings. The original wood double hung windows are remaining. The multi-gabled roof is covered in what appears to be clay tile. Situated on the southeast corner of Atkinson Street and 14th street, the front, side, and rear yards are all visible from the right-of-way. The rear of the structure currently includes an enclosed addition at the west side of the rear elevation and a two-story porch structure at the east side of the elevation. The rear yard is enclosed with a chain link fence.

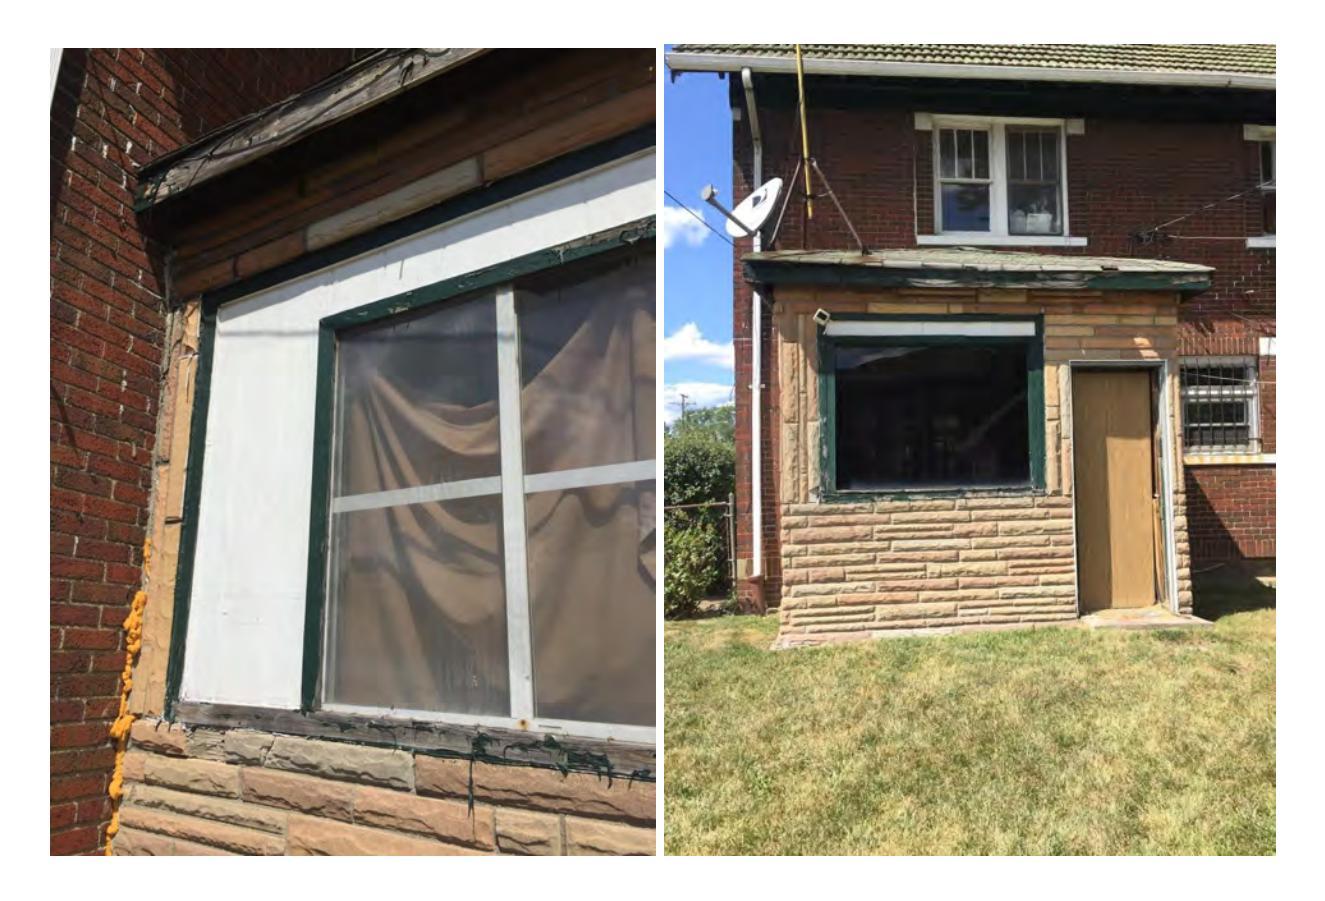
Demolition of add-on "Sunroom"

- Existing conditions:
 - Late 70s/80s addition by amateur contractor
 - Does not fit into historical context of home
 - Faux stone and wood paneling exterior cladding does not match house
 - Shoddy installation, not properly sealed from weather damage and is beginning to pull away from the house, leaving large gaps for insects and pests to enter.
 - Includes a large, gaudy antenna which is no longer in use.

- Scope of work:
 - Deconstruct add-on room entirely including large antennae, exposing the original brick of the house exterior and original metal gate/door
 - Properly dispose of all waste materials by renting 30 yard dumpster for 1-3 days.

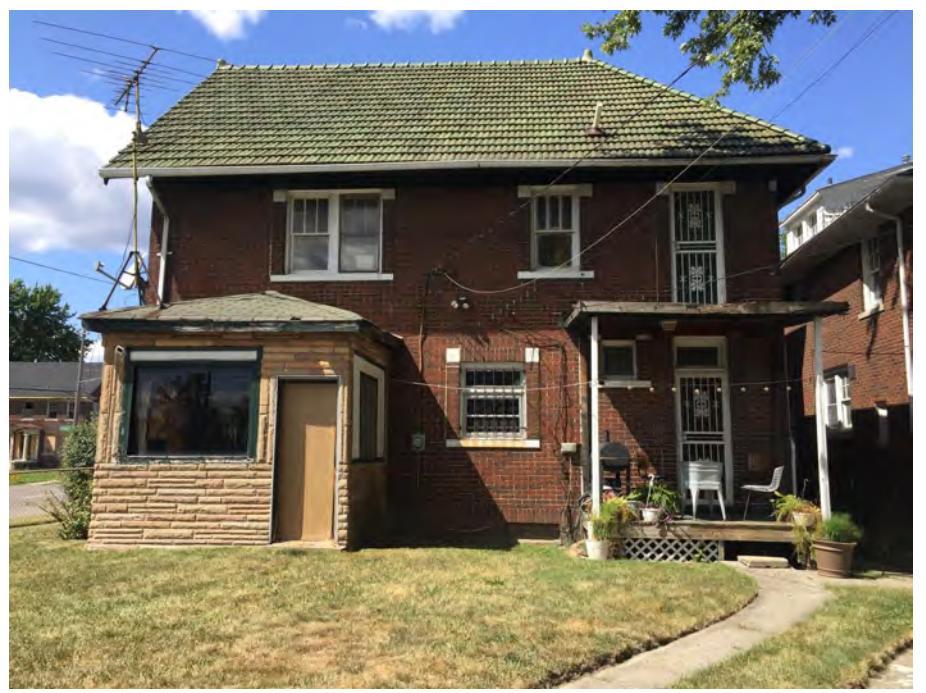
After: (see deck proposal for full scope of work) Windows and door depicted are existing, just covered by the current sunroom condition

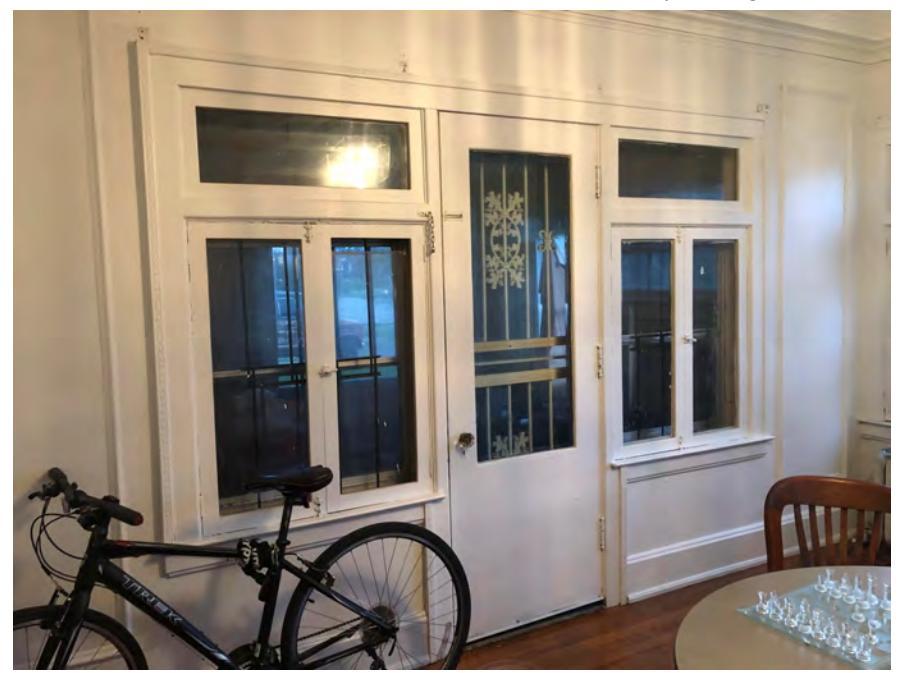
Photos of window and door from inside the house (looking into "sunroom")

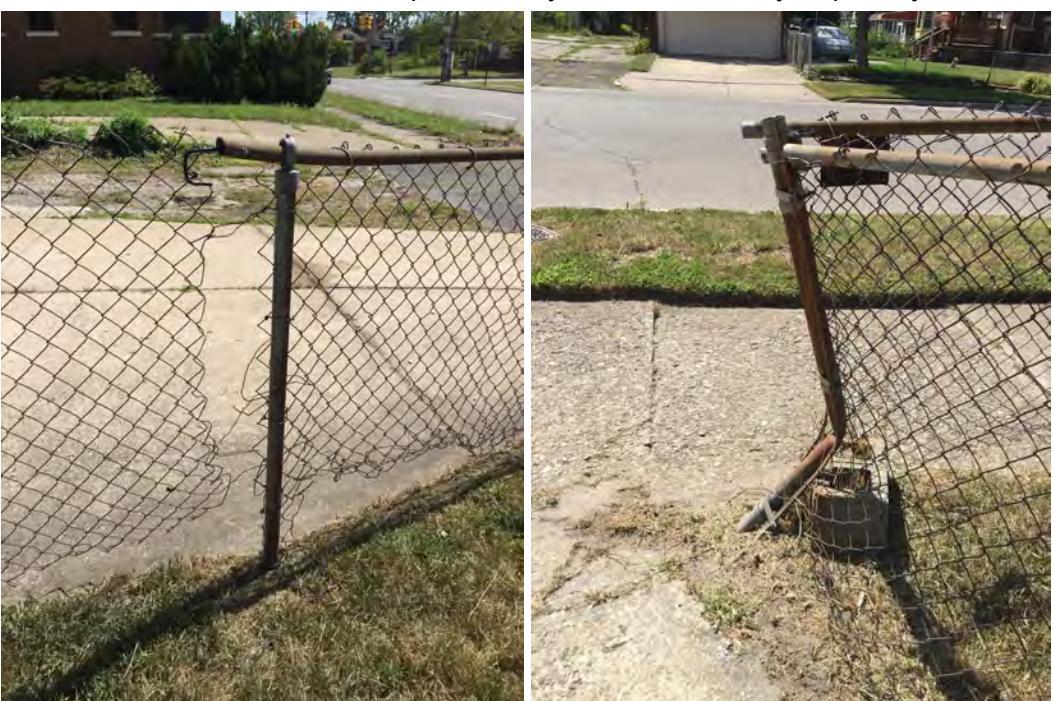
Replacement of Fence around Rear Yard

- Existing conditions: 0
 - Metal chain link fence in poor condition
 - Corner pole at driveway severely dented by collision at an unknown time
 - Nearly all fence panels unsecure / disconnected at base
 - Several unsightly areas where repairs attempted .
 - Berm along fence line makes the fence less than four feet high in some places

Does not provide any sense of security or privacy.

- Scope of work: 0
 - Remove chain link fence
 - Properly dispose of all waste materials by renting 30 yard dumpster for 1-3 days (at the same time as removal of sunroom addition, if approved)
 - Install new fence,
 - 6'-0" tall treated natural pine w/ white painted finish
 - 4x4 wood posts embedded in concrete Sonotube bases
 - 8'-0" long sections hung from brackets at each post
 - Column caps at each post

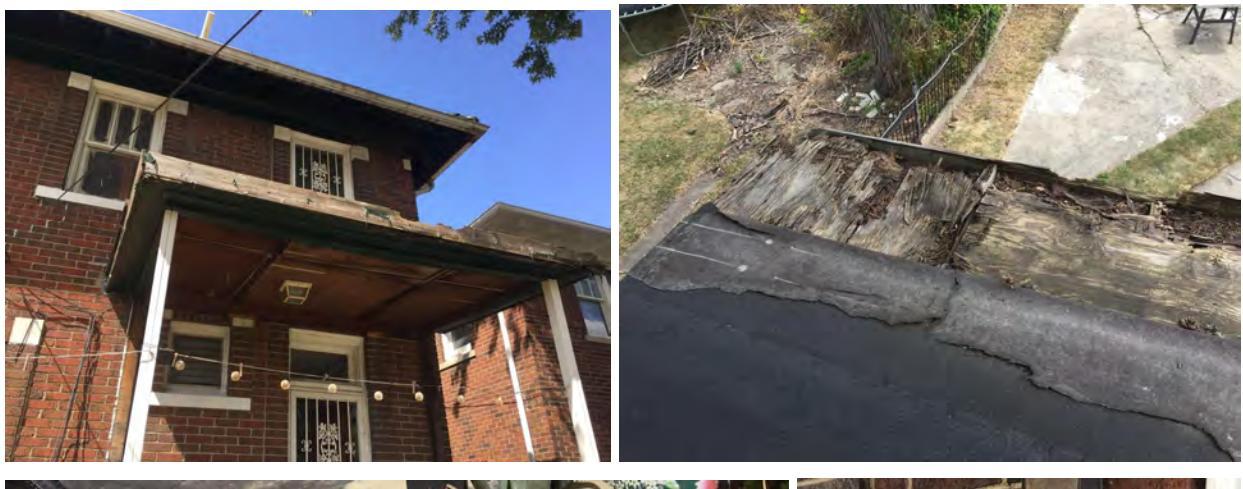
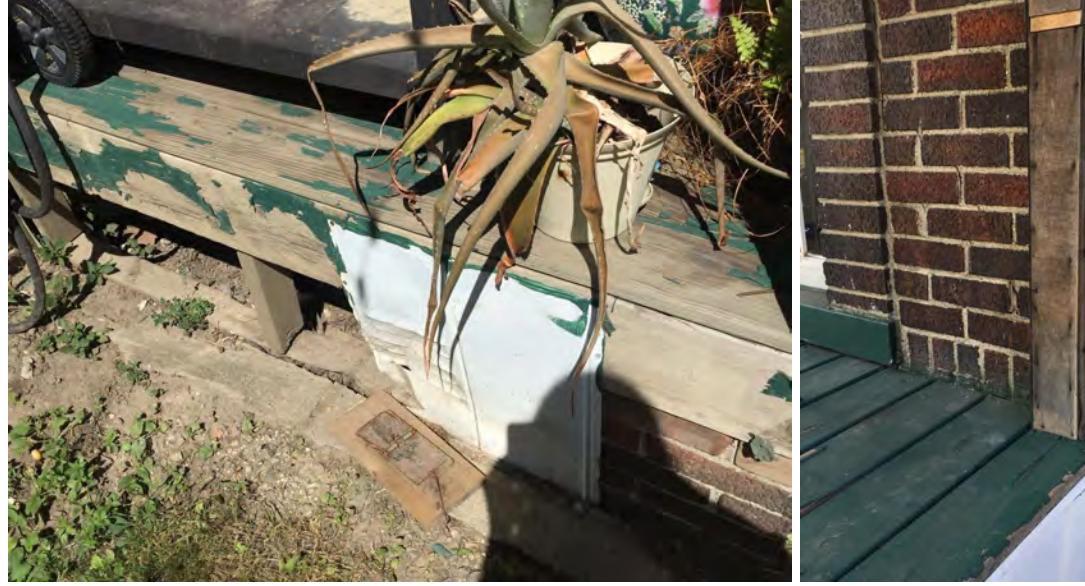
Replacement of Existing Rear Deck

- 0 Existing conditions:
 - Decomposing wood structure
 - Not properly sealed from weather conditions for years, some areas are . damaged beyond repair
 - No stairs with a 24" drop to rear yard is unsafe
 - Second (upper) level is completely rotted and is unsafe for people to stand on.
 - Lower portion has not been properly enclosed so rodents/pests have been entering the house below.

- Scope of work:
 - Deconstruction of rear porch entirely down to structural connection to house
 - Properly dispose of all waste materials by renting 30 yard dumpster for 1-3 days (at the same time as removal of sunroom addition and existing fence, if approved)
 - Install new deck in place of old, removed deck
 - Replace existing wood posts with treated 4x4 posts embedded in concrete Sonotube forms
 - Construct wood framing for porch using 4x4 posts to support upper level (2x8 16" o.c. with simpson strong ties at each intersection with ledger)
 - Install guardrails 42" high with vertical 2x2 members spaced no more than 4" apart the length of the guarail around upper level
 - Install new steps (3 steps w/ 11" deep treads, 7" risers) down to existing backyard sidewalk
 - Stain a rich natural color to match fence and compliment existing brick and green roof of house

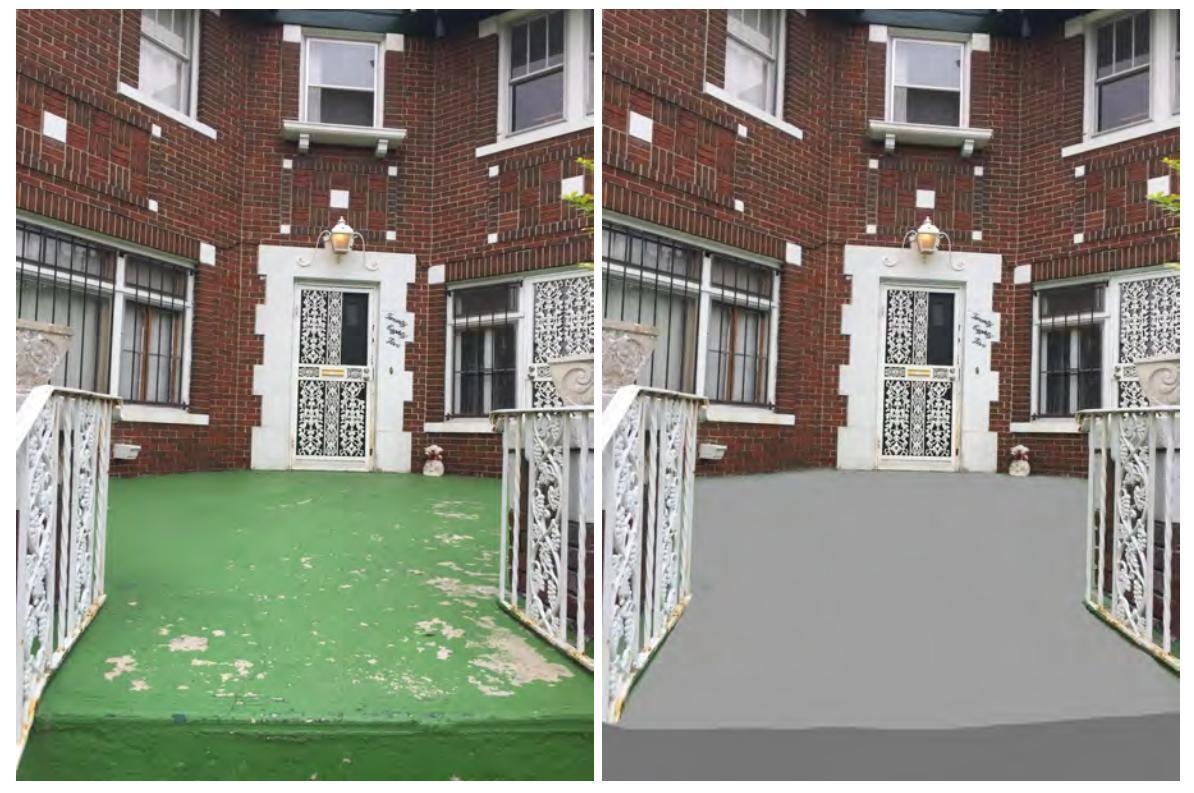
Repaint front porch

- Existing conditions: 0
 - Garish, bright green existing color
 - Concrete is breaking apart due to freeze/thaw cycle and rain damage
- Scope of work: 0
 - Remove broken concrete and rubble
 - Patch potholes and damaged areas from removed aggregates with QuickCrete patch mix with trowelled finish
 - Repaint porch using
 - Exterior floor grade paint
 - 50% grey color
 - toning down the currently vibrant porch that detracts from the home's overall curb appeal and historical character
 - using a color that will not show future deterioration of existing • porch
