## Rotted Exterior of Windows

## Window Damage

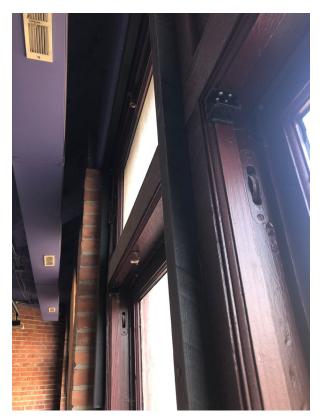
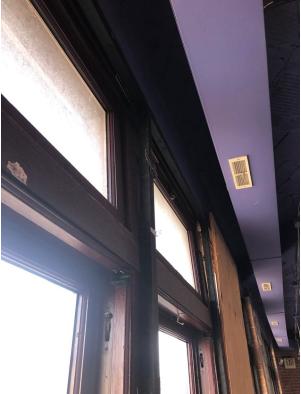
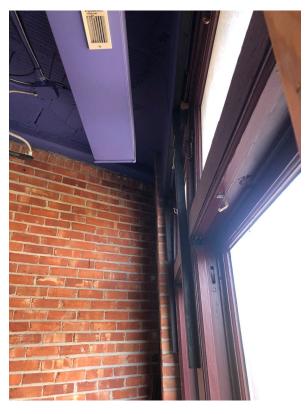
(Note: Structural damage. Vertical stabilizers were added to keep the windows from collapsing into the building because of rotted wood collapsing on itself)
