From: [Kristyn Patterson](#)
To: [Dan Rieden](#)
Cc: [Historic District Commission \(Staff\)](#); [Kelechi Okoroha](#)
Subject: [EXTERNAL]Re: [EXTERNAL]Re: HDC Meeting update: 2522 W. Boston Blvd
Date: Monday, November 29, 2021 11:18:27 AM

H & R WINDOW REPAIR COMPANY

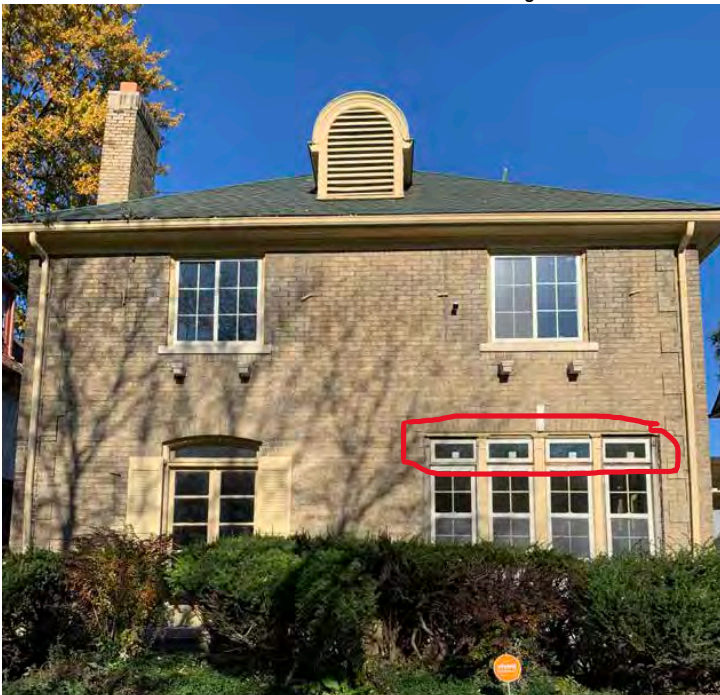
Room: 1st Floor front room
Unit is viewed from the outside looking in.

ProductTileBackendName = JELD-WEN W-2500 Clad Picture
Assembly = Full Unit,
Exterior Trim Type = Nailing Flange removed (Block frame), Exterior Trim Options = No,
Country Where Unit Will Be Installed = USA
(Certified) Measurement Type = Actual Size,
Frame Width = Custom
Size, Custom Frame
Width = 21.25, Frame
Height = Custom Size,
Custom Frame Height = 12
Interior Material Type = Auralast
Pine, Interior Finish Type = Painted,
Interior Finish = Paint
Desert Sand, Exterior Finish = Desert Sand Extension
Jamb = 4 9/16",
Thickness of extension jamb material = (Standard) 9/16 " Thick Jamb Extension
Performance Grade Rating = PG 35
Glass Energy Efficiency = Energy
Star, Installation Zip Code = 48203,
Energy Star Zone = Energy Star - Northern,
Energy Star Low-E Options = Low-E EC 366 (i89 In/366 Out), Glass Type = Standard,
Neat Glass = No,
Glass Thickness = Standard Default Thickness,
Protective Film = No Protective Film,

Glass Spacer Color = Black
Spacer, Air Space Options = Argon
Grille Type = No
Grilles U-Factor = 0.22,
Solar Heat Gain Coefficient = 0.23, Visible Light Transmittance = 0.55,
Condensation Resistance = 45, CPD# = JEL-N-889-03292-00001
Is this a Reorder? = No
Manufacturer = JELD-WEN, Rantoul(IL), Catalog Version Date = 07/29/2021, Catalog Version = 21.2.23.5

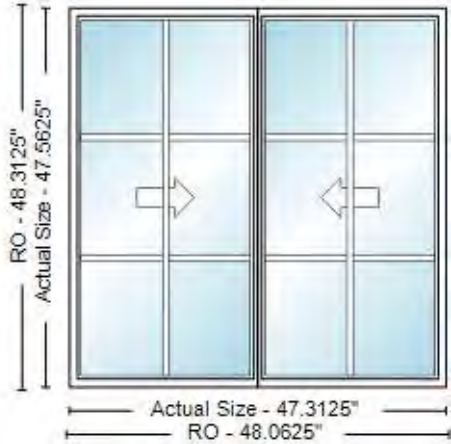
Room: 1st floor front sliders

Unit is viewed from the outside looking in.

ProductTileBackendName = JELD-WEN W-5500 Clad Double Slider
 Assembly = Full Unit,
 Exterior Trim Type = Nailing Flange removed (Block frame),Country Where Unit Will Be Installed = USA (Certified), Unit Operation = Left Hand Unit,
 Operation = 2 Panel
 Measurement Type = Actual Size,
 Frame Width = 47 5/16",
 Frame Height = 47 9/16"
 Interior Material Type = Auralast Pine,
 Interior Finish Type = Painted,
 Interior Finish = Paint Desert Sand,
 Exterior Finish = Desert Sand,
 Sash to Match Exterior Frame Finish = Yes,
 Exterior Sash Finish = Desert Sand
 Extension Jamb = 4 9/16"
 Performance Grade Rating = PG 30
 Hardware Finish = Desert Sand,
 Number of Locks = 2,
 Screen Options = BetterVue Mesh (Standard),
 Screen Frame Finish = Desert Sand
 Glass Energy Efficiency = Energy Star,
 Installation Zip Code = 48206,
 Energy Star Zone = Energy Star - Northern,
 Energy Star Low-E Options = Low-E EC 366 (i89 In/366 Out),

Glass Type = Standard,
 Neat Glass = No,
 Glass Thickness = Standard Default Thickness,
 Protective Film = Protective Film,
 Glass Spacer Color = Black Spacer,
 Air Space Options = Argon,
 Glazing Stop Style = Standard
 Grille Type = 5/8" Flat GBG,
 Grille Location in Glass = All Lite(s),
 Grille Finish = Desert Sand,
 Grille Pattern = Colonial,
 Number of Squares Wide - Left/Right = 2,
 Number of Squares High = 3
 U-Factor = 0.27,
 Solar Heat Gain Coefficient = 0.18,
 Visible Light Transmittance = 0.42,
 Condensation Resistance = 47,
 CPD# = JEL-N-338-00906-00001
 Is this a Reorder? = No
 Manufacturer = JELD-WEN, Rantoul(IL),
 Catalog Version Date = 07/29/2021,
 Catalog Version = 21.2.23.5
 5/8" Flat Grilles Between Glass (GBG),
 Colonial,
 2W3H

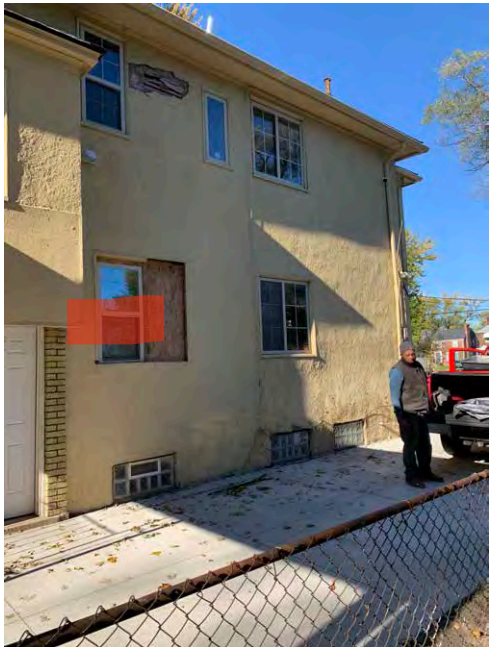
Room: 1st floor backroom DH (no SH in W2500)
Unit is viewed from the outside looking in.

ProductTileBackendName = JELD-WEN W-2500 Clad Double Hung
 Assembly = Full Unit,
 Sash Model = Standard,
 Exterior Trim Type = Nailing Flange removed (Block frame),
 Exterior Trim Options = No,
 Country Where Unit Will Be Installed = USA (Certified)
 Sash Split = Even Divide,
 Measurement Type = Actual Size,
 Frame Width = 21 3/8",
 Frame Height = 48"
 Interior Material Type = Auralast Pine,
 Interior Finish Type = Painted,
 Interior Finish = Paint Desert Sand,
 Exterior Finish = Desert Sand,
 Sash to Match Exterior Frame Finish = Yes,
 Exterior Sash Finish = Desert Sand
 Extension Jamb = 4 9/16"
 Performance Grade Rating = PG 35
 Hardware Finish = Desert Sand,
 Number of Locks = 1,
 Screen Options = BetterVue Mesh (Standard),
 Screen Frame Finish = Desert Sand
 Glass Energy Efficiency = Energy Star,
 Installation Zip Code = 48203,
 Energy Star Zone = Energy Star - Northern,
 Energy Star Low-E Options = Low-E EC 366 (i89 In/366 Out),

Glass Type = Standard,
 Neat Glass = No,
 Glass Thickness = Standard Default Thickness,
 Protective Film = No Protective Film,
 Glass Spacer Color = Black Spacer,
 Air Space Options = Argon
 Grille Type = 5/8" Flat GBG,
 Grille Location in Glass = All Lite(s),
 Grille Finish = Desert Sand,
 Grille Pattern = Colonial,
 Number of Squares Wide - Top = 2,
 Number of Squares Wide - Bottom = 2,
 Number of Squares High - Top = 2,
 Number of Squares High - Bottom = 2
 Jamb Liner = Tan Jamb Liner,
 Secondary Vent Stop / Sash Limiter = No Window Opening Control Device
 U-Factor = 0.25,
 Solar Heat Gain Coefficient = 0.19,
 Visible Light Transmittance = 0.45,
 Condensation Resistance = 45,
 CPD# = JEL-N-850-01686-00001
 Is this a Reorder? = No
 Manufacturer = JELD-WEN, Rantoul(IL),
 Catalog Version Date = 07/29/2021,
 Catalog Version = 21.2.23.5
 5/8" Flat Grilles Between Glass (GBG),
 Colonial,
 2W2H

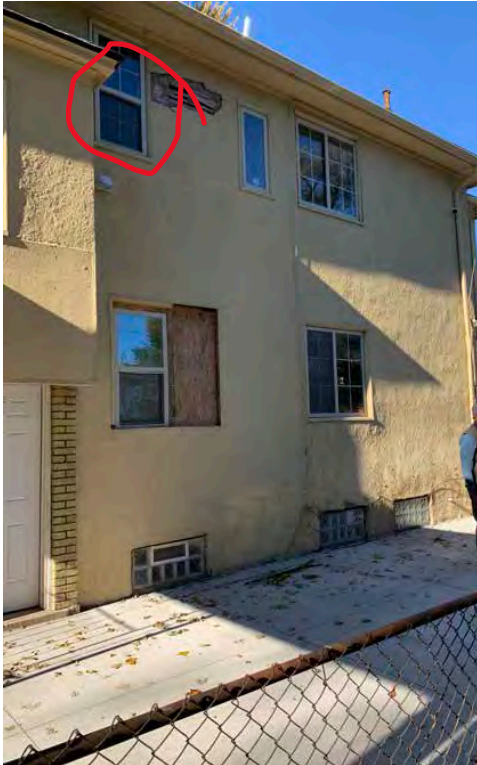
Room: 2nd floor laundry
Unit is viewed from the outside looking in.

ProductTileBackendName = JELD-WEN W-2500 Clad Double Hung
 Assembly = Full Unit,
 Sash Model = Standard,
 Exterior Trim Type = Nailing Flange removed (Block frame),
 Exterior Trim Options = No,
 Country Where Unit Will Be Installed = USA (Certified)
 Sash Split = Even Divide,
 Measurement Type = Actual Size,
 Frame Width = 21 3/8",
 Frame Height = 48"
 Interior Material Type = Auralast Pine,
 Interior Finish Type = Painted,
 Interior Finish = Paint Desert Sand,
 Exterior Finish = Desert Sand,
 Sash to Match Exterior Frame Finish = Yes,
 Exterior Sash Finish = Desert Sand
 Extension Jamb = 4 9/16"
 Performance Grade Rating = PG 35
 Hardware Finish = Desert Sand,
 Number of Locks = 1,
 Screen Options = BetterVue Mesh (Standard),
 Screen Frame Finish = Desert Sand
 Glass Energy Efficiency = Energy Star,
 Installation Zip Code = 48203,
 Energy Star Zone = Energy Star - Northern,
 Energy Star Low-E Options = Low-E EC 366 (i89 In/366 Out),

Glass Type = Standard,
 Neat Glass = No,
 Glass Thickness = Standard Default Thickness,
 Protective Film = No Protective Film,
 Glass Spacer Color = Black Spacer,
 Air Space Options = Argon
 Grille Type = 5/8" Flat GBG,
 Grille Location in Glass = All Lite(s),
 Grille Finish = Desert Sand,
 Grille Pattern = Colonial,
 Number of Squares Wide - Top = 2,
 Number of Squares Wide - Bottom = 2,
 Number of Squares High - Top = 2,
 Number of Squares High - Bottom = 2
 Jamb Liner = Tan Jamb Liner,
 Secondary Vent Stop / Sash Limiter = No Window Opening Control Device
 U-Factor = 0.25,
 Solar Heat Gain Coefficient = 0.19,
 Visible Light Transmittance = 0.45,
 Condensation Resistance = 45,
 CPD# = JEL-N-850-01686-00001
 Is this a Reorder? = No
 Manufacturer = JELD-WEN, Rantoul(IL),
 Catalog Version Date = 07/29/2021,
 Catalog Version = 21.2.23.5
 5/8" Flat Grilles Between Glass (GBG),
 Colonial,
 2W2H

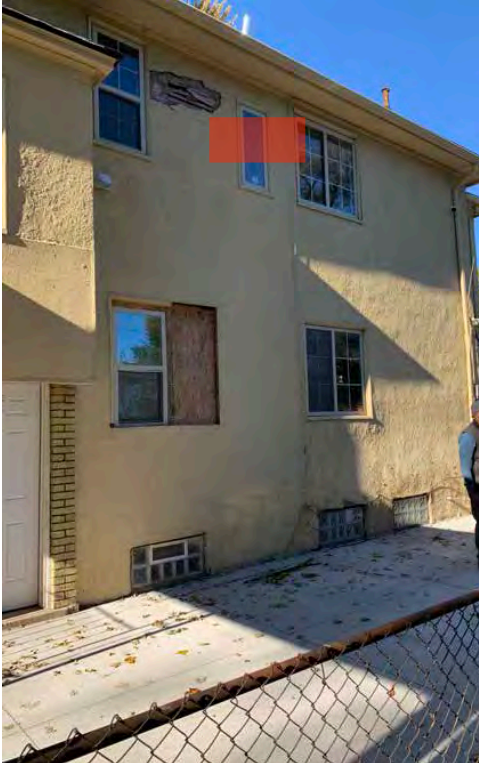
Room: 2nd floor backroom
Unit is viewed from the outside looking in.

ProductTileBackendName = JELD-WEN W-2500 Clad Picture
 Assembly = Full Unit,
 Exterior Trim Type = Nailing Flange removed (Block frame),
 Exterior Trim Options = No,
 Country Where Unit Will Be Installed = USA (Certified)
 Measurement Type = Actual Size,
 Frame Width = Custom Size,
 Custom Frame Width = 16.75,
 Frame Height = Custom Size,
 Custom Frame Height = 40.5
 Interior Material Type = Auralast Pine,
 Interior Finish Type = Painted,
 Interior Finish = Paint Desert Sand,
 Exterior Finish = Desert Sand
 Extension Jamb = 4 9/16",
 Thickness of extension jamb material = (Standard) 9/16 " Thick Jamb Extension
 Performance Grade Rating = PG 35
 Glass Energy Efficiency = Energy Star,
 Installation Zip Code = 48203,
 Energy Star Zone = Energy Star - Northern,
 Energy Star Low-E Options = Low-E EC 366 (i89 In/366 Out),
 Glass Type = Standard,
 Neat Glass = No,
 Glass Thickness = Standard Default Thickness,
 Protective Film = No Protective Film,

Glass Spacer Color = Black Spacer,
 Air Space Options = Argon
 Grille Type = No Grilles
 U-Factor = 0.22,
 Solar Heat Gain Coefficient = 0.23,
 Visible Light Transmittance = 0.55,
 Condensation Resistance = 45,
 CPD# = JEL-N-889-03292-00001
 Is this a Reorder? = No
 Manufacturer = JELD-WEN, Rantoul(IL),
 Catalog Version Date = 07/29/2021,
 Catalog Version = 21.2.23.5
 None

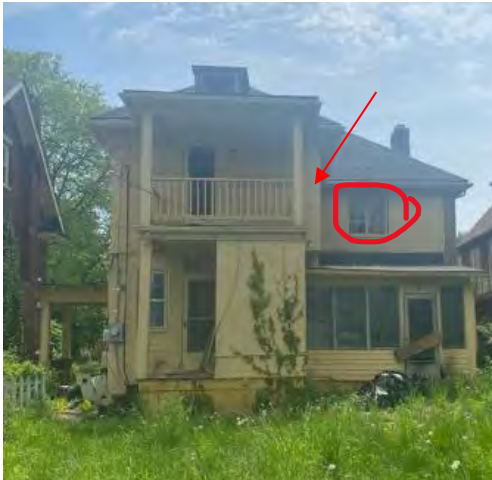
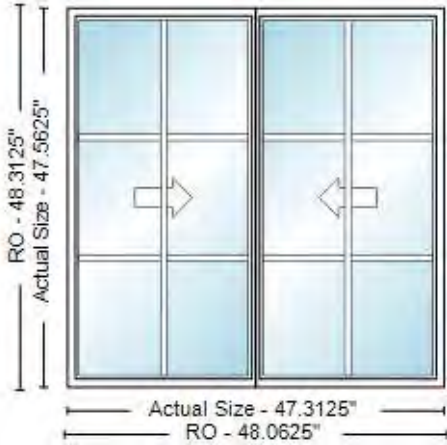
Room: 2nd floor back room
Unit is viewed from the outside looking in.

ProductTileBackendName = JELD-WEN W-5500 Clad Double Slider
 Assembly = Full Unit,
 Exterior Trim Type = Nailing Flange removed (Block frame),
 Country Where Unit Will Be Installed = USA (Certified),
 Unit Operation = Left Hand Unit,
 Operation = 2 Panel
 Measurement Type = Actual Size,
 Frame Width = 47 5/16",
 Frame Height = 47 9/16"
 Interior Material Type = Auralast Pine,
 Interior Finish Type = Painted,
 Interior Finish = Paint Desert Sand,
 Exterior Finish = Desert Sand,
 Sash to Match Exterior Frame Finish = Yes,
 Exterior Sash Finish = Desert Sand
 Extension Jamb = 4 9/16"
 Performance Grade Rating = PG 30
 Hardware Finish = Desert Sand,
 Number of Locks = 2,
 Screen Options = BetterVue Mesh (Standard),
 Screen Frame Finish = Desert Sand
 Glass Energy Efficiency = Energy Star,
 Installation Zip Code = 48206,
 Energy Star Zone = Energy Star - Northern,
 Energy Star Low-E Options = Low-E EC 366 (i89 In/366 Out),

Glass Type = Standard,
 Neat Glass = No,
 Glass Thickness = Standard Default Thickness,
 Protective Film = Protective Film,
 Glass Spacer Color = Black Spacer,
 Air Space Options = Argon,
 Glazing Stop Style = Standard
 Grille Type = 5/8" Flat GBG,
 Grille Location in Glass = All Lite(s),
 Grille Finish = Desert Sand,
 Grille Pattern = Colonial,
 Number of Squares Wide - Left/Right = 2,
 Number of Squares High = 3
 U-Factor = 0.27,
 Solar Heat Gain Coefficient = 0.18,
 Visible Light Transmittance = 0.42,
 Condensation Resistance = 47,
 CPD# = JEL-N-338-00906-00001
 Is this a Reorder? = No
 Manufacturer = JELD-WEN, Rantoul(IL),
 Catalog Version Date = 07/29/2021,
 Catalog Version = 21.2.23.5
 5/8" Flat Grilles Between Glass (GBG),
 Colonial,
 2W3H

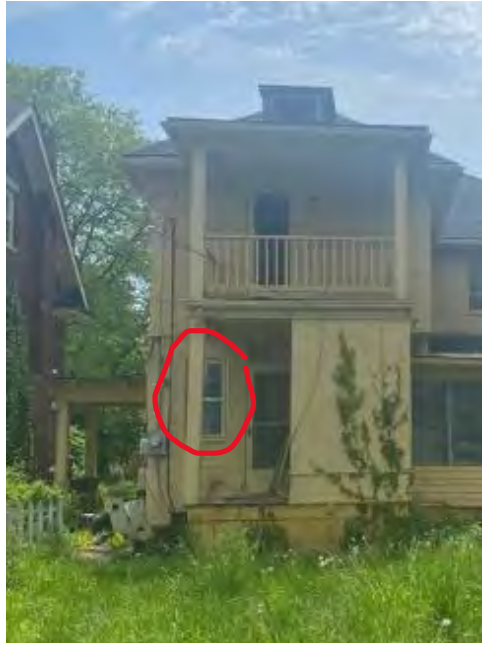
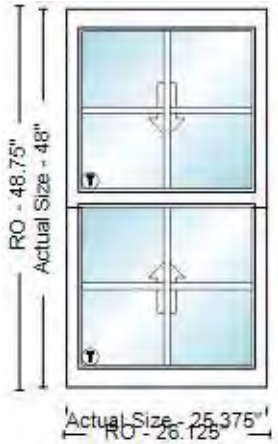
Room: 1st Back Room
Unit is viewed from the outside looking in.

ProductTileBackendName = JELD-WEN W-2500 Clad Double Hung
 Assembly = Full Unit,
 Sash Model = Standard,
 Exterior Trim Type = Nailing Flange removed (Block frame),
 Exterior Trim Options = No,
 Country Where Unit Will Be Installed = USA (Certified)
 Sash Split = Even Divide,
 Measurement Type = Actual Size,
 Frame Width = 25 3/8",
 Frame Height = 48"
 Interior Material Type = Auralast Pine,
 Interior Finish Type = Painted,
 Interior Finish = Paint Desert Sand,
 Exterior Finish = Desert Sand,
 Sash to Match Exterior Frame Finish = Yes,
 Exterior Sash Finish = Desert Sand
 Extension Jamb = 4 9/16"
 Performance Grade Rating = PG 35
 Hardware Finish = Desert Sand,
 Number of Locks = 1,
 Screen Options = BetterVue Mesh (Standard),
 Screen Frame Finish = Desert Sand
 Glass Energy Efficiency = Energy Star,
 Installation Zip Code = 48203,
 Energy Star Zone = Energy Star - Northern,
 Energy Star Low-E Options = Low-E EC 366 (i89 In/366 Out),

Glass Type = Tempered,
 Neat Glass = No,
 Glass Thickness = Standard Default Thickness,
 California Urban Fire Code Label = No,
 Protective Film = No Protective Film,
 Glass Spacer Color = Black Spacer,
 Air Space Options = Argon
 Grille Type = 5/8" Flat GBG,
 Grille Location in Glass = All Lite(s),
 Grille Finish = Desert Sand,
 Grille Pattern = Colonial,
 Number of Squares Wide - Top = 2,
 Number of Squares Wide - Bottom = 2,
 Number of Squares High - Top = 2,
 Number of Squares High - Bottom = 2
 Jamb Liner = Tan Jamb Liner,
 Secondary Vent Stop / Sash Limiter = No Window Opening Control Device
 U-Factor = 0.26,
 Solar Heat Gain Coefficient = 0.19,
 Visible Light Transmittance = 0.44,
 Condensation Resistance = 43,
 CPD# = JEL-N-850-01754-00001
 Is this a Reorder? = No
 Manufacturer = JELD-WEN, Rantoul(IL),
 Catalog Version Date = 07/29/2021,
 Catalog Version = 21.2.23.5
 5/8" Flat Grilles Between Glass (GBG),

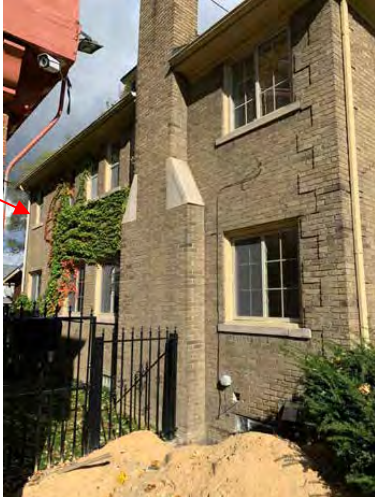
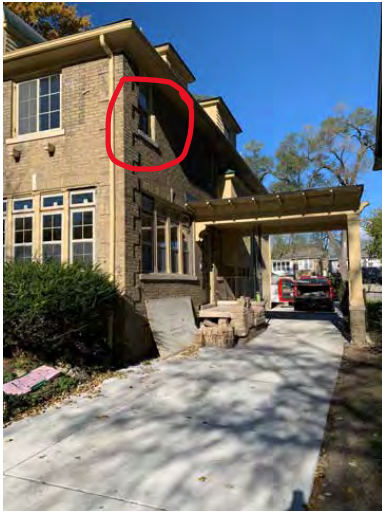
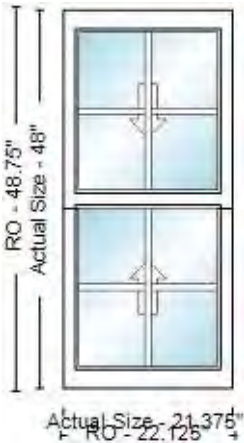
Room: 2nd floor front left room
Unit is viewed from the outside looking in.

ProductTileBackendName = JELD-WEN W-2500 Clad Double Hung
 Assembly = Full Unit,
 Sash Model = Standard,
 Exterior Trim Type = Nailing Flange removed (Block frame),
 Exterior Trim Options = No,
 Country Where Unit Will Be Installed = USA (Certified)
 Sash Split = Even Divide,
 Measurement Type = Actual Size,
 Frame Width = 21 3/8",
 Frame Height = 48"
 Interior Material Type = Auralast Pine,
 Interior Finish Type = Painted,
 Interior Finish = Paint Desert Sand,
 Exterior Finish = Desert Sand,
 Sash to Match Exterior Frame Finish = Yes,
 Exterior Sash Finish = Desert Sand
 Extension Jamb = 4 9/16"
 Performance Grade Rating = PG 35
 Hardware Finish = Desert Sand,
 Number of Locks = 1,
 Screen Options = BetterVue Mesh (Standard),
 Screen Frame Finish = Desert Sand
 Glass Energy Efficiency = Energy Star,
 Installation Zip Code = 48203,
 Energy Star Zone = Energy Star - Northern,
 Energy Star Low-E Options = Low-E EC 366 (i89 In/366 Out),

Glass Type = Standard,
 Neat Glass = No,
 Glass Thickness = Standard Default Thickness,
 Protective Film = No Protective Film,
 Glass Spacer Color = Black Spacer,
 Air Space Options = Argon
 Grille Type = 5/8" Flat GBG,
 Grille Location in Glass = All Lite(s),
 Grille Finish = Desert Sand,
 Grille Pattern = Colonial,
 Number of Squares Wide - Top = 2,
 Number of Squares Wide - Bottom = 2,
 Number of Squares High - Top = 2,
 Number of Squares High - Bottom = 2
 Jamb Liner = Tan Jamb Liner,
 Secondary Vent Stop / Sash Limiter = No Window Opening Control Device
 U-Factor = 0.25,
 Solar Heat Gain Coefficient = 0.19,
 Visible Light Transmittance = 0.45,
 Condensation Resistance = 45,
 CPD# = JEL-N-850-01686-00001
 Is this a Reorder? = No
 Manufacturer = JELD-WEN, Rantoul(IL),
 Catalog Version Date = 07/29/2021,
 Catalog Version = 21.2.23.5
 5/8" Flat Grilles Between Glass (GBG),
 Colonial,
 2W2H

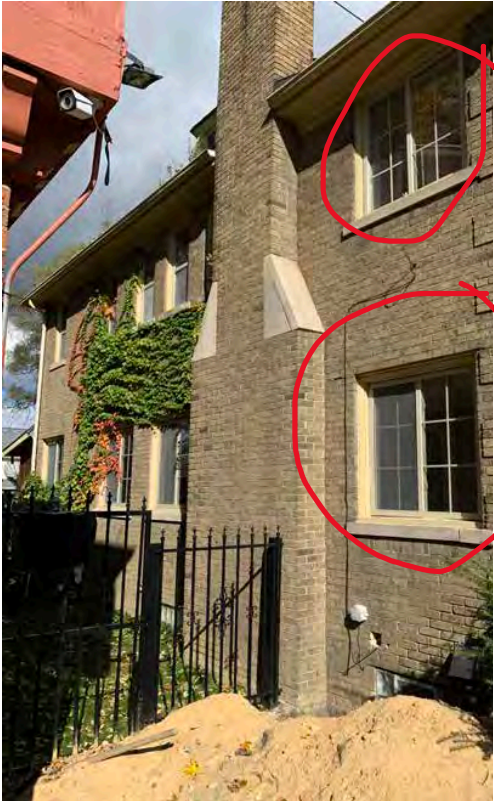
Room: 2nd floor master bedroom closet
Unit is viewed from the outside looking in.

ProductTileBackendName = JELD-WEN W-5500 Clad Double Slider
 Assembly = Full Unit,
 Exterior Trim Type = Nailing Flange removed (Block frame),
 Country Where Unit Will Be Installed = USA (Certified),
 Unit Operation = Left Hand Unit,
 Operation = 2 Panel
 Measurement Type = Actual Size,
 Frame Width = 47 5/16",
 Frame Height = 47 9/16"
 Interior Material Type = Auralast Pine,
 Interior Finish Type = Painted,
 Interior Finish = Paint Desert Sand,
 Exterior Finish = Desert Sand,
 Sash to Match Exterior Frame Finish = Yes,
 Exterior Sash Finish = Desert Sand
 Extension Jamb = 4 9/16"
 Performance Grade Rating = PG 30
 Hardware Finish = Desert Sand,
 Number of Locks = 2,
 Screen Options = BetterVue Mesh (Standard),
 Screen Frame Finish = Desert Sand
 Glass Energy Efficiency = Energy Star,
 Installation Zip Code = 48206,
 Energy Star Zone = Energy Star - Northern,
 Energy Star Low-E Options = Low-E EC 366 (i89 In/366 Out),

Glass Type = Standard,
 Neat Glass = No,
 Glass Thickness = Standard Default Thickness,
 Protective Film = Protective Film,
 Glass Spacer Color = Black Spacer,
 Air Space Options = Argon,
 Glazing Stop Style = Standard
 Grille Type = 5/8" Flat GBG,
 Grille Location in Glass = All Lite(s),
 Grille Finish = Desert Sand,
 Grille Pattern = Colonial,
 Number of Squares Wide - Left/Right = 2,
 Number of Squares High = 3
 U-Factor = 0.27,
 Solar Heat Gain Coefficient = 0.18,
 Visible Light Transmittance = 0.42,
 Condensation Resistance = 47,
 CPD# = JEL-N-338-00906-00001
 Is this a Reorder? = No
 Manufacturer = JELD-WEN, Rantoul(IL),
 Catalog Version Date = 07/29/2021,
 Catalog Version = 21.2.23.5
 5/8" Flat Grilles Between Glass (GBG),
 Colonial,
 2W3H

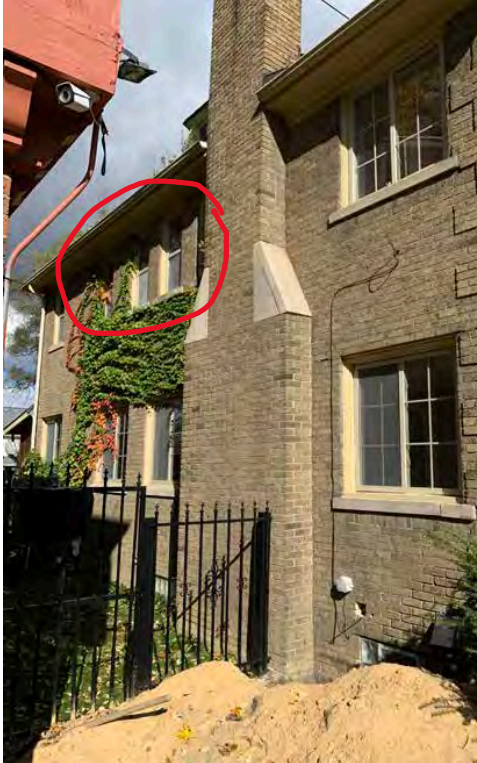
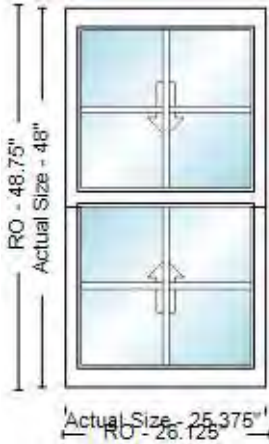
Unit is viewed from the outside looking in.

ProductTileBackendName = JELD-WEN W-2500 Clad Double Hung
 Assembly = Full Unit,
 Sash Model = Standard,
 Exterior Trim Type = Nailing Flange removed (Block frame),
 Exterior Trim Options = No,
 Country Where Unit Will Be Installed = USA (Certified)
 Sash Split = Even Divide,
 Measurement Type = Actual Size,
 Frame Width = 25 3/8",
 Frame Height = 48"
 Interior Material Type = Auralast Pine,
 Interior Finish Type = Painted,
 Interior Finish = Paint Desert Sand,
 Exterior Finish = Desert Sand,
 Sash to Match Exterior Frame Finish = Yes,
 Exterior Sash Finish = Desert Sand
 Extension Jamb = 4 9/16"
 Performance Grade Rating = PG 35
 Hardware Finish = Desert Sand,
 Number of Locks = 1,
 Screen Options = BetterVue Mesh (Standard),
 Screen Frame Finish = Desert Sand
 Glass Energy Efficiency = Energy Star,
 Installation Zip Code = 48203,
 Energy Star Zone = Energy Star - Northern,
 Energy Star Low-E Options = Low-E EC 366 (i89 In/366 Out),

Glass Type = Standard,
 Neat Glass = No,
 Glass Thickness = Standard Default Thickness,
 Protective Film = No Protective Film,
 Glass Spacer Color = Black Spacer,
 Air Space Options = Argon
 Grille Type = 5/8" Flat GBG,
 Grille Location in Glass = All Lite(s),
 Grille Finish = Desert Sand,
 Grille Pattern = Colonial,
 Number of Squares Wide - Top = 2,
 Number of Squares Wide - Bottom = 2,
 Number of Squares High - Top = 2,
 Number of Squares High - Bottom = 2
 Jamb Liner = Tan Jamb Liner,
 Secondary Vent Stop / Sash Limiter = No Window Opening Control Device
 U-Factor = 0.25,
 Solar Heat Gain Coefficient = 0.19,
 Visible Light Transmittance = 0.45,
 Condensation Resistance = 45,
 CPD# = JEL-N-850-01686-00001
 Is this a Reorder? = No
 Manufacturer = JELD-WEN, Rantoul(IL),
 Catalog Version Date = 07/29/2021,
 Catalog Version = 21.2.23.5
 5/8" Flat Grilles Between Glass (GBG),
 Colonial,
 2W2H

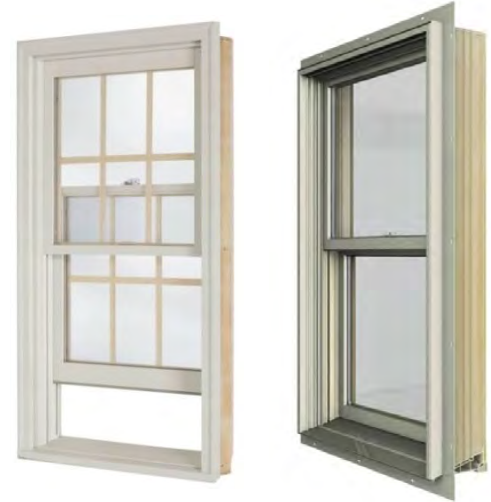
- W2500™ Frame / Heavier Traditional Sash
- Clad Units
- Double-Hung, Casements, & Awnings

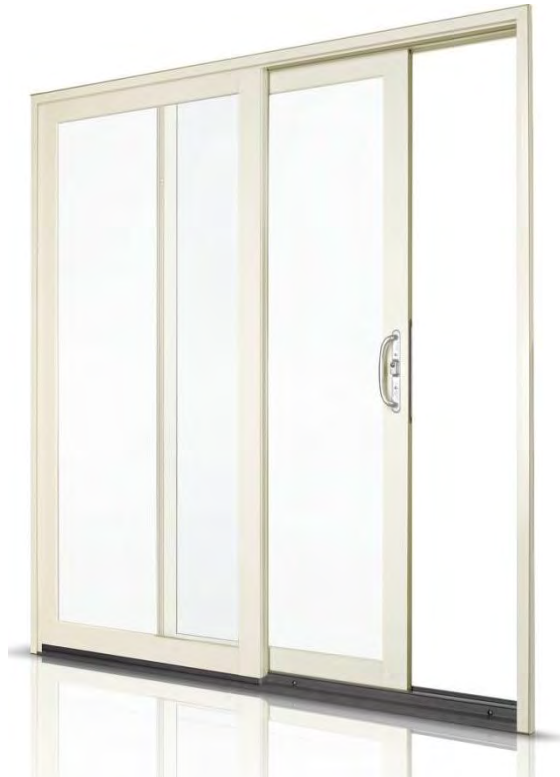
- Clad Casement
- Clad Awning
- Double Hung
 - Clad
 - Natural & Primed
- Pictures & Transoms
- Fixed Geometric Shapes
- Sliding Patio Doors
- Swinging Patio Doors

- Aluminum Cladding Stops at Glazing
 - Improved Energy Efficiency
- Engineered Sill - Aluminum / PVC
 - Extruded Aluminum Skin
 - PVC Chambered Interior Construction
 - Improved Energy Efficiency
 - Added Strength
- ENERGY STAR® Available
- Extruded Frame & Roll Form Sash

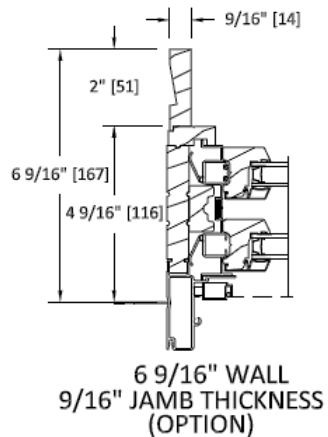
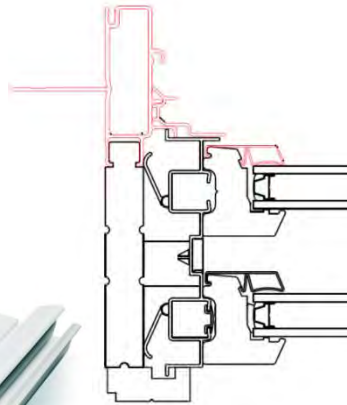
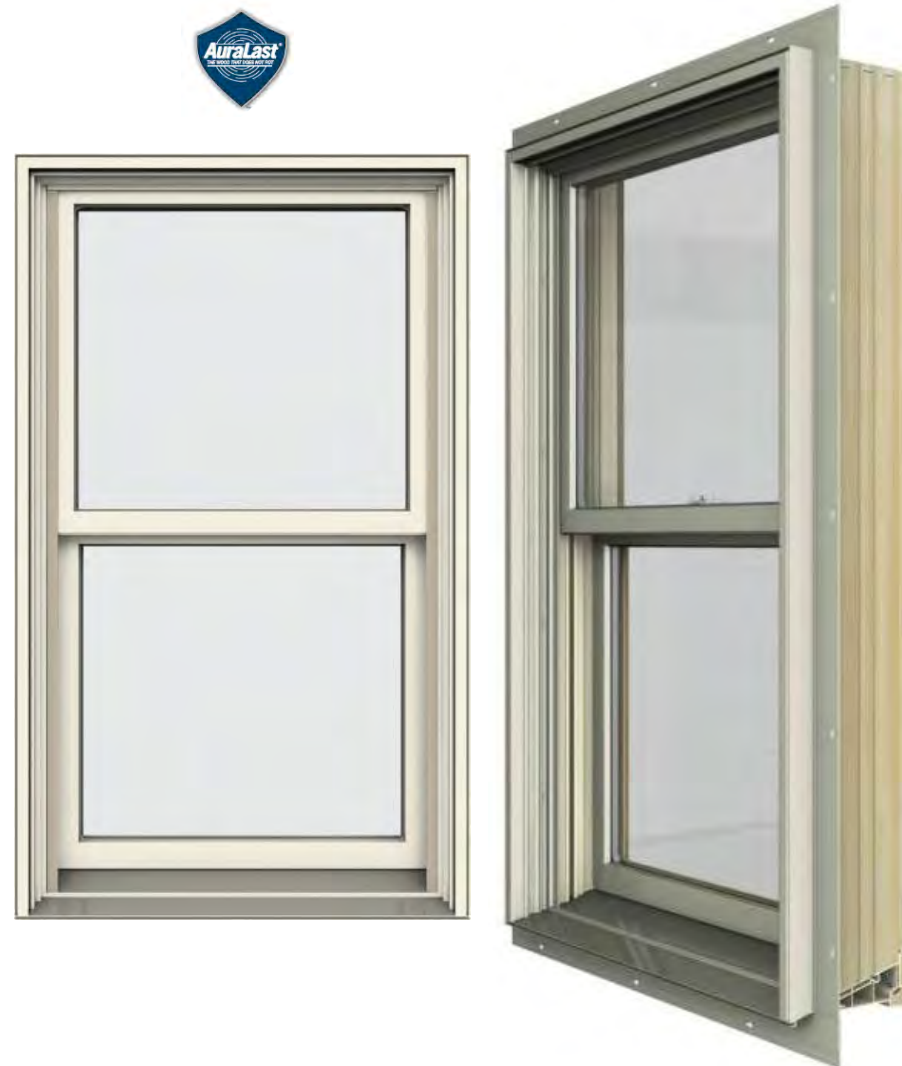
Frame

- AuraLast Pine
- Jambs 4-9/16", 6-9/16" and 7-9/16"
- Jamb Liner – Compression
- Front View / Hidden Jamb Liner
- Screen Frames Match Cladding Color

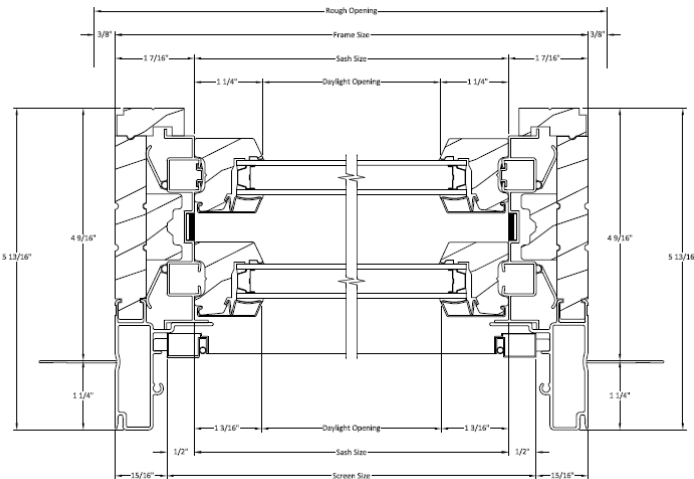
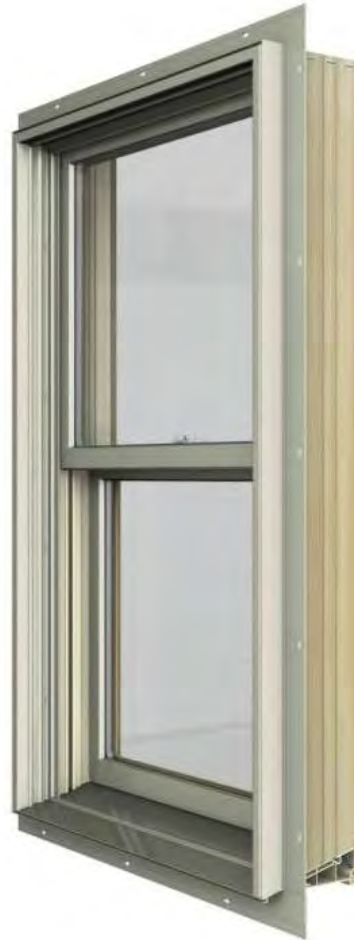
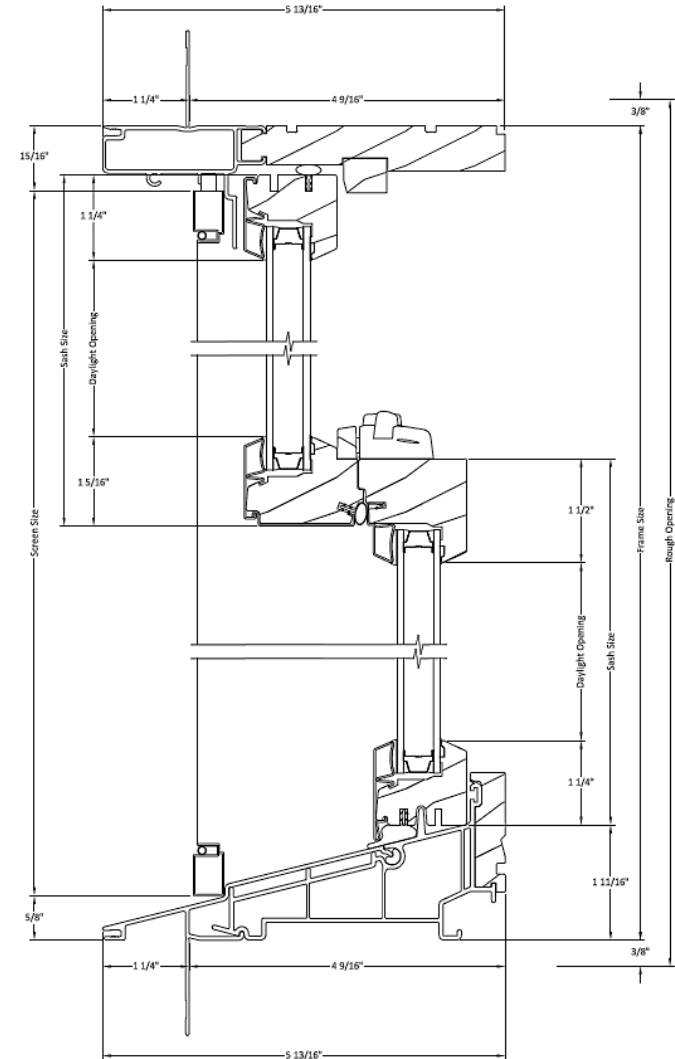
W2500 Clad Double-Hung

- Pine
- Glass Area Maximized
 - Sizes
 - Stiles - 1 1/4"
 - Top & Bottom Rails - 1 1/4"

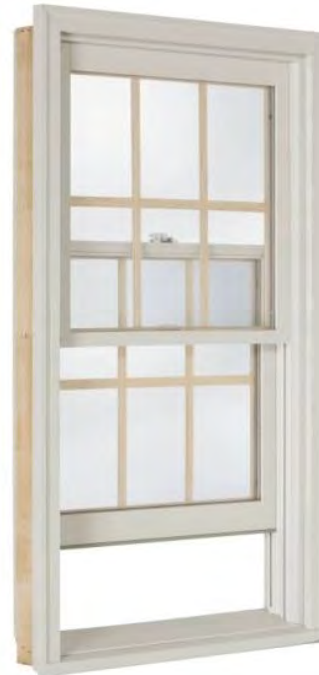
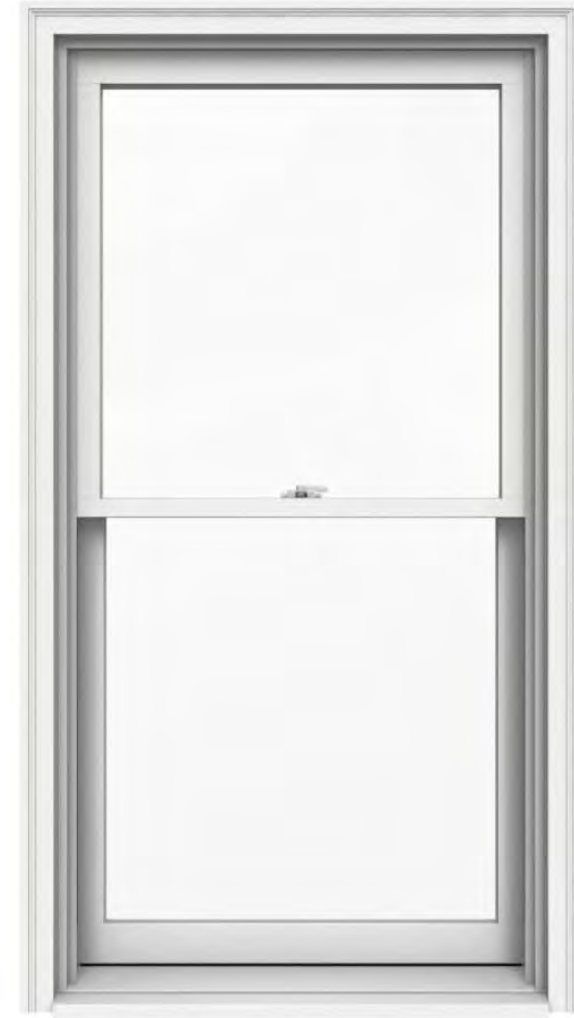
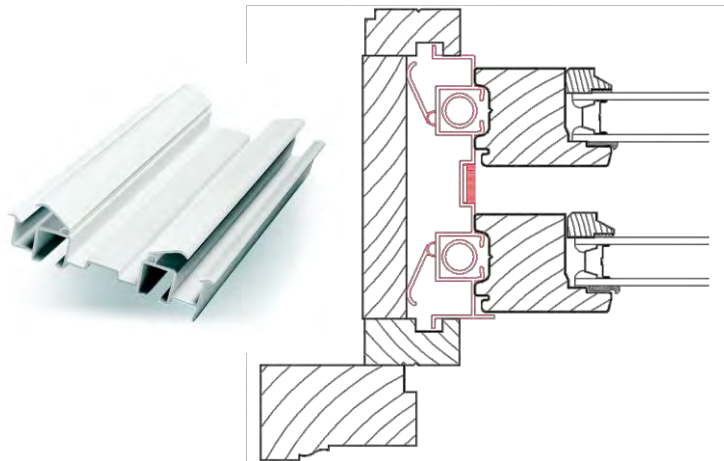
Wood Double Hung

- AuraLast Pine
- AuraLast Primed Pine
- Jambs 4-9/16", 6-9/16" and 7-9/16"
- Jamb Liner - Compression
- Unit Sizes / Standard & Custom
 - Width: 21³/₈ to 45³/₈
 - Height: 36¹/₂ to 92¹/₂

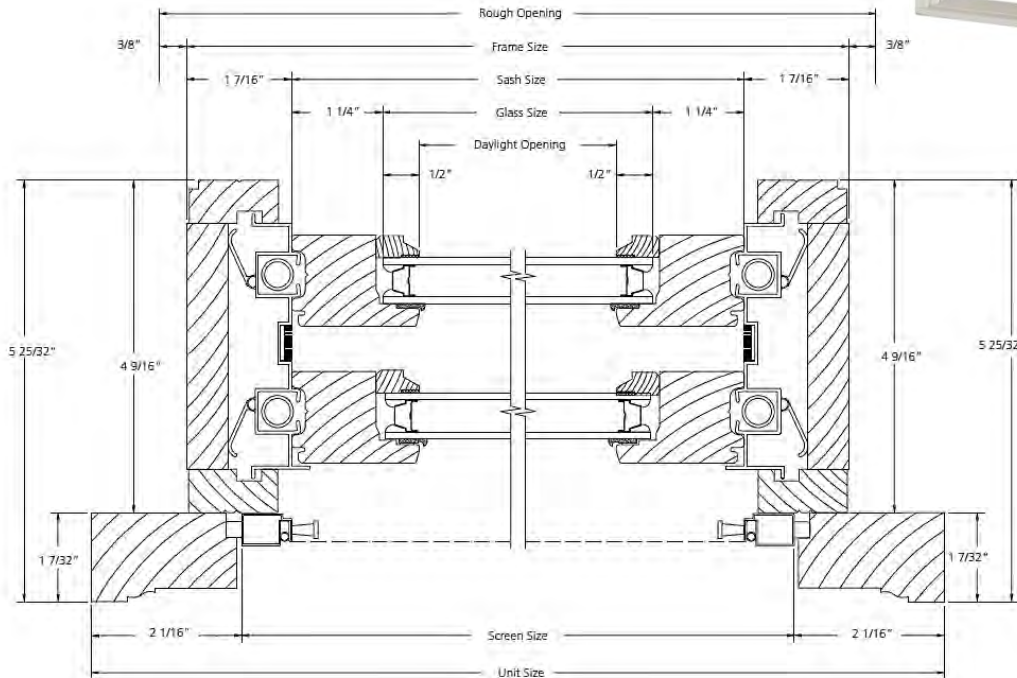
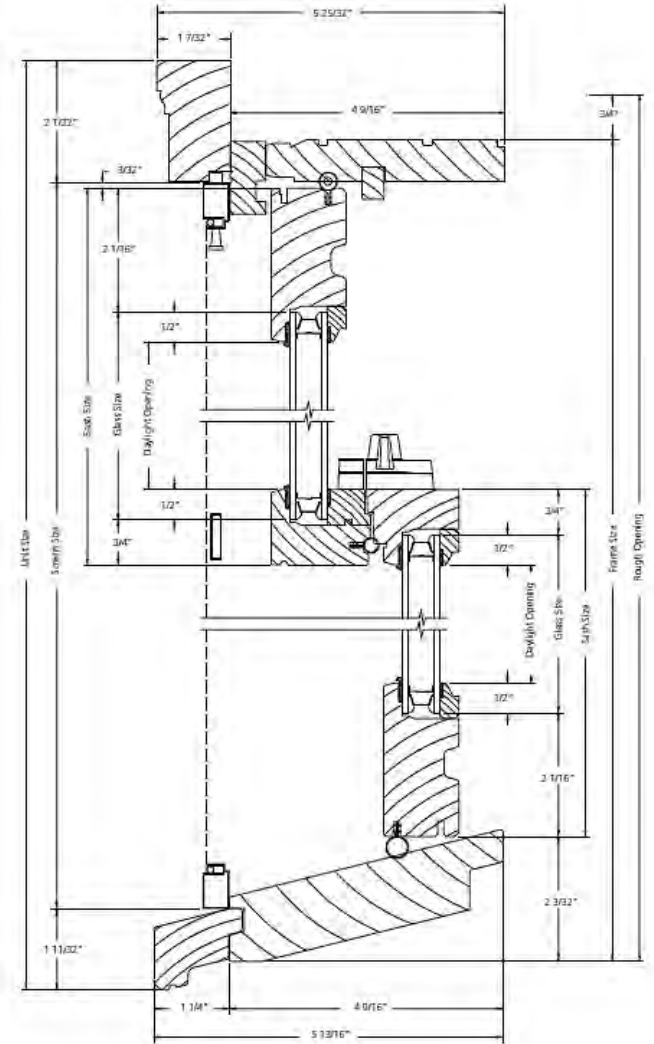
Wood Double Hung

- Sash
 - Stiles - 1 3/4"
 - Top & Bottom Rails - 2 9/16"

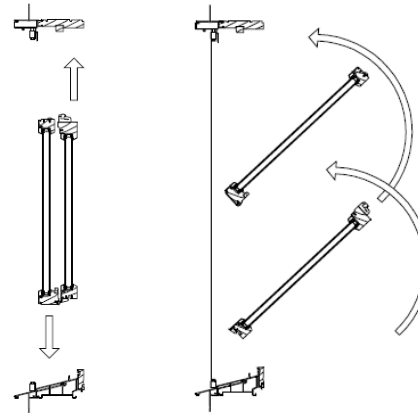
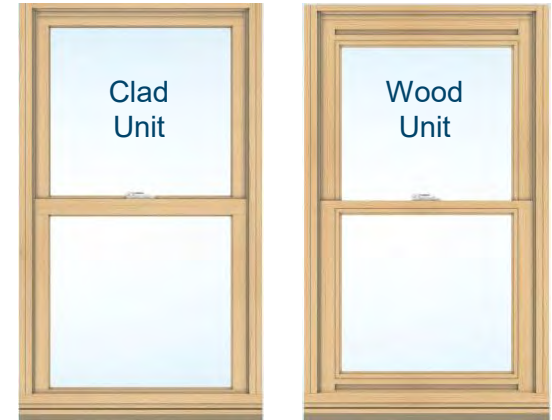
Interiors

- Pine Interior
- Compression Jamb Liner
 - Sash Tilt Out
 - Sash Removable
- Secure Stylized Cam Lock
 - 7 Hardware Finishes
 - Provides Solid Weather-strip Contact

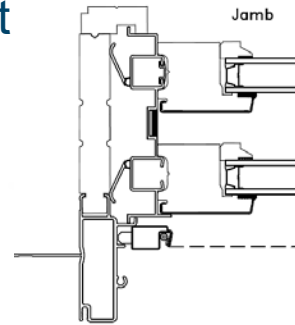
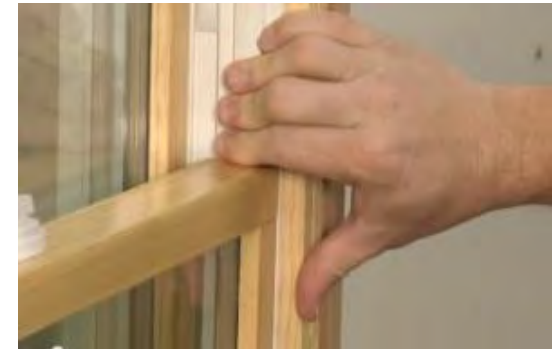
- Pine Interior
- Compression Jamb Liner
 - Sash Tilt Out
 - Sash Removable
- Secure Stylized Cam Lock
 - Provides Solid Weather-strip contact
 - 7 Hardware Finishes

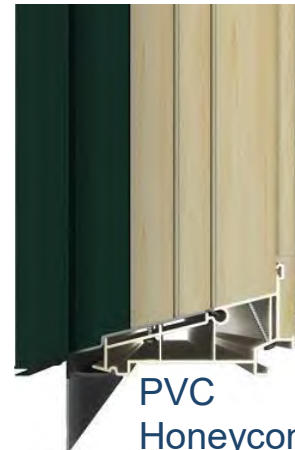
- Aluminum Clad Units Only
 - Frame: Extruded Aluminum Clad / W2500
 - Sash: Roll Form Aluminum Clad
 - Sill: Engineered - Aluminum / PVC Honeycomb
 - Aluminum Skin
 - PVC Chambered Interior Construction
 - Improved Energy Efficiency
 - Added Strength
 - ENERGY STAR® Available
- AuraLast® Wood
- Standard & Custom Sizes
 - Width: 21 3/8 to 41 3/8
 - Height : 36 to 76
- Jambs 4-9/16"

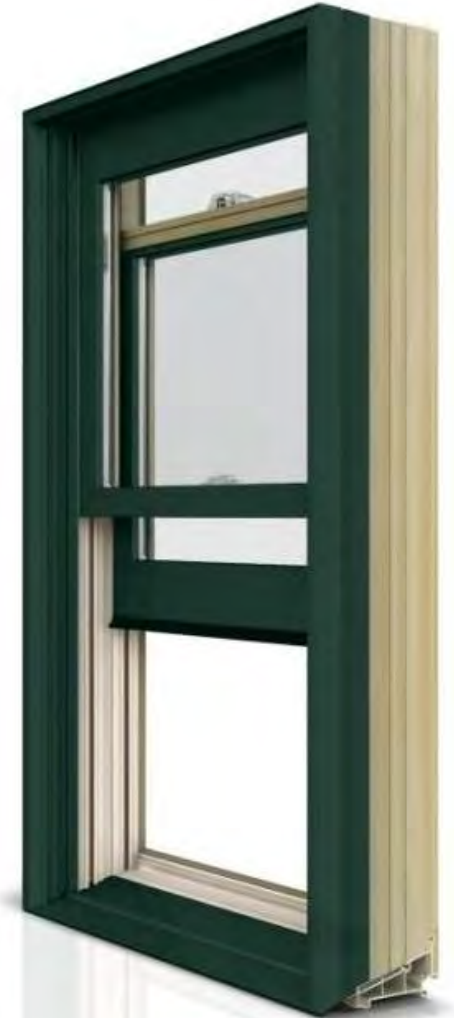
PVC
Honeycomb

Exterior Standard Specifications

- Sash
 - Stiles - 1 3/4"
 - Rails - 2 9/16"
- Optional Cottage Units
- Multiple Assemblies
