STAFF REPORT: DECEMBER 14, 2022 REGULAR MEETING

APPLICATION NUMBER: 22-8162

ADDRESS: 15350 GRANDVILLE

SCOPE: REPLACE SIX (6) CASEMENT WINDOWS WITH VINYL WINDOWS

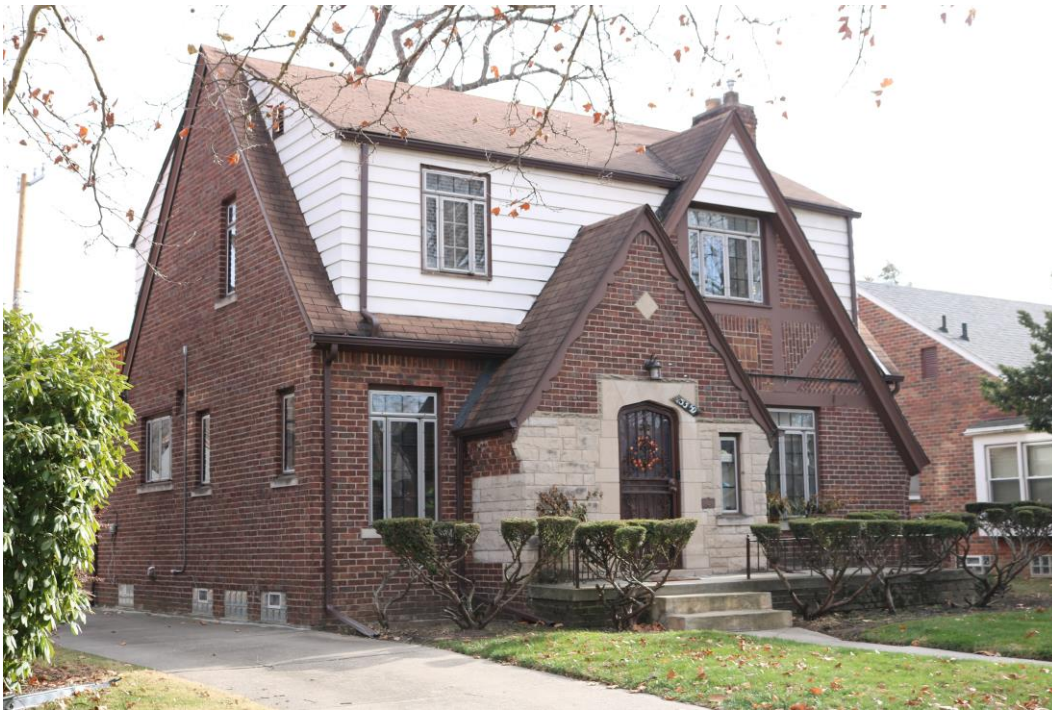
15350 Grandville is a two-and-a-half story, brick, Tudor Revival house built in 1936. It faces west onto Grandville Avenue. Defining features include sharp gables on the front façade and projecting entrance bay, a Tudor-arched doorway with tabbed stone surround, stone veneer on the entrance bay, and steel casement windows (covered behind aluminum storm windows), the subject of this application.

View from northwest. December 2022 photo by staff.

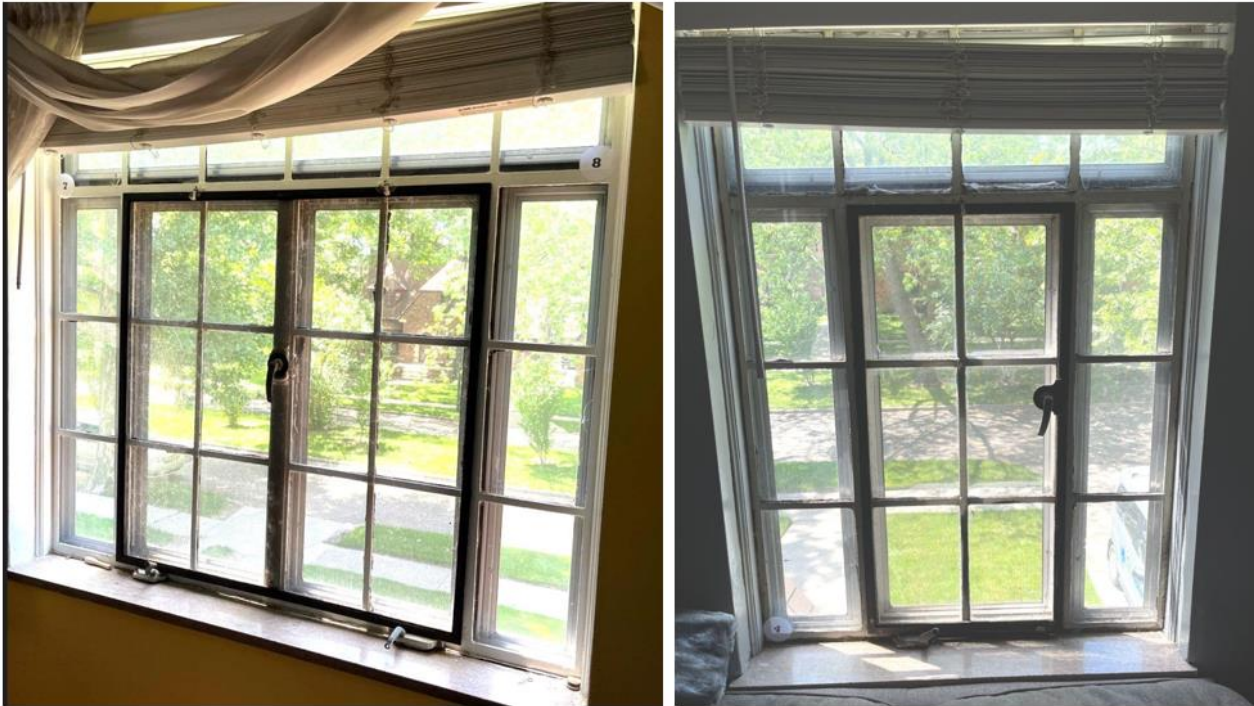
The existing windows are rolled steel, out-swinging, crank-operated casement windows with interior screens. Each window consists of a fixed section and one or two operable sections. They are currently painted a dark color. Each window is covered with aluminum storms, subdivided to accommodate operation of the window.

Left: Example double casement window. Note that it consists of fixed upper and side panes, with two out-swinging units in the center. The proposed replacement would fill the entire space with a pair of operable casement units. Right: Example single casement window. Again, this consists of a fixed portion and an operable portion. The proposal is to replace the entire unit with a single operable casement window. Other windows on the building vary in dimensions but are the same age and style. Photos from application, cropped by staff.

- The building’s windows are both historic (original to the house or dating from the Period of Significance) and distinctive (as suggested by the Elements of Design, and as observed on comparable houses in the neighborhood) and have not deteriorated beyond repair. The Secretary of the Interior’s Standards for Rehabilitation, cited below, direct that they be retained.
- Further, should a replacement window be warranted (for instance, if the existing windows had deteriorated beyond repair), an appropriate replacement window would, at a minimum, be a metal or metal-clad casement window mimicking the dimensions and muntin pattern and replicating the operation of the historic windows (including a juxtaposition of fixed panes with one or paired operable sashes within each window opening).

Staff recommends that the Commission issue a Denial of the proposed window replacement as it does not meet the Secretary of the Interior’s Standards for Rehabilitation, in particular:

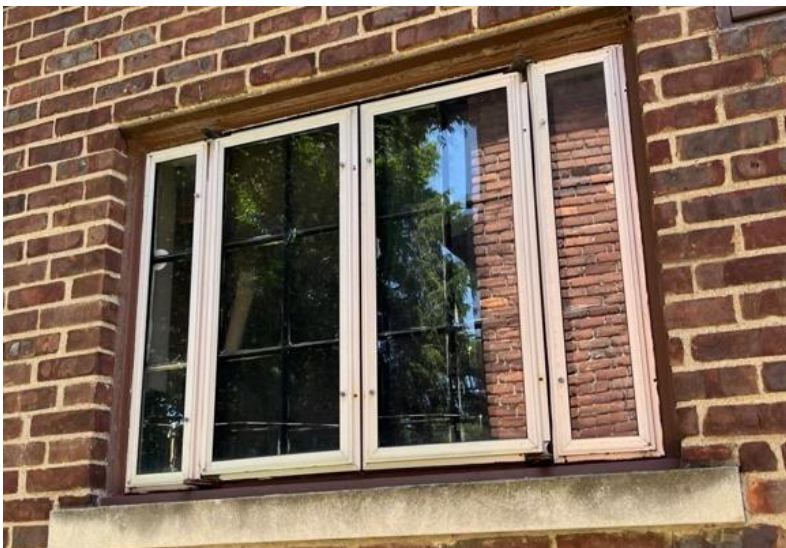
Example window proposed for replacement. Photo from application, cropped by staff.

- The Elements of Design for the district state:
 - Windows are “often subdivided.”
 - Textural interest is created by “subdivided windows.”
 - “Windows are commonly either of the metal casement or wooden sash variety.”
- The Final Report asserts that the historic district is “significant for its varied housing stock that dates from the 1910s into the 1950s,” implying a Period of Significance for the district.
- The proposed window color closely matches the trim color and B:8 Grayish Brown as shown in Color System D as appropriate.
- Staff does not observe any major deterioration to the windows as shown in photos provided by the applicant.

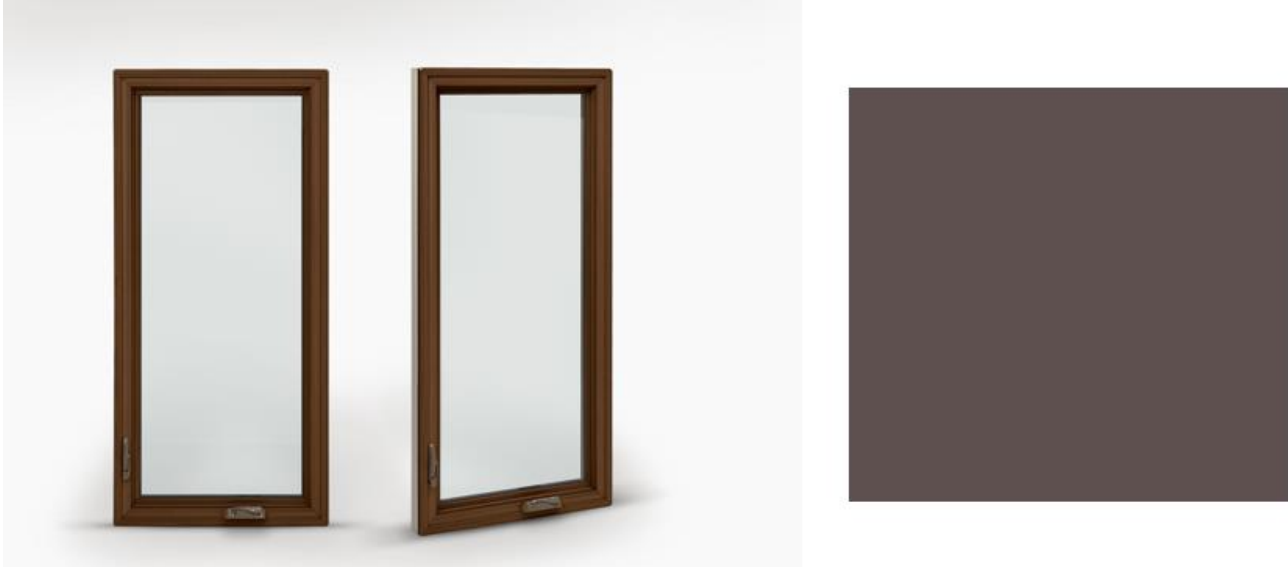
The proposed new windows are WeatherGard 700 Series custom windows. Casement windows are proposed for the

Glass is to be “premium” low-E glass, except for the bathroom window, for which “obscure” glass is proposed. Simulated muntin “grids” in bronze-colored aluminum are proposed to match the existing muntin pattern. On the exterior, windows are proposed to be custom painted 202 Royal Brown. Exact dimensions of the rails or simulated muntins are not provided. Windows are proposed to include interior screens.

Left: WeatherGard 700 Series vinyl casement windows, interior view. Note that the proposed product would look different from the image, as bronze-colored aluminum simulated muntins are proposed, and a brown color is specified for the exterior. Image: www.weathergard.com. Right: 202 Royal Brown. Source: www.myperfectcolor.com.

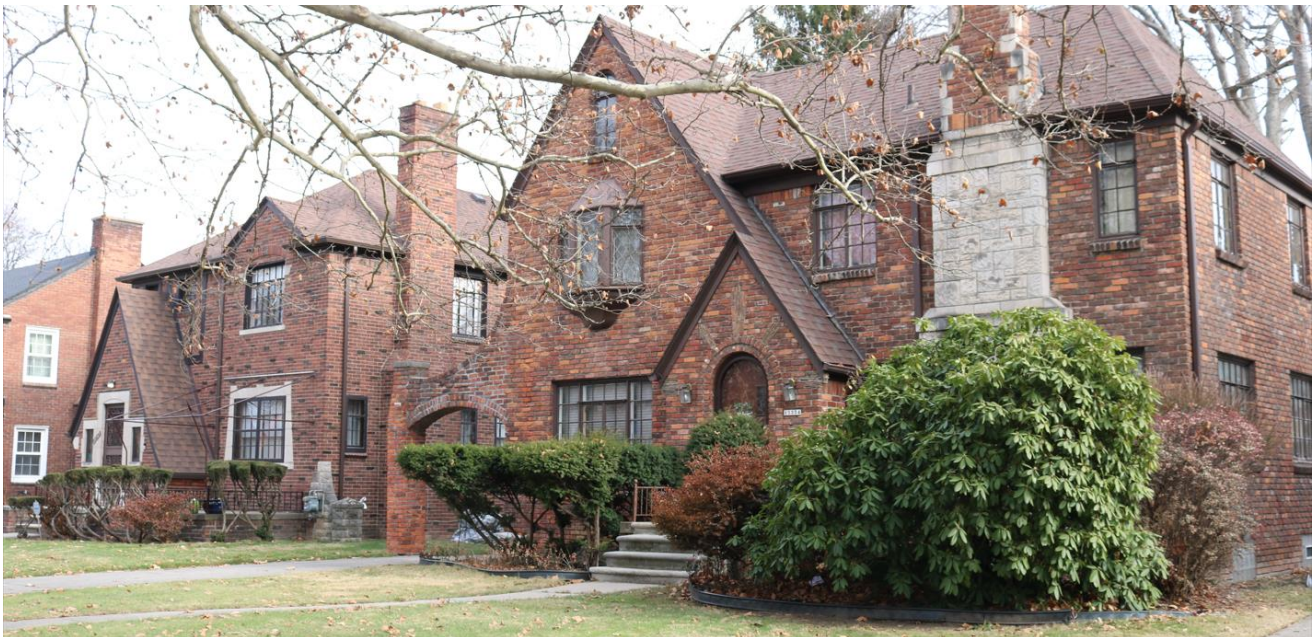
- The Rosedale Park Historic District was established by Ordinance 03-07 in 2007. Its Final Report frequently mentions leaded glass casement windows as noteworthy features.
- Staff notes that subdivided, leaded- or zinc-came casement windows are a hallmark of 1930s Tudor Revival houses in general, and very common in Rosedale Park specifically. For instance, two neighboring houses to the subject property also have similar windows.

Tudor Revival houses at 15345 and 15362 Grandville. Note that windows have similar proportions, subdivision, and operability as the subject property. Photo by staff.
