STAFF REPORT: MAY 10, 2023 REGULAR MEETING

APPLICATION NUMBER: 23-8335

ADDRESS: 14921 GREENVIEW

SCOPE: INSTALL VINYL WINDOWS

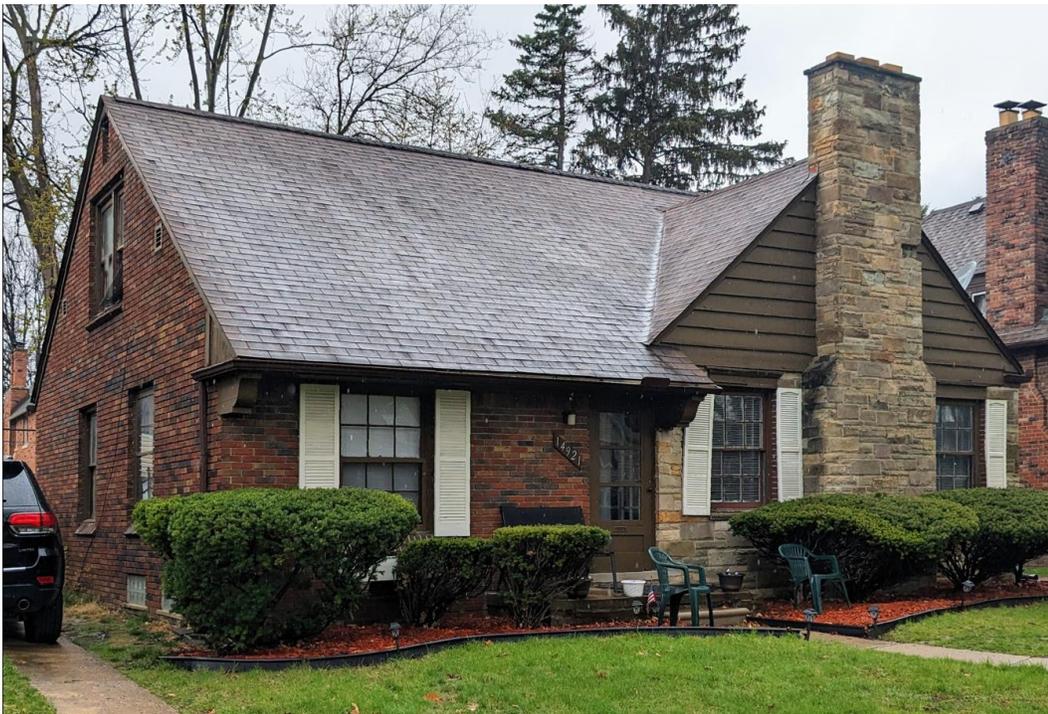
14921 Greenview is a one-and-one-half story, gable roof, Ranch-style brick building in the Rosedale Park Historic District, built in 1950, and facing east onto the street. Notable details include a prominent, front-facing gable with a centered wall chimney; both the gable façade and chimney feature stone cladding.

The windows, subject of this application, appear to be original and come in several configurations. On the front (east) façade are six-over-six wood sash windows. On other elevations are one-over-one sash windows and a bay window. Many windows feature historic storm windows or screens.

View from southeast. April 2023 photo by staff.

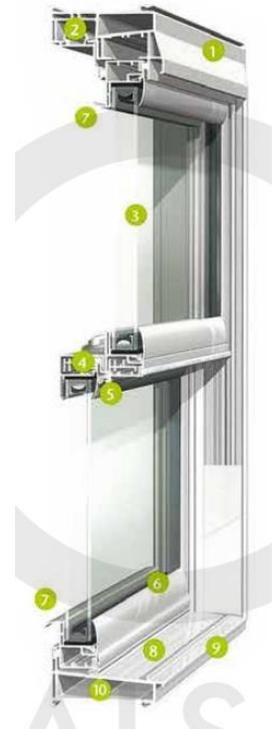
The application materials mention two different types of proposed windows. According to a submitted window schedule and brochure, the proposed windows are Encore double-hung vinyl sash windows from First Choice Windows and Doors. The color is white, with brown exterior trim to match the siding, gutters, and doors. The Encore windows optionally include between-the-glass grids to approximate the appearance of muntins; the application does not specify if these are proposed.

Encore window. Image from submitted brochure.

- If a replacement window were to be warranted (for instance, if the existing windows had deteriorated beyond repair), staff notes that an appropriate replacement window would be a wood sash window with similar dimensions in a compatible trim color. A white vinyl window is not appropriate on this building.

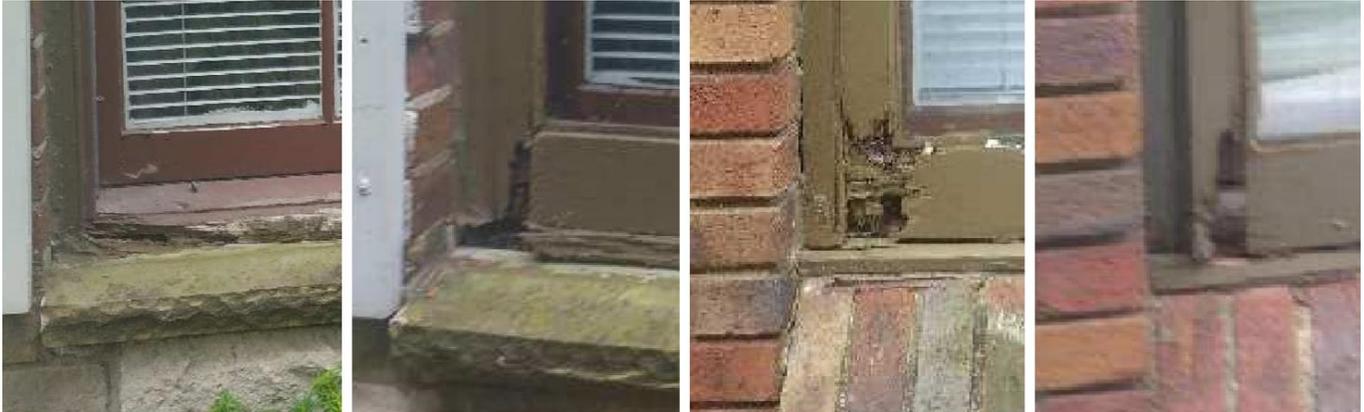
- The applicant states that the existing windows are “rotten and falling out.” The Project Review Request Form mentions concerns including “rotten wood around frames,” “open gaps,” “broken seals,” and a desire for “energy efficiency.”

- Staff was not able to view the front (east) and side (north and south) windows up close due to the distance from the street; staff was not able to view the rear (west) windows at all. Consequently, staff relies upon the application materials for description and photos.
- Staff observes that some areas of deterioration of storm windows and surrounding frames are visible in the submitted application materials and that screens are damaged.

Deterioration of window frames and storm windows (no storm window is present on the leftmost image). Photos from application materials.

- Beyond general description (quoted above), the photos from the applicant do not show significant deterioration to the historic primary windows.

- The building's windows are historic (appearing to be original to the house and dating from the Period of Significance) and are not shown to have deteriorated beyond repair. Standard #6 of the Secretary of the Interior's Standards for Rehabilitation, cited below, directs that they be retained.

Staff recommends that the Commission issue a Denial of the proposed window and storm window replacement as it would remove historic features of the property and replace them with features of non-historic materials and appearance; consequently, the proposed work does not meet the Secretary of the Interior's Standards for Rehabilitation, in particular:
