STAFF REPORT: OCTOBER 11, 2023, REGULAR MEETING **PREPARED BY:** T. BOSCARINO
APPLICATION NUMBER: HDC23-00029
ADDRESS: 2020 CHICAGO
HISTORIC DISTRICT: BOSTON-EDISON
APPLICANT: GEORGE SHIHADDEH
OWNER: GEORGE SHIHADDEH
DATE OF PROVISIONALLY COMPLETE APPLICATION: AUGUST 24, 2023
DATE OF STAFF SITE VISIT: SEPTEMBER 28, 2023

SCOPE: ALTER VERGEBOARDS

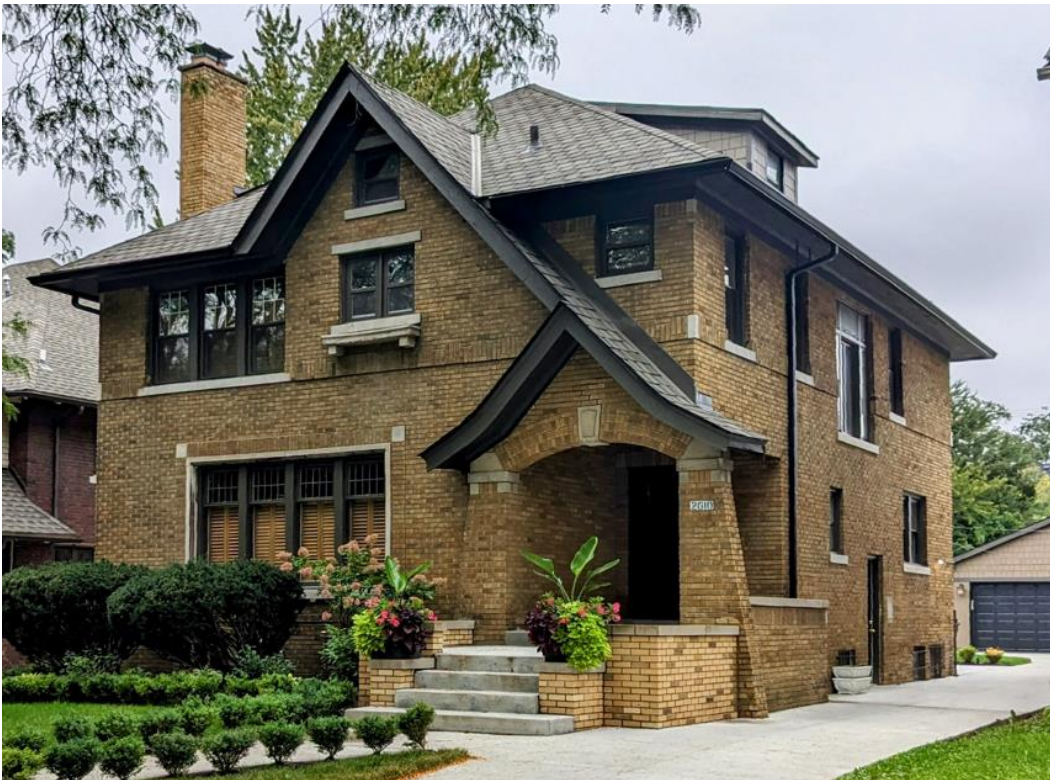
In 2018 or 2019, the façade was altered by covering original wood vergeboards (subject of this application) fascia, and soffits with vinyl, without approval of the Historic District Commission. The vinyl has since been removed and the underlying wood repaired.

September 2023 photo by staff.

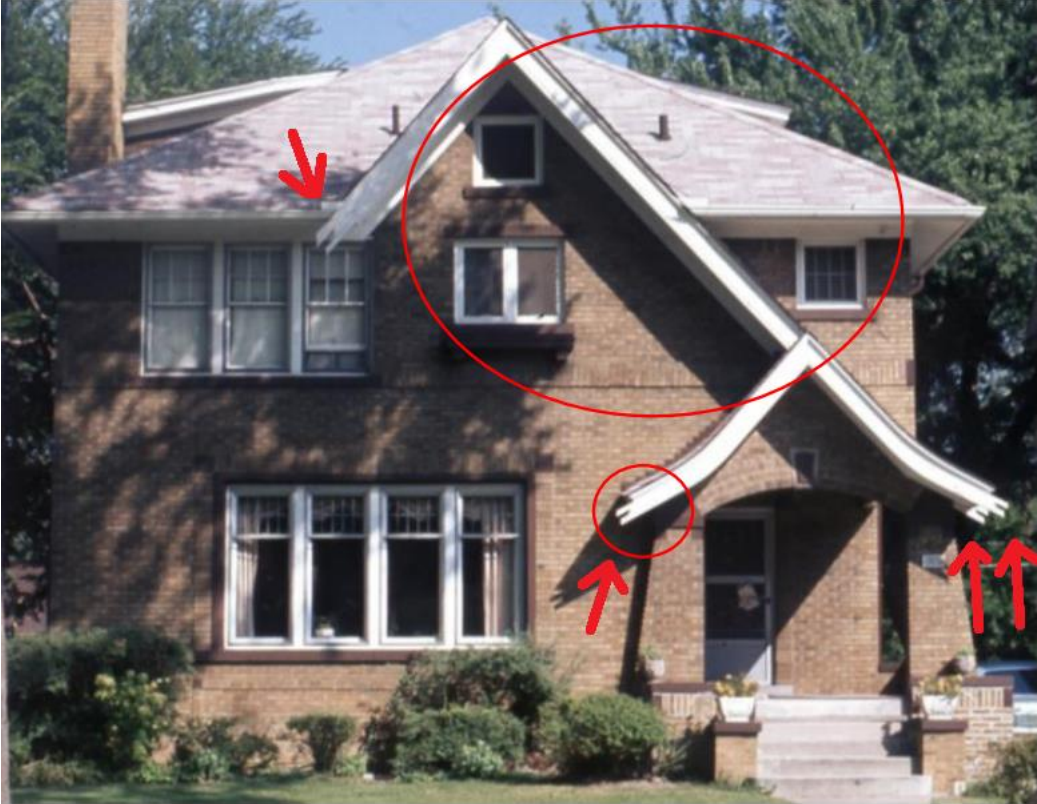
The 2018 or 2019 work, described above, involved the truncation of decorative, pointed vergeboard ends in

four locations. This work, being already completed, is presently visible on the building. The applicant seeks approval from the Historic District Commission to retain this condition.

1974 photo by Historic Designation Advisory Board, notations added to highlight now-missing details.

- The work eliminates a distinctive, character defining-feature (pointed vergeboard ends) of the property.

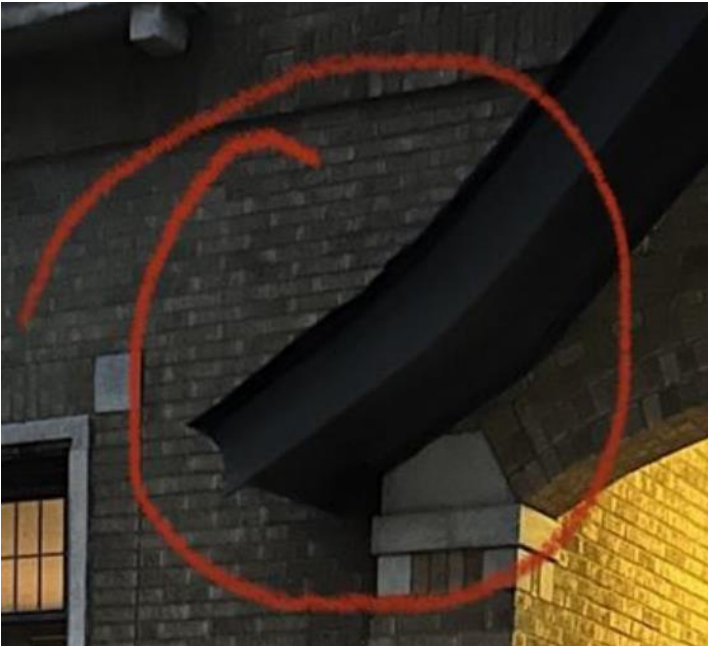
Detail of current condition (typical of all four locations). Photo provided by applicant, cropped by staff to highlight pertinent area.

- The removal of decorative, pointed vergeboard ends was not appropriate as it eliminated a unique, distinctive, character-defining feature of the building. This is contrary to Standard #5, which states that “distinctive features, finishes, and construction techniques or examples of craftsmanship that characterize a historic property shall be preserved.”

Therefore, staff recommends that the Commission issue a Denial as the proposed work fails to meet the Secretary of the Interior’s Standards for Rehabilitation, in particular:
