STAFF REPORT: FEBRUARY 7, 2024 MEETING

APPLICATION NUMBER: HDC2023-00142

ADDRESS: 19650 CANTERBURY

SCOPE: REPLACE SLATE ROOF WITH ASPHALT SHINGLES (WORK COMPLETED WITHOUT APPROVAL),

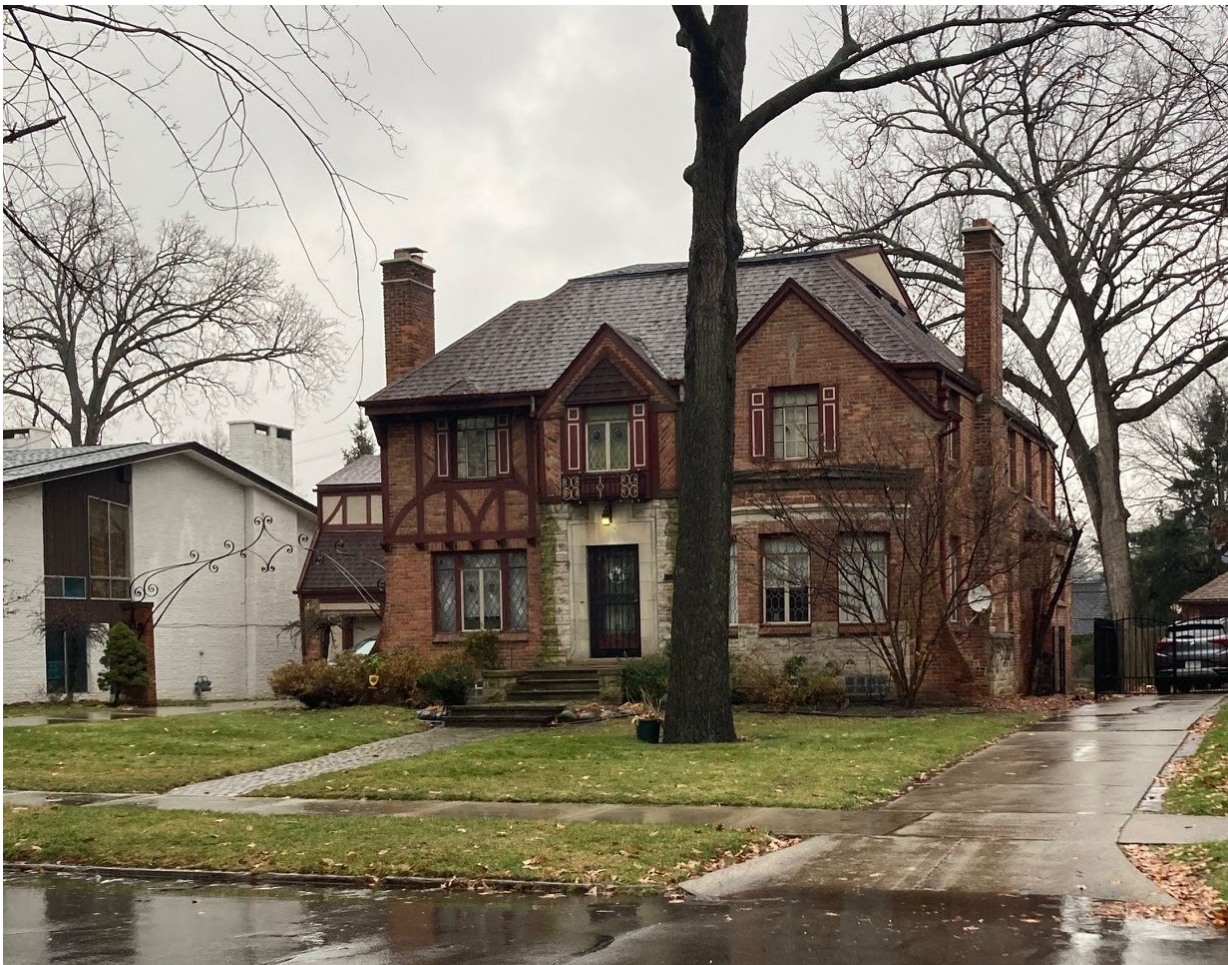
Figure 1: View of 19650 Canterbury, looking northeast.

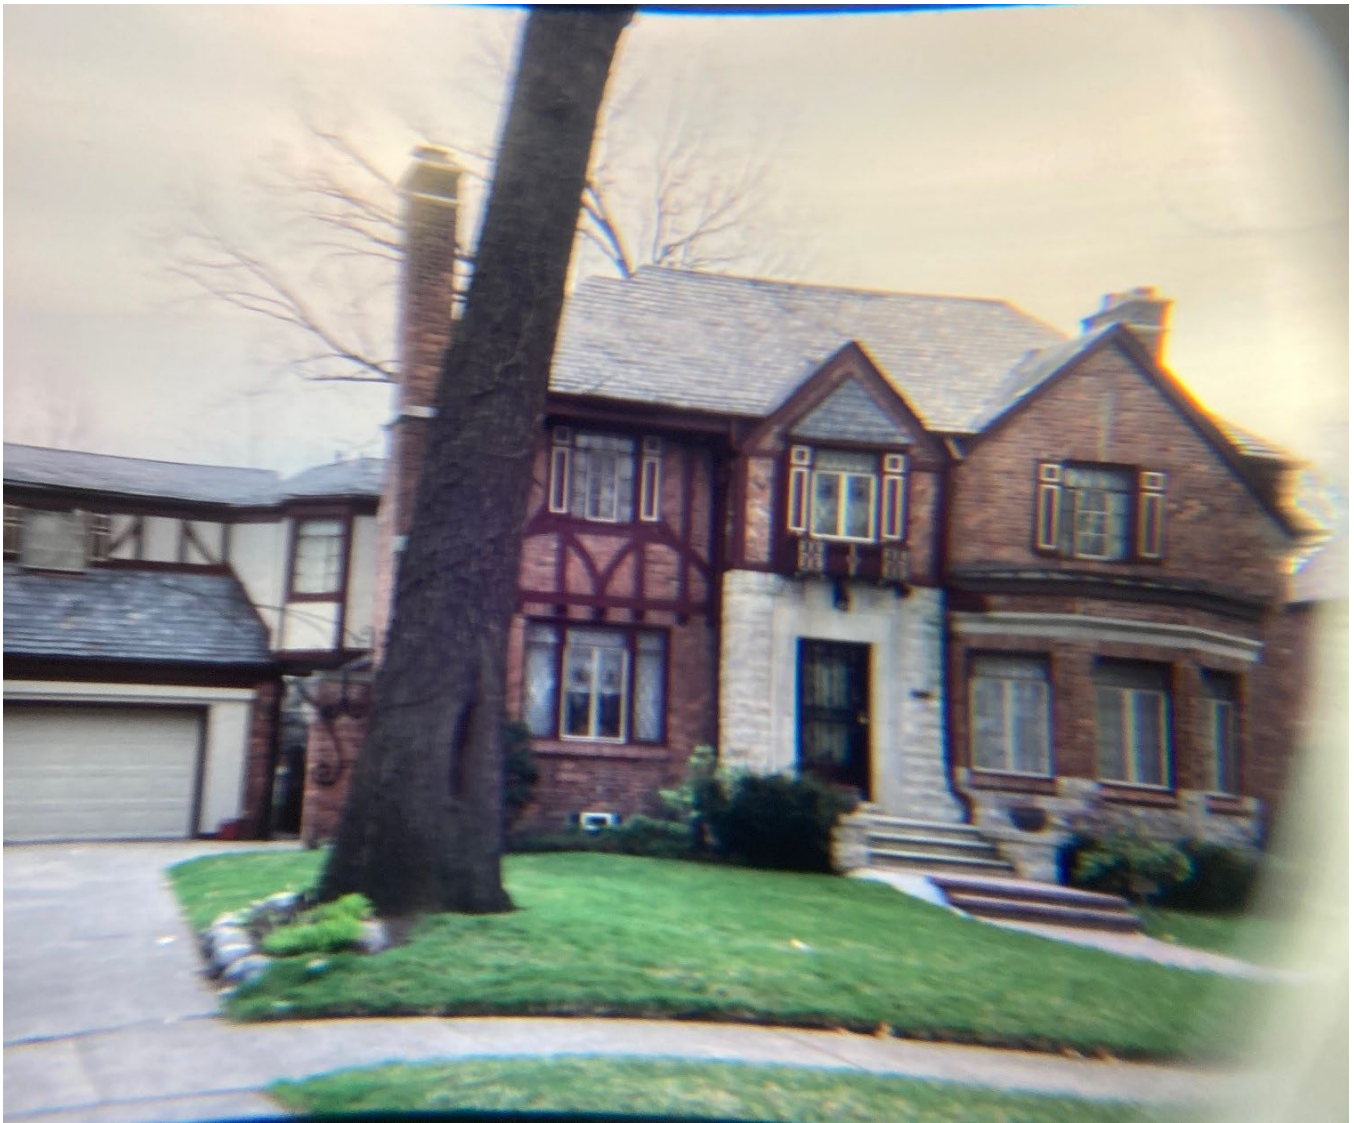
Figure 2: 2002 designation photograph of 19650 Canterbury showing the original slate roof. HDAB

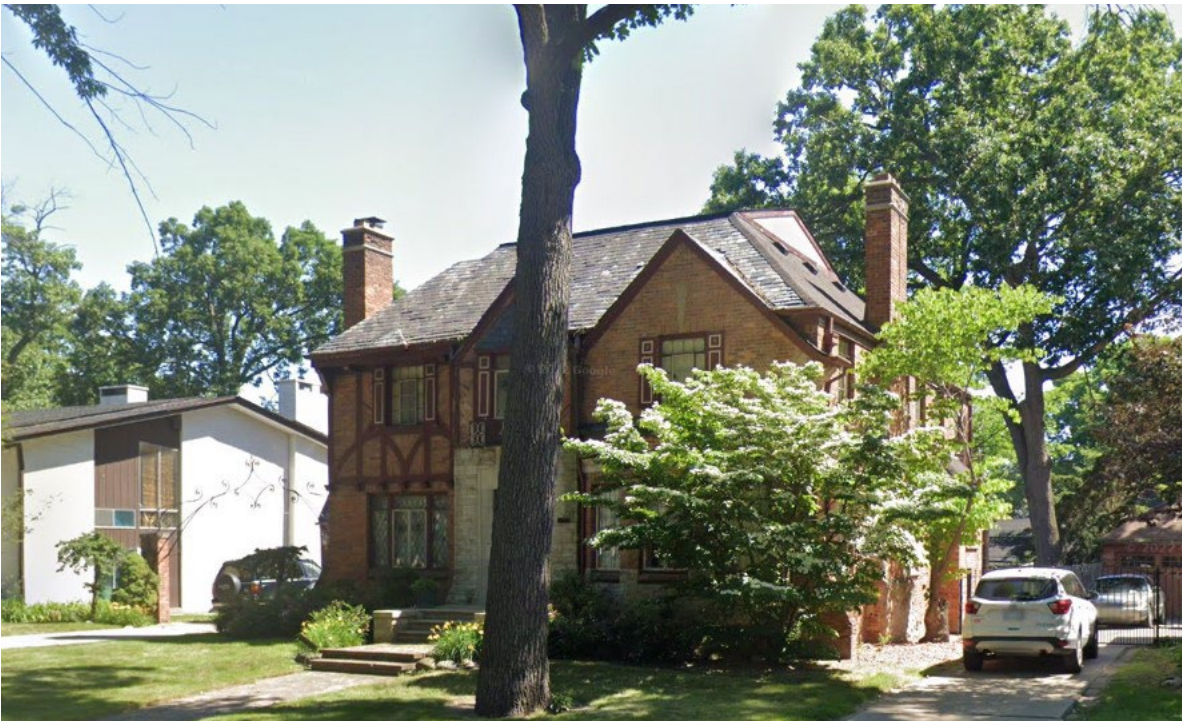
- The Sherwood Forest Historic District was established in 2002.
- The removal of the slate roof tiles at the rear and sides of the home was completed ca. 2019, while the slate at the front of the home and garage was removed in 2022.

Figure 2: Image of 19650 Canterbury from 2019, showing the partial replacement of the slate roof at the side elevation. Google Street View

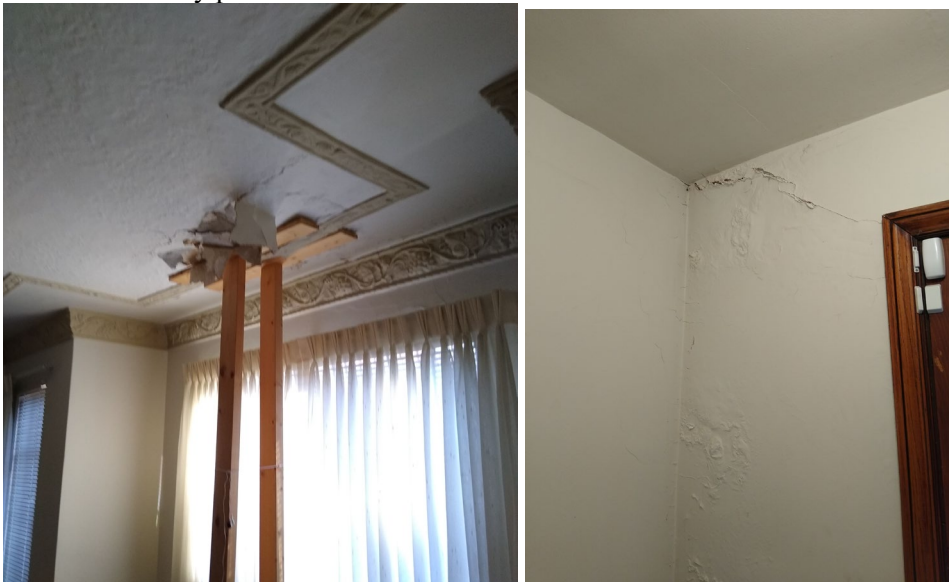
- The applicant provided photographs of plaster and paint damage occurring at the second floor of the home caused by prior leaks from the slate roof.

Figures 3,4: Images provided by the applicant showing paint and plaster damage at the second floor of the home.

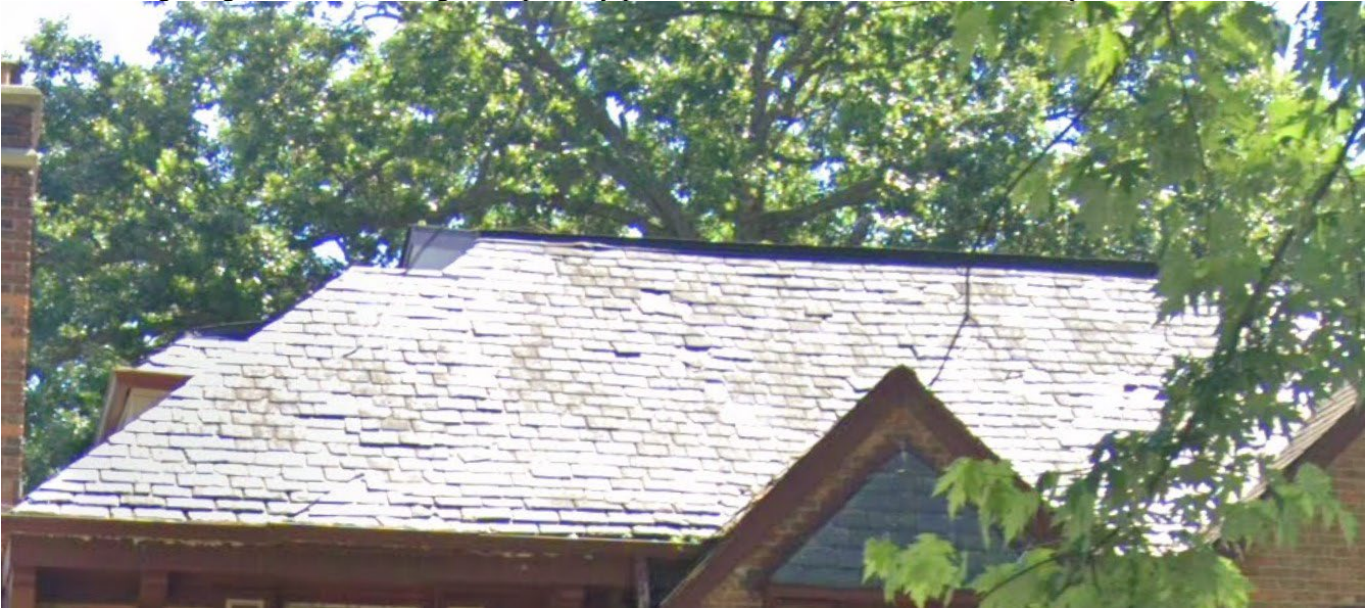
- Images of the former slate roof on Google Street View show the slate was experiencing significant deterioration, including large numbers of broken, delaminated, and dislodged tiles, as well as heavy biological growth. The damage is especially prevalent at the courses of tiles directly above the eaves.

Figure 5: Image of 19650 Canterbury from 2022 showing deterioration of the slate roof. Google Street View

- According to the National Park Service’s Preservation Brief 29: “The Repair, Replacement and Maintenance of Historic Slate Roofs,” the replacement rather than repair of slate roofs should be considered when more than 20% of the slate is “damaged or missing.” As observed in images from Google Street View, it appears that 20% or more of the slate roof was damaged or dislodged, meriting complete replacement. Assuming that the slate roof was original to the building, it was also likely the slate was reaching the end of its lifespan as an effective roofing material.

Staff finds that the proposed replacement of the slate roof with asphalt shingle roofing adheres to the Secretary of the Interior’s Standards for Rehabilitation when taking into consideration reasonable economic feasibility, and therefore recommends the Commission issue a Certificate of Appropriateness for the work as completed.
