STAFF REPORT: MARCH 12, 2025 MEETING -- REVISED 03/24/25

APPLICATION NUMBER: HDC2025-00069

ADDRESS: 1090 VINEWOOD

SCOPE: ERECT ROOFTOP ADDITION/DORMERS

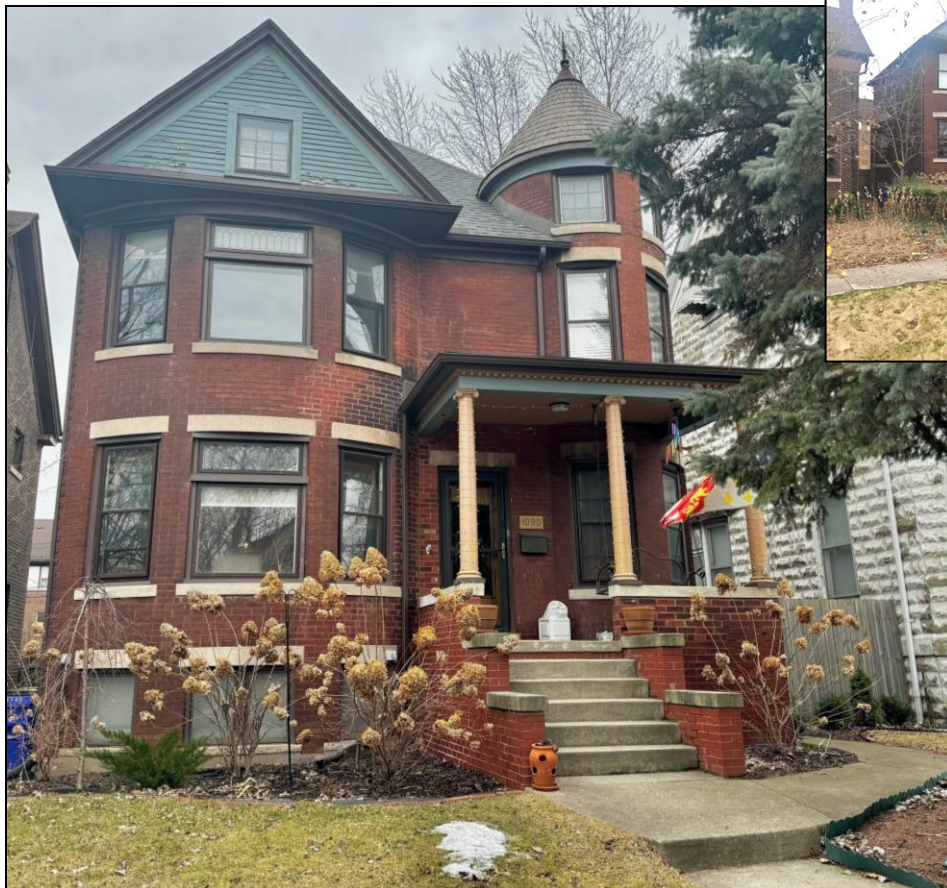
Top: Google street view, showing the height differential between the street, sidewalk, and houses.

This photo was taken at the sidewalk, which is approximately three feet higher than the roadway. The lawns on this side of the street also rise from the sidewalk, the raised basement at 1090 Vinewood further increases the distance of the roof from the sidewalk, which will help obscure the proposed dormer from the street.

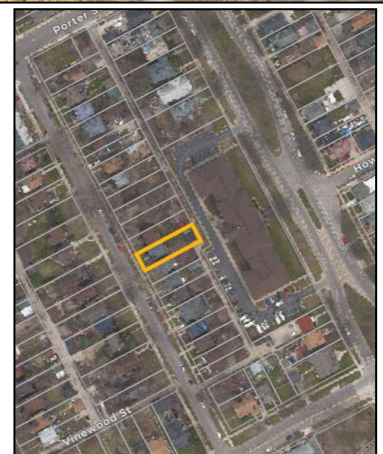
Left: Façade. Staff photo, February 2025.

The parcel is located mid-block on the east side of Vinewood, between Porter and W. Lafayette Blvd. Erected ca. 1910, the 3-story structure sits high above the street. The dwelling is faced with solid, dark red brick on the façade and dark brown common brick on the side and rear walls. The raised basement allows for large at-grade window openings on each side of the dwelling, with undivided glass on the façade and glass block on the side and rear walls. The windows at the first and second floors are predominately one-over-one double-hung units, except for the leaded glass/fixed units within the façade's two-story bay. Sub-divided casement or fixed units are in the third-floor window openings.

Ornamentation on this Queen Anne-style dwelling is exhibited through a steeply-pitched hip roof with front-facing cross gable that overhangs the wide two-story rounded bay, as well as a small three-sided dormer; a bay window on each side elevation; window openings with contrasting stone sills and headers; a 3-story tower with a conical roof; and a partial-width raised entry porch. The main roof is covered with asphalt shingles, while the conical roof retains slate shingles. The porch is accessed by stairs that are enclosed with two sets of masonry wing walls. The porch's flat roof is supported by columns with ionic capitals.

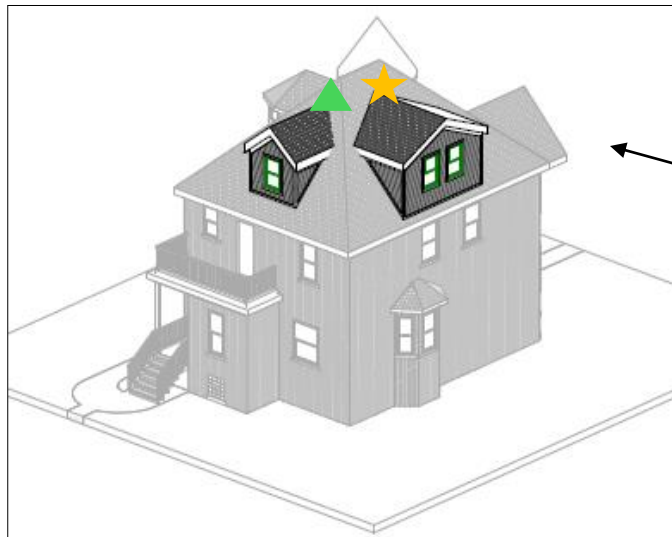
Front of house
– facing
Vinewood

Erect two gable roofed dormers: one at north/side (★) and one at east/rear (▲)

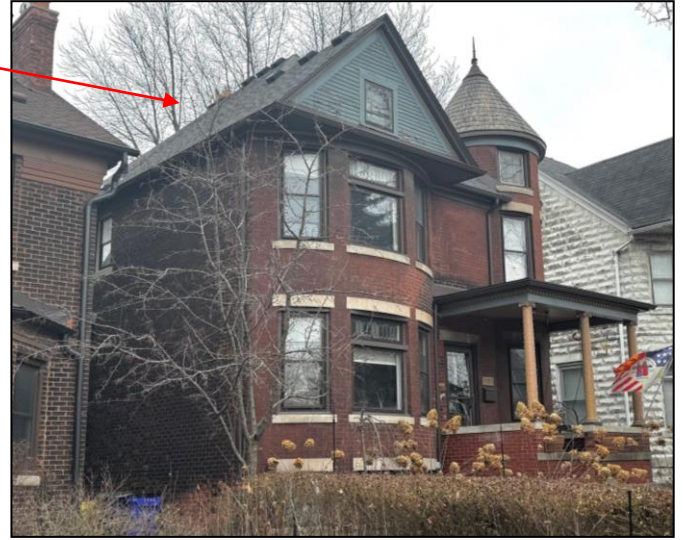
~~Above right: Staff photo looking southeast from the sidewalk. February 2025. This vantage point offers greater visibility of the proposed north dormer.~~

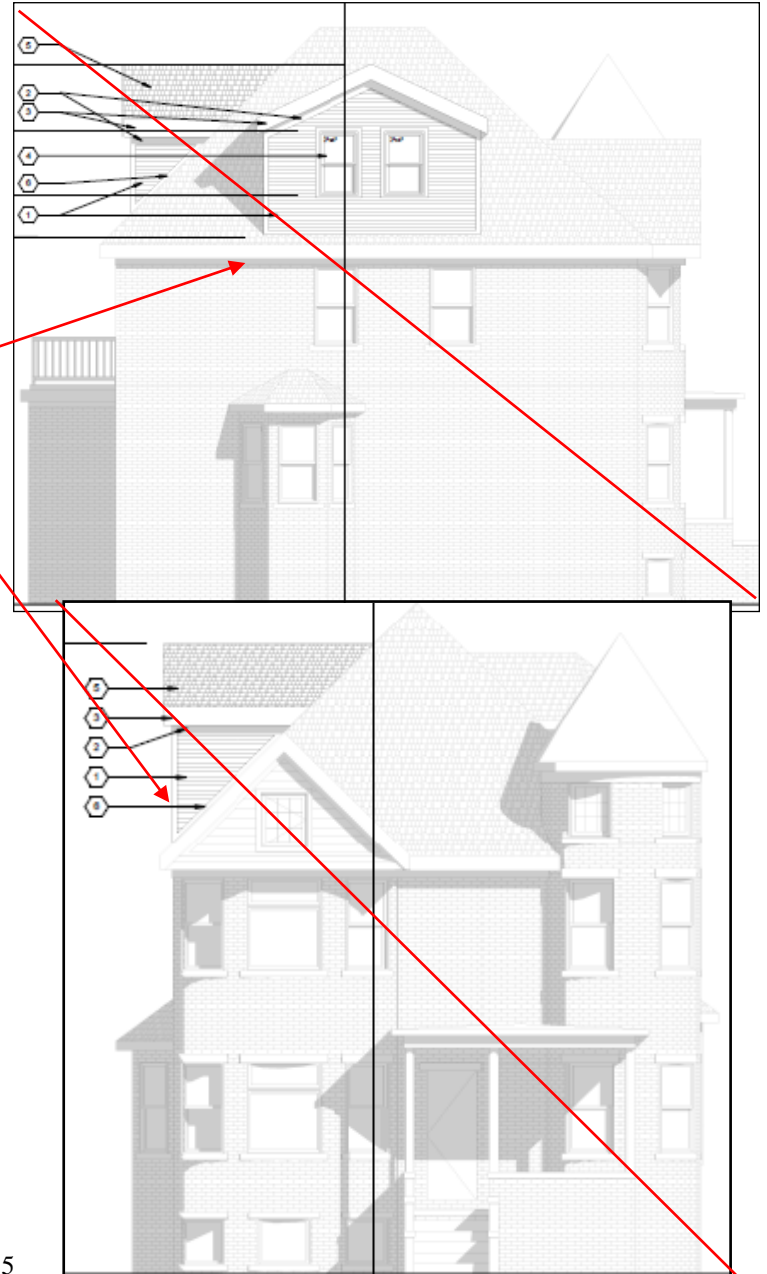
Applicant drawing. Building section, looking through the dwelling from west-east (front to rear). The north wall is at the left side of the drawing; the dark thick lines

- Using a hip roof (rather than the suggested gable) would echo the angular profile of the house's hip roof and match the profile of the southern roof line of the historic dormer. This would reduce the visual impact of the dormer while allowing the applicant to retain the majority of the requested interior vertical space.

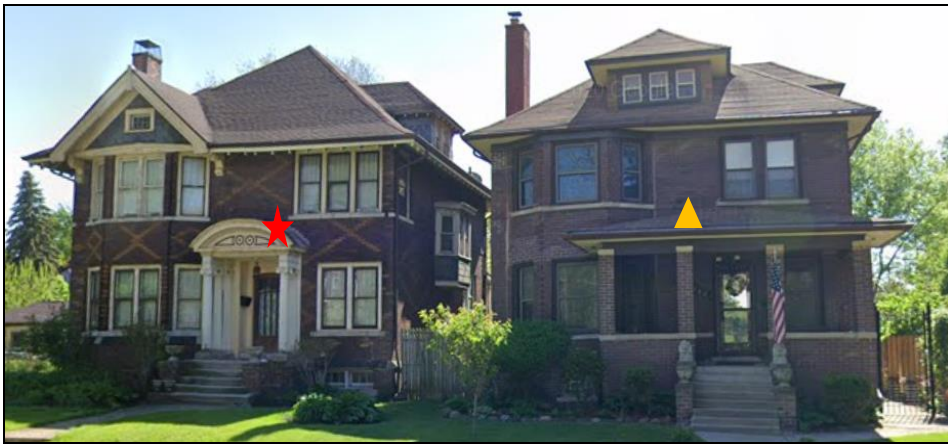
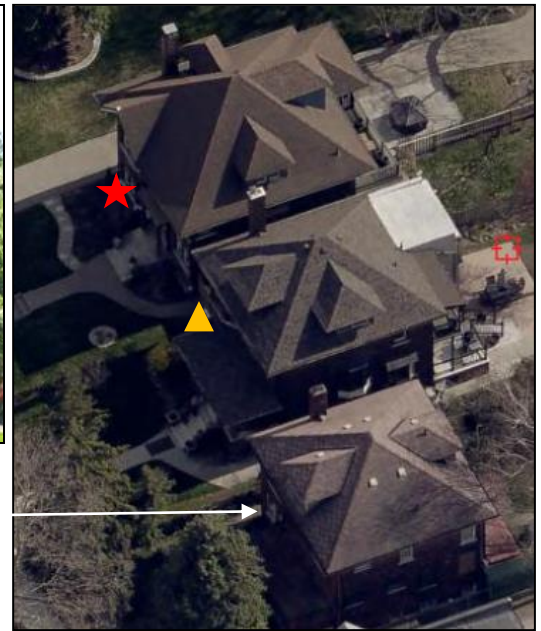
Above: Streetview shows similarly placed north/side dormers within hip roofs.

Right: Aerial view of the above houses (including 1151 Vinewood at bottom of photo), showing the large number of hip roof dormers used on these three houses.

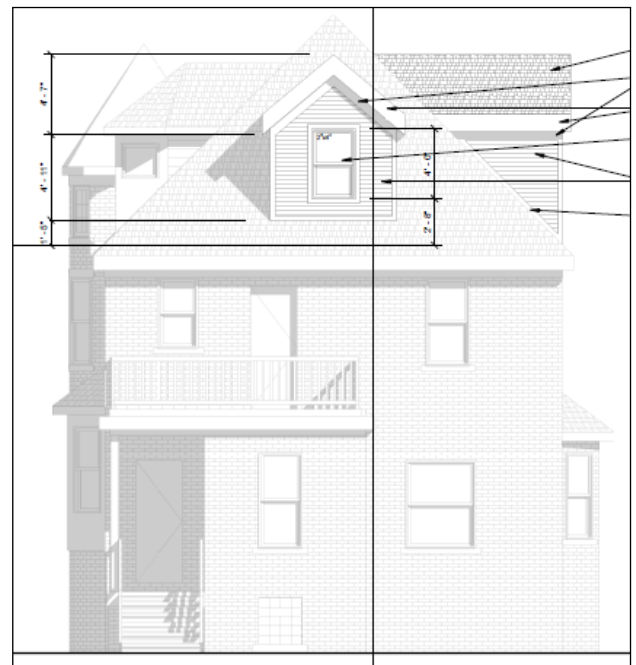
Applicant drawing -- Rear elevation. The placement of the dormer is proportional to the surface area of the roof. The dominant view of this dormer will be from the rear, therefore the primary profile of the dormer's gable roof matches that of the hip roof (in contrast to the dominant side view of the north dormer).
