**STAFF REPORT: MARCH 12, 2025 REGULAR MEETING**

**APPLICATION NUMBER: HDC2025-00052**

**ADDRESS: 4236 LESLIE**

**SCOPE: REPLACE WOOD SIDING AND TRIM WITH VINYL AND ALUMINUM**

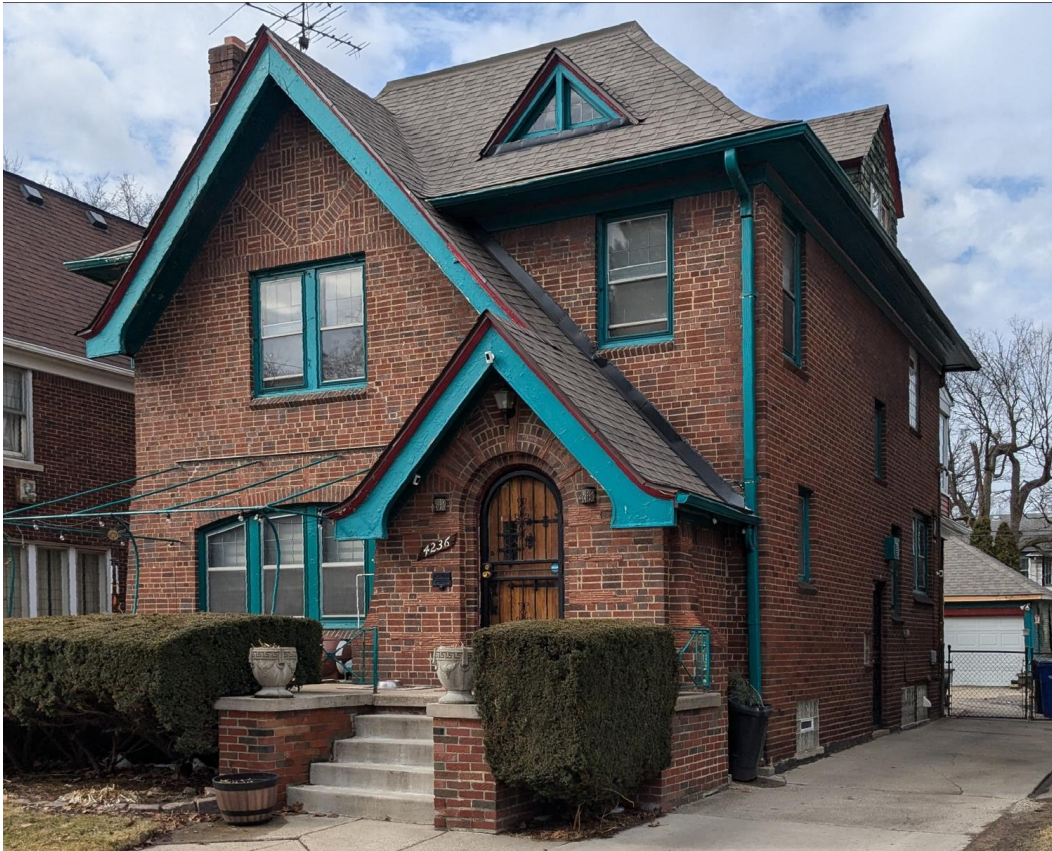
*February 2025 photo by staff.*

The house at 4236 Leslie is a two-story, red brick, Tudor Revival building built in 1926. Character-defining features include elaborate patterned brickwork, a projecting entry pavilion with brick buttresses and a recessed, arched entryway, prominent, flared vergeboards, original wood sash windows, and gable dormers.

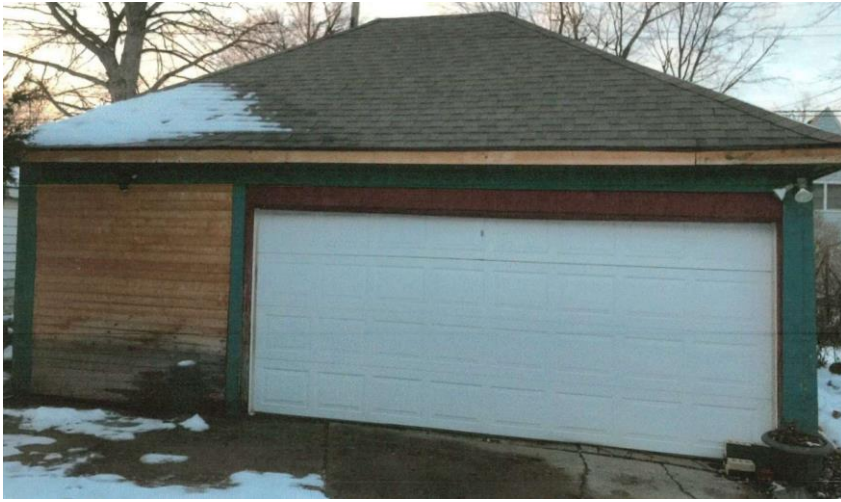
The two-car garage, also subject of this application, was built at an unknown date. It has been altered with a newer, segmental steel door and replacement wood clapboard siding and fascia.

It appears (see photos next page) that the blue-green paint and the garage door installation occurred sometime after 1999 without approval of the Historic District Commission. The property owner is encouraged to submit an application for this unapproved work.

*The garage. Undated photo from application materials.*

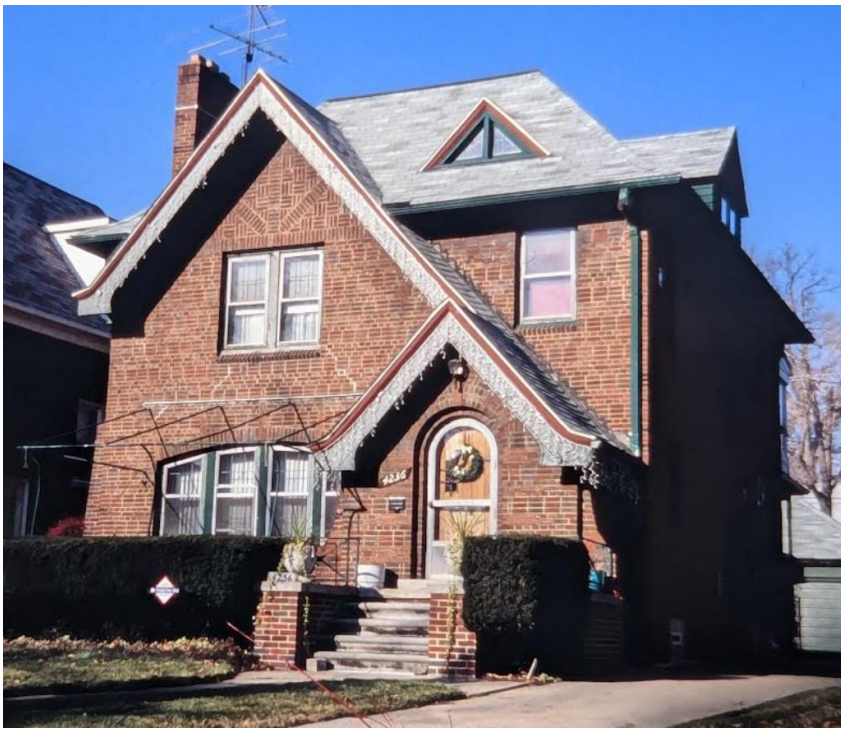
*1999 photo by the Historic Designation Advisory Board.*

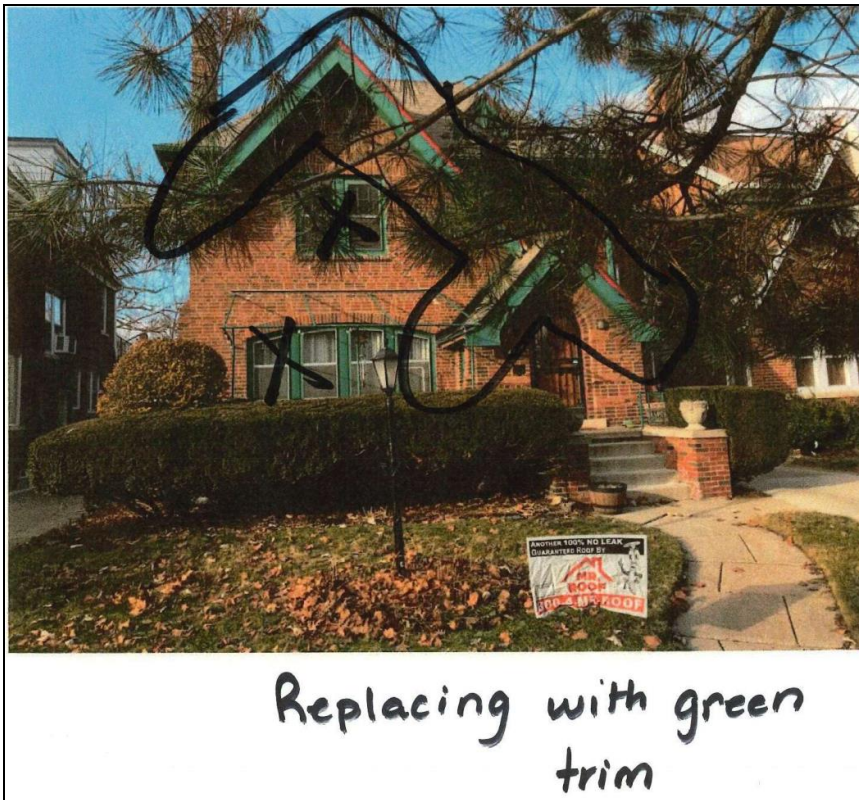
The soffits and fascia would be replaced on the front (south) and the east and west sides of the house. A sketch on page 5 of the application indicates that this would also include replacement of the historic vergeboards on the front of the house.

*Image from page 5 of the application.*

- The existing vergeboards are a highly distinctive feature that are particularly important to the character of the building. Removing these elements would greatly compromise the building’s historic appearance. Even if the vergeboards were substantially deteriorated, the Standards would require that they be replaced with new work of the same dimensions, design, and materials. (See Standard #5, quoted below.)

- The historic vergeboards are highly distinctive elements, important to the building's overall appearance and character. Their removal would eliminate a distinctive feature, contrary to Standard #5.

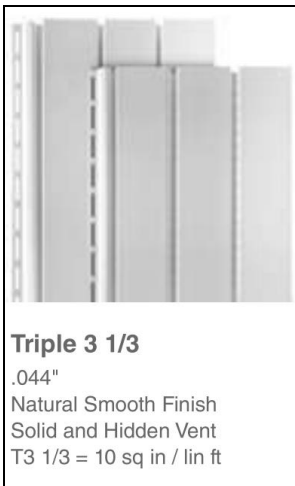
The new material would be Craneboard “solid core” siding, a vinyl material, in Lighthouse Red color, for soffits, and aluminum in Grecian Green color for other trim.

*Craneboard siding. Image from application documents.*

- Should any historic elements be demonstrated to be deteriorated to the point where repair is not feasible, Standard #6 requires that the replacement elements "match the old in design, color, texture, and other visual qualities and, where possible, materials." The proposed new products do not match in texture and materials (they are vinyl and aluminum, which have a noticeably different appearance than wood and wear differently), and often do not match in design (the orientation and reveal would be different on the soffit panels and dormer walls, and the dimensions of the historic vergeboards would not be duplicated by the new installation).

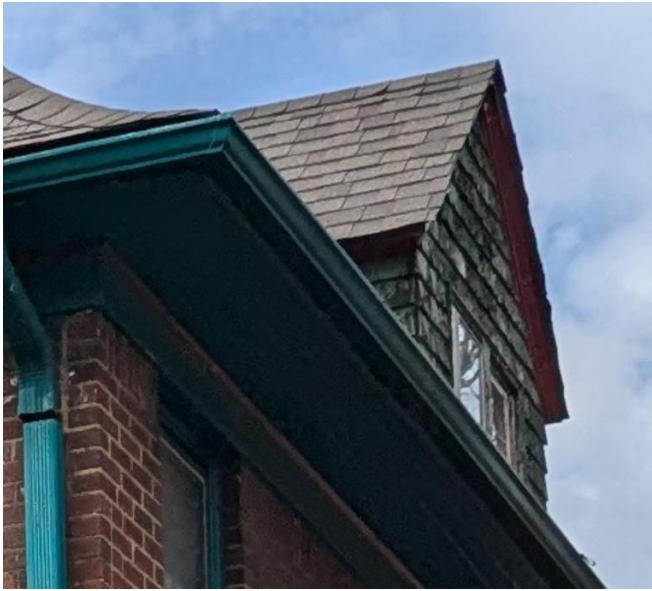
The dormer walls, presently clad in wood shingles, would also be replaced with Craneboard siding and aluminum trim, also in the same color scheme.

*Existing condition of dormer walls. February 2025 photo by staff.*

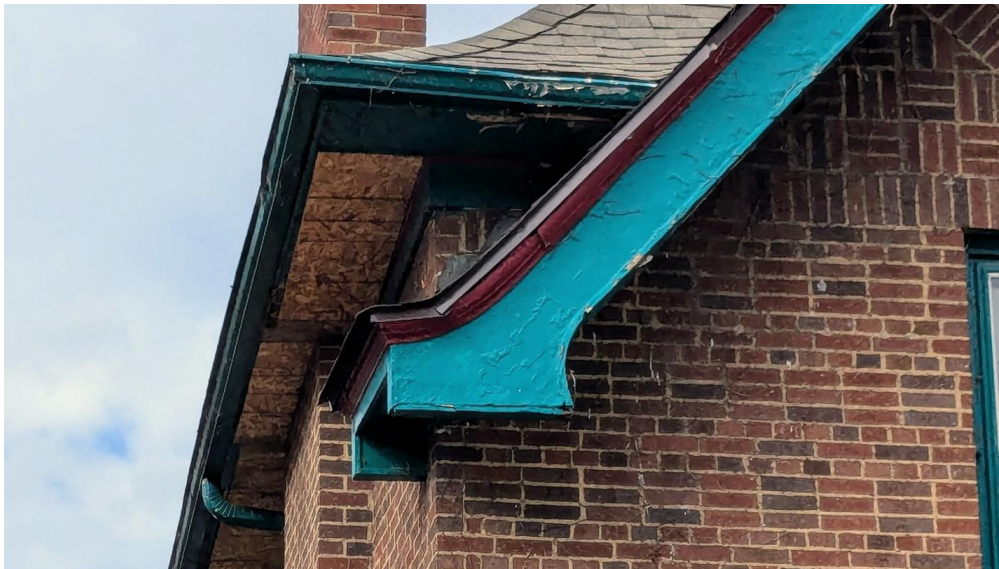
- From a staff site visit and available photos, noticeable deterioration was observed in only one location: an expanse of missing or damaged soffit board on the west side of the house. As mentioned above, the Standards would require that this be replaced with a wood tongue-and-groove material matching what was lost.

*Area of lost soffit material. February 2025 photo by staff.*
