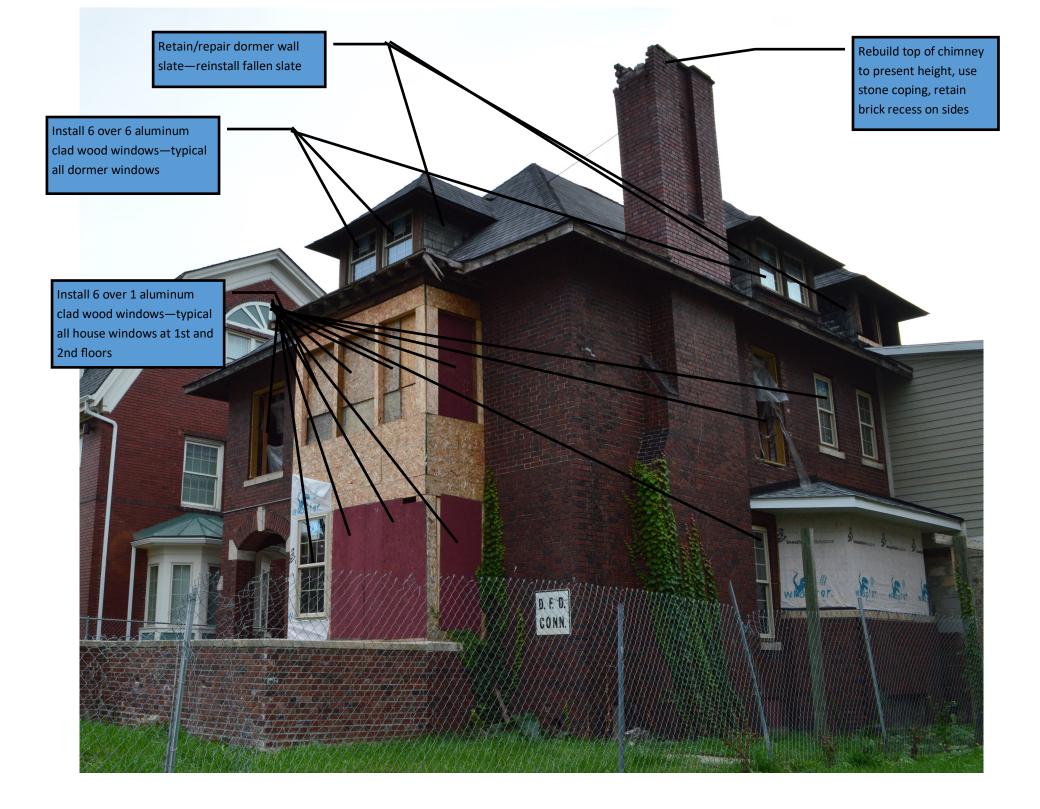
Retain/repair dormer wall Remove shed roof and recon-Install three 6 over 6 alumislate—reinstall fallen slate struction original shallow hip num clad wood window per roof configuration original configuration Install 6 over 6 aluminum Remove siding and restore or clad wood windows-typical recreate stucco wall surface all dormer windows with wood trim similar to tutor style houses Remove roof and restore flat roof without overhangs. Remove aluminum soffit and fascia—install tall fascia per original aptor Install 6 over 1 aluminum clad wood windows—typical all house windows

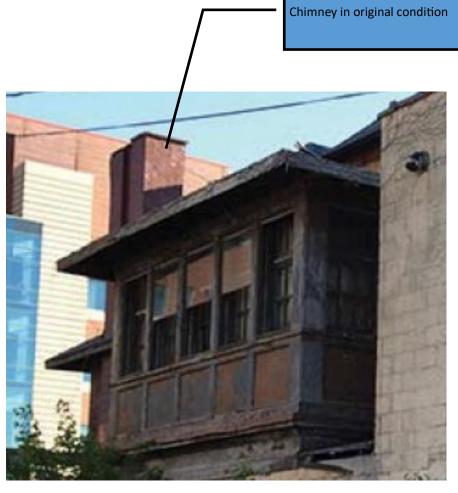
West side second story enclosed porch—original appearance
