3940 3RD STREET

REHABILITATION OF A COMMERCIAL
BUILDING

THE CITY OF DETROIT HISTORIC
DISTRICT COMMISSION HEARING

SEPTEMBER 14 , 2022

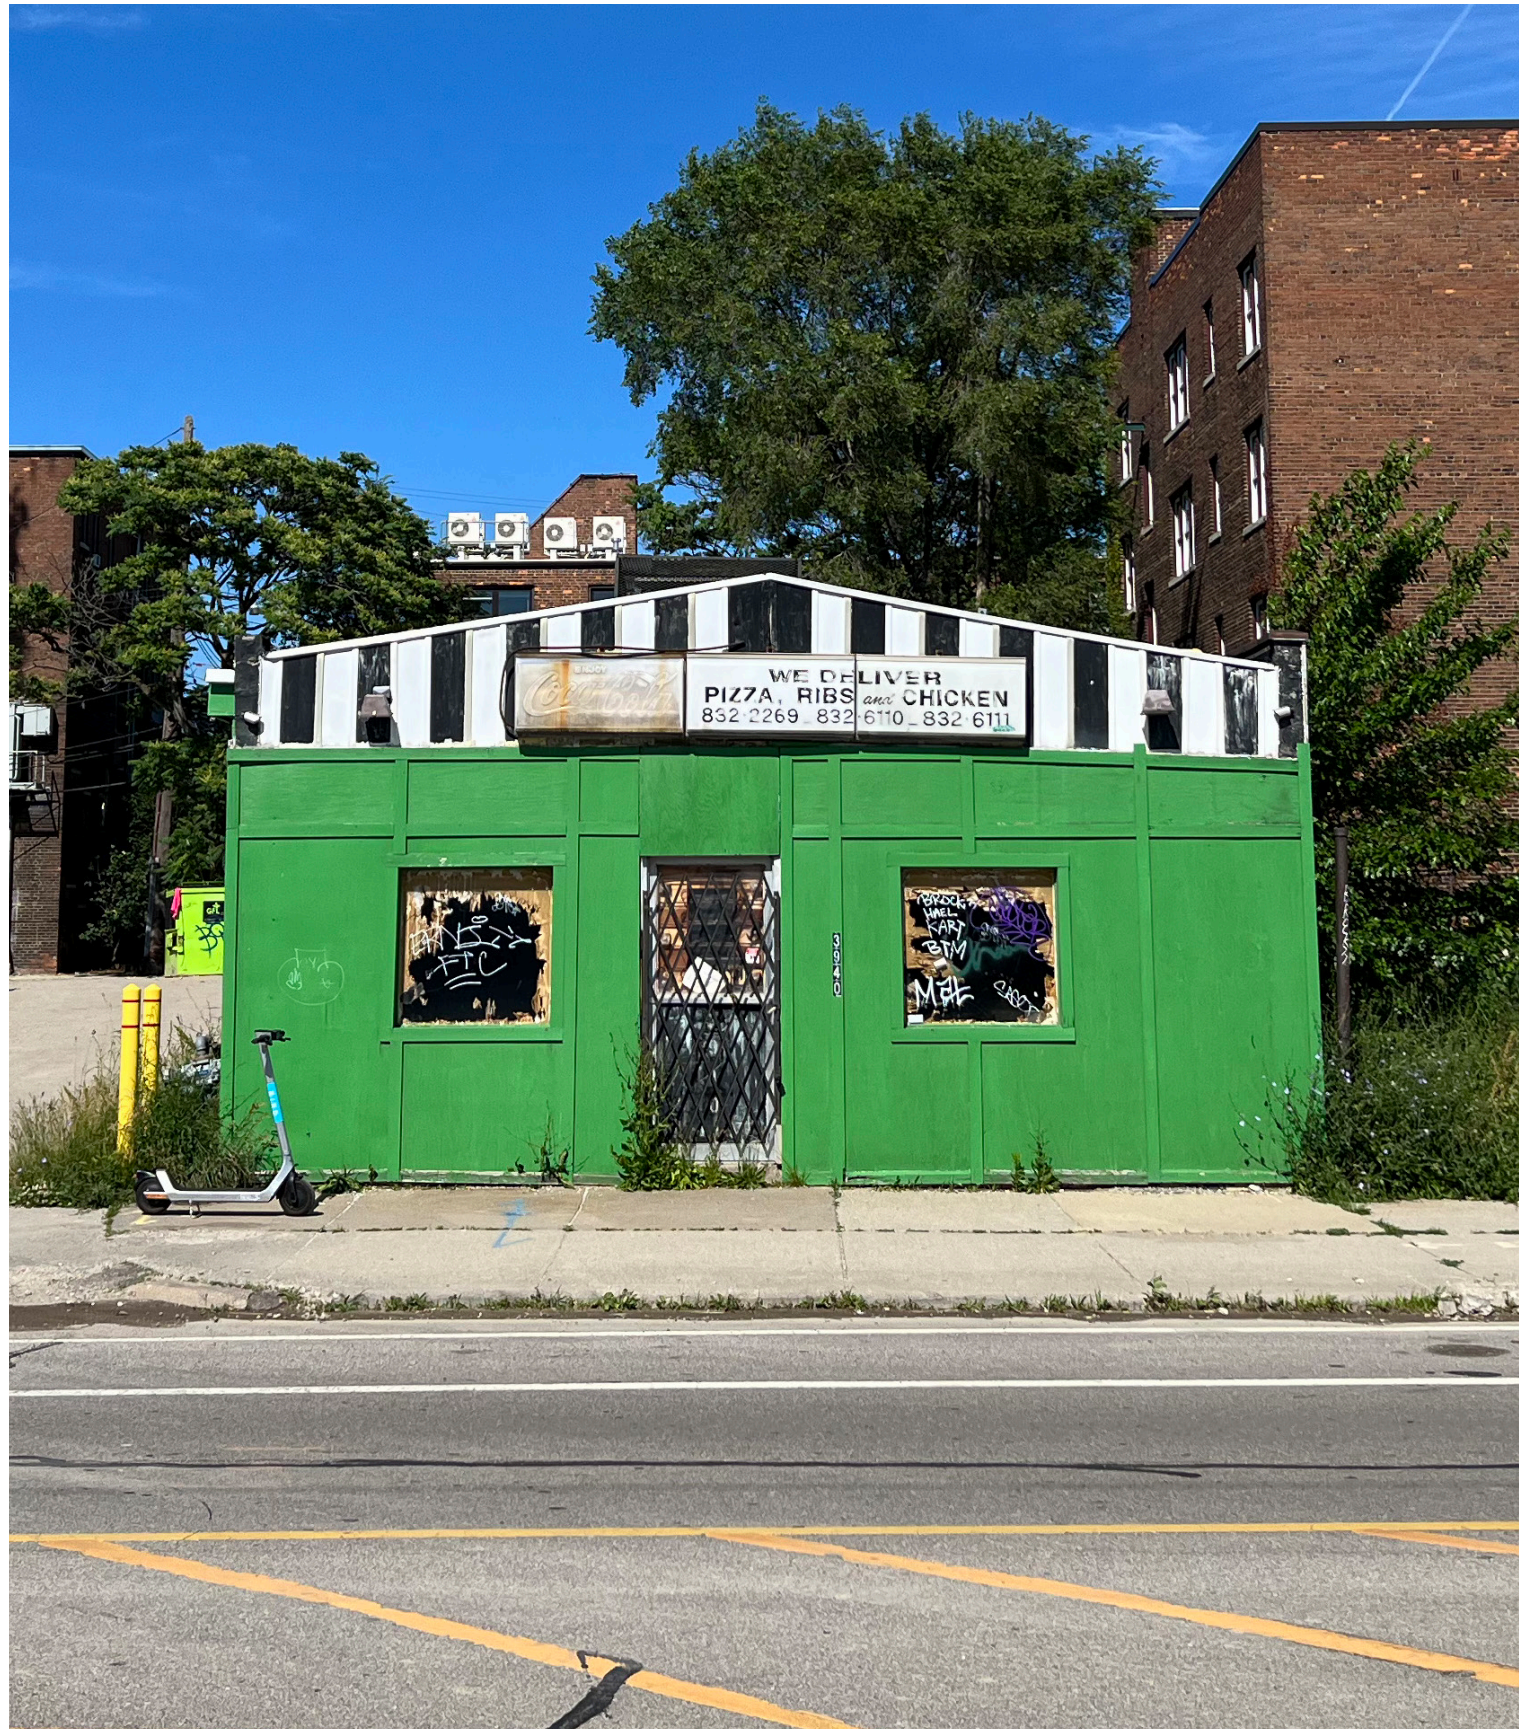
1

The building's facade currently consists of painted plywood panels with irregularly spaced, wood trim partially covering CMU walls. Parts of the wood trim and plywood panels are damaged. The plywood panels with wood trim are limited to the entire west and partially the north facades.

- 1. Front (West) facade
- 2. North facade
- 3. South facade
- 4. East facade

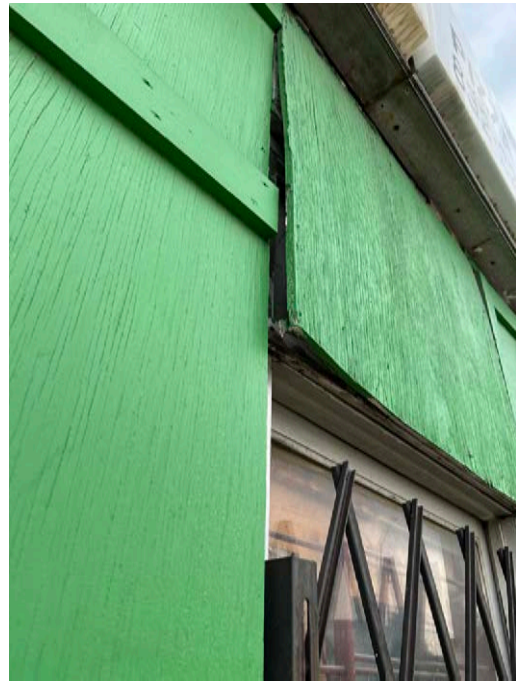
4

- 1. Front facade direct-set glass openings will be replaced with modern storefront system to improve thermal performance
- 3. Front entrance door will be replaced with modern aluminum storefront system
- 4. Damaged plywood above front entrance will be removed to reveal opening for storefront glazing above new door

The front entrance door will be replaced including it's transom window. The plywood above the current door will be removed to reveal the transom window above.

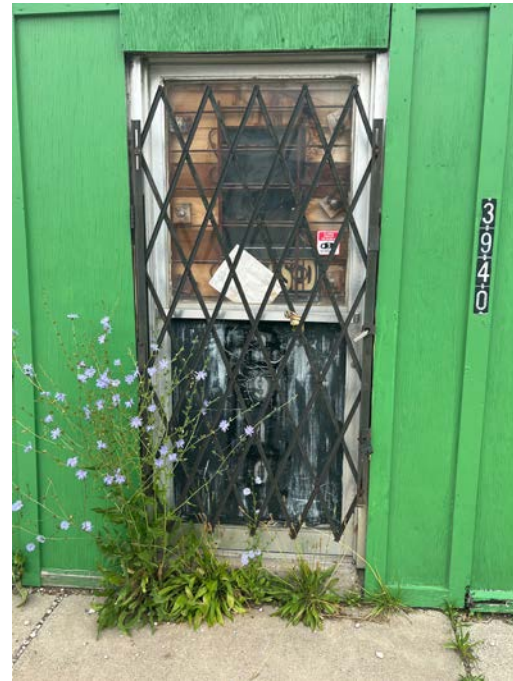
3

The front entrance door is damaged.

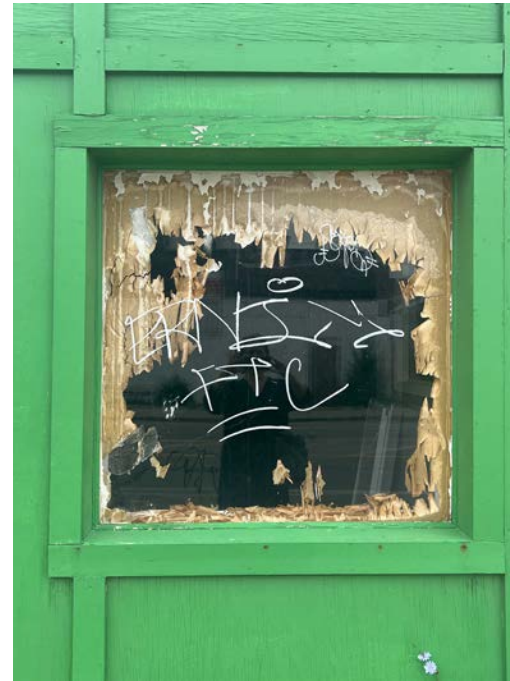
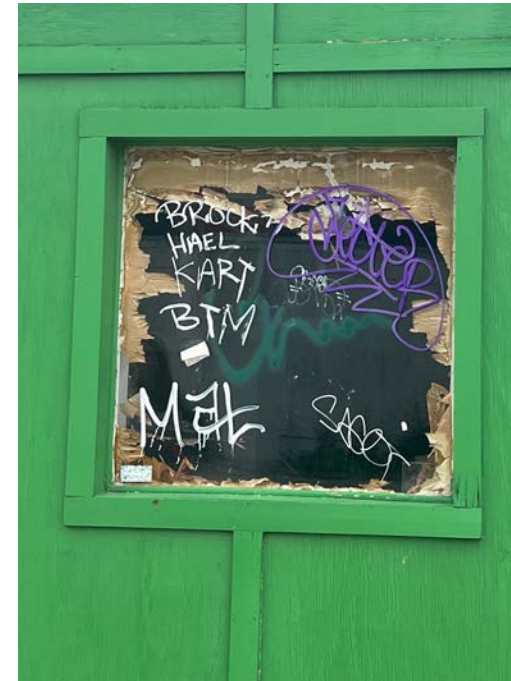
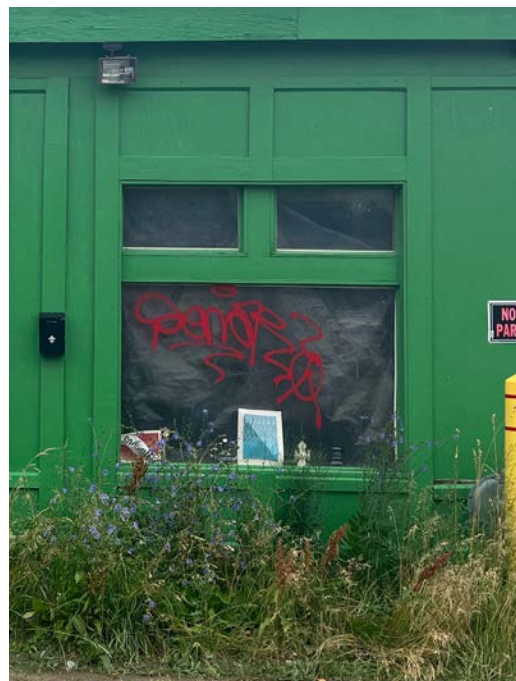
1

As part of a previous renovation, direct-set single-pane glass were installed instead of windows on the west and north facades.

The owner plans to replace the direct-set glass panes on the west facade with a more energy efficient aluminum storefront window system.

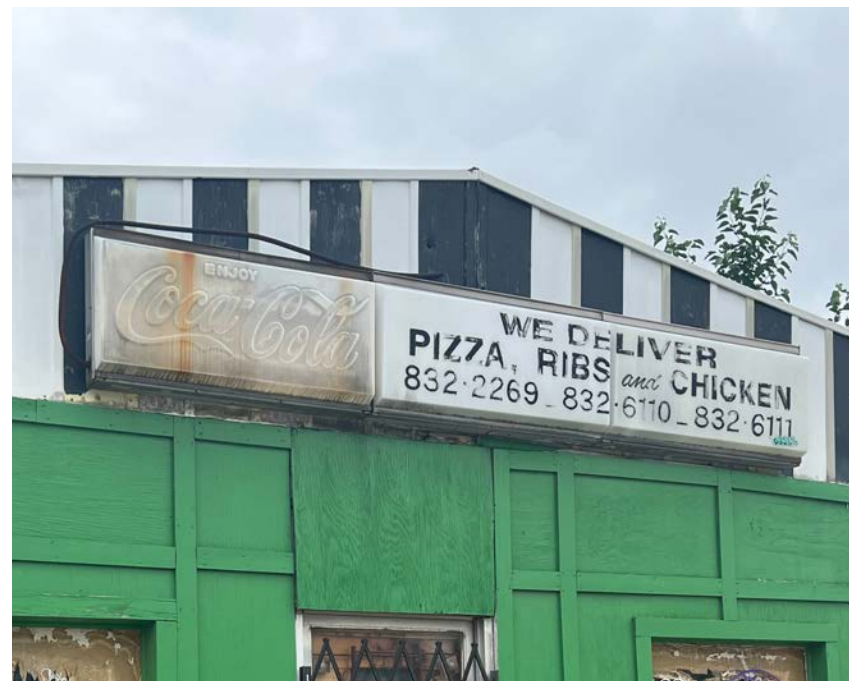
2

An illuminated sign [*Coca-Cola; We deliver Pizza, Ribs and Chicken*] from a previous business remains on the front facade in poor condition.

- 7. Damaged trim on north facade to be replaced
- 2. Signage above front entrance to be removed
- 1. North facade direct-set glass opening to be replaced with door storefront system

The previous business' signage will be removed.

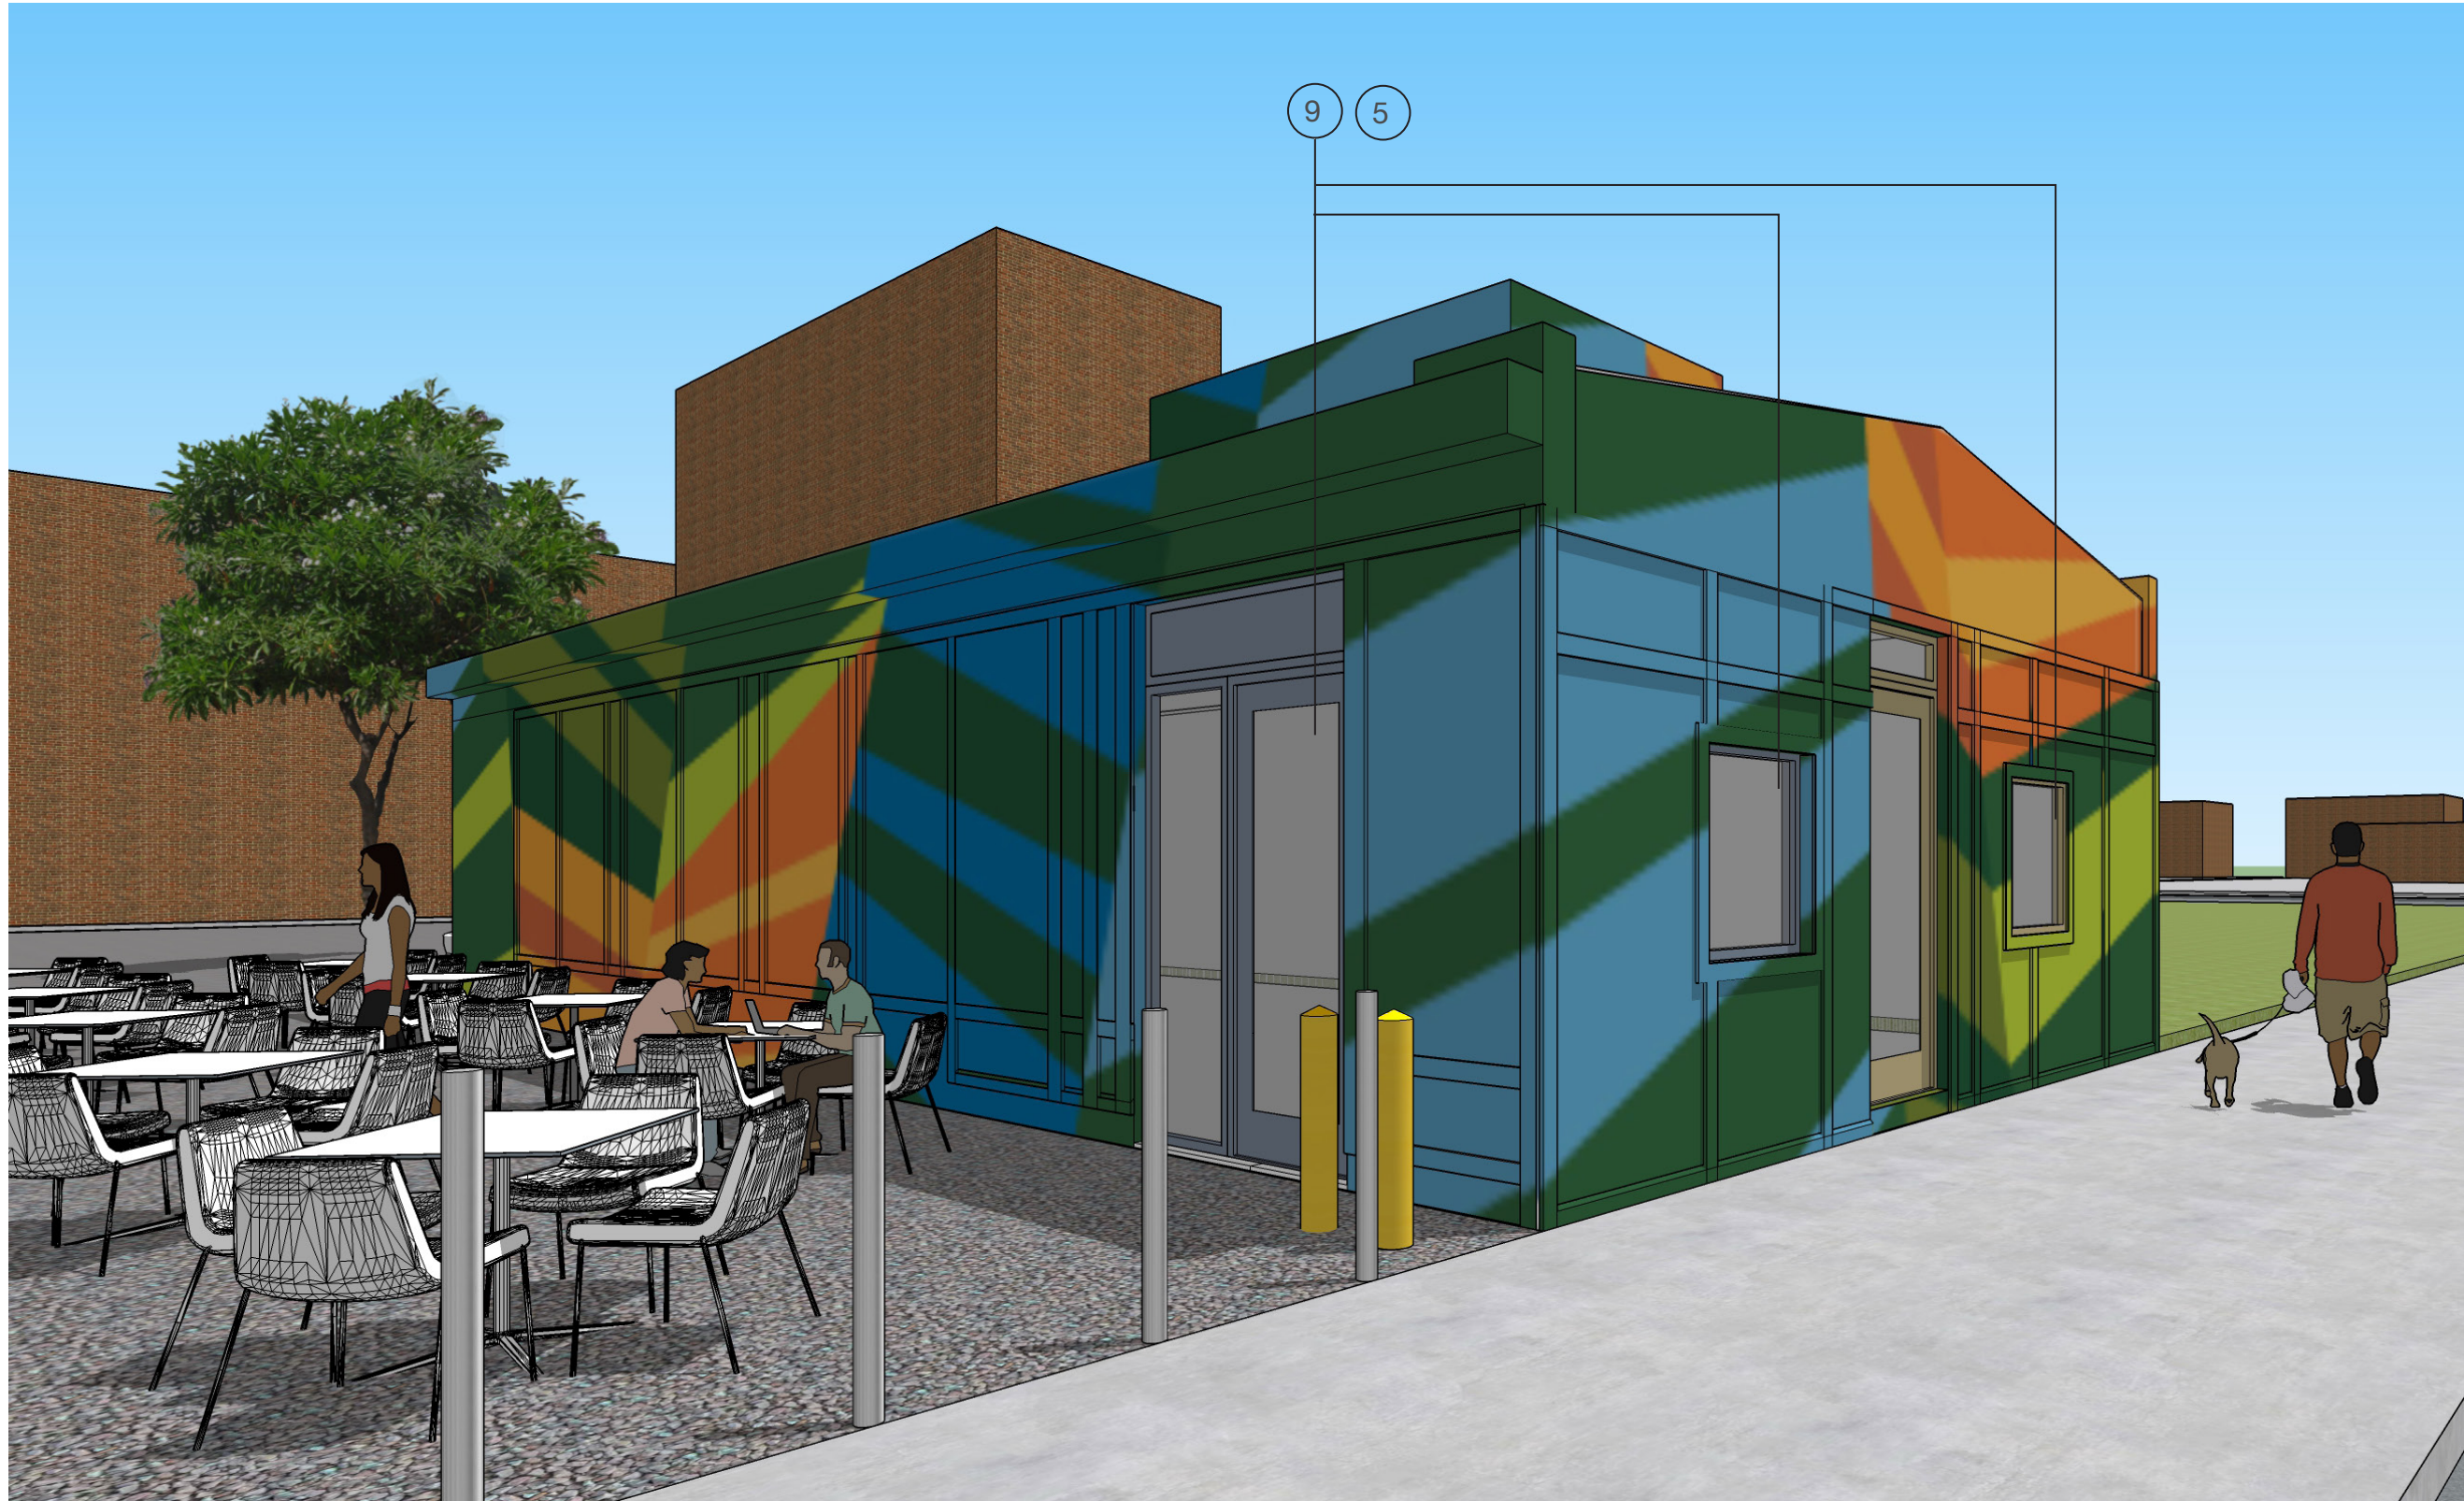
NORTH AND FRONT FACADE

To address the facade's appearance, the owner proposes repainting all facades with a mural. The mural's design is intended to add both friendly colors and excitement to the otherwise simple building.

Using large, bold patterning, the mural will use an applied perspective [Razzle Dazzle] to alter the building's perceived shape and disguise the facade's irregular material palette.
