NORTH ELEVATION
"FRONT"

691 W CANFIELD

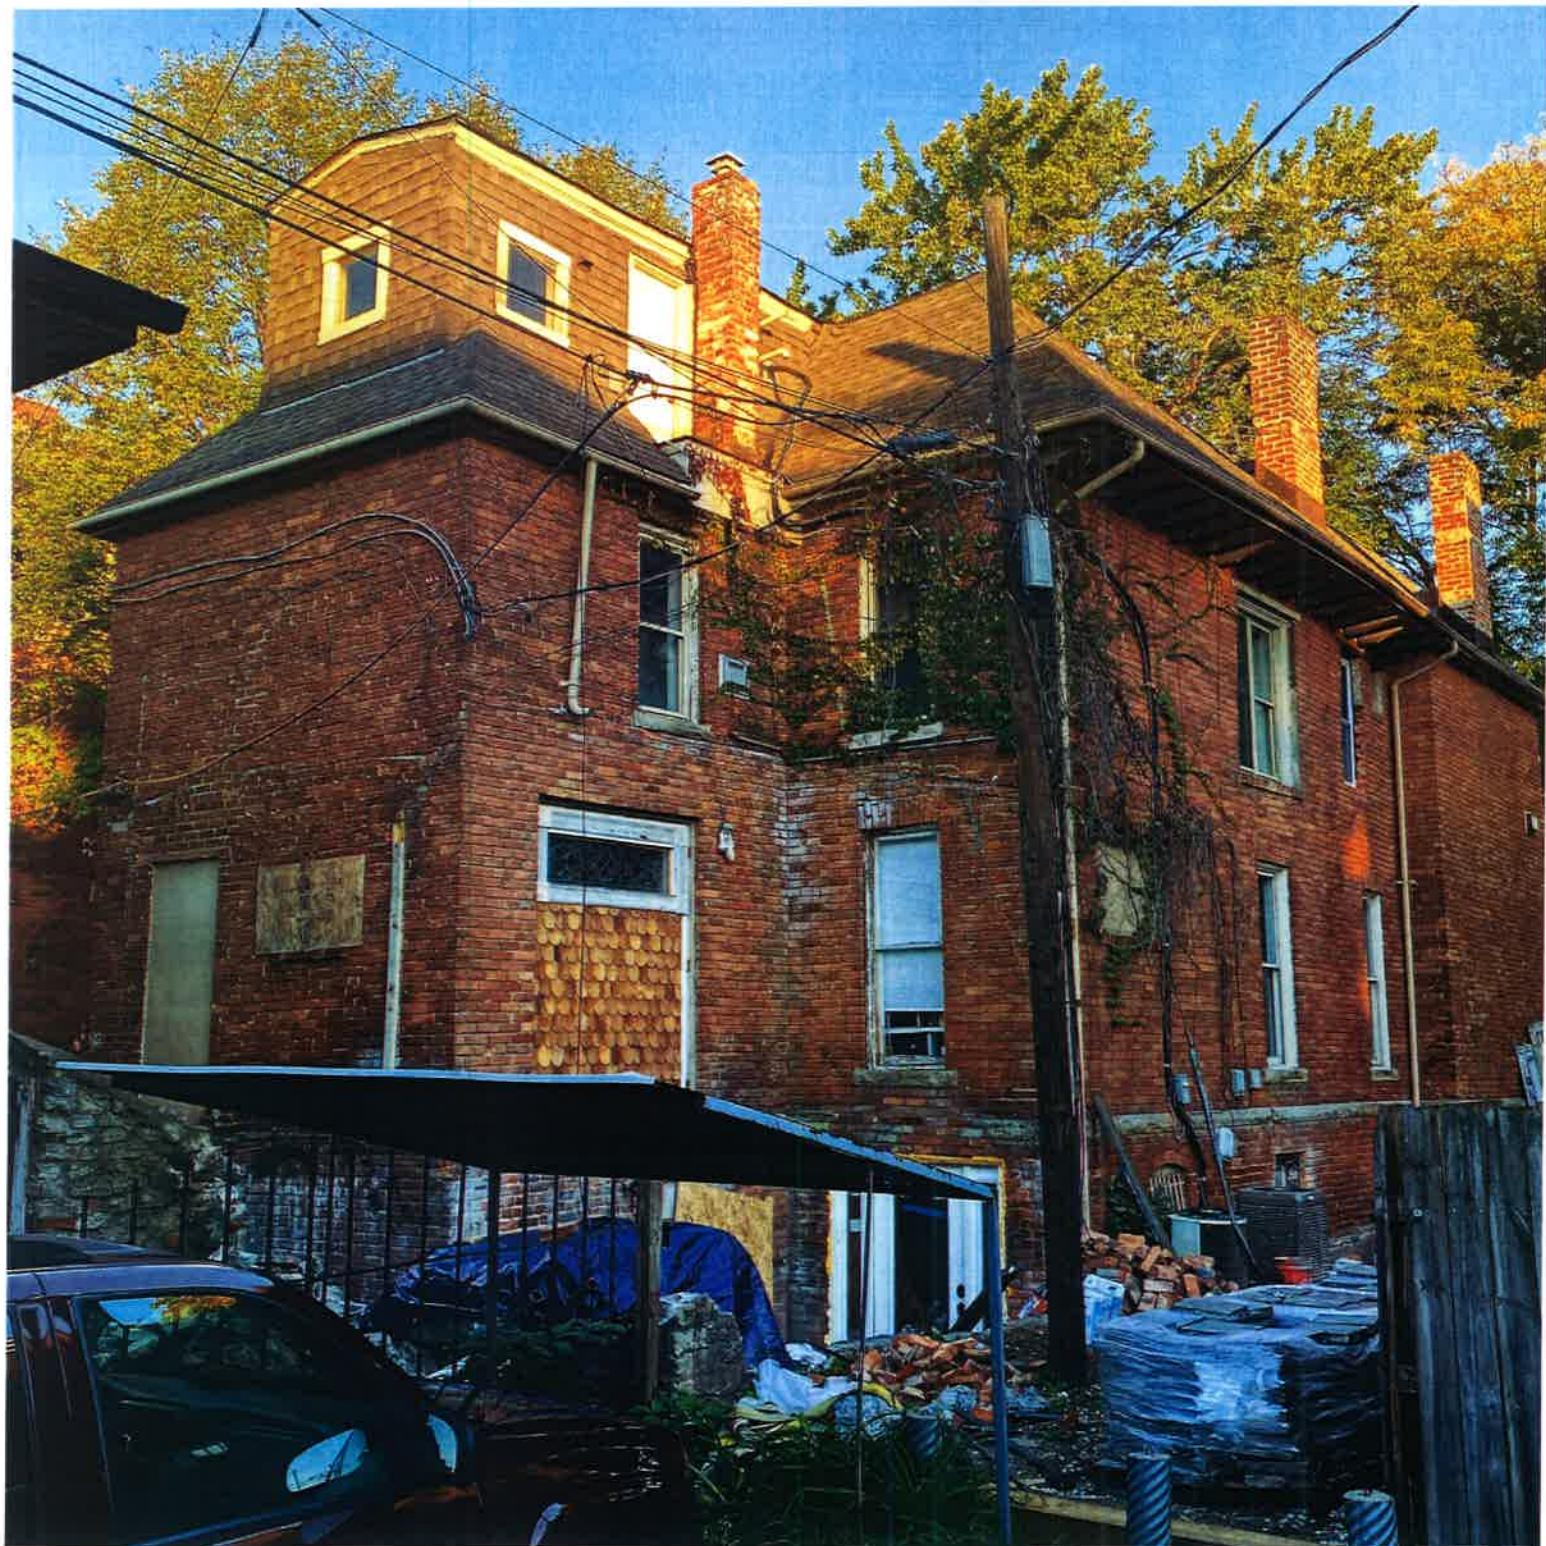
SOUTH ELEVATION
1 OF 3

EXISTING CONCRETE
STAIRS AND RUBBLE
STRUCTURE TO BE
STABILIZED AND REMAIN

REMOVE PLYWOOD AT
DOOR AND WINDOW.
INFILL WITH EXISTING
SALVAGED BRICK
FROM THE SITE

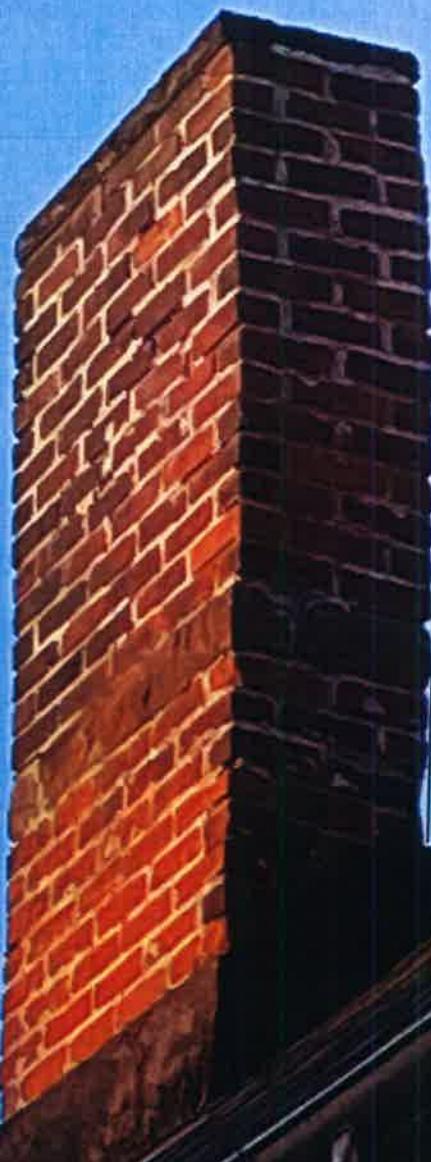
EAST ELEVATION
SECOND CHIMNEY
BACK

691 W CANFIELD
MASONRY CHIMNEY

INVESTIGATE STRUCTURAL
INTEGRITY OF LEANING
CHIMNEY. DETERMINE IF
CHIMNEY HAS CRACKED
AND REMOVE BRICK
DOWN TO STONE COLLAR,
OR INTRODUCE CHIMNEY
BRACE.

EXISTING BRICK FROM
HOUSE TO BE REUSED
IF REQUIRED
