**Element 7 - Relationship of materials.** A majority of buildings are faced with brick and feature stone or cast stone trim. Sash windows are historically wood but, in many cases, have been replaced with windows of modern materials. Stone is used for window sills on a majority of buildings within the district. While roofs within the district are generally flat and not visible, pitched roofs typically feature visible slate or asphalt shingles.

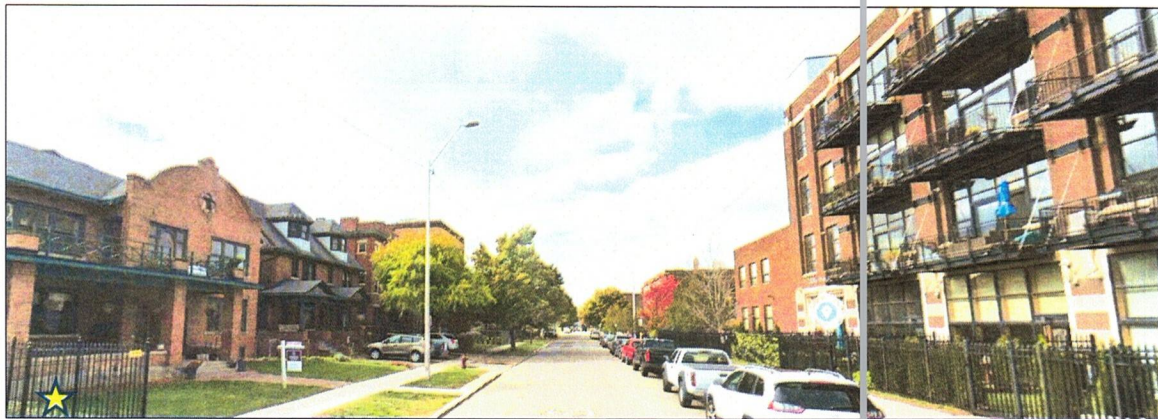
Streetscape view, looking west on W. Willis. Subject property is denoted by the metal fence at bottom left (★). There are two dominant wall materials for each building on this block: brick and stone.

Staff's concern is how the multiple cladding materials relate to the district as well as to each other. In contrast to the above streetscape photo, which shows two dominate wall materials and colors per building, the subject property has four wall materials and seven colors.

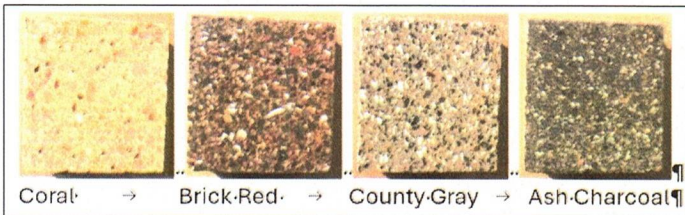
Above: Selected colors of CMU blocks, submitted by applicant and photographed by staff. Staff agrees the colors fall within the district's dominate colors.
