MINUTES**DETROIT HISTORIC DISTRICT COMMISSION REGULAR MEETING**

April 8, 2026

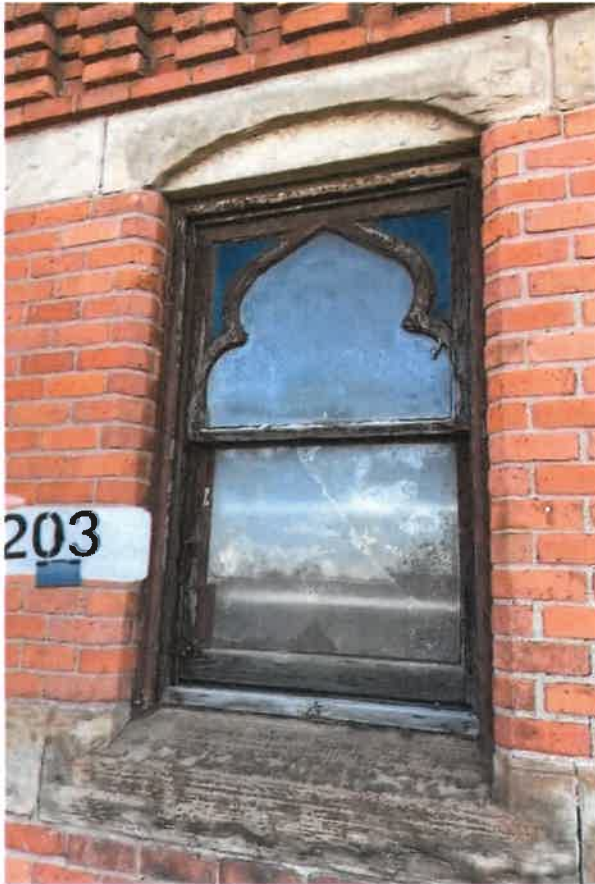
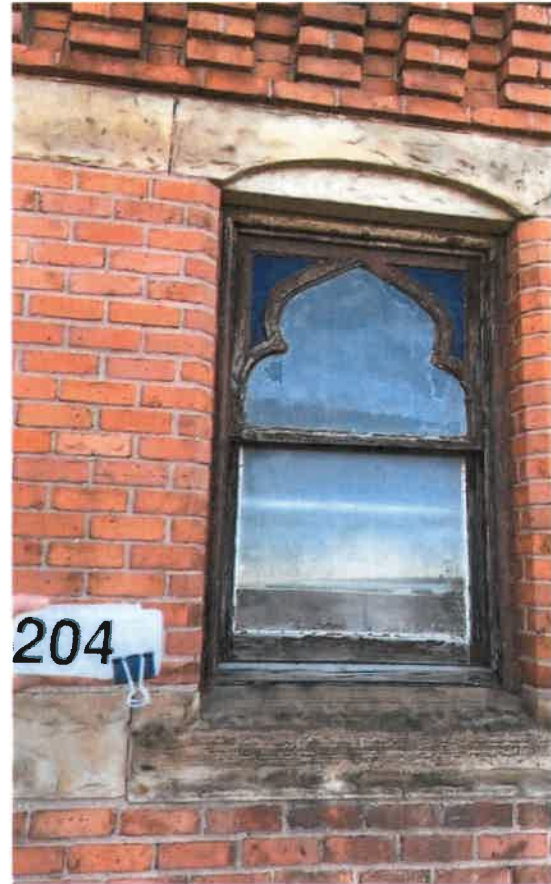
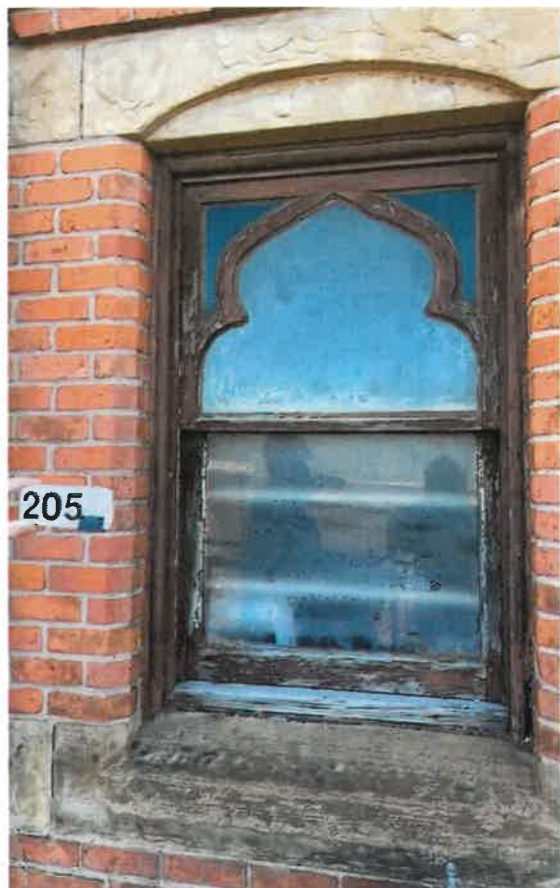
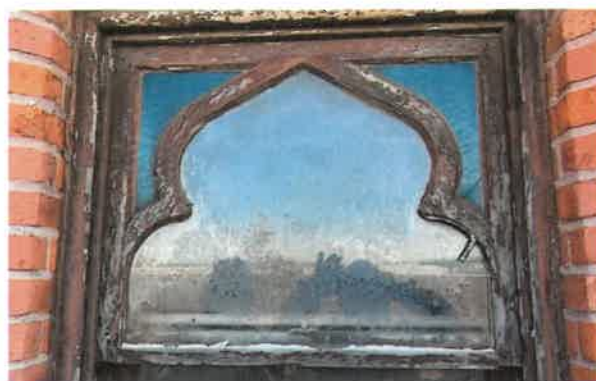
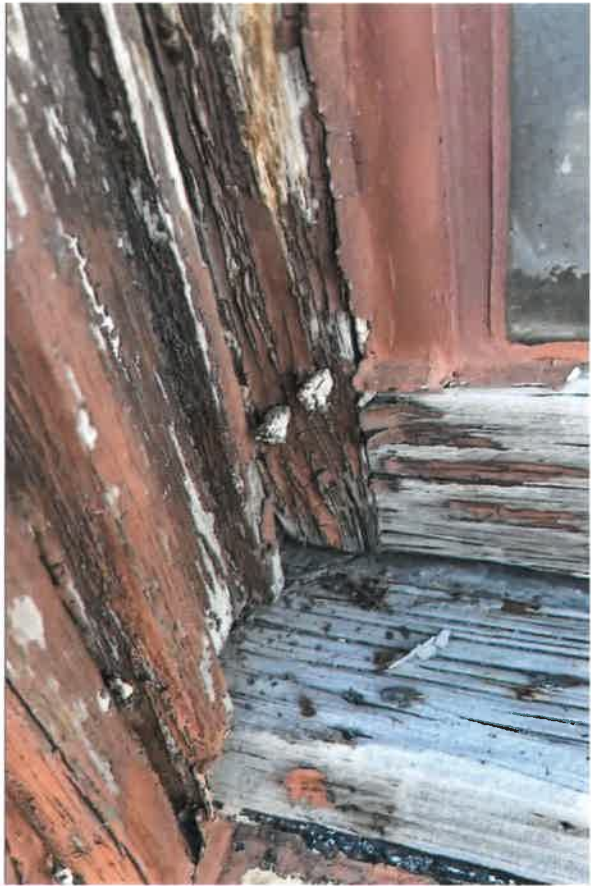
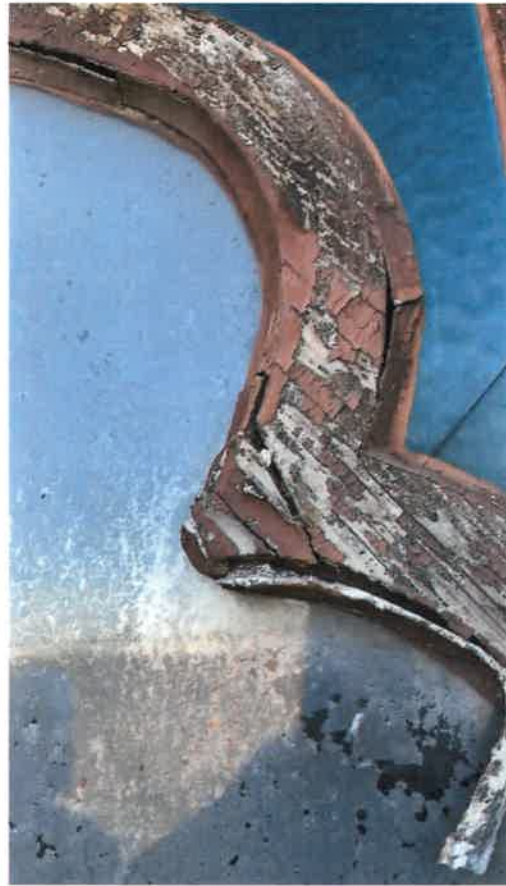
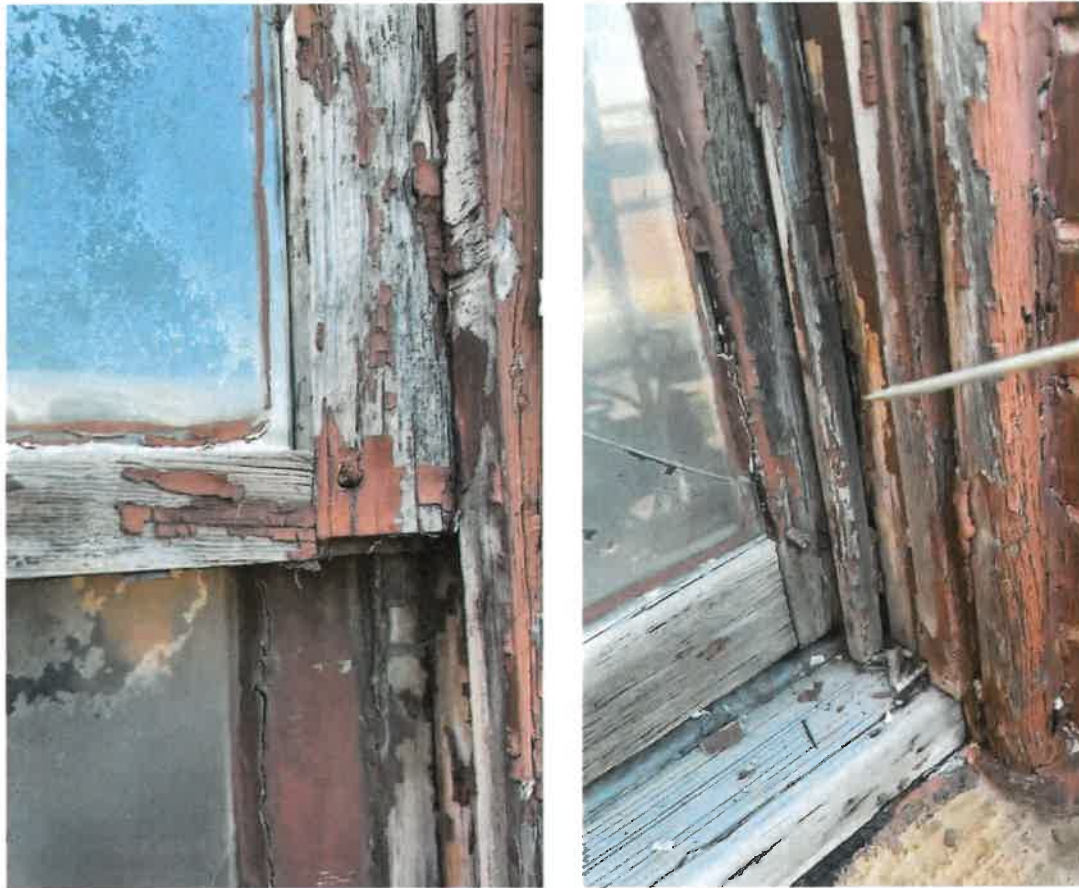
- Bottom 8" (both sides) split and rotted. Twisted from long-term moisture saturation. Dutchman repair unlikely to result in sound functional frame; likely to impede sash operation.
- Parting stops deeply checked, twisted and shrunk.
- Brickmold – bottom 8" deeply checked and split.

- Meeting rail ends deeply checked and rotted, show evidence of shrinkage at joints indicating breakdown of internal fiber structure.
- Side rails deeply checked and split at joints with meeting rail.
- Joints with side rails failed and vertically displaced.
- Tracery: Deeply checked and dried out. Extensive cracks parallel to grain. Shrunk away from frame on one side.

- Bottom 6" (both sides) split and rotted. Twisted from long-term moisture saturation. Dutchman repair unlikely to result in sound functional frame; likely to impede sash operation.
- Brickmold – bottom 8"-12" deeply checked and split.

- Meeting rail sagged in center; prevents proper locking. Ends checked and rotted. Checking extends to interior.
- Side rails deeply checked and split at joints with meeting rail.
- Joints with side rails failed and vertically displaced.
- Tracery: Deeply checked and dried out. Extensive cracks parallel to grain. Pieces missing. Ends shrunk away from side rails.

- Bottom 8" (both sides) split and rotted. Dutchman repair unlikely to result in sound functional frame; likely to impede sash operation.
- Parting stops deeply checked, twisted and shrunk.
- Brickmold – bottom 2"-8" deeply checked and split.

- Meeting rail ends deeply checked and rotted, show evidence of shrinkage at joints indicating breakdown of internal fiber structure. Sags at center.
- Side rails ends checked and split at joints with meeting rail.
- Joints with side rails failed and vertically displaced.
- Tracery: Deeply checked and dried out. Many cracks parallel to grain. Shrunk away from frame on both sides.

Windows 203, 204, and 205 are in very similar condition. The extent, depth and quantity of deterioration is such that the quantity of dutchman and epoxy repairs would be so numerous that they are not likely to result in a sound functional window unit, and not likely to withstand the test of time.

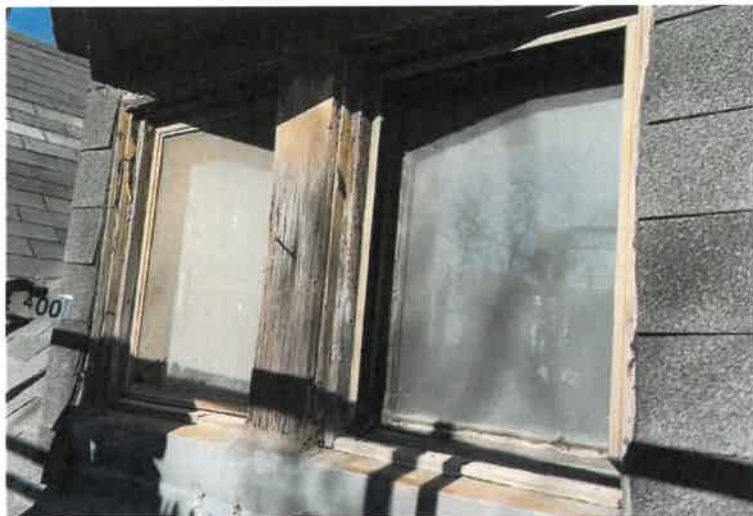
Sills have been repaired with inaccurately cut dutchmen that are nailed in place rather than glued.

There are large gaps around repairs. Also, shrinkage and water penetration around repairs is evident, and has resulted in additional rotting. Sills are checked, and deeply oxidized, and fibers are “fuzzy.”

Modern screens were added at some point, but provided little protection, and appear to trap wind-blown water behind frames. Screen fabric on 400B is missing.

Sashes have significant deterioration on glazing rabbets. Rotting and splitting has resulted in loss of materials. Ad hoc repairs have been made with sealants, which has exacerbated deterioration.

The overall condition of these windows and frames is poor. The depth and extent of deterioration would require replacement of so many components, that little of the original window would remain.

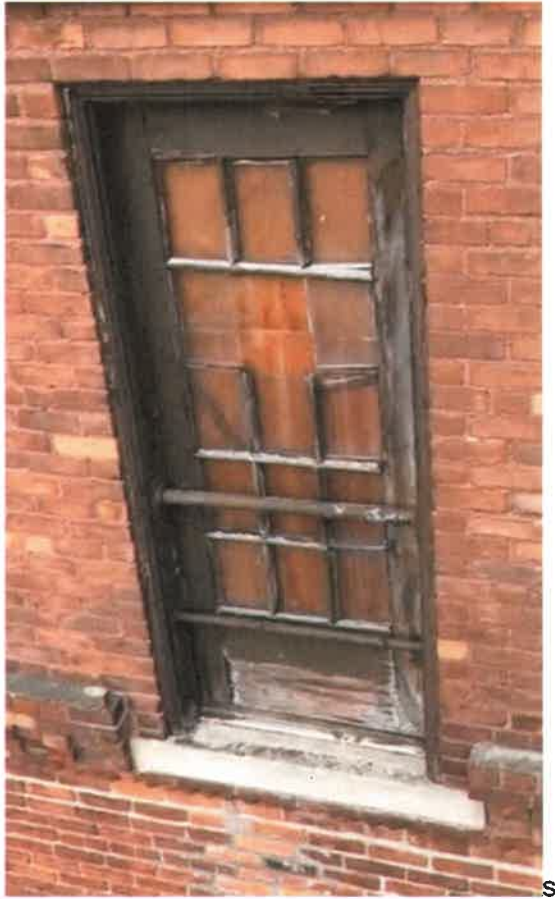
11. Revised plan for the Wellness Center's Door 300.

This door, which exists at the rear elevation, third floor, is no longer in use. It's condition as observed at the exterior is in extensive disrepair. The depth and extent of deterioration would require replacement of so many components, that little of the existing door would remain. As a concern for maintenance and safety, and since this door is not used or accessible from the interior, we propose to provide a recessed masonry infill (4" rusticated face stone w/ CMU backup); integrity and visual reading of original M.O. will be maintained.

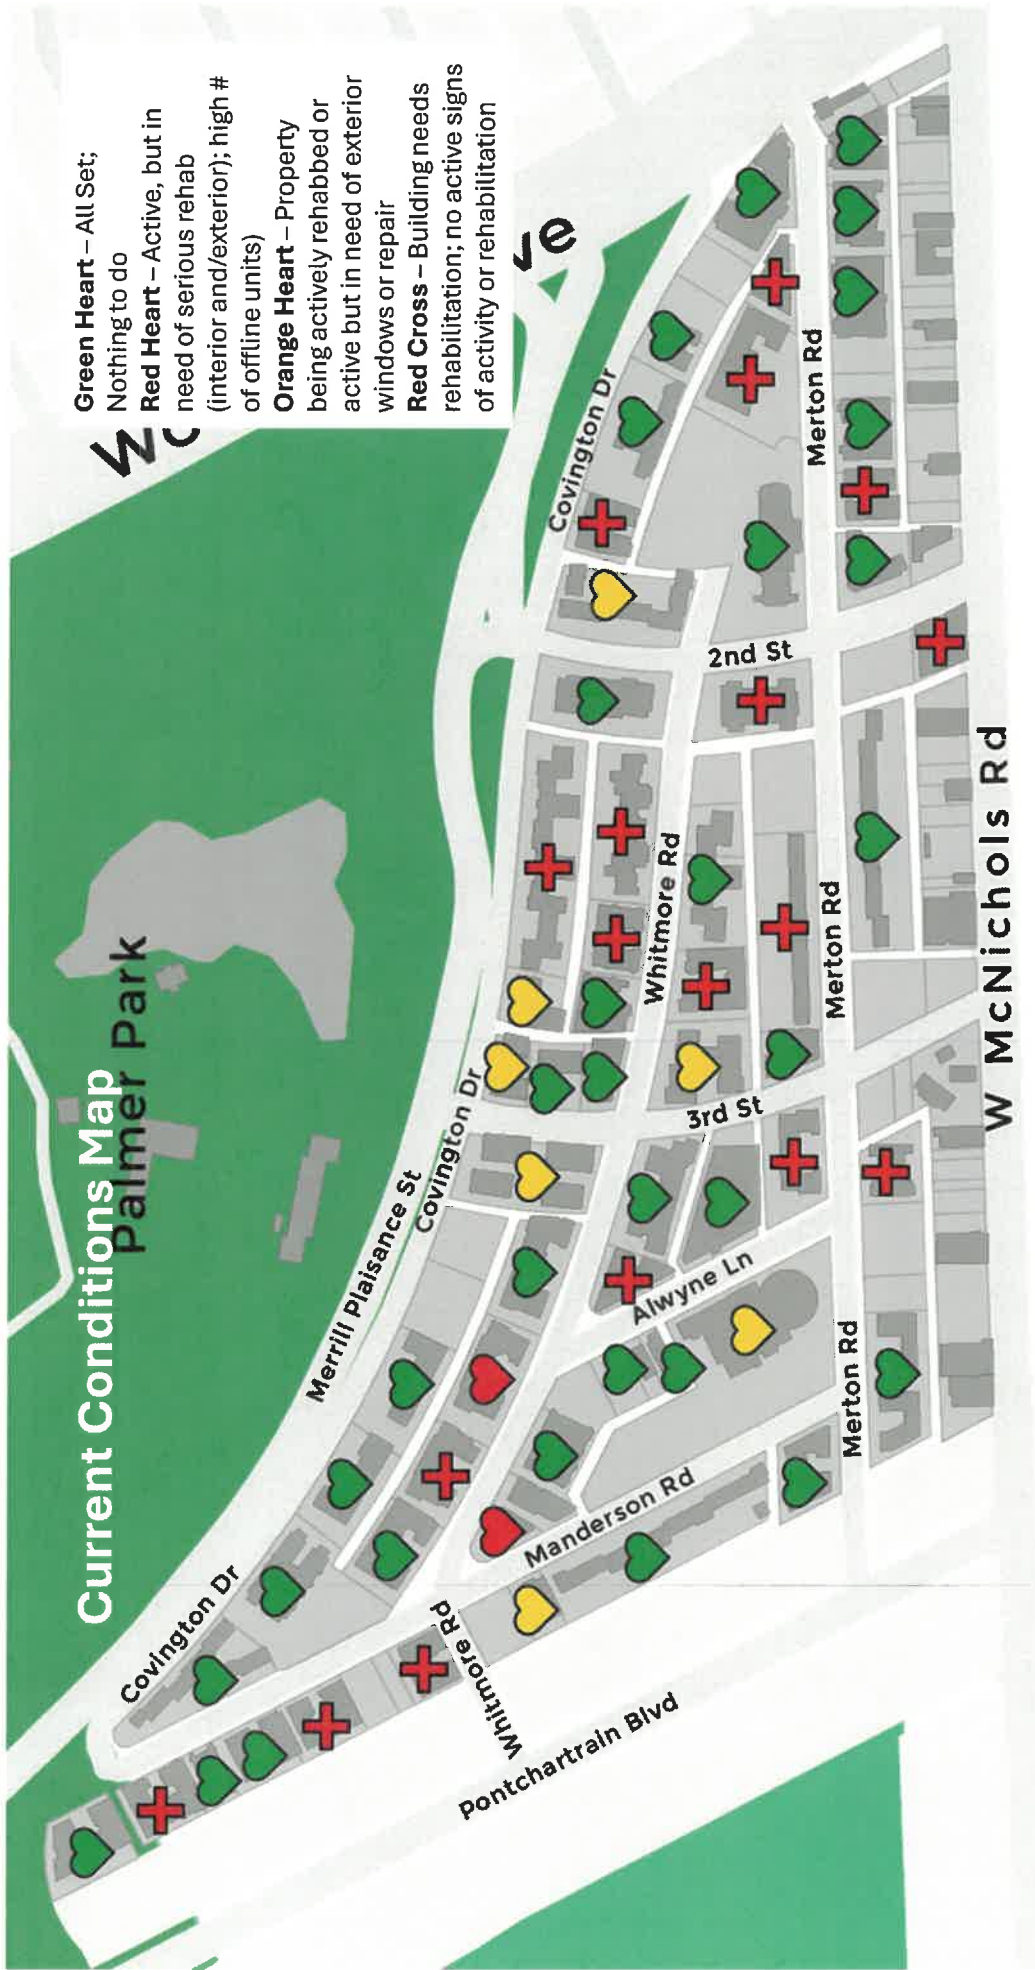
Current Conditions Map Palmer Park

- Green Heart** – All Set; Nothing to do
- Red Heart** – Active, but in need of serious rehab (interior and/exterior); high # of offline units)
- Orange Heart** – Property being actively rehabbed or active but in need of exterior windows or repair
- Red Cross** – Building needs rehabilitation; no active signs of activity or rehabilitation
