STAFF REPORT: 7/13/2022 MEETING

ADDRESS: 2151 SEMINOLE

APPLICATION NO: #22-7907

SCOPE: REBABILITATE GARAGE, INSTALL REAR YARD WALK AND PATIO, AND ERECT TRASH ENCLOSURE

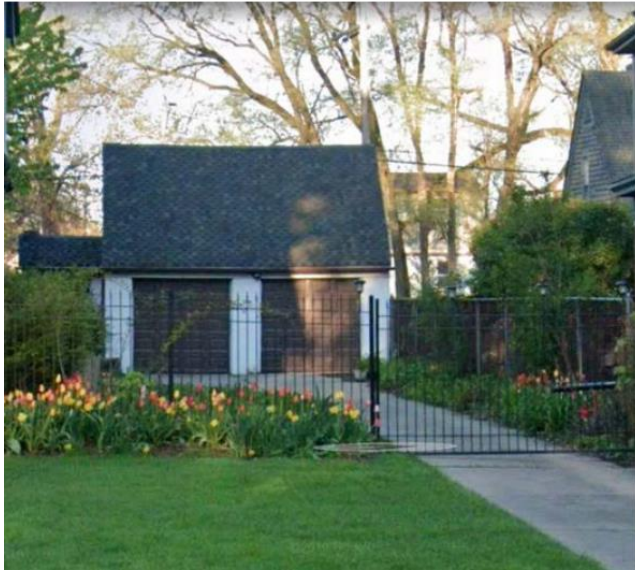
Garage, front elevation, facing Seminole, applicant photo

- The doors at the garage's front elevation are not of historic age. It is staff's opinion that the new doors are compatible with the garage's historic appearance

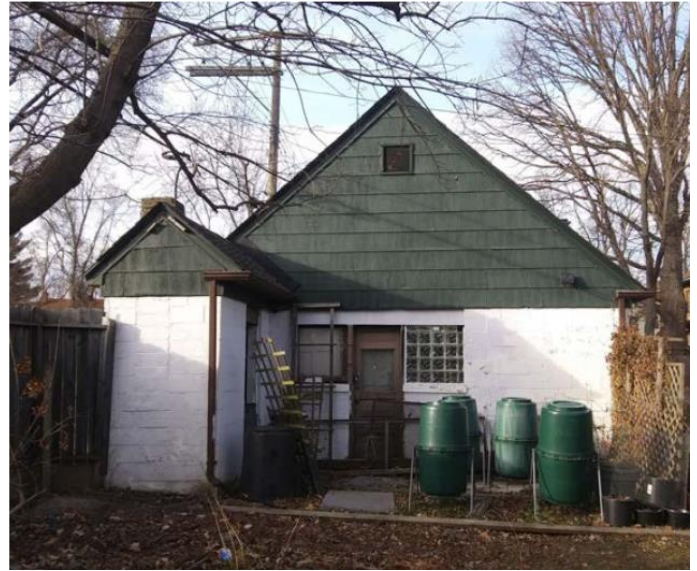
Garage, south elevation, applicant photo

- The windows proposed for replacement at the side elevation are of historic age. Also, the doors and windows at this elevation are not visible from the public right of way

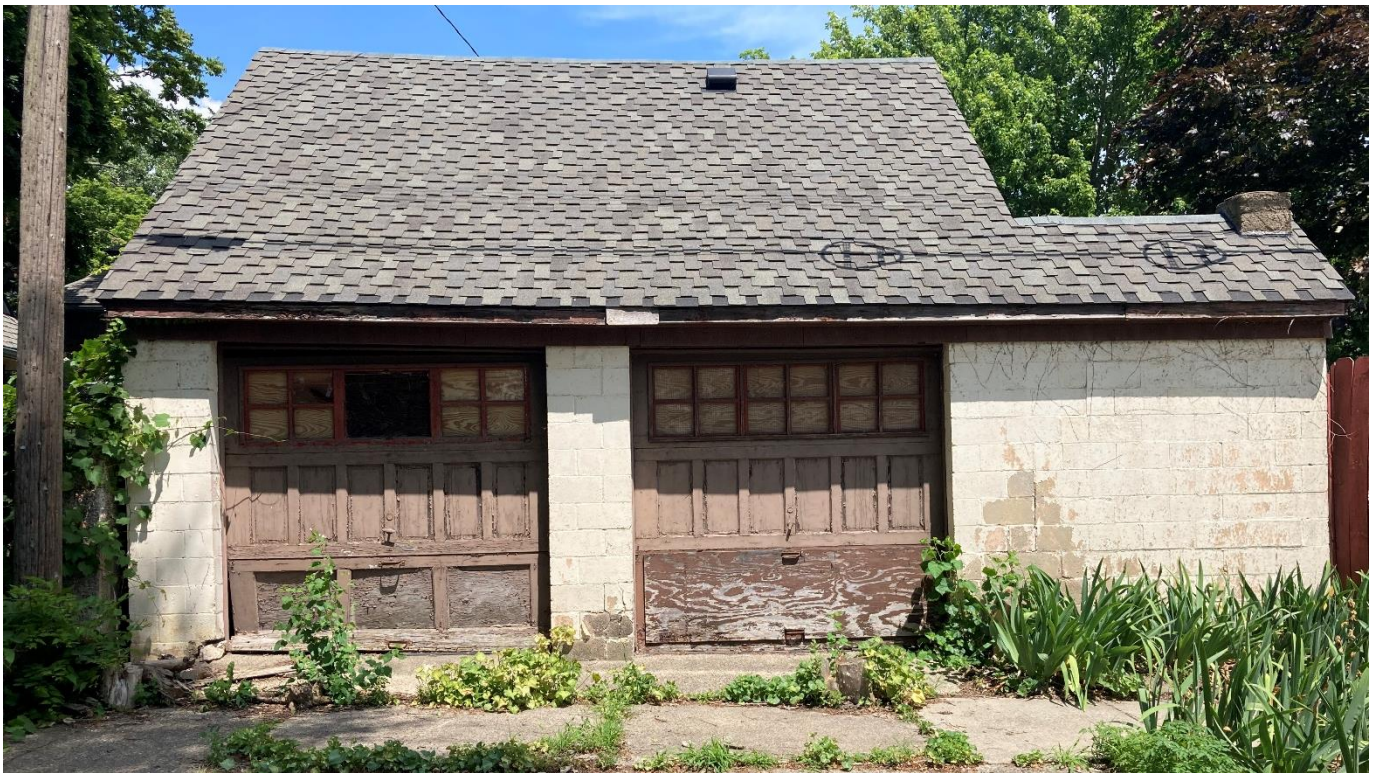
2151 Seminole garage, rear elevation (facing Maxwell), 7/2/2022 staff photo

- The garage doors which are located at the building's rear/west elevation are likely date to the building's original construction. It is staff's opinion that the doors are distinctive character-defining elements of the building. Staff visited the building and observed the doors' current condition. While deteriorated, especially at the bottom panel at each door, the doors do not appear to be beyond repair. The removal of the doors therefore does not meet the Secretary of the Interior's Standard #6, which prioritizes repair over replacement. Staff did request that the applicant share photos of the doors from the interior so that the full condition of the doors might be discerned, but the applicant has yet to provide the requested photos

HDC staff recommends that the Commission issue a *Denial* for the proposed removal and replacement of the west elevation garage doors because the work does not conform to the district's Elements of Design nor does it meet the Secretary of the Interior's Standards, in particular Standards #:

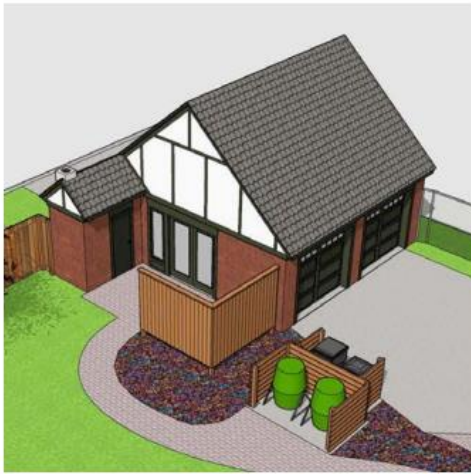
PROPOSED VIEW FROM SOUTHEAST

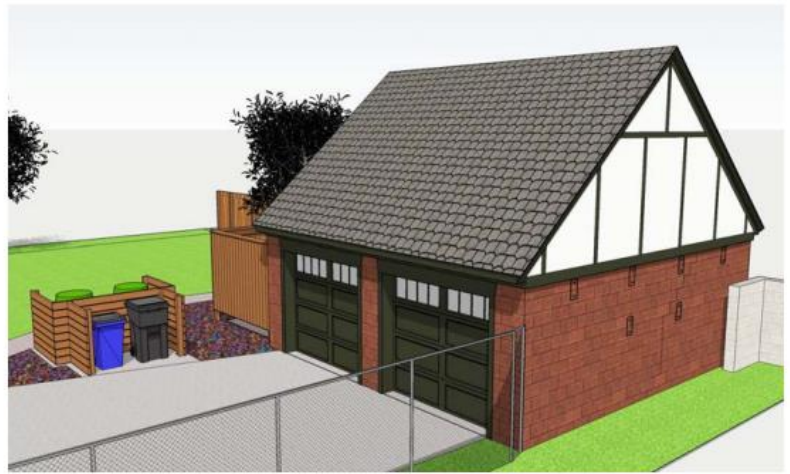
PROPOSED VIEW FROM NORTHEAST

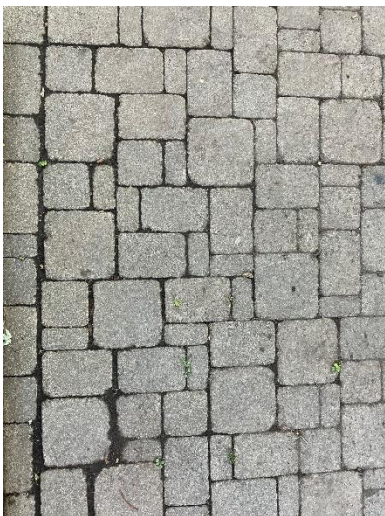
Pavers proposed for new walkways and patio
