STAFF REPORT: 10/12/22 REGULAR MEETING

APPLICATION NUMBER: 22-8050

ADDRESS: 19471 SHREWSBURY

SCOPE: INSTALL SECURITY DOORS, REPLACE PATIO DOORS

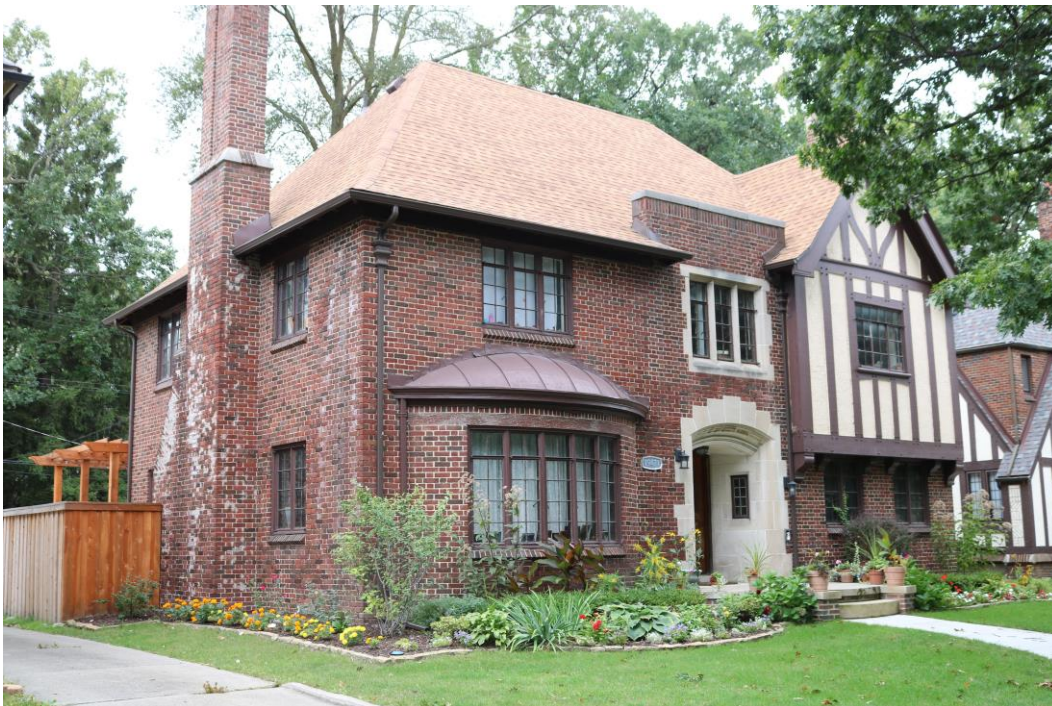
19471 Shrewsbury is a two-story, Tudor Revival (sometimes called English Revival) house in the Sherwood Forest Historic District, facing northeast onto a curvilinear street. Its Romantic design elements such as decorative half-timbering, tabbed stone surrounds, English bond brickwork, and mullioned windows, further subdivided by muntins, are defining features characteristic of the building and commonly found on buildings throughout the district. The front door, one of the work areas subject to this application, is a heavy, wood, arched panel door recessed within an arched stone opening. Other work areas include a side (northwest) door, and two rear patio doors that each consist of interior steel doors covered by exterior wood storm doors.

September 2022 photo by staff.

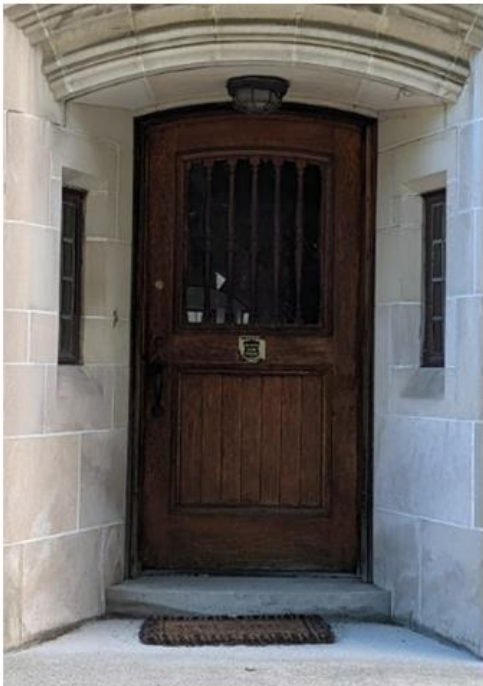
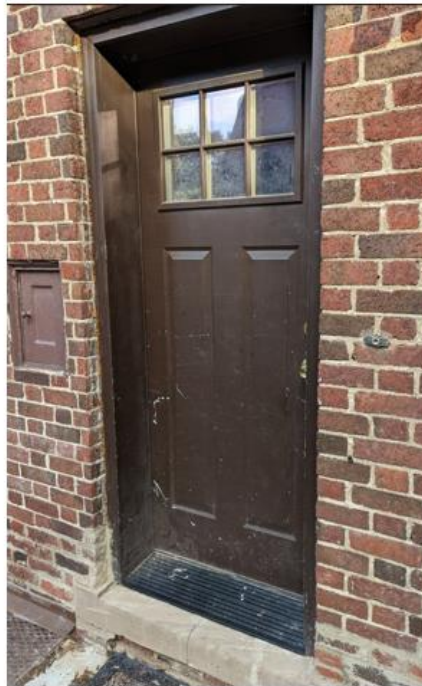
New security doors are proposed to be added to the front and side (northeast and northwest) door openings. These

are to be steel security doors produced by Duraweld Doors. They are proposed to be hunter green, which the applicant believes to be the original sash and door paint color, as evidenced by the garage sashes and patio doors.

Front door (left) and side door (right). Photos by applicant.

- The color of the security door should not exactly match the sash color. It should be “differentiated” (Standard #9) to avoid creating a “false sense of historical development” (Standard #3). A dark brown or black color would reduce the door’s visibility and avoid distracting from the historic wood door and stone surround (Standard #2).
- The diamond pattern on the proposed security door introduces an incompatible visual element which distracts from the architectural character of the doorway and opening (Standards #2 and #9). A design without this element would be appropriate.

- The security doors shall be black, or another appropriate color subject to approval by staff.
- The design of the security doors shall eliminate the proposed central diamond pattern, subject to approval by staff.

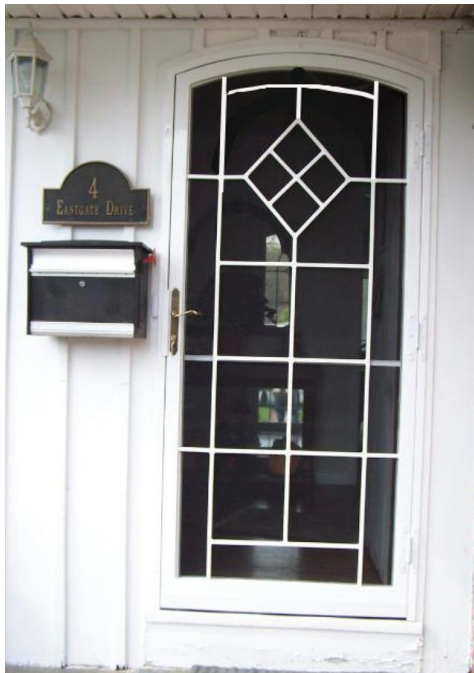
Proposed security door by Duraweld (shown on different property). Image by applicant.

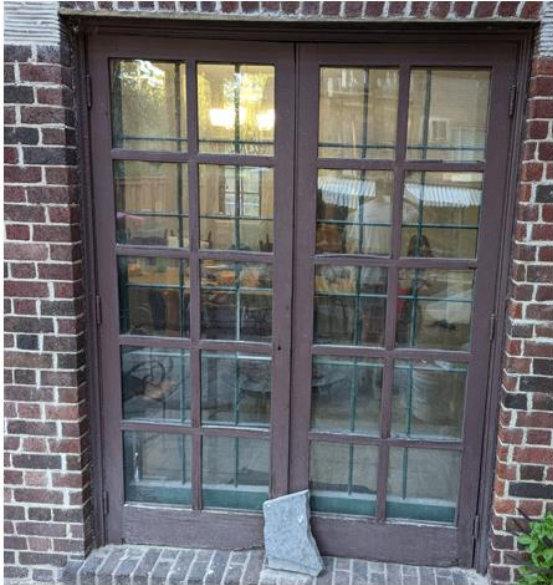
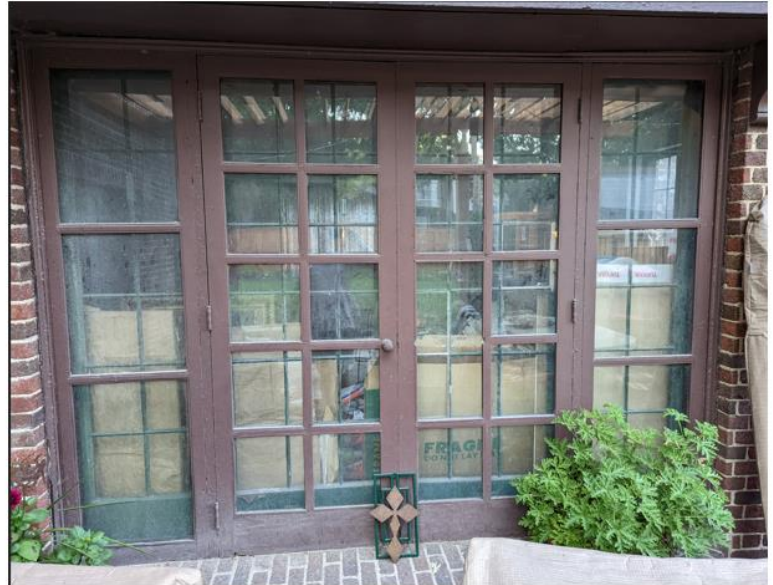
- The applicant proposed to replace two patio doors. On the narrower door opening without sidelights, the entire unit will be replaced. On the wider door opening with sidelights, the operable doors will be replaced

and the sidelights will remain. The proposed new doors are single-glazed steel doors, to be hunter green in color.

Exterior doors proposed for replacement. Images by applicant.

- The exterior patio doors proposed for replacement are not visible from the public right-of-way.
- Based on materials, design, and hardware, staff concludes that the exterior patio doors date from the Period of Significance. It is possible that they were originally screen doors rather than glazed.

- The applicant states that the exterior patio doors are not functional due to missing knobs and latches, and “the wood is sagging and rotted at the bottom of each door.”

- The current exterior patio doors provide “textural interest” and “complexity,” as described in the Elements of Design. Eliminating the current doors will diminish these qualities.
- The design of the current exterior patio doors, with wider vertical elements separating multilight windows, is consistent with the muntin-and-mullion character of the building’s windows. A door with a different design would be a deviation from this character.
- The exterior patio doors are both historic (original or dating from the Period of Significance) and distinctive (as suggested by “textural interest” and “complexity” items in the Elements of Design, and the consistency in character with the building’s windows as mentioned above) and have not deteriorated beyond repair. The Secretary of the Interior’s Standards for Rehabilitation, cited below, direct that they be retained and preserved or repaired.

Staff recommends that the Commission issue a Denial of the proposed patio door replacement as it does not meet the Secretary of the Interior’s Standards for Rehabilitation, in particular:

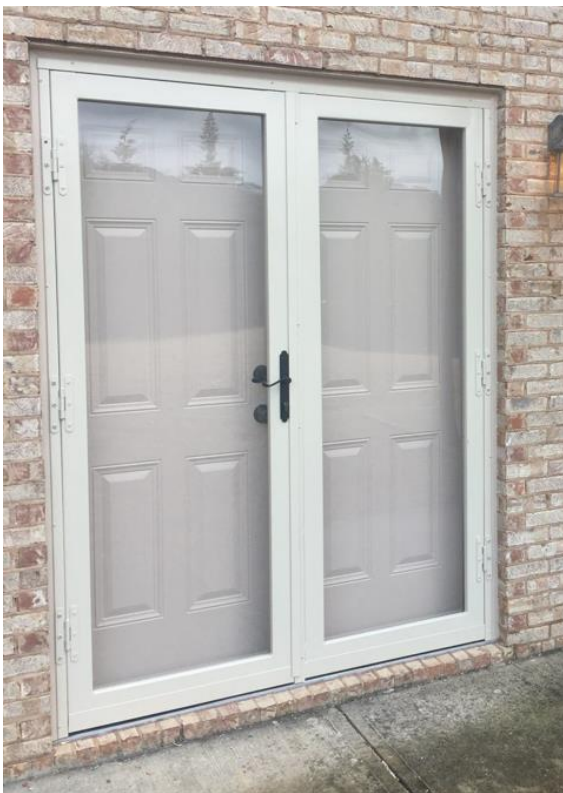
Proposed new exterior door (shown on different property). Image by applicant.

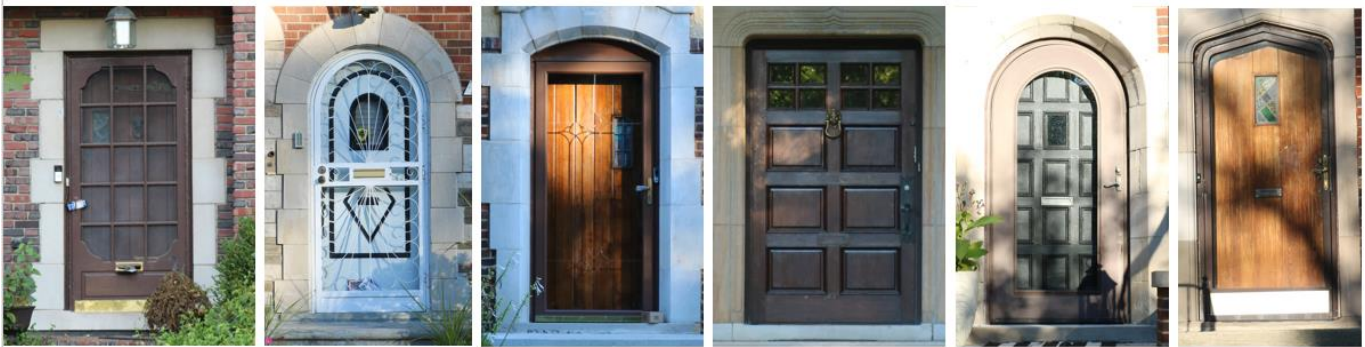
- Staff surveyed several blocks in the Sherwood Forest Historic District and observed that houses feature security doors, storm doors, and uncovered original doors in approximately equal numbers. Staff observed security doors in a wide variety of designs. Security doors such as the ones proposed would not be out of place in the district.

Doors in the Sherwood Forest Historic District. Photos by staff.
