STAFF REPORT: 9/13/2023 MEETING

APPLICATION NUMBER: HDC2023-00049

ADDRESS: 3769-3777 STURTEVANT

SCOPE OF WORK: DEMOLISH GARAGE, ERECT GARAGE

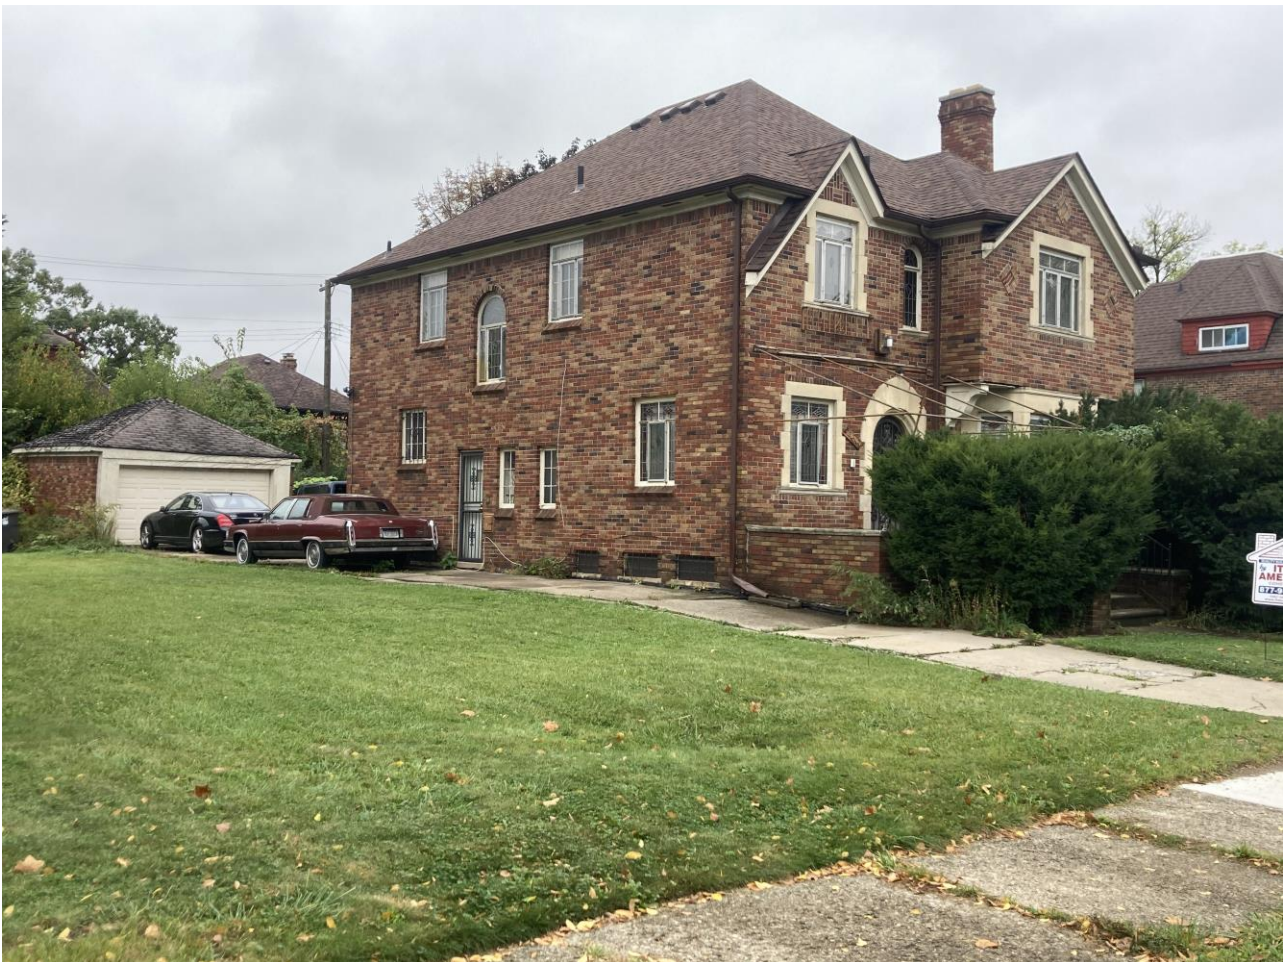
3769 Sturtevant (vacant lot to the left) and 3777 Sturtevant (house and garage), current condition. Staff photo taken on 9/28/2023

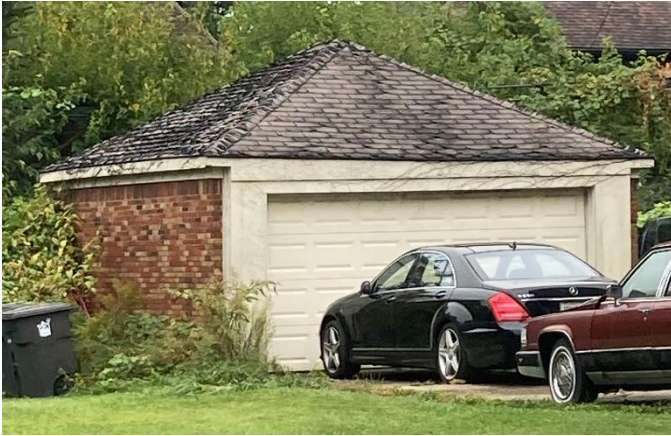
3777 Sturtevant garage, current condition. Staff photo taken on 9/28/2023

- The field visit revealed that the majority of homes within the 3700-3800 blocks of Sturtevant retain their original two-car, historic-age garages
- It is staff's opinion that the garage proposed for demolition is contributing to the subject parcel and the wider neighborhood/historic district. The design of the garage, with its red brick cladding

and hipped roof, reflects that of the property's home. Also, the current garage's modest scale is in keeping with the extant historic garages in the general vicinity.

- In re: to the condition of the existing garage, the applicant has stated that "the roof is not in great shape and the garage has settled. The option to expand the garage was discussed, but after inspecting the garage, we concluded that the foundation and roof are compromised. The rear wall of the garage is also missing brick, but it is hard to see right now because of the foliage. There is no way to enlarge the existing garage without tearing off the entire roof, since the existing roof line will not allow for a hip style at this enlarged size. The garage has had small repairs throughout the years to try and keep it as is, but it has reached a point where it may be beyond repair." The applicant has also provided some exterior photos to support their assessment. Staff did review the submitted exterior photos and visit the site to assess the condition of the existing garage from the public right-of-way (ROW) and noted that it did appear to be in good condition/it is not deteriorated beyond repair. It is staff's opinion that the current application does not provide sufficient documentation that the current deteriorated conditions could not be successfully addressed via repair versus demolition. The proposal to demolish the garage is therefore not in keeping with the Secretary of the Interior's (SOI) Standards because it would destroy a contributing building that can be repaired.

- The existing garage proposed for demolition is contributing to the subject parcel and the wider neighborhood/historic district.
- The current application does not provide sufficient documentation that the current deteriorated conditions of the contributing garage could not be successfully addressed via repair versus demolition.
- The proposed new garage's and driveway's extension into the adjacent parcel as well as the width of the new driveway is inconsistent with extant properties within the district.

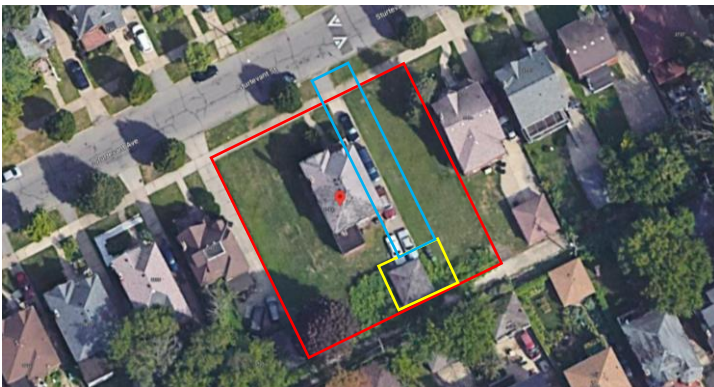
- Per the below aerial image, vacant lots are located to the direct east (3769 Sturtevant) and west (3783 Sturtevant) of 3777 Sturtevant. The applicant has indicated that 3777 Sturtevant's owner also owns these two adjacent vacant lots. A review of available Sanborn Fire Insurance maps and the property's designation slide indicate that this condition existed at the time of the district's designation. The lack of curbcuts at 3769 and 3783 Sturtevant suggest that these lots have been vacant since the Sullivan subdivision was platted.

Google Streetview, 3769-3783 Sturtevant. Yellow box indicates location of proposed new garage and blue box indicates location of new driveway, curbcut, and parking apron

- The new garage and driveway footprints will extend into 3769 Sturtevant/the vacant lot to the east of 3777 Sturtevant. Also, note that the new garage, driveway, and curbcut will be considerably wider than those which exist within the near vicinity of 3777 Sturtevant. Due to the adjacent vacant lots, these new elements will be highly visible from ROW. It is staff's opinion that the proposed work does not conform to the district's historic character because the garage's extension into the adjacent parcel and the width of the new driveway is inconsistent with extant properties within the district.
