14 PRESERVATION BRIEFS

New Exterior Additions to Historic Buildings: Preservation Concerns

Anne E. Grimmer and Kay D. Weeks

National Park Service
U.S. Department of the Interior
Technical Preservation Services

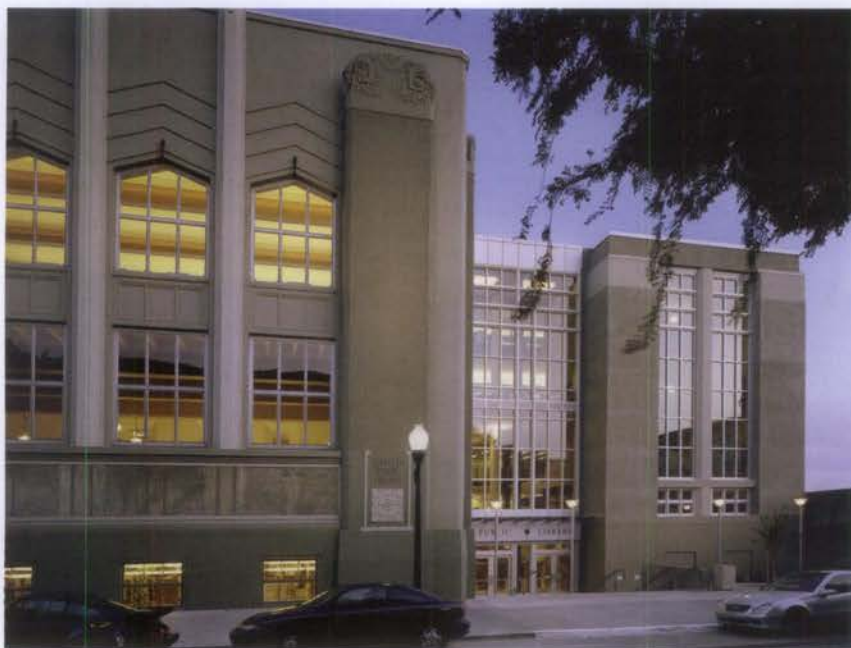
Figure 1. The addition to the right with its connecting hyphen is compatible with the Collegiate Gothic-style library. The addition is set back from the front of the library and uses the same materials and a simplified design that references, but does not copy, the historic building. Photo: David Wakely Photography.

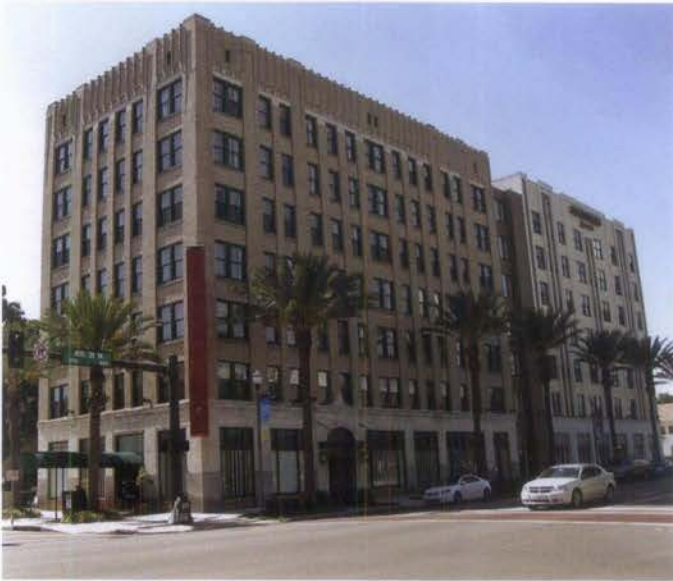
Figure 2. The new section on the right is appropriately scaled and reflects the design of the historic Art Deco-style hotel. The apparent separation created by the recessed connector also enables the addition to be viewed as an individual building.

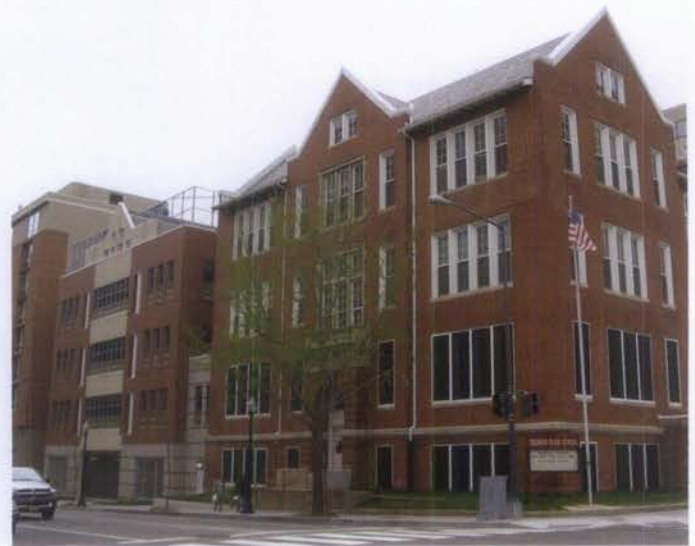
Figure 3. The red and buff-colored parking addition with a rooftop playground is compatible with the early-20th century school as well as with the neighborhood in which it also serves as infill in the urban setting.

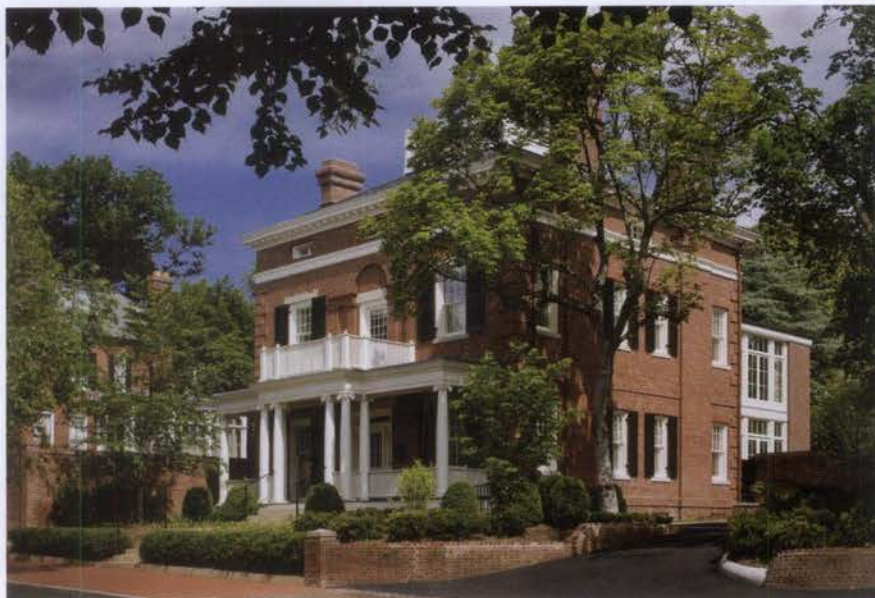
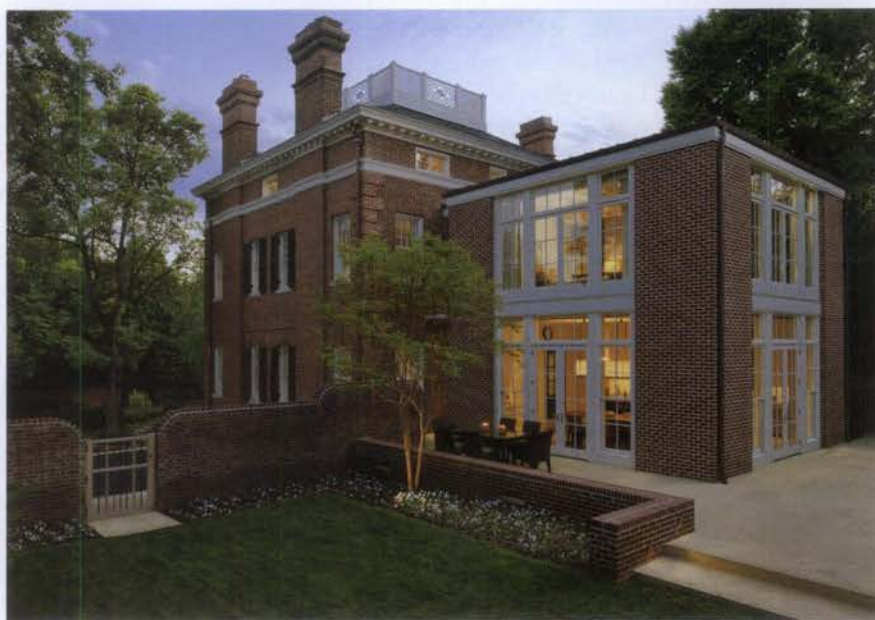
Figure 4. This glass and brick structure is a harmonious addition set back and connected to the rear of the Colonial Revival-style brick house. Cunningham/Quill Architects. Photos: © Maxwell MacKenzie.

Anne E. Grimmer, Senior Architectural Historian, Technical Preservation Services Branch, National Park Service, revised *Preservation Brief 14*, written by Kay D. Weeks and first published in 1986. The revised Brief features all new illustrations and contains expanded and updated design guidance on the subject of new additions that has been developed by the Technical Preservation Services Branch since the original publication of the Brief. Several individuals generously contributed their time and expertise to review the revision of this *Preservation Brief*, including: Sharon C. Park, FAIA, Chief, Architectural History and Historic Preservation, Smithsonian Institution; Elizabeth Tune and Karen Brandt, Department of Historic Resources, Commonwealth of Virginia; and Phillip Wisley and David Ferro, Division of Historical Resources, Florida Department of State. The Technical Preservation Services professional staff, in particular Michael J. Auer, Jo Ellen Hensley, Gary Sachau and Rebecca Shiffer, also provided important guidance in the development of this publication. All illustrations are from National Park Service files unless otherwise credited. Front cover image: Detail of new addition shown in Figure 4. Photo: © Maxwell MacKenzie.

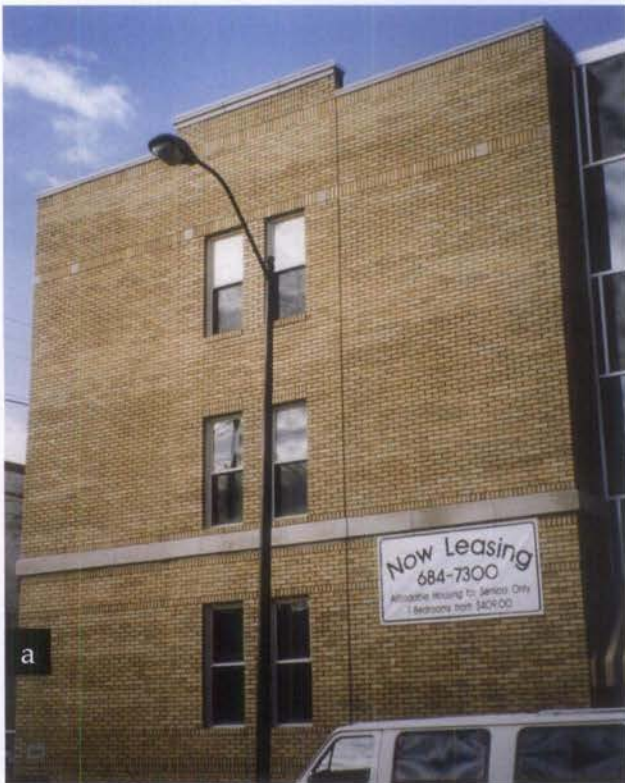
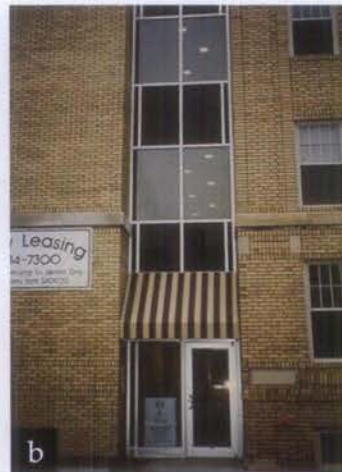
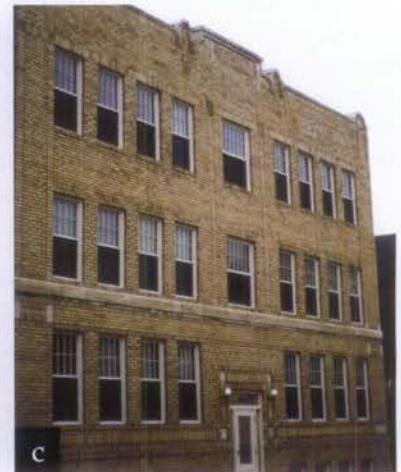
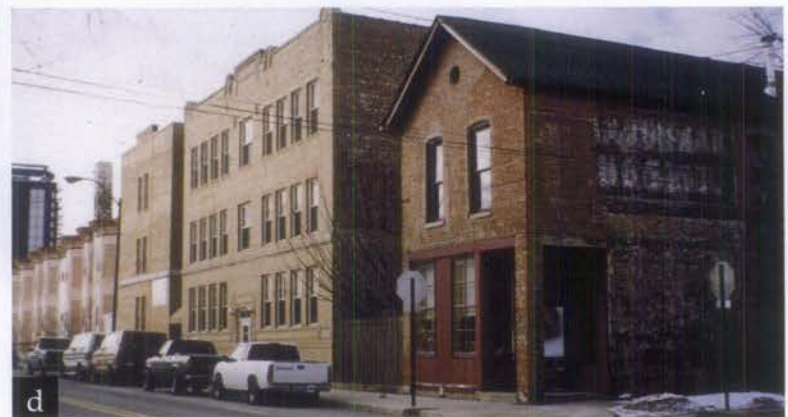
Figure 5. This addition (a) is constructed of matching brick and attached by a recessed connector (b) to the 1914 apartment building (c). The design is compatible and the addition is smaller and subordinate to the historic building (d).

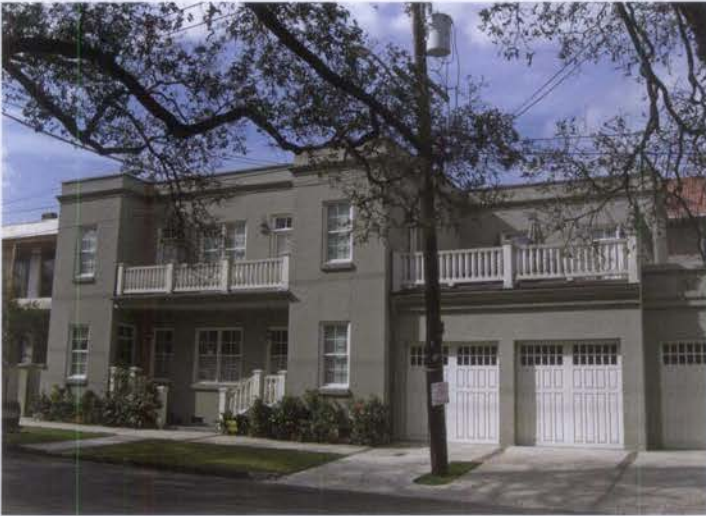
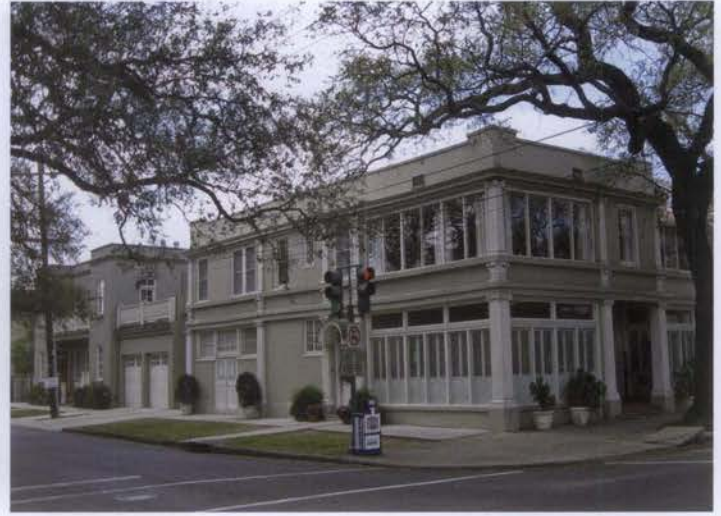
Figure 6. A new addition (left) is connected to the garage which separates it from the main block of the c. 1910 former florist shop (right). The addition is traditional in style, yet sufficiently restrained in design to distinguish it from the historic building.

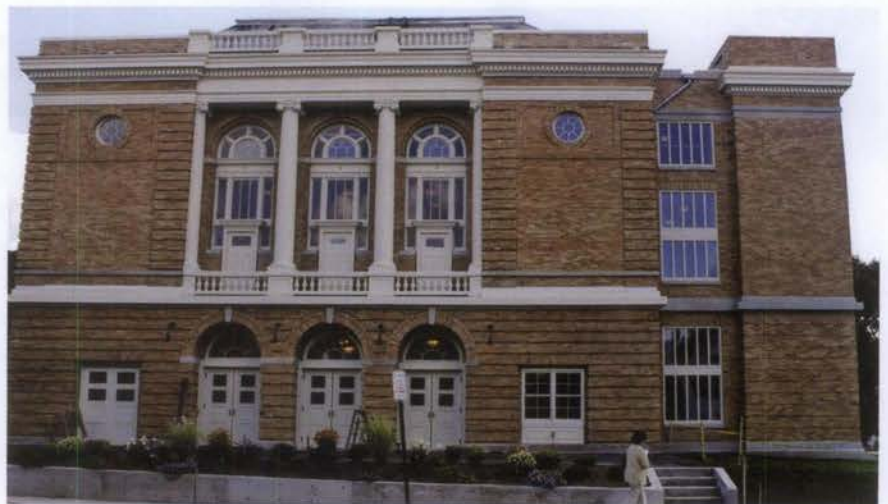
Figure 7. A vacant side lot was the only place a new stair tower could be built when this 1903 theater was rehabilitated as a performing arts center. Constructed with matching materials, the stair tower is set back with a recessed connector and, despite its prominent location, it is clearly subordinate and differentiated from the historic theater.

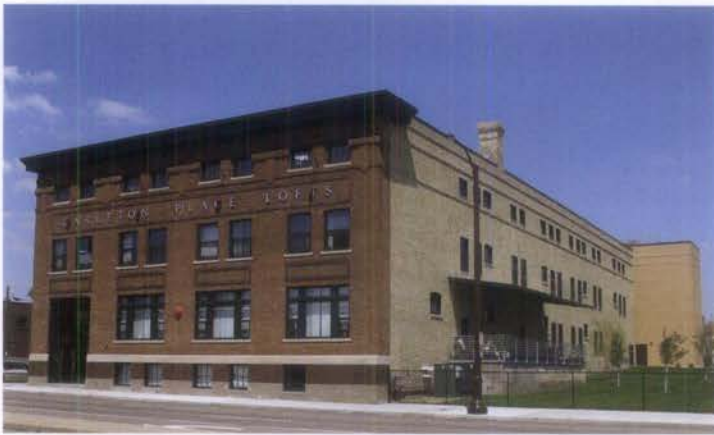
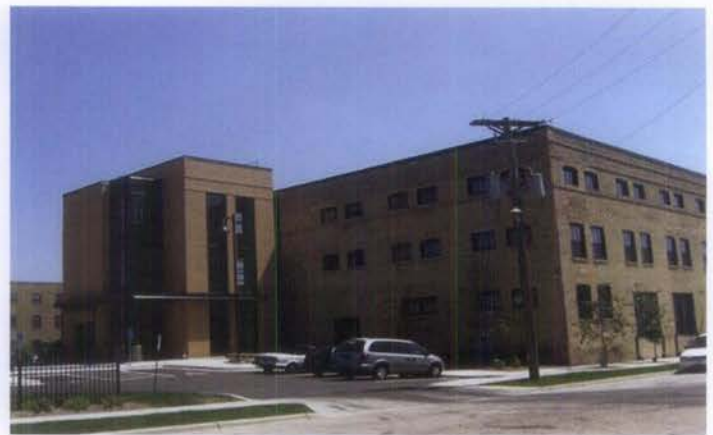
Figure 8. The rehabilitation of this large, early-20th century warehouse (left) into affordable artists' lofts included the addition of a compatible glass and brick elevator/stair tower at the back (right).

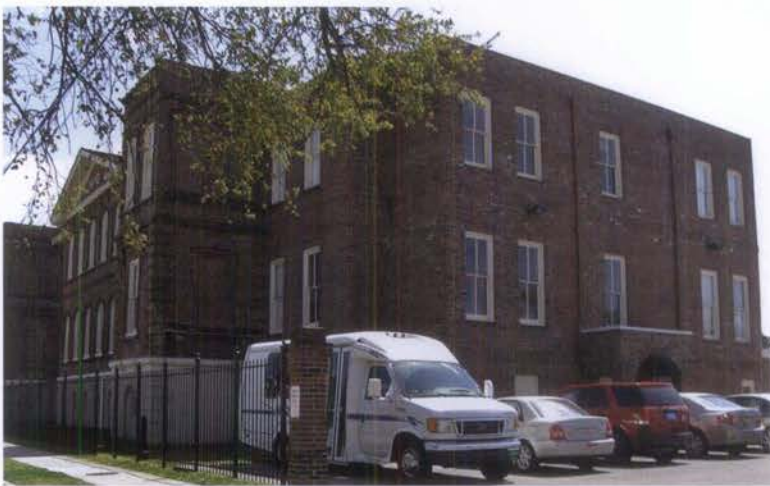
Figure 9. A simple, brick stair tower replaced two non-historic additions at the rear of this 1879 school building when it was rehabilitated as a women's and children's shelter. The addition is set back and it is not visible from the front of the school.

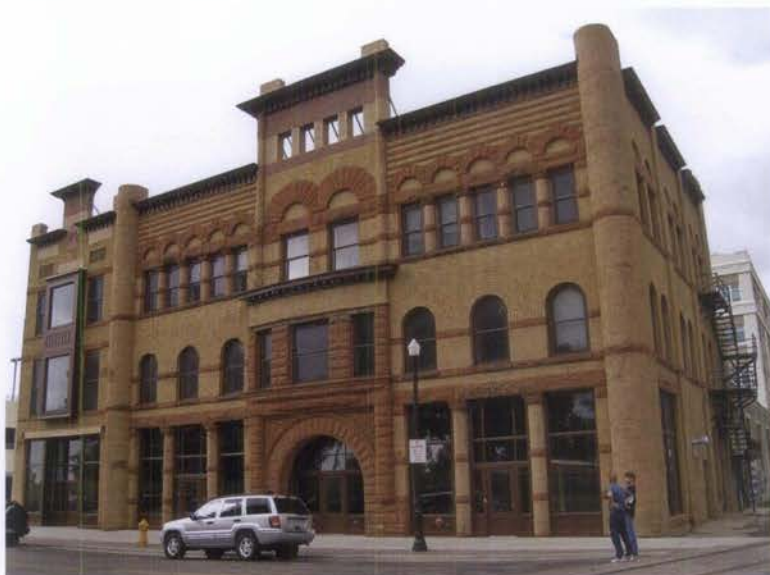
Figure 10. The small size and the use of matching materials ensures that the new addition on the left is compatible with the historic Romanesque Revival-style building.

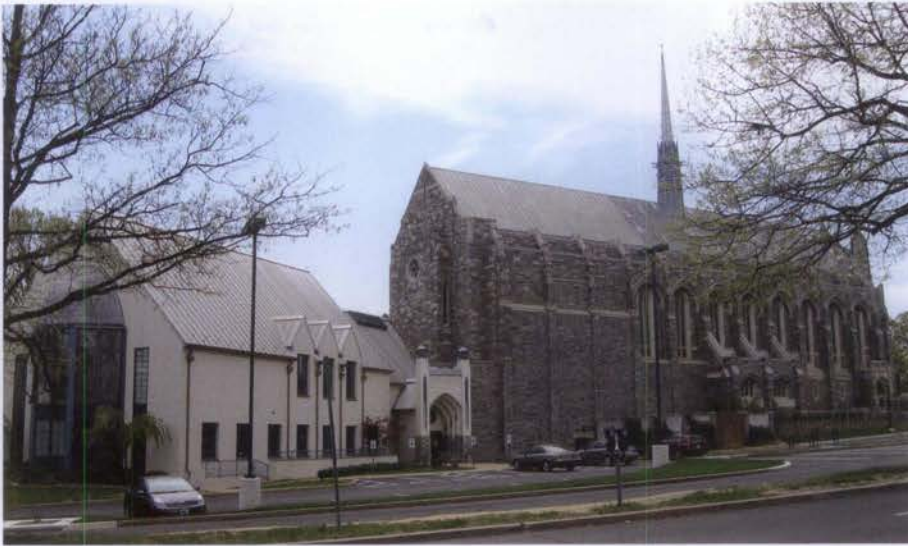
Figure 11. The addition to this early-20th century Gothic Revival-style church provides space for offices, a great hall for gatherings and an accessible entrance (left). The stucco finish, metal roof, narrow gables and the Gothic-arched entrance complement the architecture of the historic church. Placing the addition in back where the ground slopes away ensures that it is subordinate and minimizes its impact on the church (below).

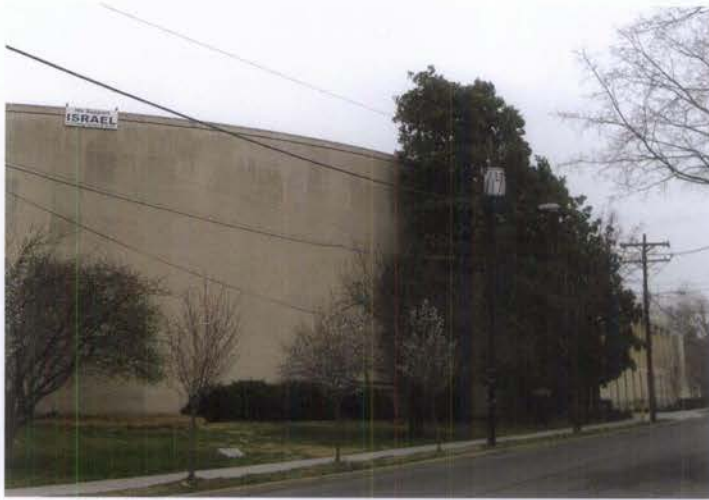
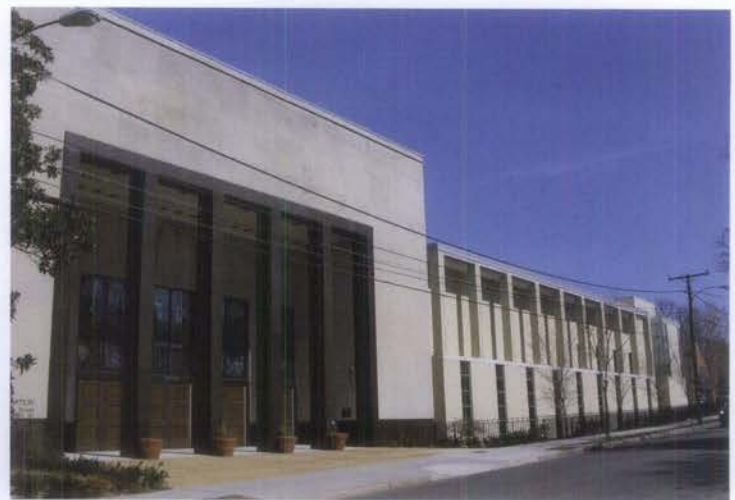
Figure 12. This 1954 synagogue (left) is accessed through a monumental entrance to the right. The new education wing (far right) added to it features the same vertical elements and color and, even though it is quite large, its smaller scale and height ensure that it is secondary to the historic resource.

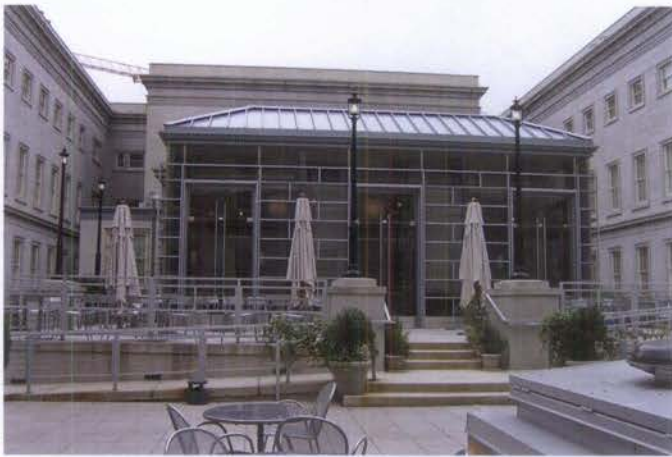
Figure 13. A glass and metal structure was constructed in the courtyard as a restaurant when this 1839 building was converted to a hotel. Although such an addition might not be appropriate in a more public location, it is compatible here in the courtyard of this historic building.

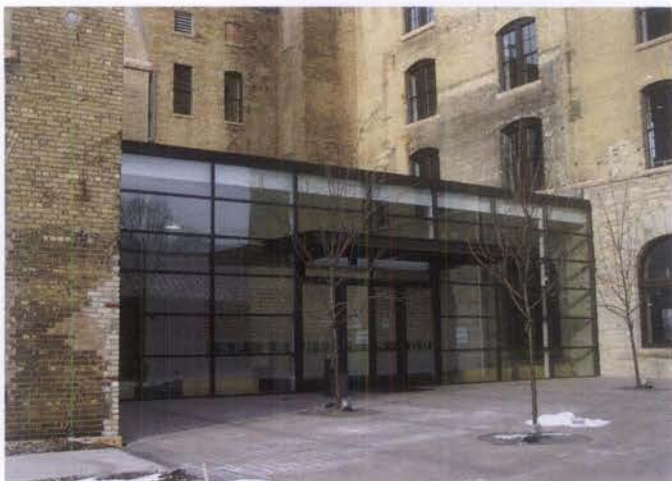
Figure 14. This glass addition was erected at the back of an 1895 former brewery during rehabilitation to provide another entrance. The addition is compatible with the plain character of this secondary elevation.

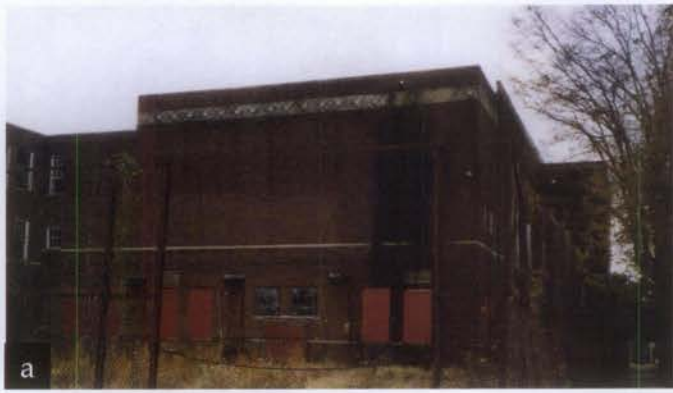
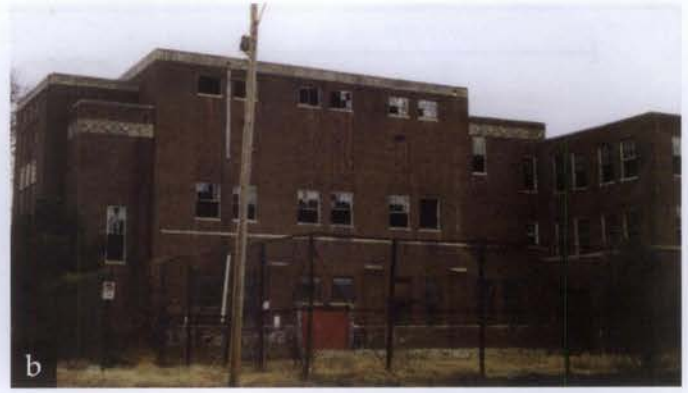
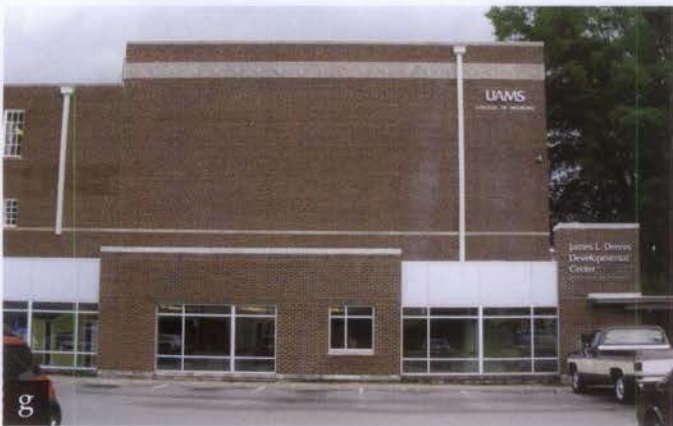
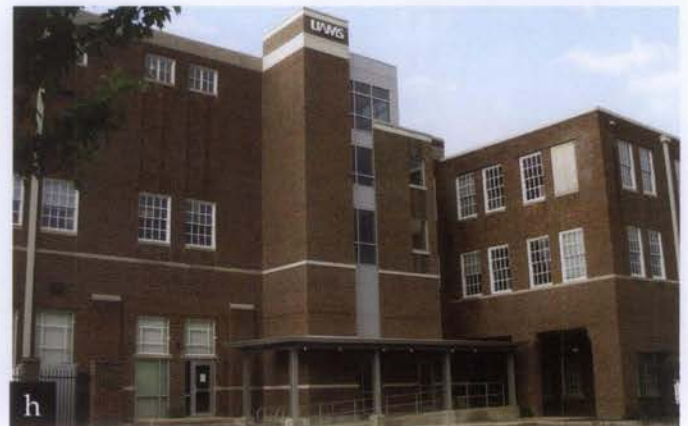
Figure 15. The rehabilitation of a c. 1930 high school auditorium for a clinic and offices proposed two additions: a one-story entrance and reception area on this elevation (a); and a four-story elevator and stair tower on another side (b). The gabled entrance (c) first proposed was not compatible with the flat-roofed auditorium and the design of the proposed stair tower (d) was also incompatible and overwhelmed the historic building. The designs were revised (e-f) resulting in new additions that meet the Standards (g-h).

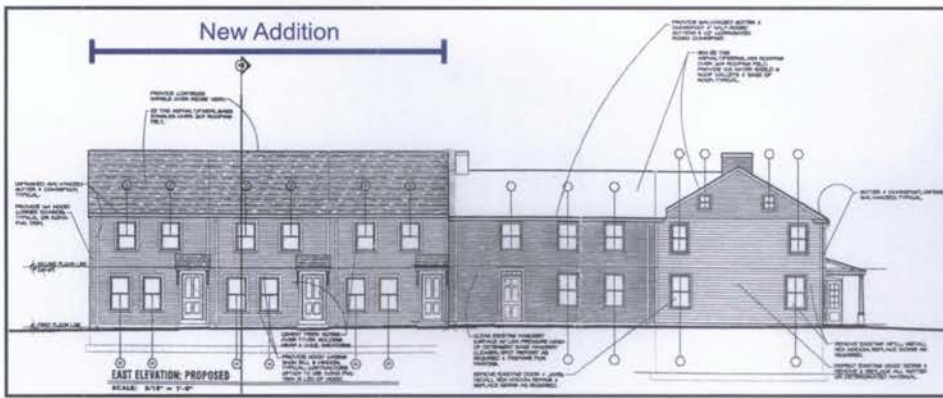
Figure 16. The proposal to add three row houses to the rear ell of this early-19th century residential property doubles its size and does not meet the Standards..

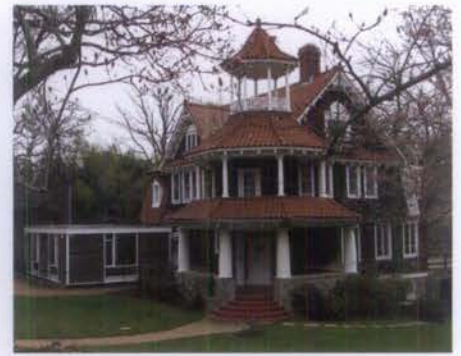
Figure 17. The small addition on the left is starkly different and it is not compatible with the eclectic, late-19th century house.

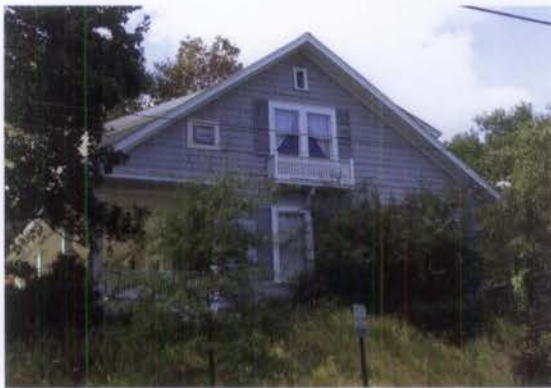
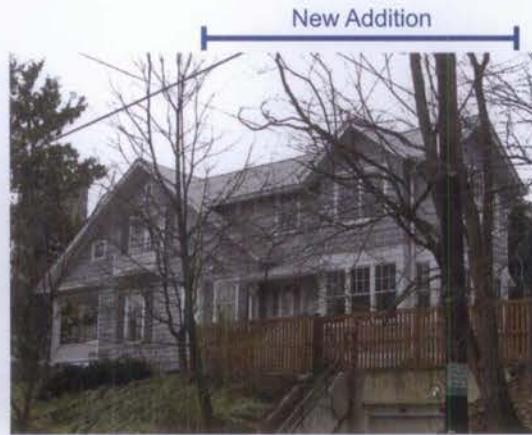
Figure 18. The expansion of a one- and one-half story historic bungalow (left) with a large two-story rear addition (right) has greatly altered and obscured its distinctive shape and form.

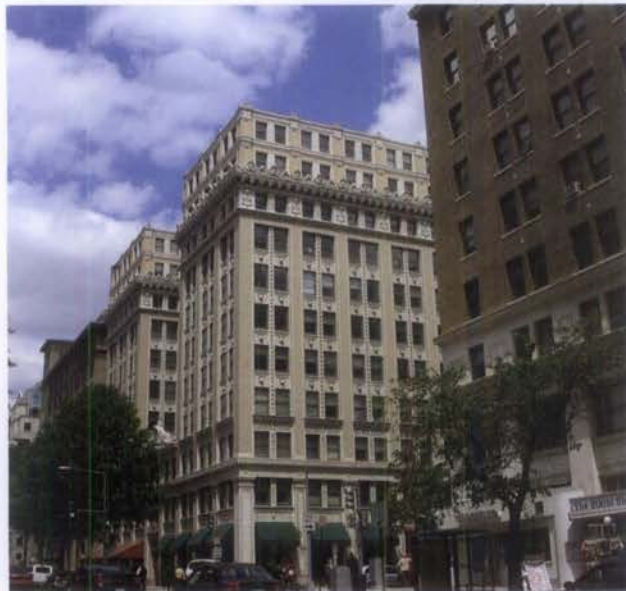
Figure 19. The upper two floors of this early-20th century office building were part of the original design, but were not built. During rehabilitation, the two stories were finally constructed. This treatment does not meet the Standards because the addition has given the building an appearance it never had historically.

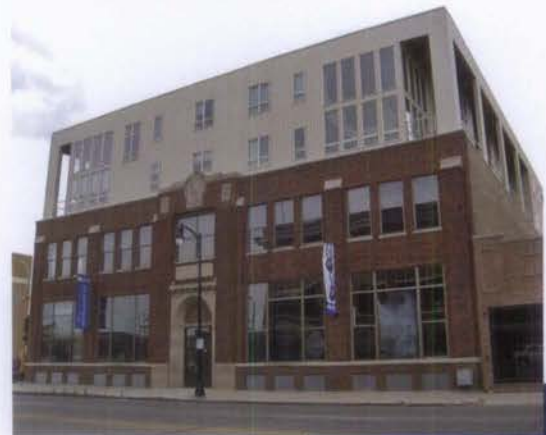
Figure 20. The height, as well as the design, of these two-story rooftop additions overwhelms the two-story and the one-story, low-rise historic buildings.

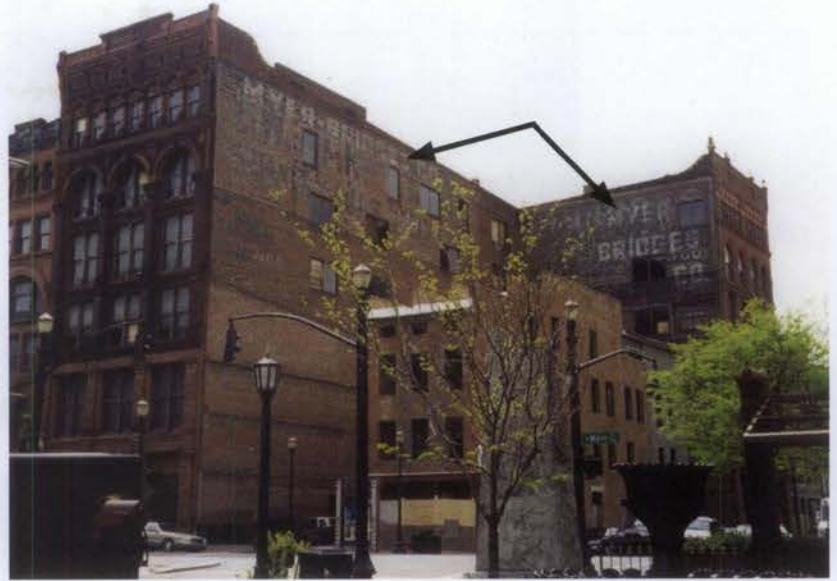
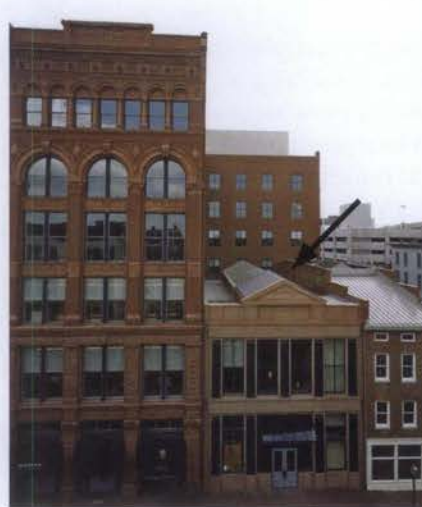
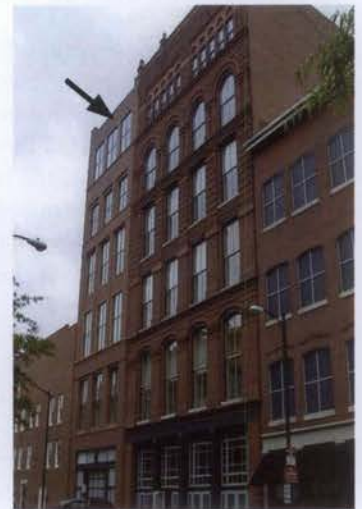
Figure 21. Both wings of this historic L-shaped building (top), which fronts on two city streets, adjoined vacant lots. A two-story addition was constructed on one lot (above, left) and a six-story addition was built on the other (above, right). Like the historic building, which has two different facades, the compatible new additions are also different and appear to be separate structures rather than part of the historic building.

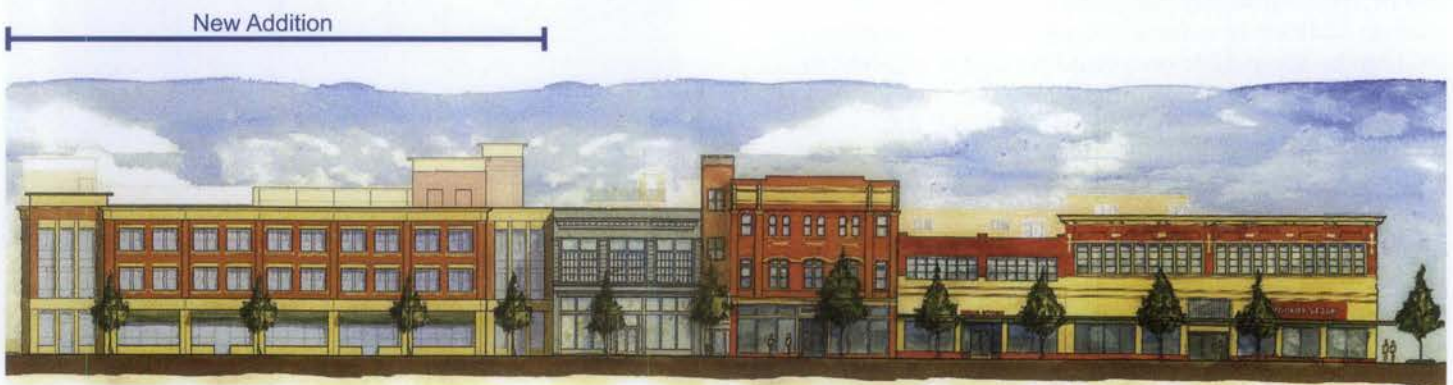
Figure 22. The proposed new addition is compatible with the historic buildings that remain on the block. Its design with multiple storefronts helps break up the mass.

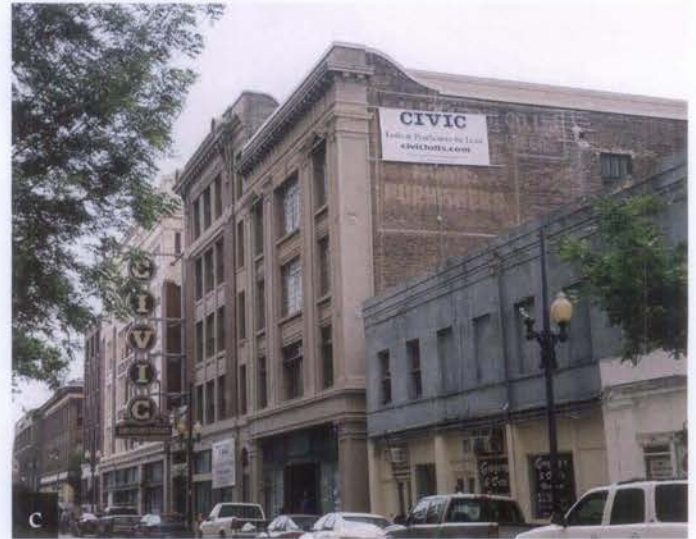
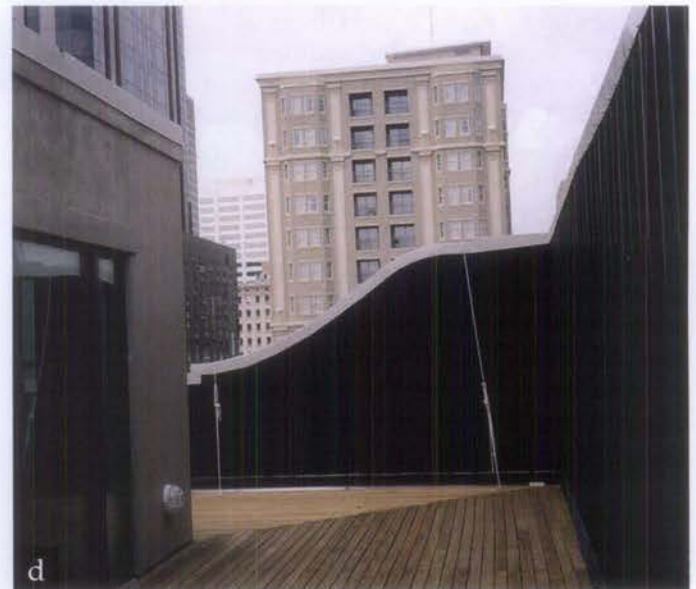
Figure 23. Colored flags marking the location of a proposed penthouse addition (a) were placed on the roof to help evaluate the impact and visibility of an addition planned for this historic furniture store (b). Based on this evaluation, the addition was constructed as proposed. It is minimally visible and compatible with the 1912 structure (c). The tall parapet wall conceals the addition from the street below (d).

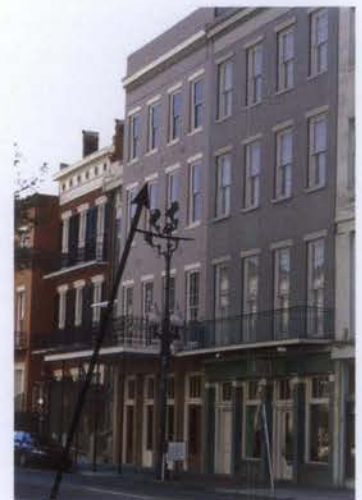
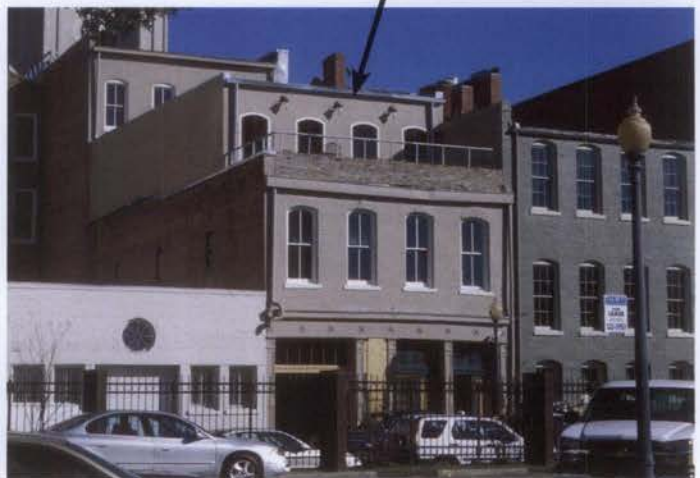
Figure 26. A rooftop addition would have negatively impacted the character of the primary facade (right) of this mid-19th century, four-story structure and the low-rise historic district. However, a third floor was successfully added on the two-story rear portion (below) of the same building with little impact to the building or the district because it blends in with the height of the adjacent building.

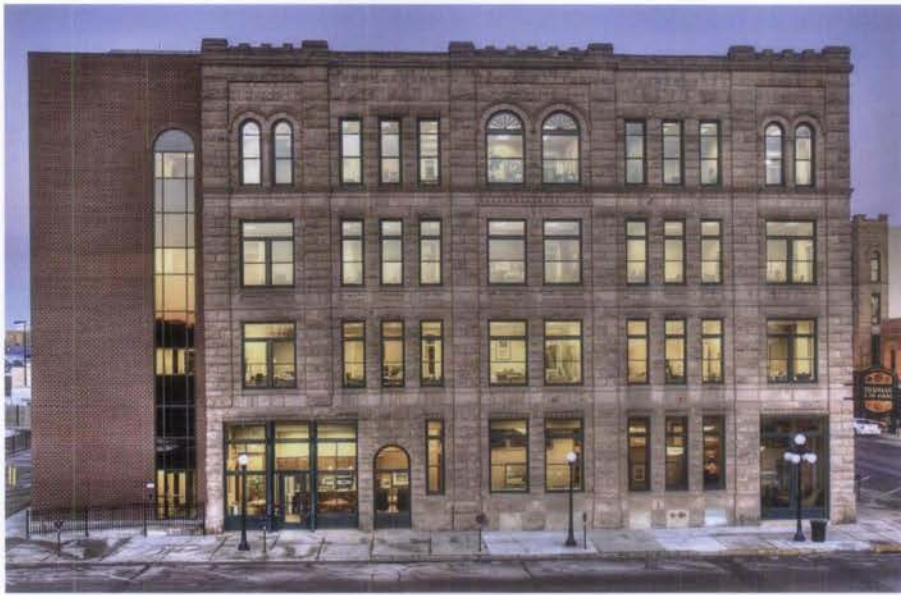
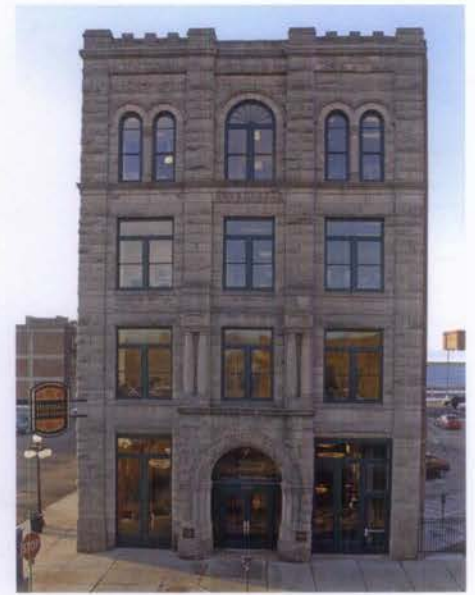
Figure 27. Although the new brick stair/elevator tower (left) is not visible from the front (right), it is on a prominent side elevation of this 1890 stone bank. The compatible addition is set back and does not compete with the historic building. Photos: Chadd Gossmann, Aurora Photography, LLC.

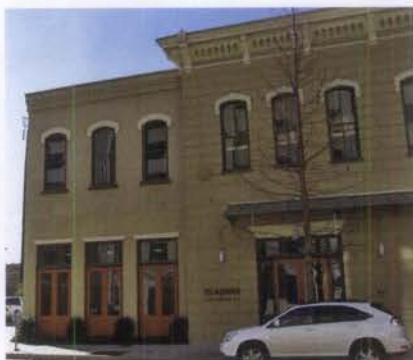
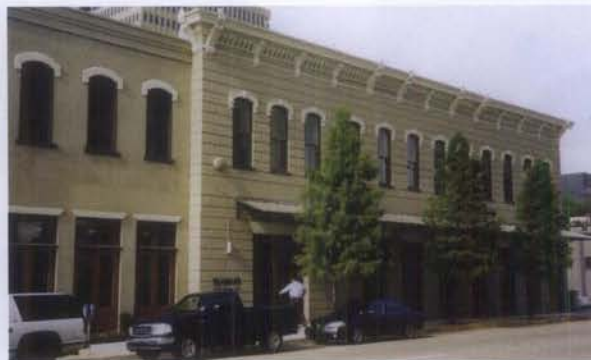
Figure 28. A small addition (left) was constructed when this 1880s train station was converted for office use. The paired doors with transoms and arched windows on the compatible addition reflect, but do not replicate, the historic building (right).

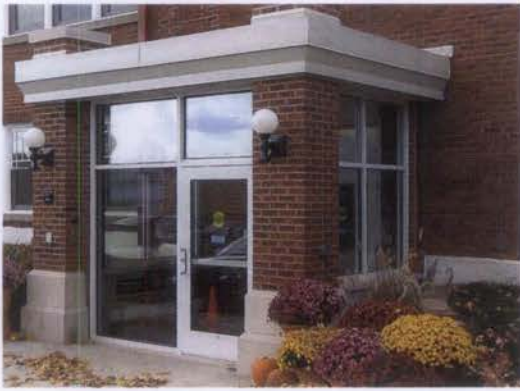
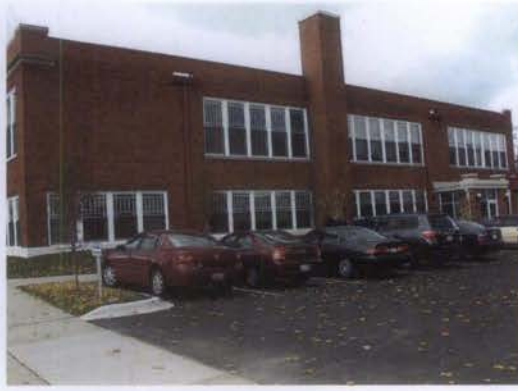
Figure 29. This simple glass and brick entrance (left) added to a secondary elevation of a 1920s school building (right) is compatible with the original structure.

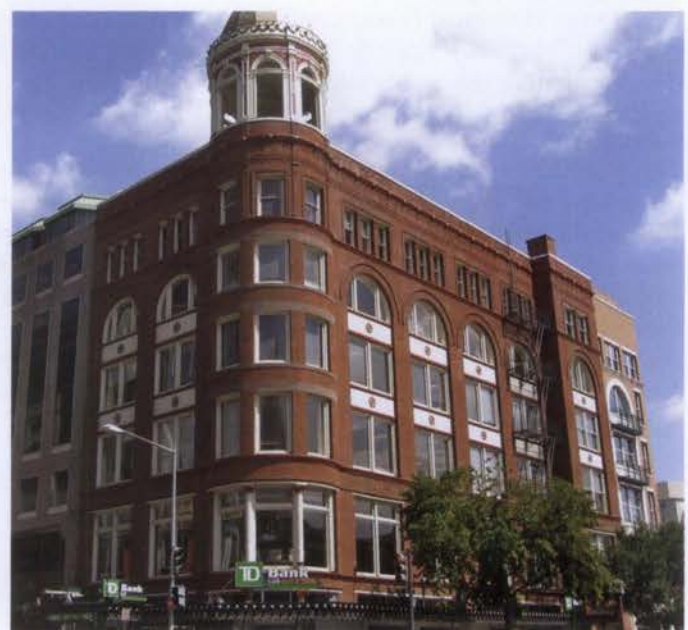
Figure 30. The small addition on the right of this late-19th century commercial structure is clearly secondary and compatible in size, materials and design with the historic building.

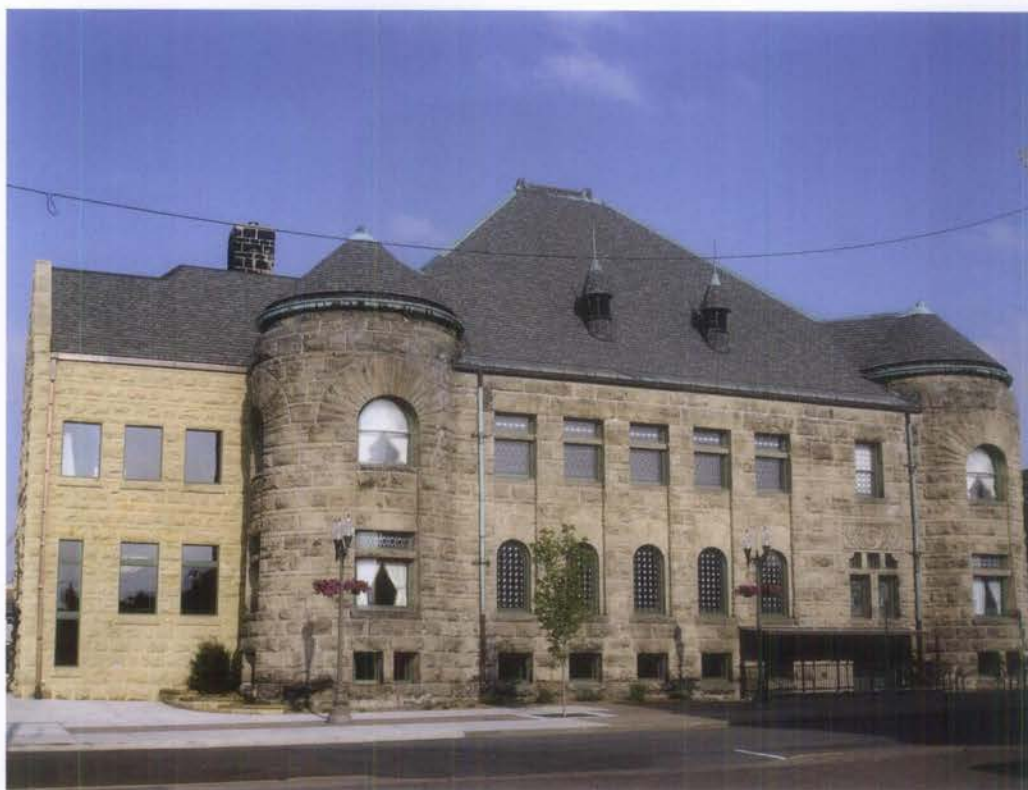
Figure 31. An elevator/stair tower was added at the back of this Richardsonian Romanesque-style theater when it was rehabilitated. Rough-cut stone and simple cut-out openings ensure that the addition is compatible and subordinate to the historic building. Photo: Chuck Liddy, AIA.
