STAFF REPORT: 10/08/2025 REGULAR MEETING PREPARED BY: A. DYE

APPLICATION NUMBER: HDC2025-00575

ADDRESS: 2733 SECOND AVENUE (AKA CASS PARK)

SCOPE: ALTER & REHABILITATE PARK, REVISE INTERNAL PATH LAYOUT

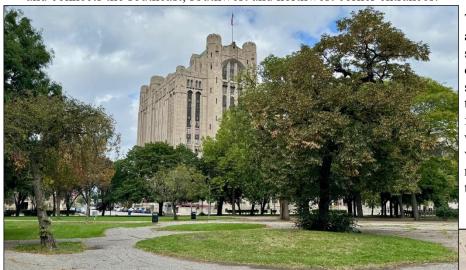
Top left: View looking northeast, from the center of the park. Masonic Temple is visible in the background. Staff photo, September 25, 2025.

Above: Aerial view of the park looking southeast. ConnectExplorer, 2024.

Bottom left: Front of Robert Burns monument that faces Second and Temple Streets).

Bottom center: Front of current Cass Park monument with sign and flagpoles that faces Second and Ledyard Streets).

Cass Park is a 1.1-acre open space that is bound by Temple Avenue to the north, Second Avenue to the east and west (east side is northbound; west side is southbound) and Ledyard Street to the south. The park is comprised of eight entrances, centrally placed on the four sides and at each corner. Wide, straight concrete paths lead from each entrance toward the center of the park, which is comprised of three asymmetrically placed, and differently sized, mounded circular areas covered with turf. The largest mound holds a contemporary sculpture "Pink Landscape, Three Trusses Plus" designed by James Lawton. Most of the ground is flat covered with turf or concrete/asphalt surfaces. An additional narrow, straight concrete path is located within the tree canopy on three sides of the park and connects the southeast, southwest and northwest corner entrances.

The north- and south-central entrances align with Second Avenue, before the street splits to travel around the park as one-way, north-south streets. The Burns statue at the north-central entrance, and the Cass Park sign and set of three (3) flags at the south-central entrance align with Second Avenue, offering a striking visual and physical connection to the north and south as well as directly through the park.

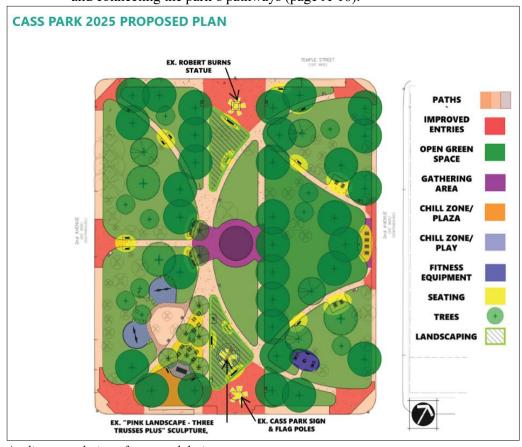
Applicant's previous park proposal, HDC2025-00489.

Applicant rendering of proposed design.

- Instead of one primary off-center pathway, the proposal now includes two symmetrical pathways that extend from 2nd Avenue through the park (pages A-10 and A-14).
- An avenue of trees that flanks the two symmetrical pathways through the park was enhanced, to emphasize the view down 2_{nd} Avenue through the park, which was referenced in the historic significance considerations (page A-23).
- The large lawn space was reduced to accommodate the symmetrical paths (page A-15). To maximize the remaining lawn space for programming the mid-block plaza off east 2_{nd} Ave was condensed, while retaining the function needed for the food service program (pages A-16 and A-20).
- A central focal point was added that is in the exact center of the park, referencing the historic fountain area, and connecting the park's pathways (page A-16).

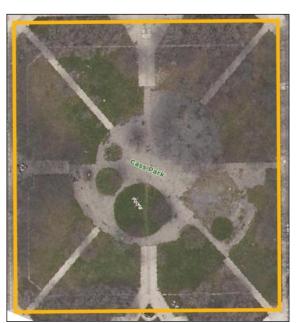
EX. ROBERT BURNS
STATUE

EX. PINK LANDSCAPF - THREE
TRUSSES PLUS" SCULPTURE,

EX. CASS PARK SIGN
& FLAG POLES

Existing conditions

Applicant rendering of proposed design.

• However, taking into account the district's Elements of Design and the park's level of integrity, it is staff's opinion that the proposed overall layout is still not a compatible park plan as it will destroy the symmetrical design of eight entries converging on the center of the park from each corner and center of the four sides, which is significant and distinctive character-defining feature of the park, and the one element that has essentially remained unchanged from the original 1860 park design.
