**STAFF REPORT:** 02/11/2026 MEETING  
**APPLICATION NUMBER:** HDC2026-00005  
**ADDRESS:** 19630 ROSLYN

**HISTORIC DISTRICT:** SHERWOOD FOREST  
**APPLICANT:** ALBERT BENEZRA, WEATHERGARD WINDOWS  
**PROPERTY OWNER:** LADONNA BARNES  
**DATE OF PROVISIONALLY COMPLETE APPLICATION:** 01/20/2026  
**DATE OF STAFF SITE VISIT:** 01/28/2026

**SCOPE:** REPLACE VINYL WINDOWS WITH CASEMENT-STYLE VINYL WINDOWS

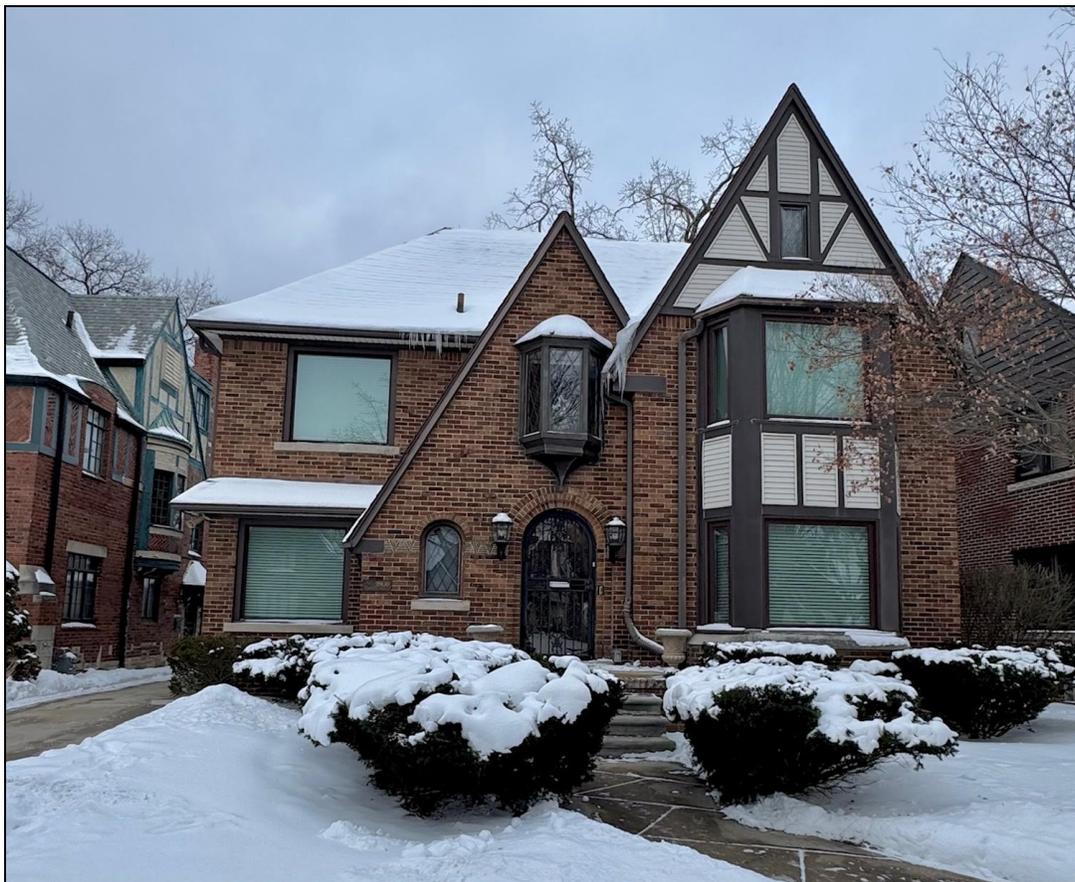
The dwelling at 19630 Roslyn was erected in 1926. The house exhibits Tudor revival styling through the steeply pitched roof, asymmetrical front elevation with multiple front-facing gables, an oriel window, and arched front entry with flanking small arched window. Vinyl siding covers some of the wall surfaces on each elevation; the pattern gives reference to possibly covered half-timber and stucco finishes. obscuring the original architectural character of the house

*Staff photo, January, 28, 2026.*

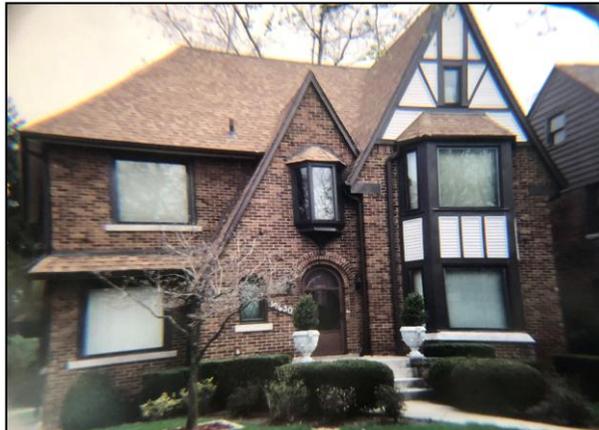
Designation photo, 2002. HDAB.

- Per the designation photo, the house's original windows were no longer extant at the time of district designation.
  - The vinyl window units do not have architectural or historical significance.

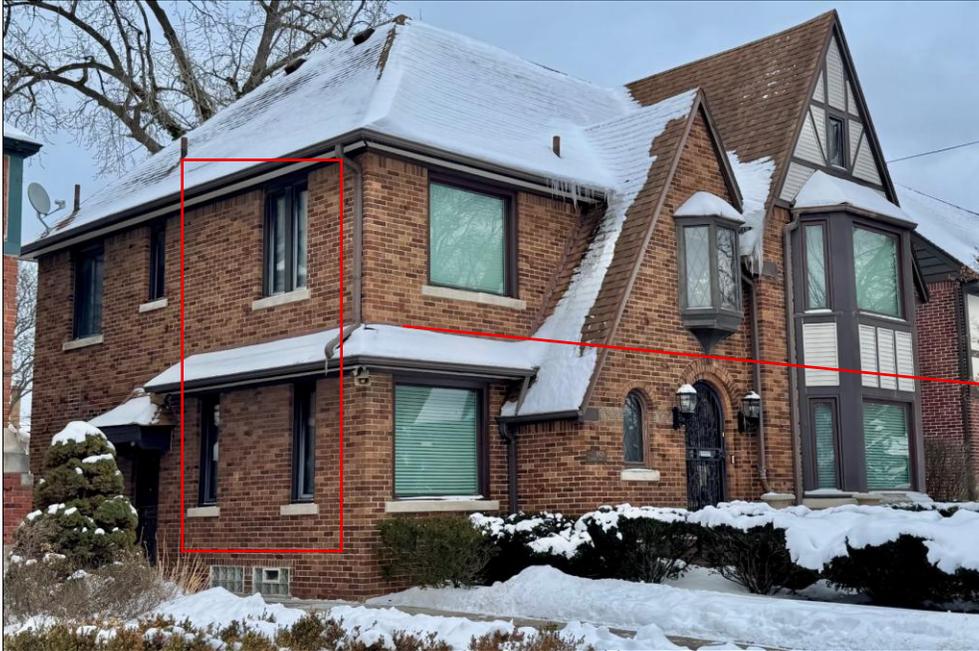
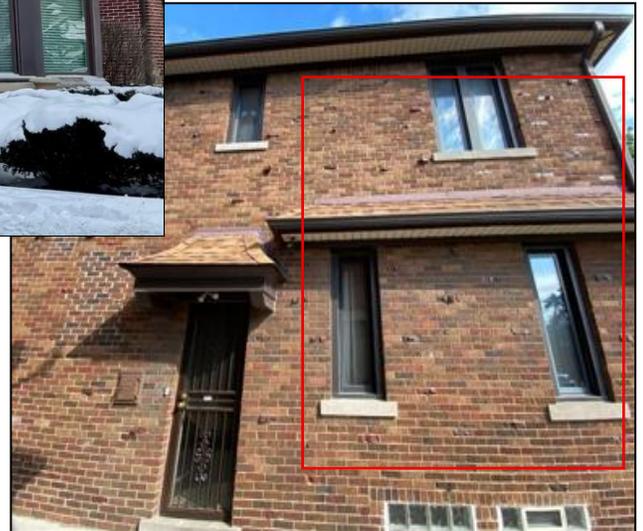
- Consumer grade vinyl windows weather poorly, deteriorate rapidly, and exhibit poor detailing and detracting color/sheen.
- The framing material, glazing, and seals (which keeps the argon gas intact between the insulated glass) of vinyl windows break down more quickly in ultraviolet light than wood or steel-framed windows.
- Vinyl also lacks rigidity and can expand and contract more greatly than wood and steel. This can result in discoloration and warping of the vinyl frames, as well as condensation between the glass layers.
- The below view of the north-side wall and west-front walls offers a good view of the position of the four (4) window openings included in this application. Two individual openings are at the first floor, one double window-mulled unit is at the second floor, and all are undivided casement windows. Flat aluminum coil stock surrounds each window.

Staff photo, looking southeast from the Roslyn sidewalk, January 28, 2026.  
Right: Applicant photo.

- Flat aluminum coil stock surrounds each window. Staff doesn't know if the original wood brickmould remains under the aluminum, but it is highly likely. Any window replacement application should consider the condition of removal of the aluminum coil and exposure of the profiled wood trim.

### **Recommendation 1 of 1, Denial**

Staff recommends that the proposed work will be inappropriate according to the Secretary of the Interior's Standards for Rehabilitation and the Sherwood Forest Historic District's Elements of Design, specifically:
