SR-1 – OBJECTIVE STAFF REPORT (02-27-2026)

ADDRESS: 19170 WARRINGTON

HISTORIC DISTRICT: SHERWOOD FOREST

SCOPE PHRASE FOR AGENDA: REMOVE FRONT FAÇADE BALCONY (WORK COMPLETED WITHOUT APPROVAL)

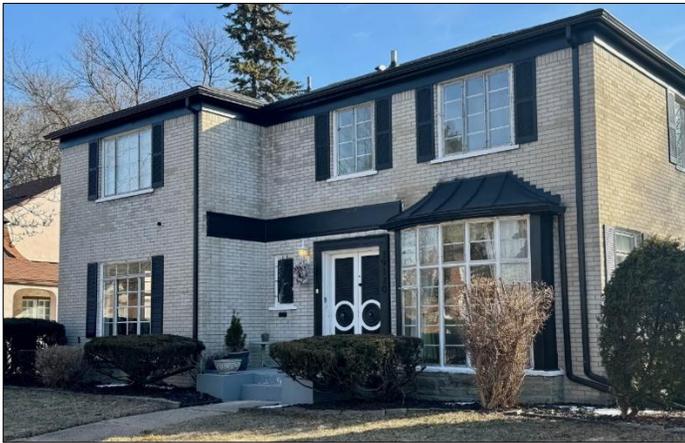
- A narrow, tall single window adjacent to the front door is partially covered with decorative metal scrollwork, which has been painted black.
 - Above the front door and small window, a second story porch with cantilevered platform, flat roof and metal posts/railing was removed without HDC approval in 2023. The area where the porch was attached to the house has been covered with black aluminum trim coil.

Façade/front wall, looking north from sidewalk. Staff photo, 02/26/2026.
