**SR-1 – SUMMARY STAFF REPORT (05/29/2026)**

**ADDRESS:** 12546 DEXTER

**APPLICATION NUMBER:** HDC2026-00271

**SCOPE PHRASE FOR AGENDA:** REHABILITATE BUILDING

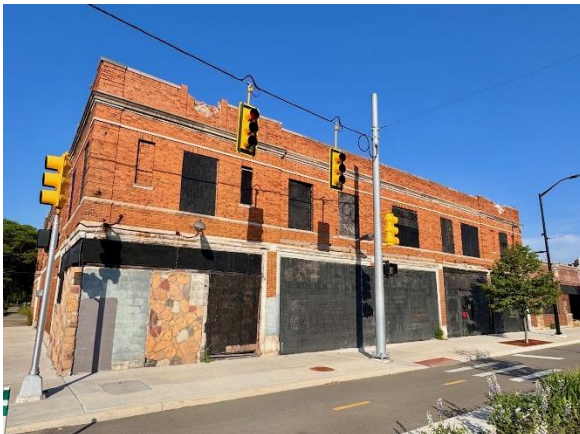
- Staff photo, Dexter facade, May 27, 2026

- The structure is two stories tall and is clad with yellowish-orange face brick on the Dexter and Fullerton facades, accentuated with brick quoins, cast stone trim, as well as CMU block and stone that enclose former commercial storefronts. The majority of window openings are boarded over. The rear facades are clad in red common brick. Portions of the masonry parapet is missing in three areas; two on Dexter and one at Fullerton.

- **Roof**
  - **Rebuild parapet and pediment with reclaimed brick (existing on site), new coping and decorative roundel**
  - **Install elevator**
- **Second Floor**
