Scope of work.

1505 Chicago Blvd. Detroit, MI 48206.

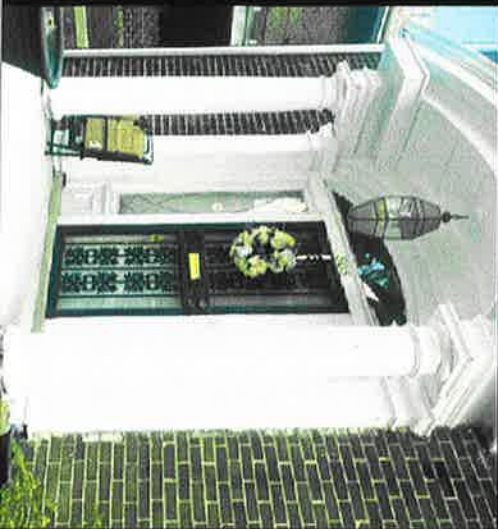
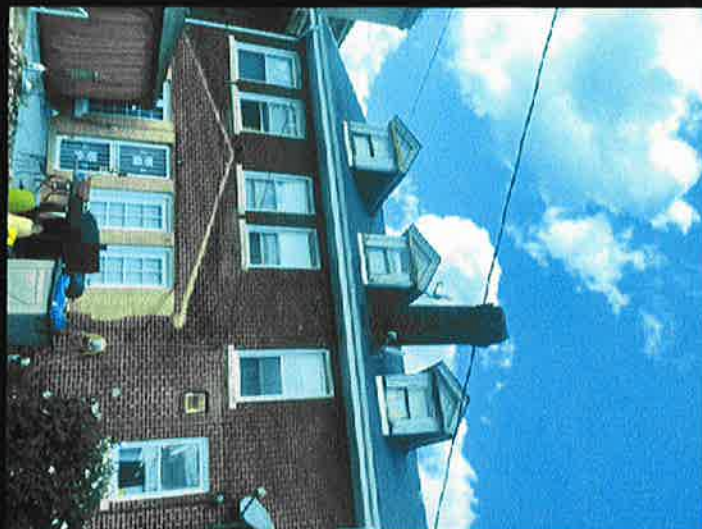
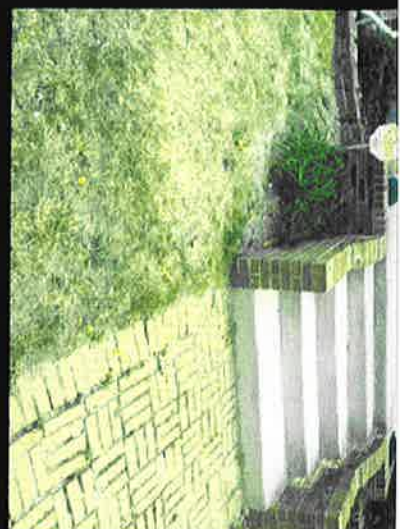
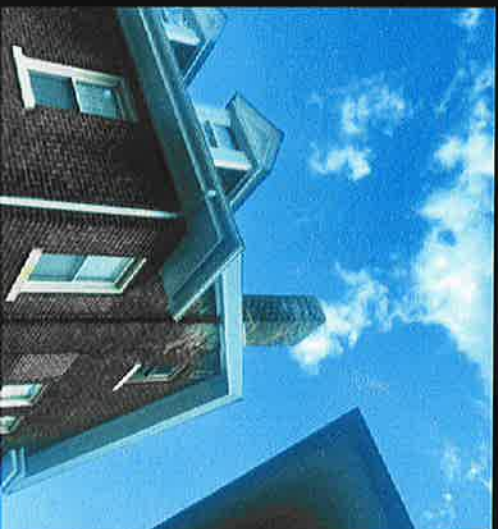
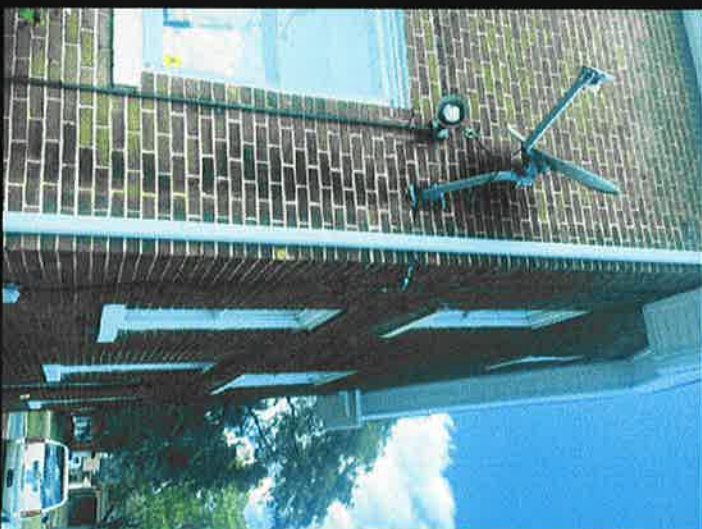
Water leaking in front bathroom along valley of dormer.

Facial boards rotting due water running under roofing shingles damaging facia boards and gutters hanging off.

Remove front portion of roof. Replace sheathing boards.

Install roofing shingles matching the rear roof.

Installing new 1"x 6" facia boards.

Installing new White gutters to match existing gutters

install new downspouts.

Scrape and paint front dormers.

Replace boards around dormers as needed.

Install aluminum siding on new facia boards.

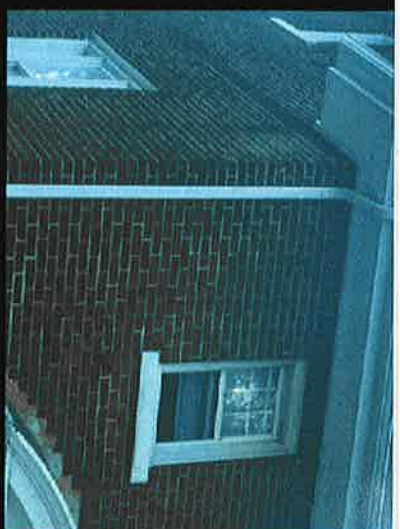
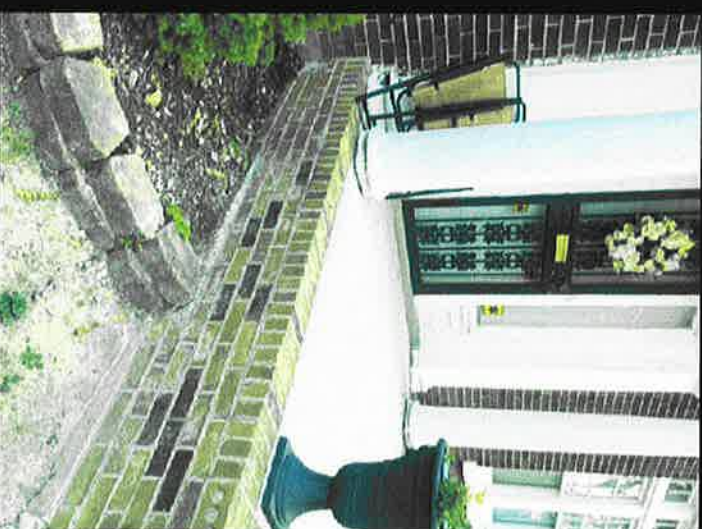
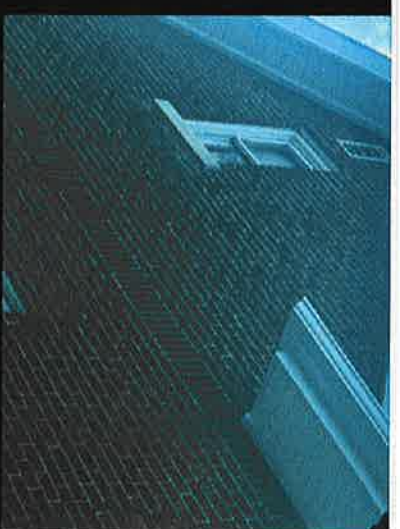
Brick Side walls of separating from porch

Porch cap deteriorating

5 foot precast steps deteriorating

Remove existing porch columns

Remove existing brick walls

Remove existing porch and precast steps

Rebuild brick support walls with original matching bricks

Pour new concrete porch cap and 5 steps

Reinstall existing porch columns
