1453 W Boston Blvd – Project Review Request Roof Replacement

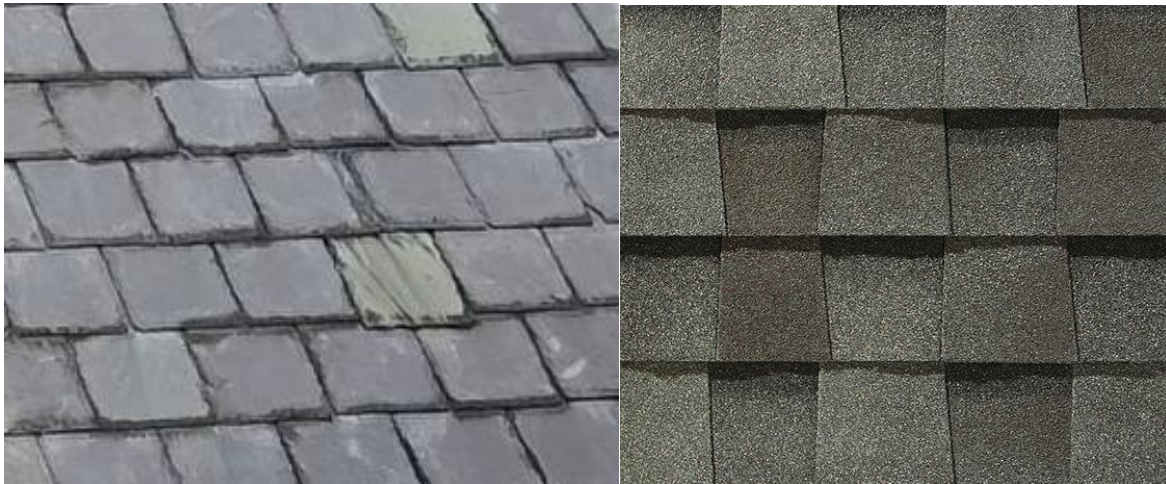
Certainteed Landmark® Climateflex® - Colonial Slate

It is several shades of grey with undertones of blue and red.

Photos below: Existing slate (left) vs. example Colonial Slate asphalt roof
