**STAFF REPORT: JULY 8, 2020 MEETING**

**APPLICATION NUMBER: 20-6770**

**ADDRESS: 1225 WOODWARD AKA *THE FOWLER BUILDING***

**SCOPE OF WORK: REHAB BUILDING, REPLACE WINDOWS, STOREFRONT SYSTEM**

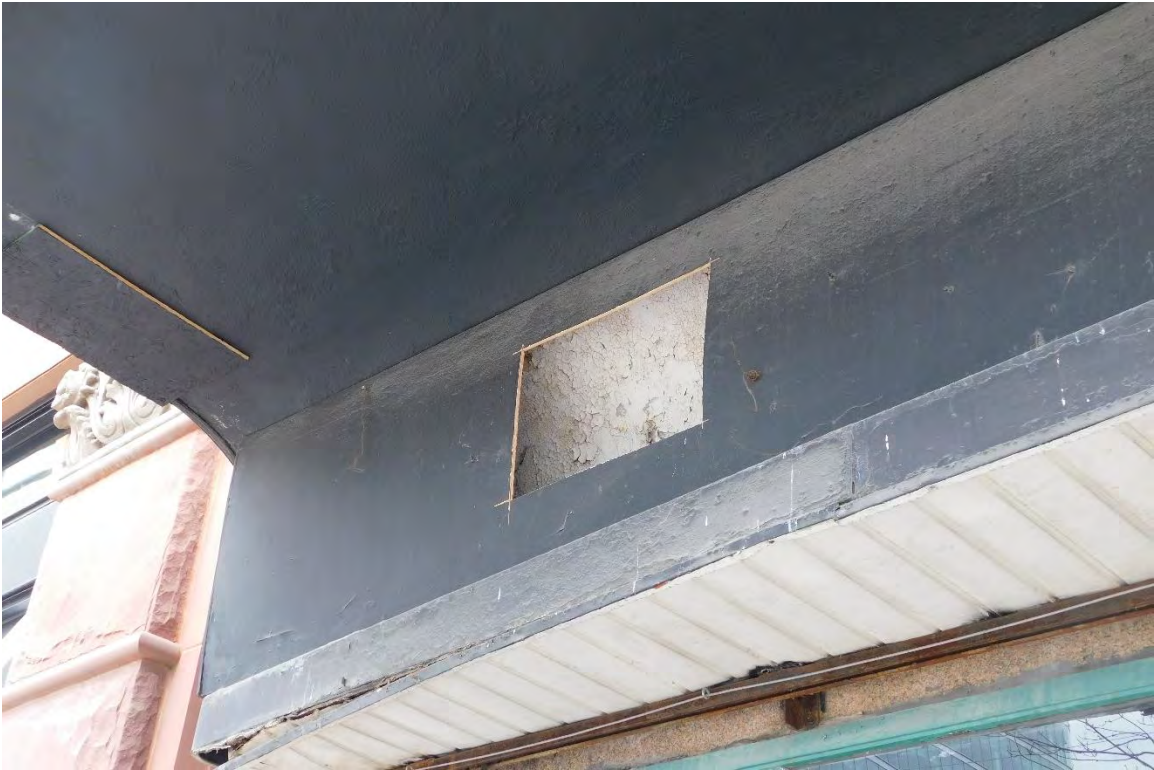
Figure #27: Exterior, Canopy Detail of Plaster Underside, Looking Up. 7/17/19

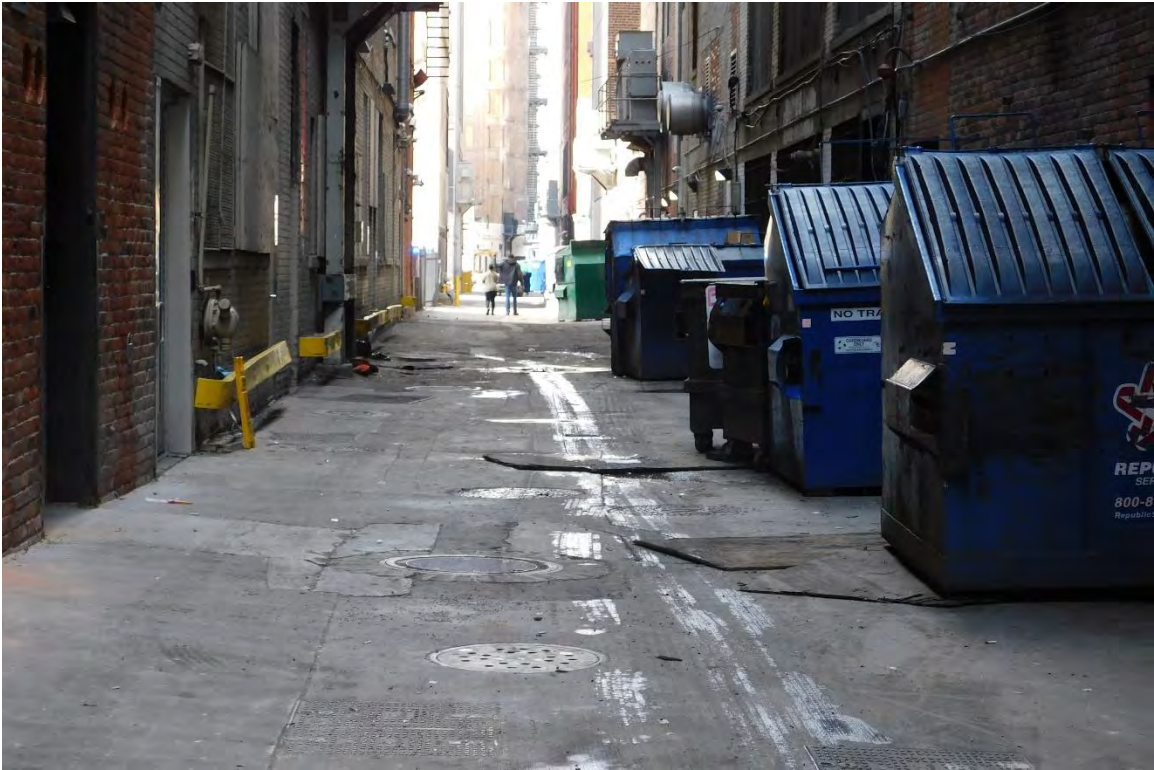
Figure #31: Exterior, Alley, Looking North. 10/15/19

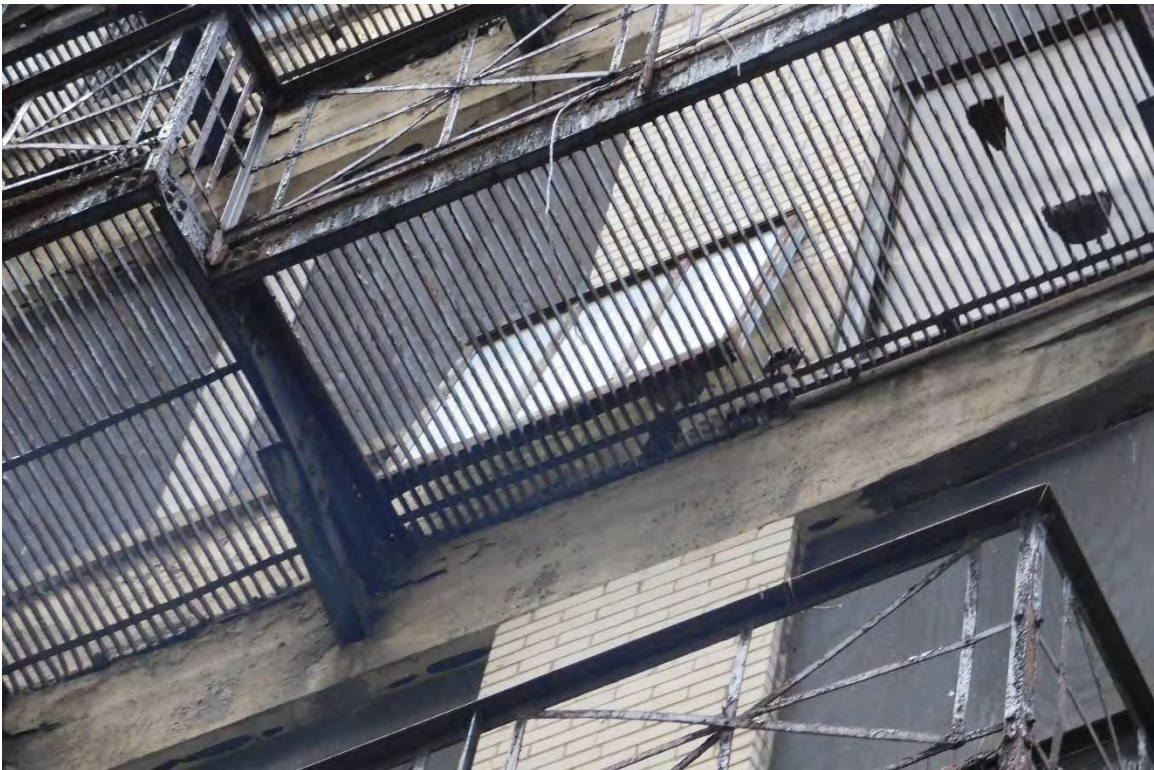
Figure #47: Exterior, Alley Façade and Fire Escape, Looking Up. 10/15/19

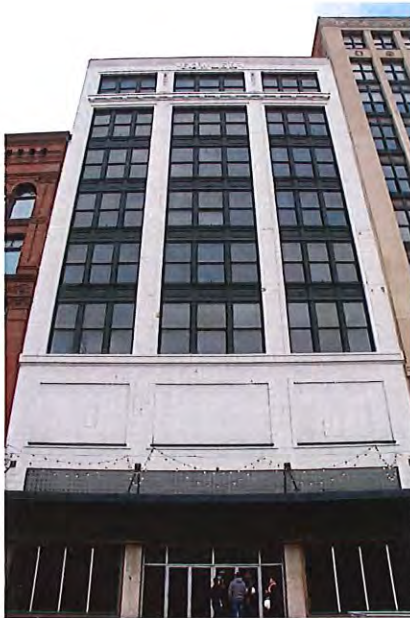
The windows are in very poor condition including sashes, parting bead, and interior sash trim. The master frames and sills are in good condition. We observed all the exterior components including the sill, blind stop, mullions, and all exterior millwork

Fowler Building  
Front Façade  
Wood Double Hung Windows

**Recommendation:** BlackBerry recommends the scope of work should replace the double hung sashes with new historic replica sashes that are aluminum clad on the exterior and wood on the interior. In our investigation we have found a manufacturer that has such a product used on a recent landmark project. Because of the sash size and profiles this type of product is not typically available. Also because of the small number of openings custom extrusions would be cost prohibitive typically. If the leaving of the exterior cladding on the exterior casework including sills, blind stops, mullions, and spandrel panels is acceptable to NPS this suggested approach would be ideal. New sashes can set in place and fixed with the replacement of parting bead and interior sash stop. The new sashes would include insulated glass with low-e/argon. Pricing would include interior and exterior finish. Windows will require lead paint and ACM abatement.

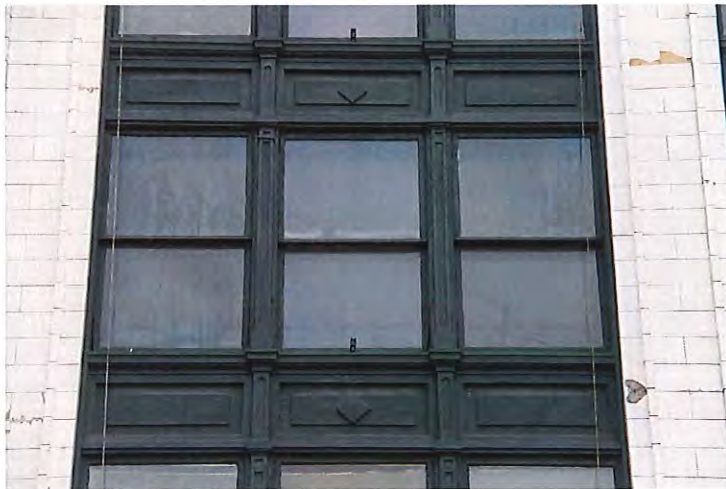
was covered with custom formed break metal (type of metal to be determined). This was carefully executed and appears in very good condition especially in sealing out water penetration. Before a final analysis can be concluded this façade needs to be inspected on the exterior using a lift or swing stage. **The years of disrepair, and exposure to the elements has taken its toll on the sash components. Most all the double hung sashes have failed joinery at the meeting rails or bottom rails. Not maintaining the exterior glazing compound has allowed water to get into the sash rails and stiles causing warping, joinery failure, and decay. We estimate that over 65% have failed joinery that is not repairable.** All sashes need to be fully replaced with a replicated product. We would suspect that all the exterior perimeter caulking will need to be abated for containing asbestos which is common with a building of this age.

Front Façade  
Wood Windows and  
Cover Casework

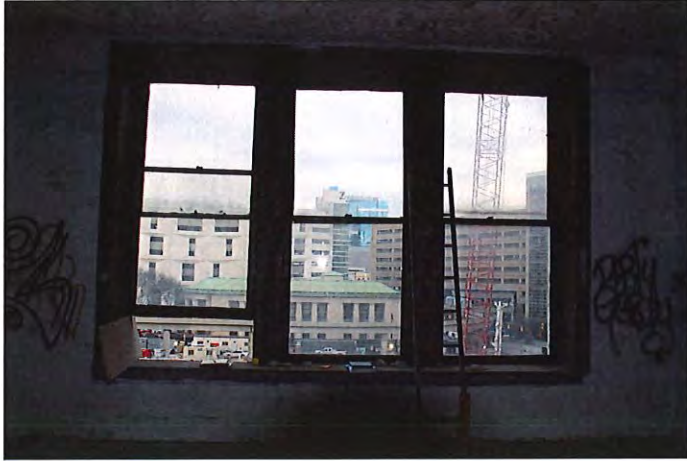
Typical Interior  
Wood Double Hung

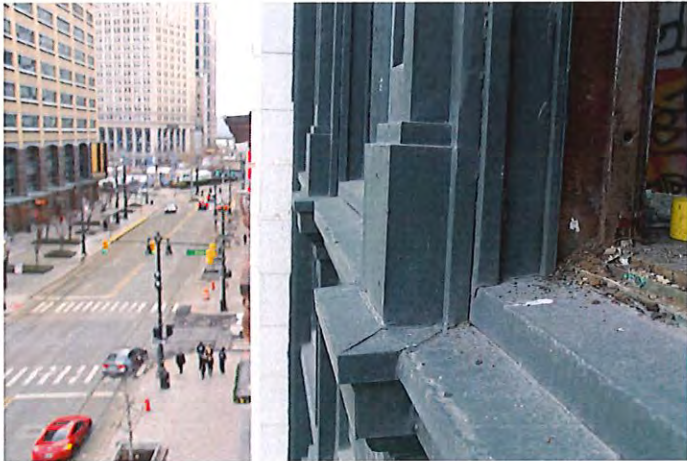
Exterior View of Metal Clad  
Casework and Master Frame

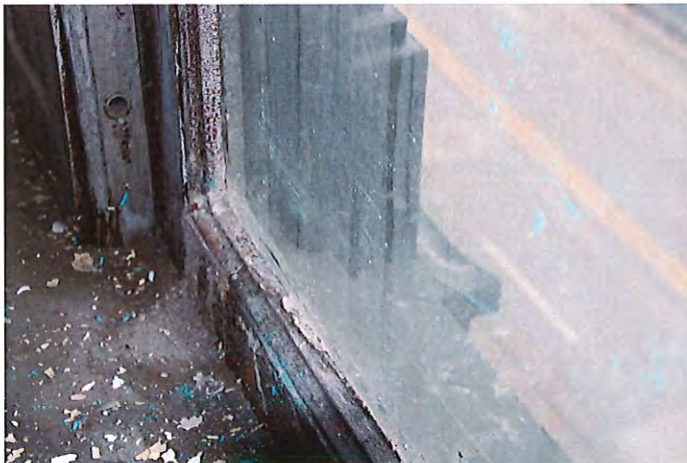
Stool/Sash Detail  
Wood Double Hung

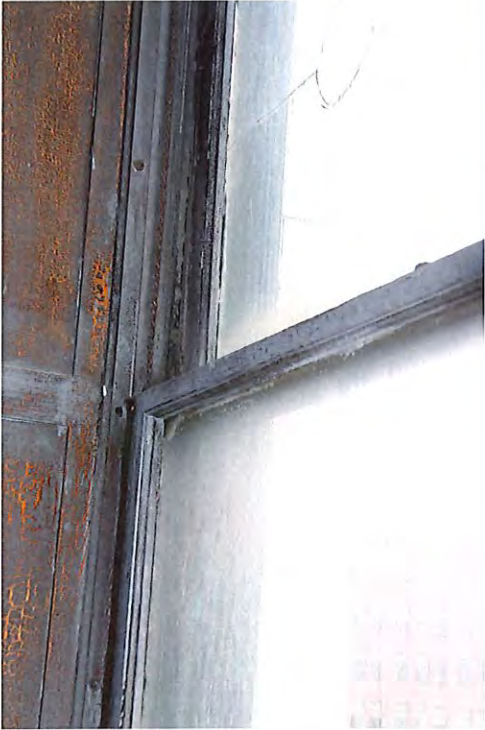
Interior Jamb Detail  
Wood Double Hung

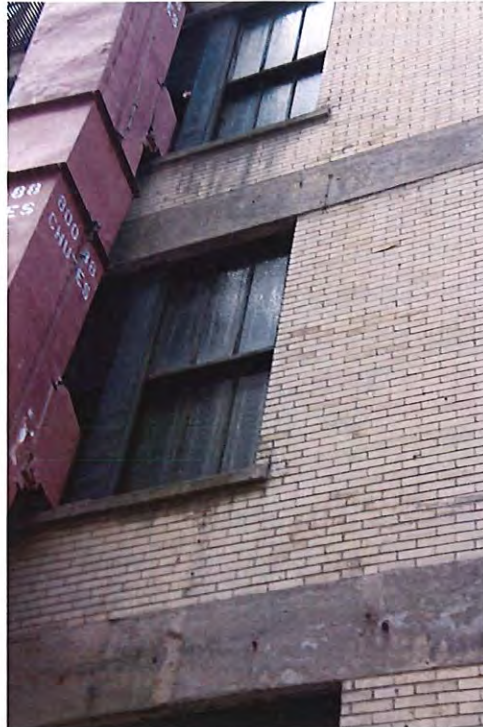
These windows are located on the West Elevation, rear façade on the alley side of the building. The windows are in poor condition with heavy corrosion and rust on all exterior components. Because of water penetration there is joinery failure at the bottom sash rail and meeting and meeting rail. These windows are notoriously difficult to restore since there is no way to arrest the corrosion in the tubular profiles. Even when the exterior surfaces are in good condition the joinery will show rust deposits soon after full restoration. Glazing compound is failed and likely contains asbestos as well as all the perimeter exterior caulking. The sash and frame components mimic wood window in the era. The bottom rail is 4", the typical side rail is 1 3/4" and top rail is 1 3/4"; meeting rail is 1 3/4". The parting bead is 1/2" x 1/2" and sash stop is 1/2" x 1 3/4". Note all window components are galvanized steel. All sashes are 2" thick and have 1/4" clear plate glass. Muntins are 1 1/2", and mullions are approximately 9" but must be checked from the exterior since the window are inoperable. The interior case work is in various states of condition, some is missing, some is damaged, and some is in good shape.

Exterior of Steel  
Double Hung

**Recommendation: BlackBerry would recommend the full replacement of the cold rolled steel windows with an historic replica thermally broken aluminum single hung window. The entire existing metal frames and sash would be removed and replaced. The following budget price does not include the metal door and transoms. We would need direction as to the design, hardware, and code compliance issues. Windows will require lead paint and ACM abatement.**

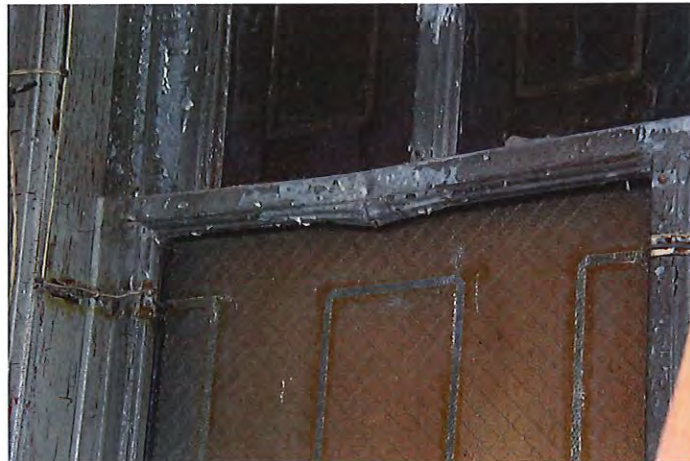
Meeting Rail of Steel  
Double Hung

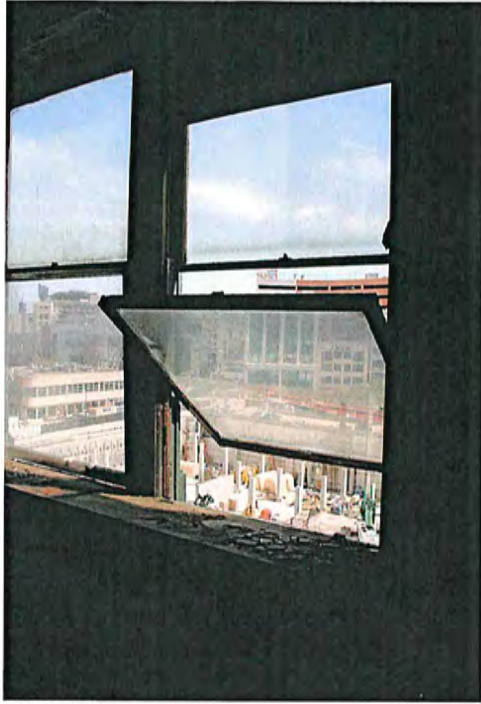
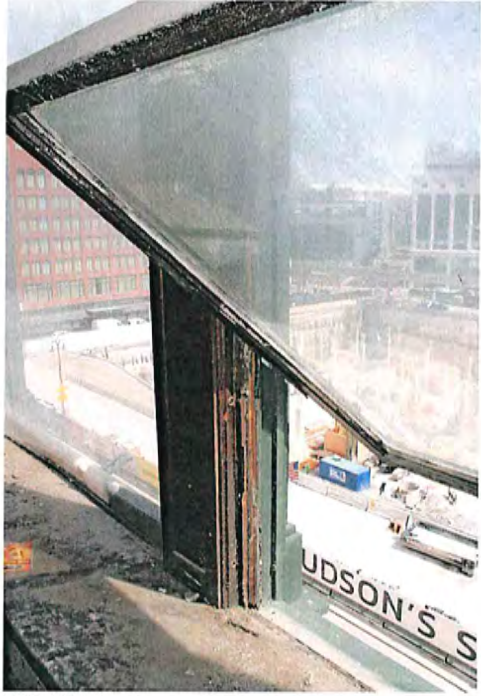
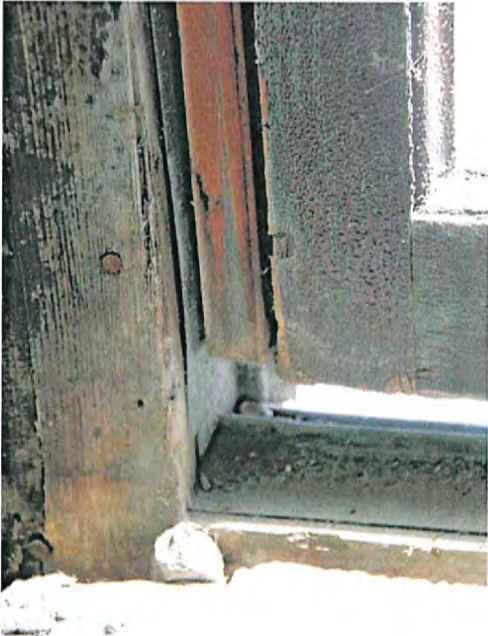
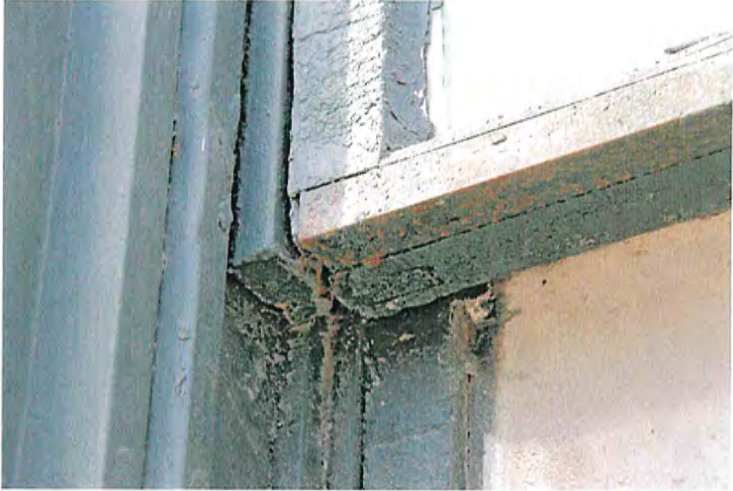
rotate on a horizontal axis to be washed from the interior. All jambs have a split side stile that allows a portion of the sash to separate from main body of the sash, staying in place in the jamb pocket. See Figures 1- 4. From inspection the majority of the upper and lower sashes do not have functioning pivot hardware and the portion of the jambs that stay stationary are broken, split, and not functioning. All these would have to be replaced and no tooling is available nor replacement hardware since the product has not been manufactured since after WWII. The condition really eliminates any option for any sash restoration. Replacement sashes can be manufactured without this feature as proposed and fixed in place to provide a restoration/replication scenario.

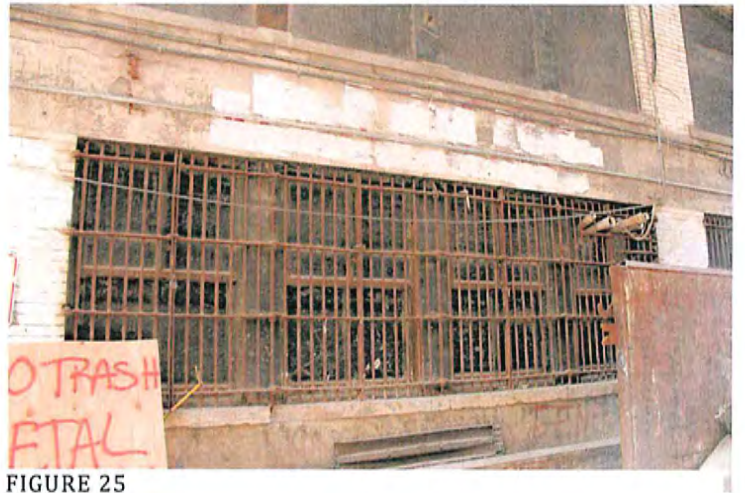
FIGURE 24

These windows are located on the West Elevation, rear façade on the alley side of the building. The windows are in poor condition with heavy corrosion and rust on all exterior components. These windows are notoriously difficult to restore since there is no way to arrest the corrosion in the tubular profiles. Even when the exterior surfaces are in good condition the joinery will show rust deposits soon after full restoration. The key concerns and areas of deterioration are as follows:

- These windows appear to not have been maintained for decades without any exterior painting or caulking. Sashes are rusted shut with no signs of galvanized material remaining. Many of the sill and frame corner joinery location are failed or failing with metal twisted or material is missing by corrosion. See Figures 20-23.
- It is difficult to provide photos because the majority of the openings are covered by heavy metal bars or metal fire escape sections. Likewise, the alley is only about 12' wide so getting photos showing the entire rear façade was not possible, even with a lift. Without reservation these windows need to be removed and replicated with a thermally broken aluminum historic replication. See Figures 24-25.
