**STAFF REPORT:** 08-12-2020 MEETING

**APPLICATION NUMBER:** 20-6791

**ADDRESS:** 869 LONGFELLOW

**SCOPE:** REPLACE 10 WOOD 1/1 DOUBLE-HUNG WINDOWS WITH PELLA ARCHITECT SERIES 1/1 DOUBLE-HUNG WINDOWS

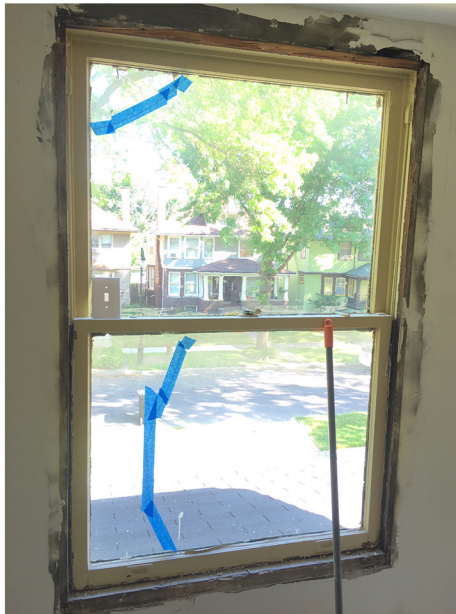
**ROTTED WOOD**

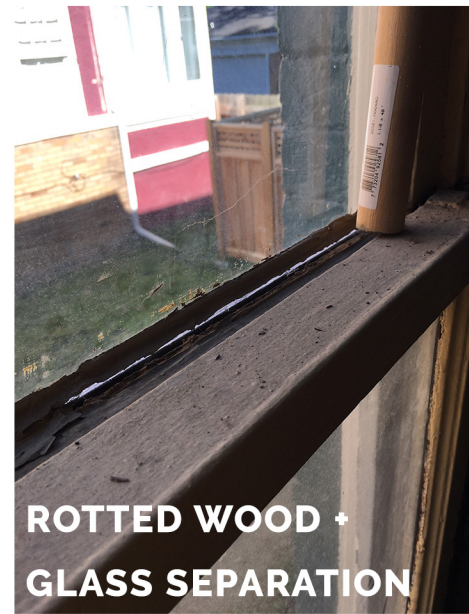
**BROCKEN GLASS**

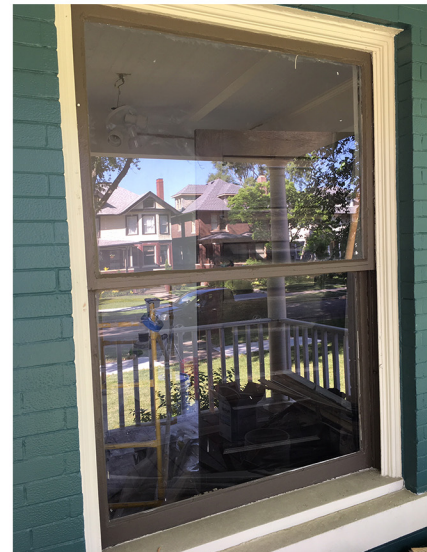
**ROTTED WOOD +  
GLASS SEPARATION**

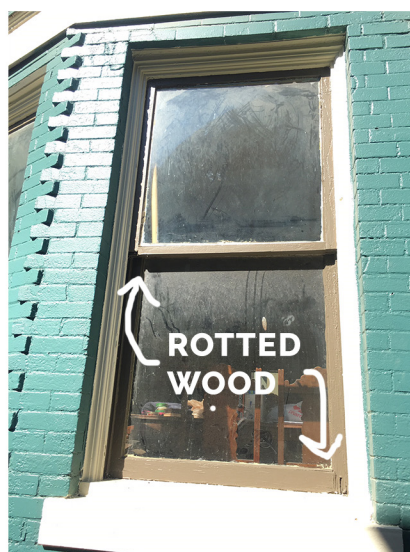
**EXTERIOR VIEWS**
