STAFF REPORT: 12/16/2020 MEETING

APPLICATION NUMBER: #20-6988

ADDRESS: 701 W. CANFIELD

SCOPE: REPLACE EXISTING VINYL AND WOOD WINDOWS WITH ALUMINUM CLAD WOOD WINDOWS

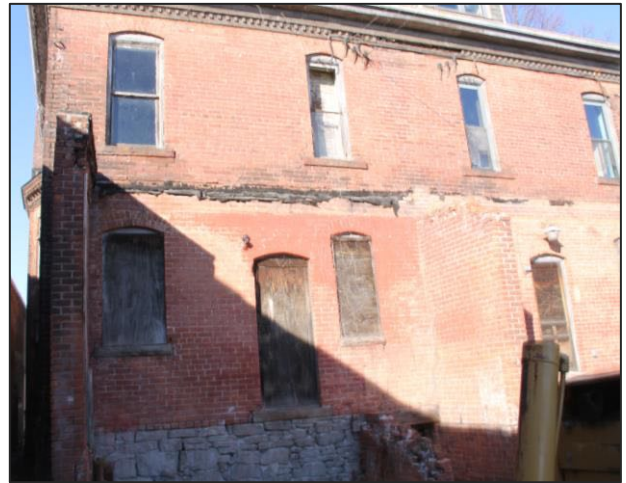
Rear Elevation of 701 W. Canfield

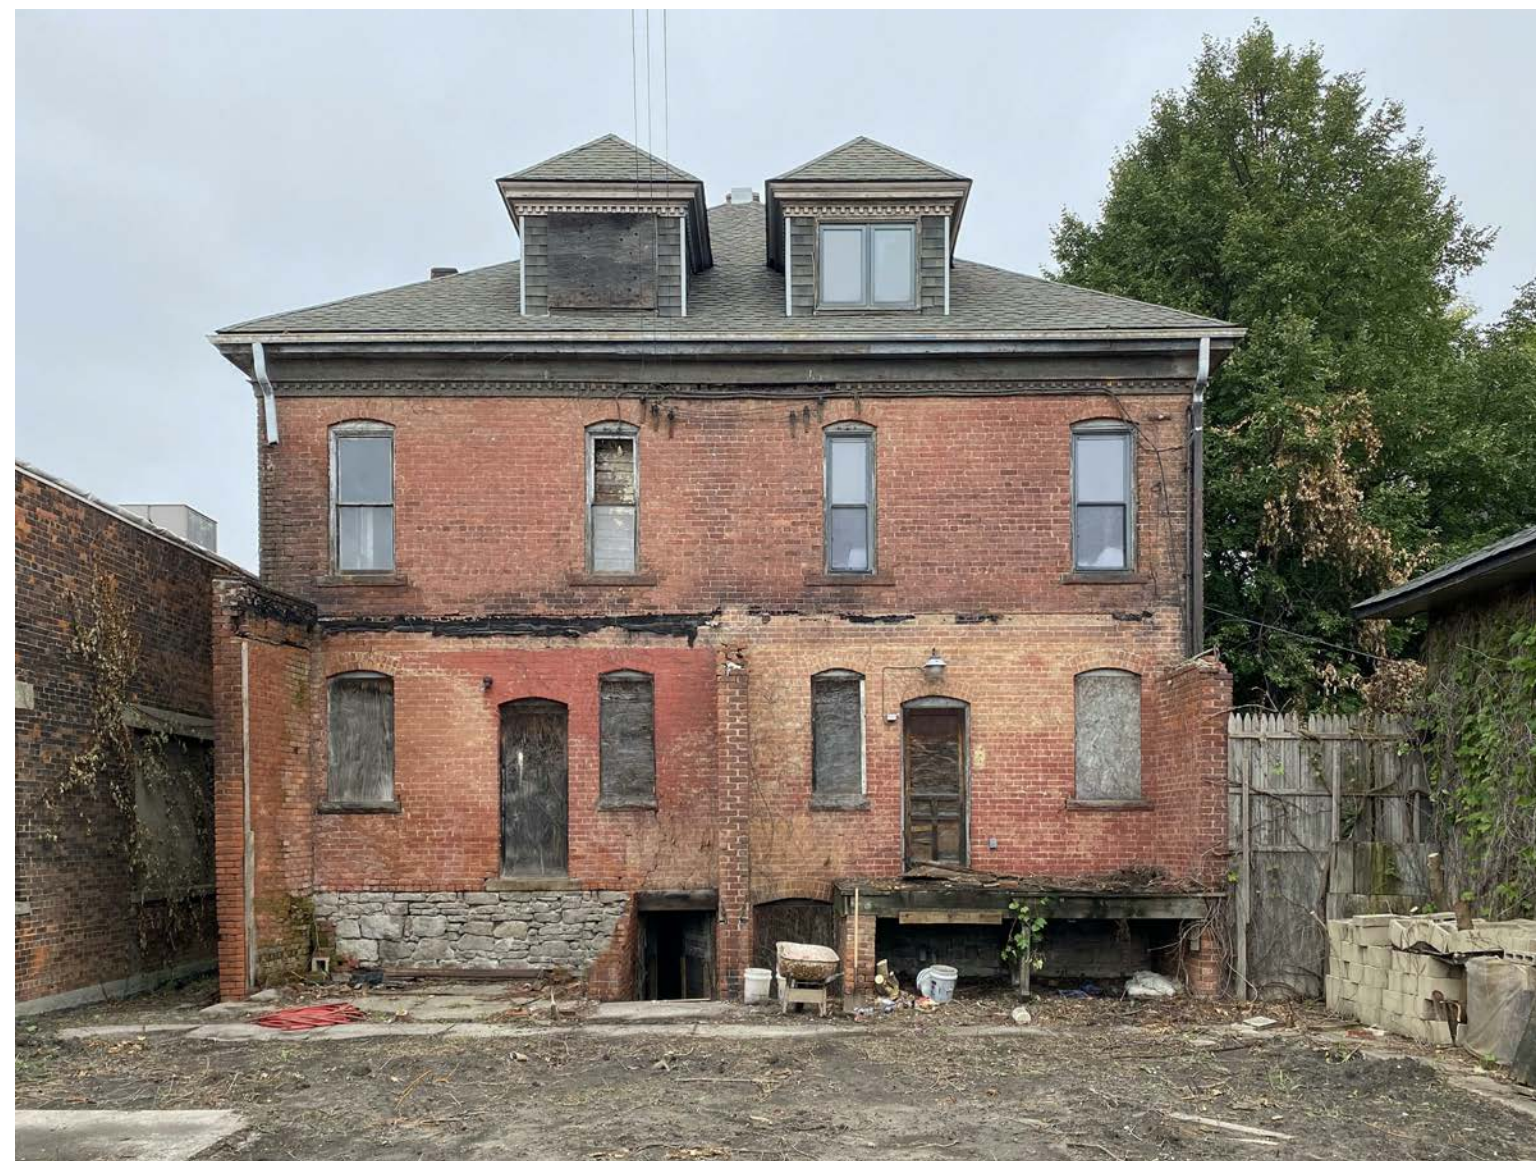
2. PHOTO FROM REAR - EXISTING CONDITIONS

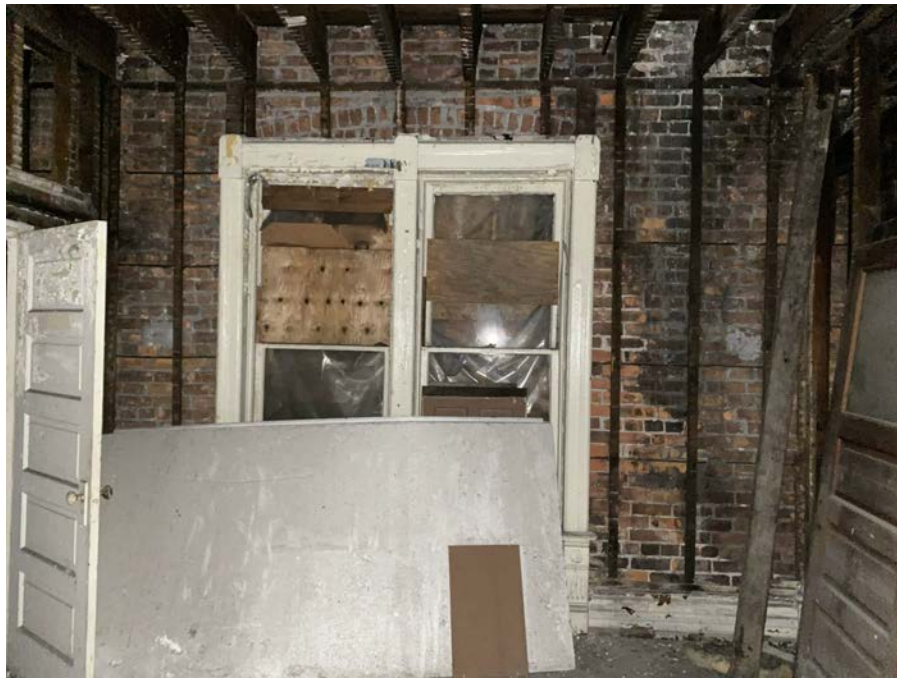
4. EXISTING WINDOW TYPE 1F (WEST)

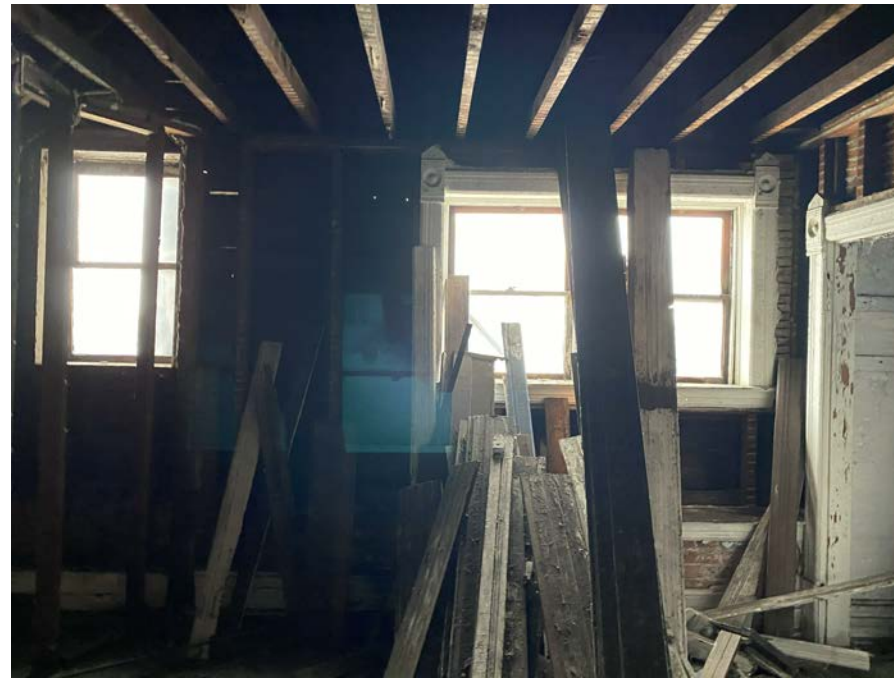
5. EXISTING WINDOW TYPES 3C & 3D (WEST)

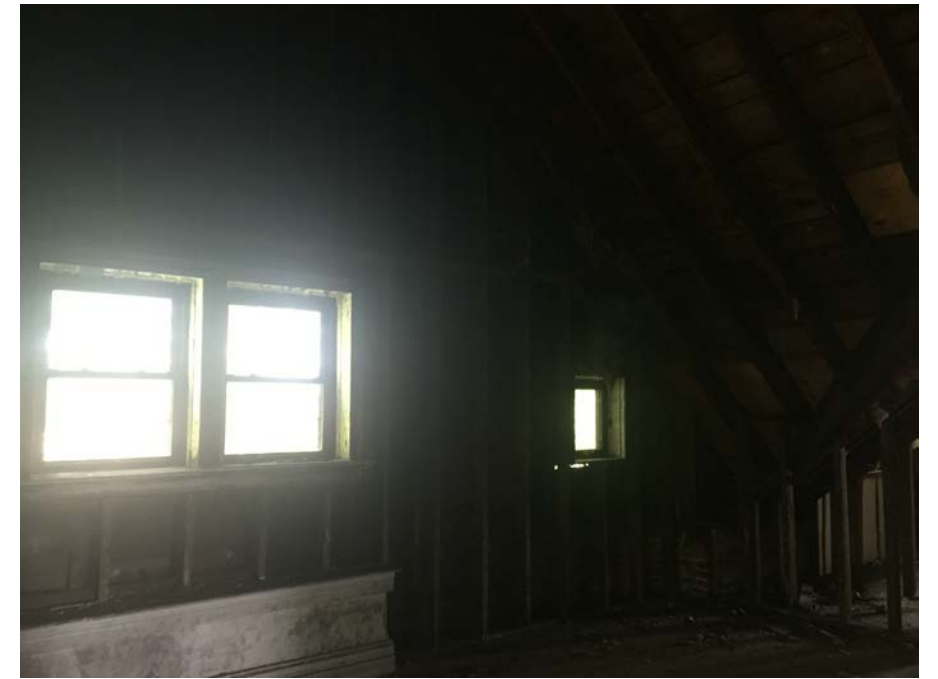
6. EXISTING WINDOW TYPES 3C & 3D (EAST)

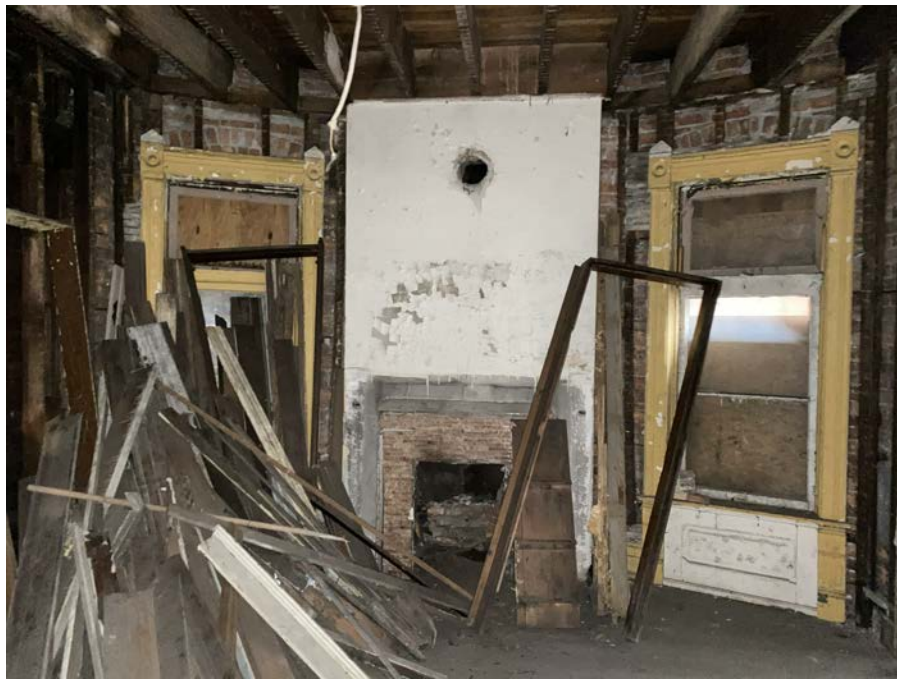
1. EXISTING WINDOW TYPES 1D & 1E (WEST)

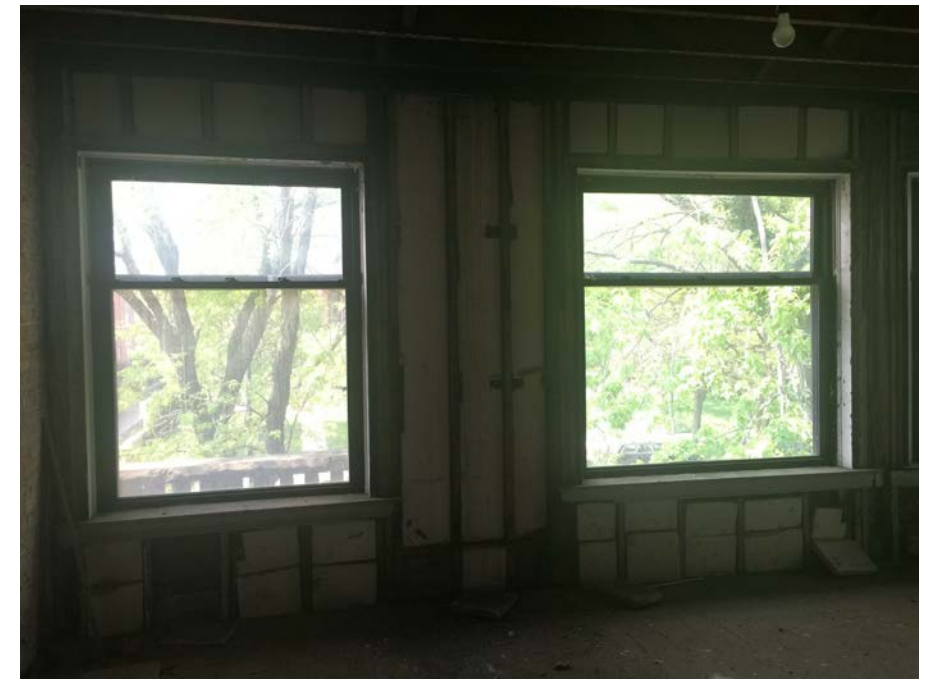
3. EXISTING WINDOW TYPES 2A & 2B (EAST)

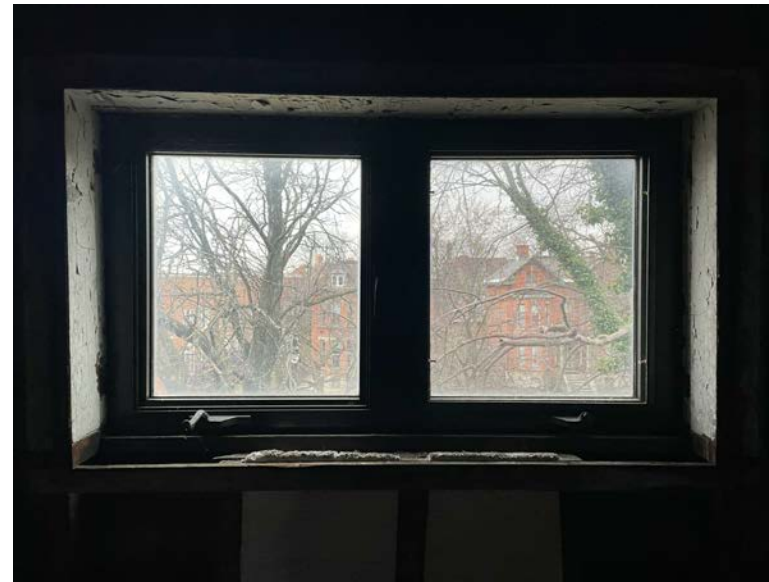
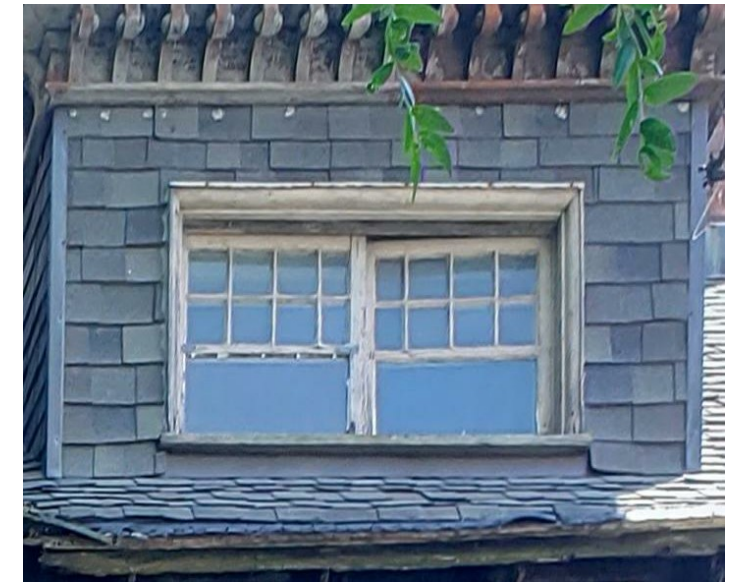
2 WINDOW TYPE 3B

EXISTING WINDOW 3B WEST:
WOOD FRENCH INSWING CASEMENT

WINDOW 3B - EAST (INTERIOR)
(2) OUTSWING VINYL CASEMENT

WINDOW 3B - WEST:
WOOD INSWING FRENCH CASEMENT
WITH MUNTIN GRID

PROPOSED WINDOW:
MARVIN CLAD ULTIMATE INSWING CASEMENT G2
WITH SDL MUNTIN AND INTERNAL SPACER BAR

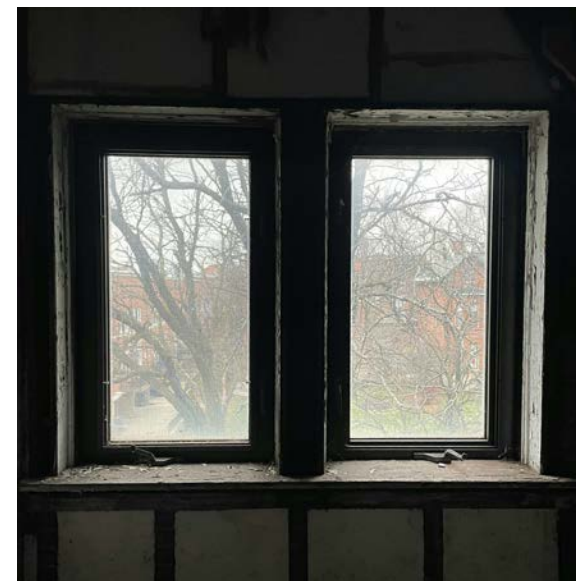
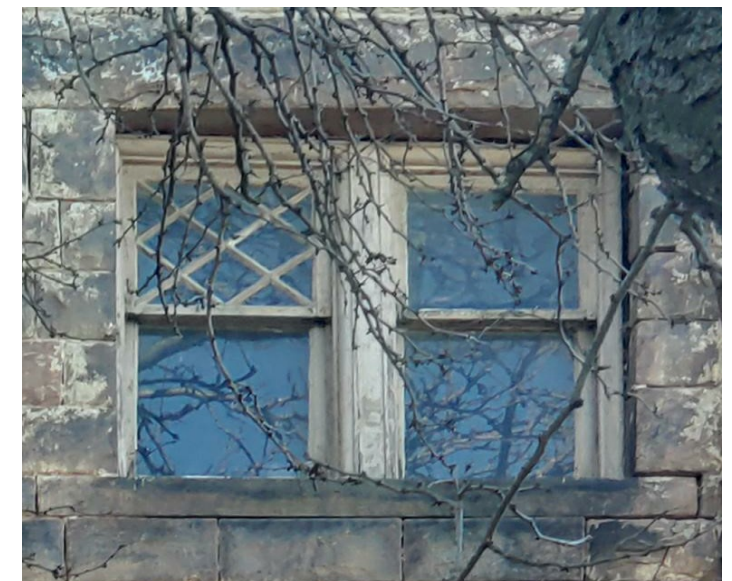
1 WINDOW TYPE 3A

EXISTING WINDOW 2F:
EAST: (2) VINYL CASEMENT
WEST: (2) WOOD DOUBLE-HUNG

WINDOW 3A - EAST (INTERIOR)
VINYL CASEMENT

WINDOW 3A - WEST
WOOD DOUBLE-HUNG

PROPOSED WINDOW:
MARVIN CLAD ULTIMATE DBL-HUNG G2
WITH SDL MUNTIN AND INTERNAL SPACER BAR

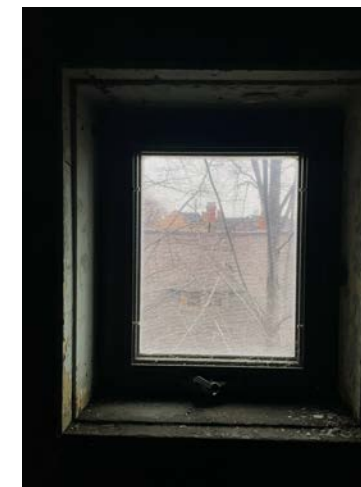
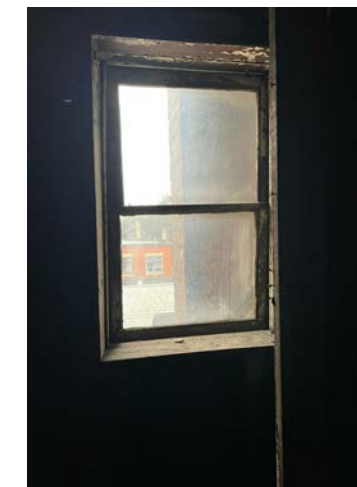
2 WINDOW TYPE 3D

EXISTING WINDOW 3D EAST
VINYL CASEMENT

EXISTING WINDOW 3D WEST
WOOD DOUBLE-HUNG

WINDOW 3D - EAST (INTERIOR)
OUTSWING VINYL CASEMENT

WINDOW 3D - WEST (INTERIOR)
WOOD DOUBLE-HUNG

PROPOSED WINDOW 3D EAST
MARVIN CLAD ULTIMATE
CASEMENT

PROPOSED WINDOW 3D WEST
MARVIN CLAD ULTIMATE
DBL-HUNG G2

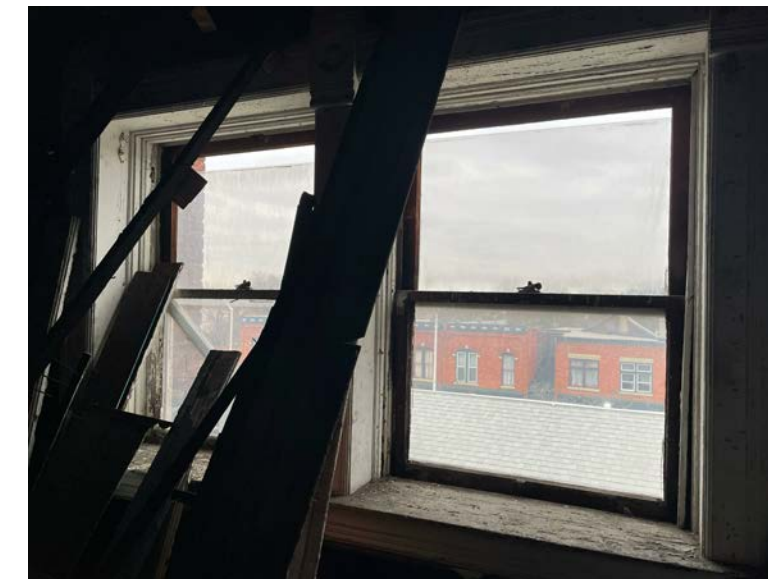
1 WINDOW TYPE 3C

EXISTING WINDOW 2F:
EAST: VINYL DOUBLE-HUNG
WEST: WOOD DOUBLE-HUNG

WINDOW 3C - EAST (INTERIOR)
(2) VINYL DOUBLE-HUNG

WINDOW 3C - WEST
(2) WOOD DOUBLE-HUNG

PROPOSED WINDOW:
MARVIN CLAD ULTIMATE DBL-HUNG G2

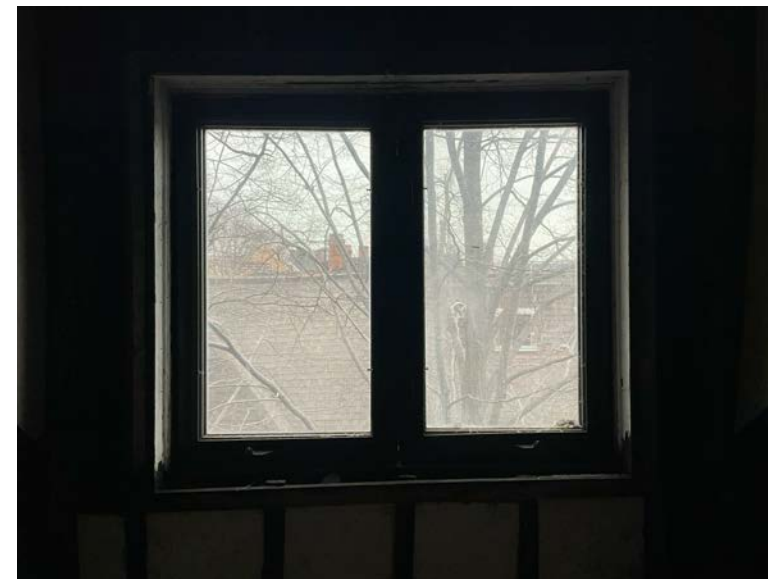
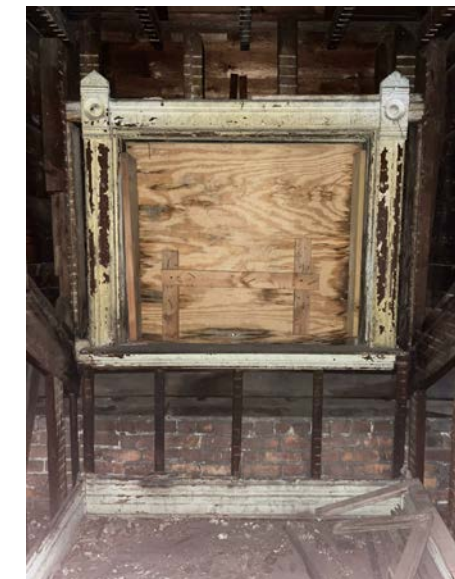
1 WINDOW TYPE 3E

EXISTING WINDOW 3E EAST:
(2) VINYL CASEMENT

EXISTING WINDOW 3B WEST:
MISSING

WINDOW 3E - EAST (INTERIOR)
(2) OUTSWING VINYL CASEMENT

WINDOW 3B - WEST (INTERIOR)
MISSING
ASSUMED FRENCH CASEMENT

PROPOSED WINDOW:
MARVIN CLAD ULTIMATE FRENCH INSWING
CASEMENT G2
