**STAFF REPORT: FEBURARY 17, 2021 MEETING**

**APPLICATION NUMBER: 21-6997**

**ADDRESS: 14935 WESTWOOD**

**SCOPE OF WORK: REPLACE EXISTING WINDOWS, ADD ALUMINUM TRIM TO SOFFITS, FASCIA**

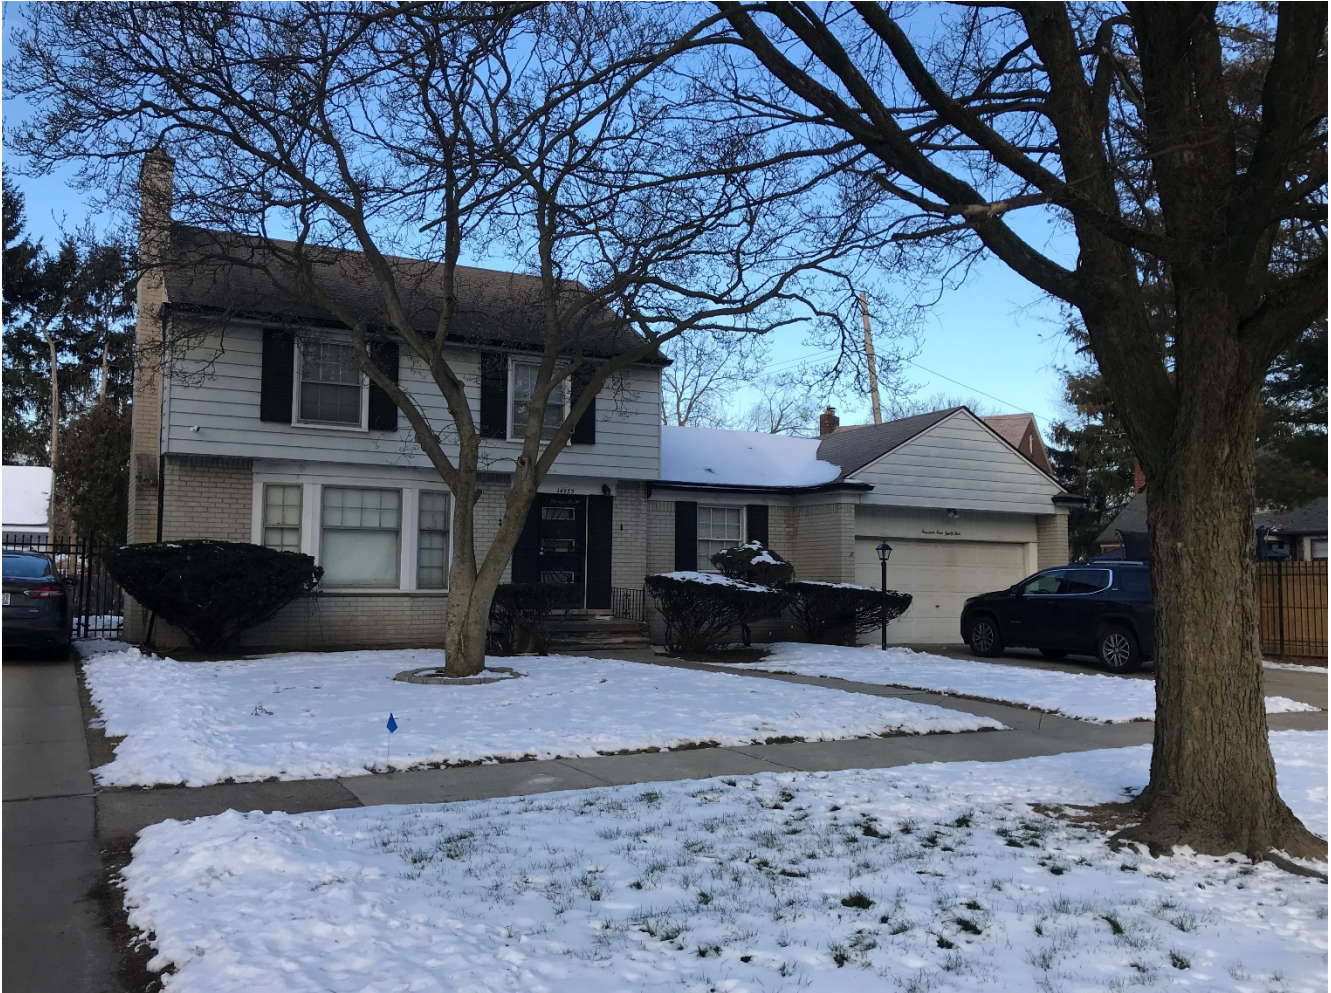
*14935 Westwood, staff photo.*

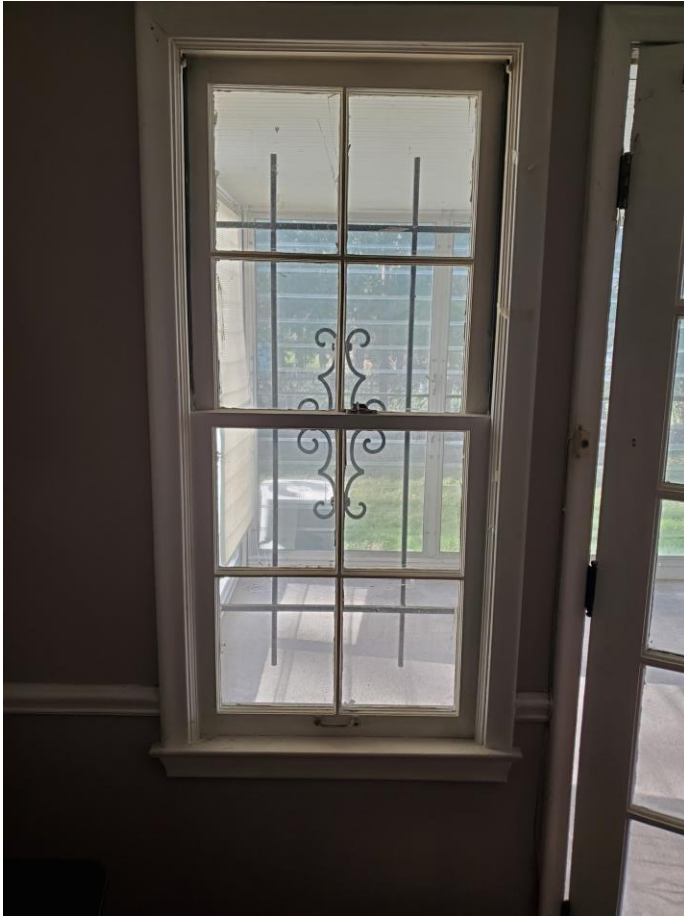
Dining room windows

painted shut

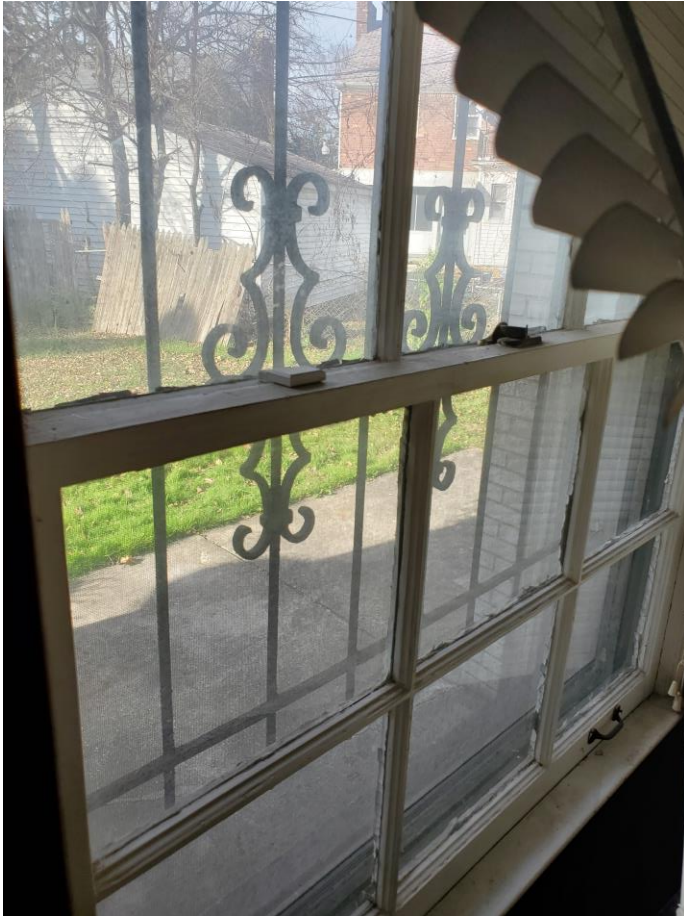
Living room 2 / Family  
room windows – 2 Units

Units does not operate well

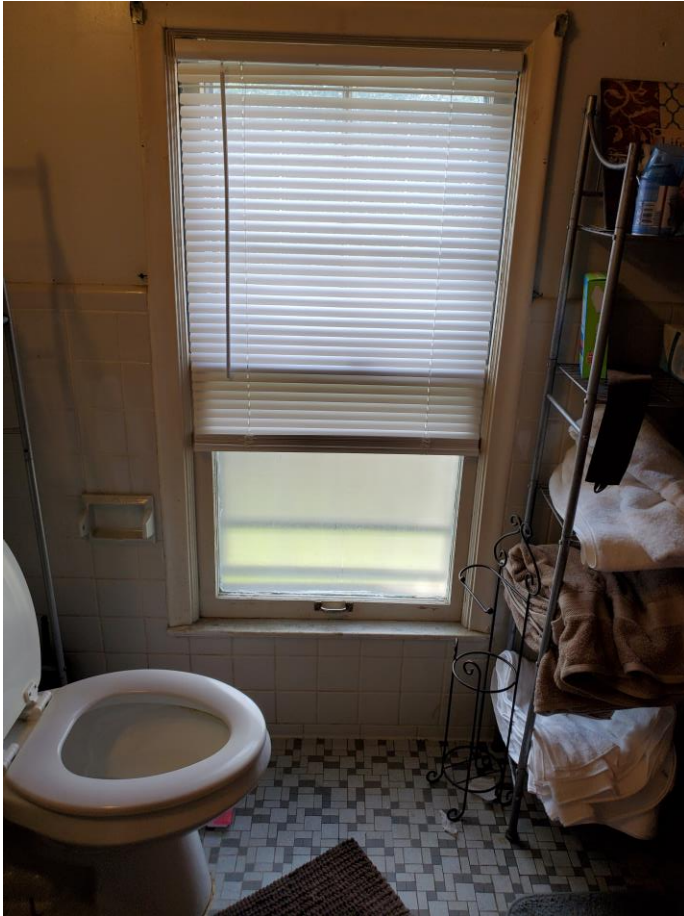
Side C Full Bath window

Unit does not operate well

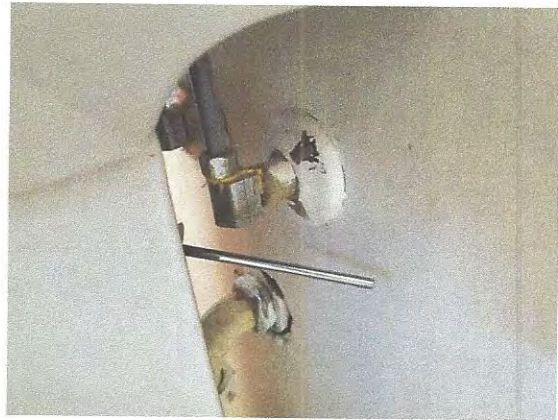
Bath 6 No Sink Shutoff

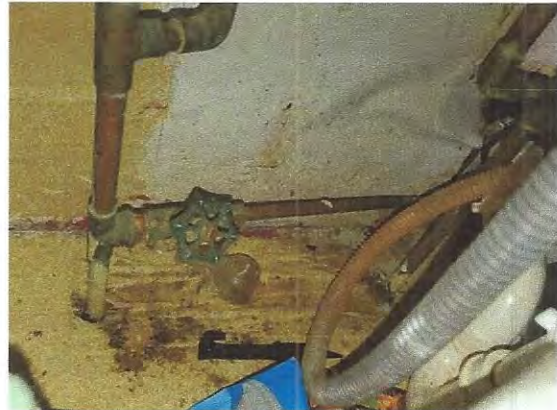
Kitchen 5 No Sink Shutoff

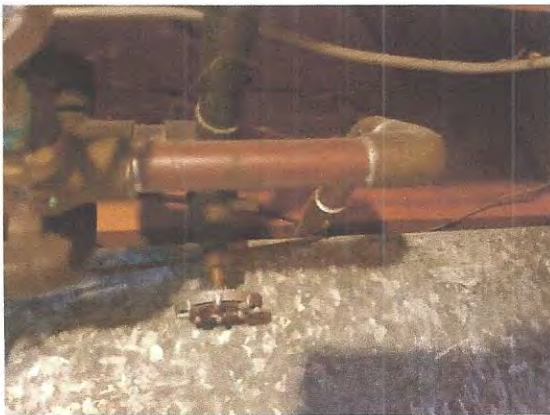
Utility 16 Soldered Copper Plumbing
