STAFF REPORT: FEBURARY 17, 2021 MEETING

APPLICATION NUMBER: 21-7096 & 21-7104

ADDRESS: 15327 WARWICK

SCOPE OF WORK: REPLACE 6 WINDOWS WITH VINYL WINDOWS (21-7096);

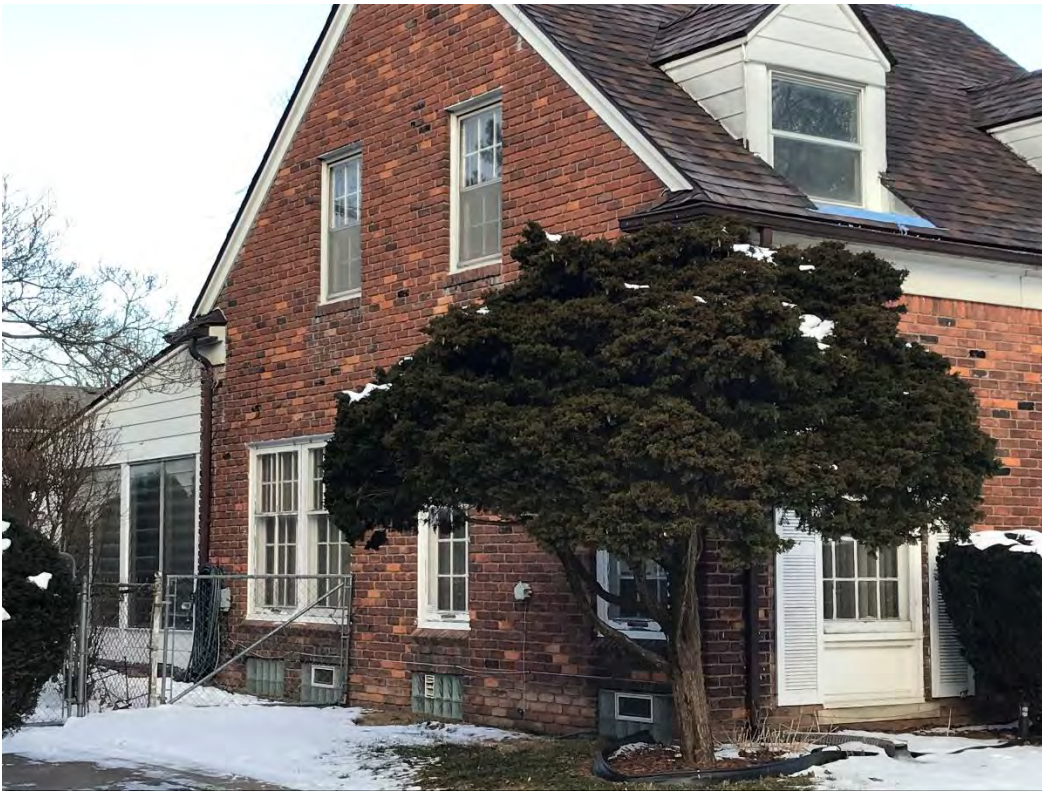
15327 Warwick, southwest view, staff photo.

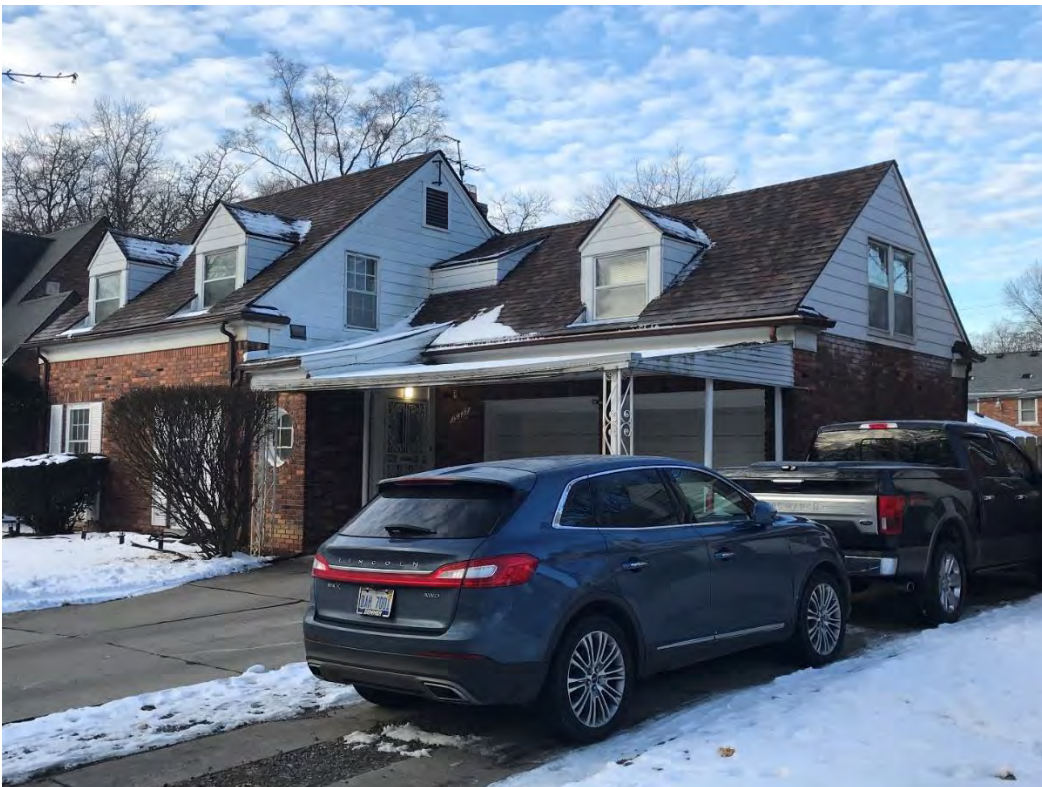
15327 Warwick, northwest view, staff photo.
