STAFF REPORT: FEBRUARY 9, 2022 MEETING

APPLICATION NUMBER: 22-7665, VIOLATION NUMBER: 543

ADDRESS: 715 VAN DYKE

SCOPE: DEMOLISH (WORK DONE WITHOUT APPROVAL) AND REBUILD FRONT PORCH

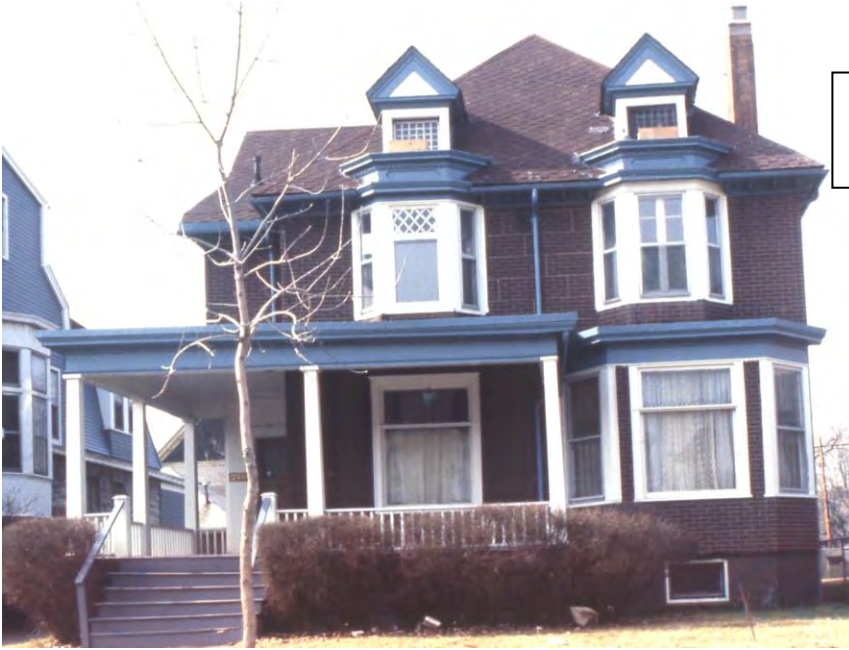
Left: Designation Photo, HDAB, 1983
Below: Sanborn Map, Vol. 8, 1910

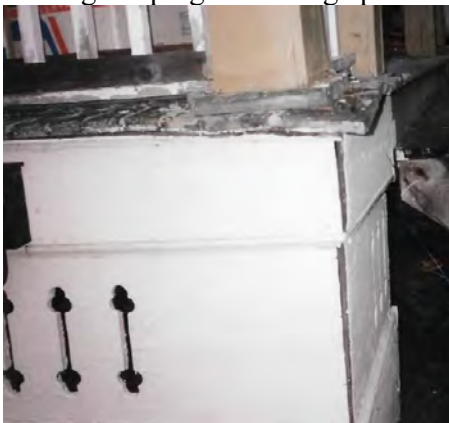
- Much discussion was held (between the applicant and staff, and then amongst staff) about the existing (at the time of demolition) porch skirting. The skirting to the left of the stairs was the oldest portion of this element. It is staff's opinion it is not a character-defining feature as it wasn't constructed in the manner of historic skirting, and likely not original to the house: it was constructed of solid pieces of wood (rather than vertical boards with the pattern cut at the board edges), and it wasn't framed out with the skirting sitting behind the frame. Staff also feels the below left design would not be stable over time due to moisture wicking into the wood and causing warping of the large panels.

- The skirting design will be revised to include framing and vertical boards at column/pier locations and will be submitted for staff review.
- The paint color/finish for each porch component (including decking) will be submitted for staff review.
- The porch elements won't be painted until the wood members have dried out.

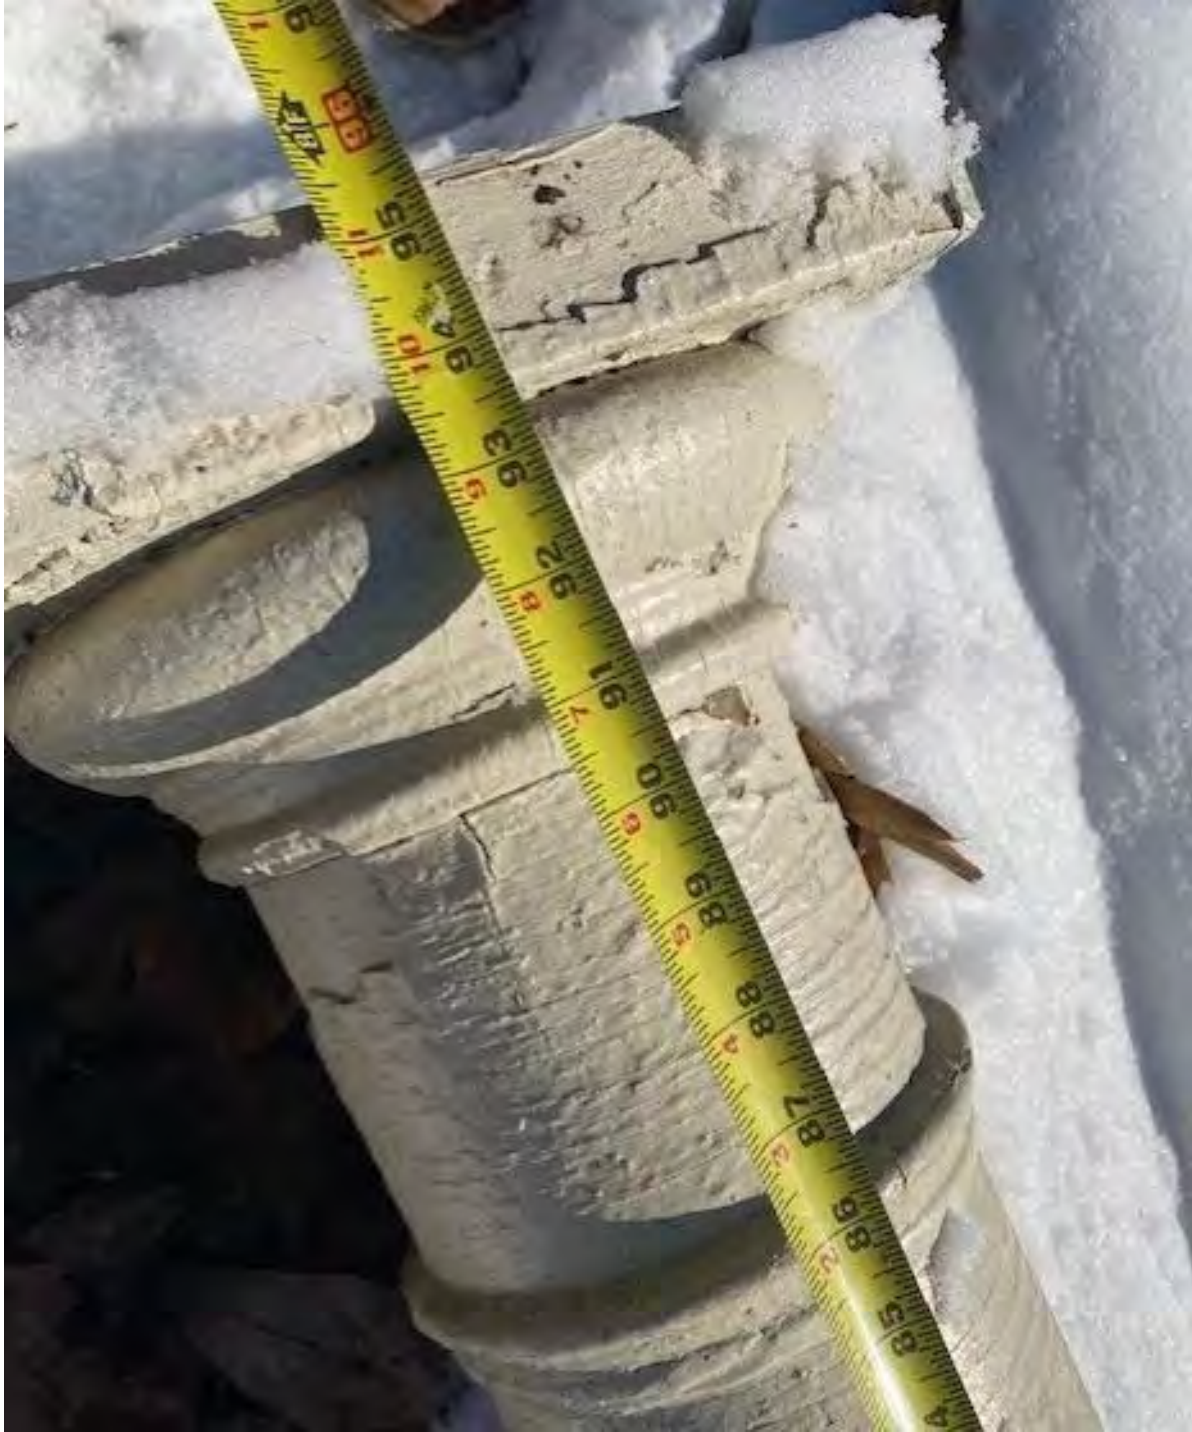
Height of the echinus (lower portion of the capital)

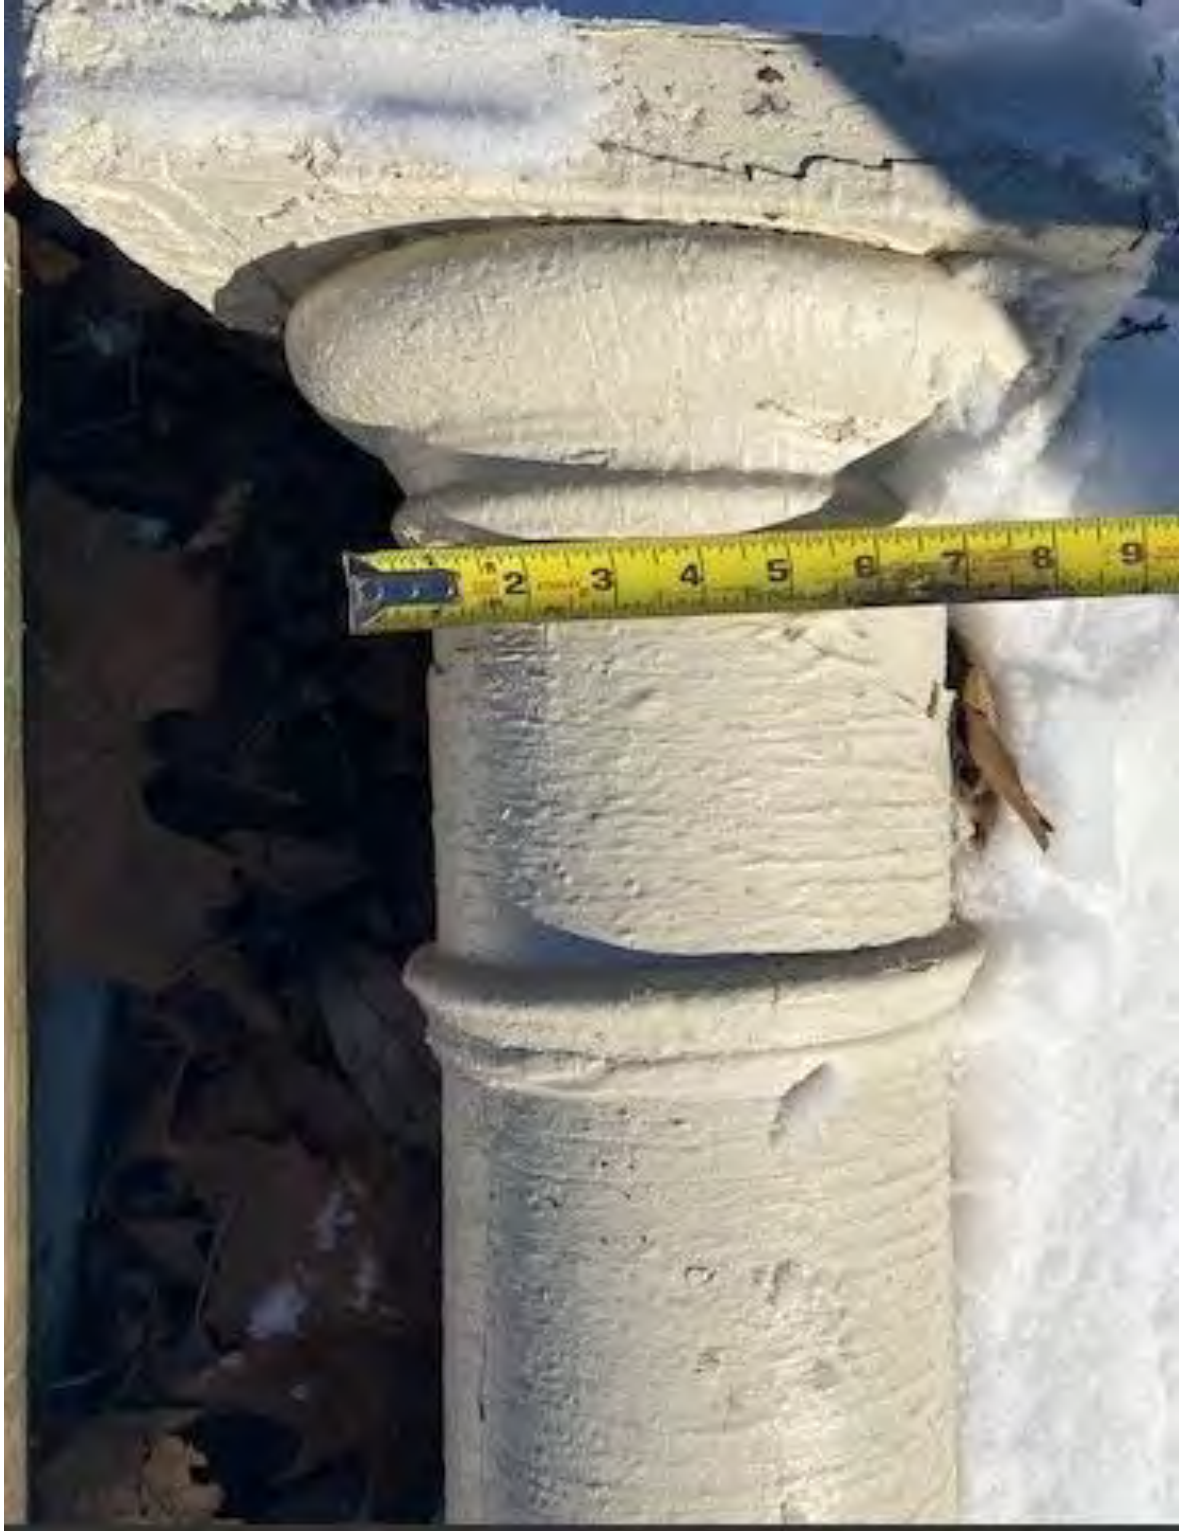
Width of the top of the pilaster shaft

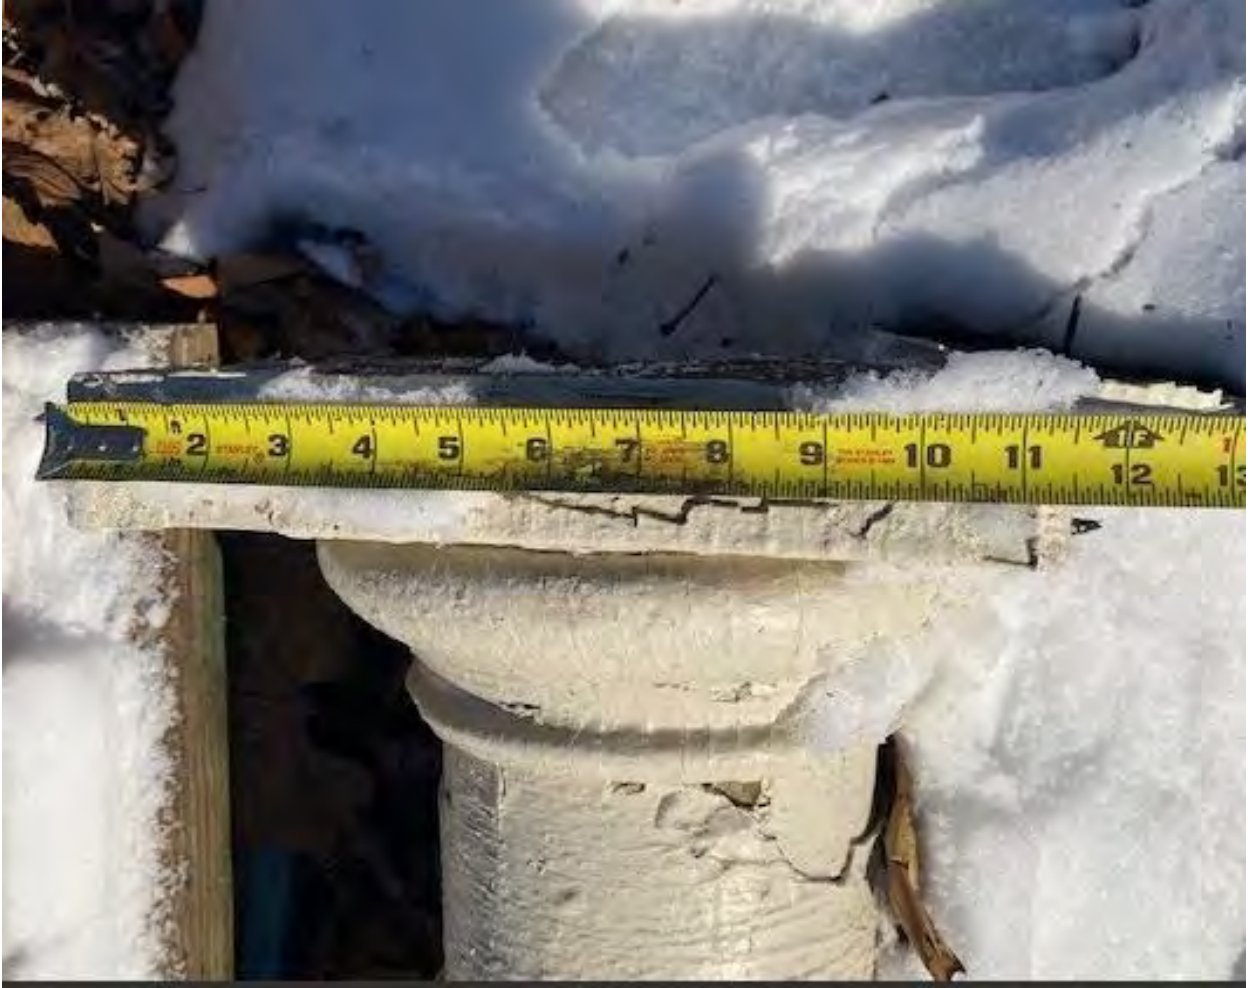
Width of the abacus (the flat slab forming the uppermost member of the capital of the column).

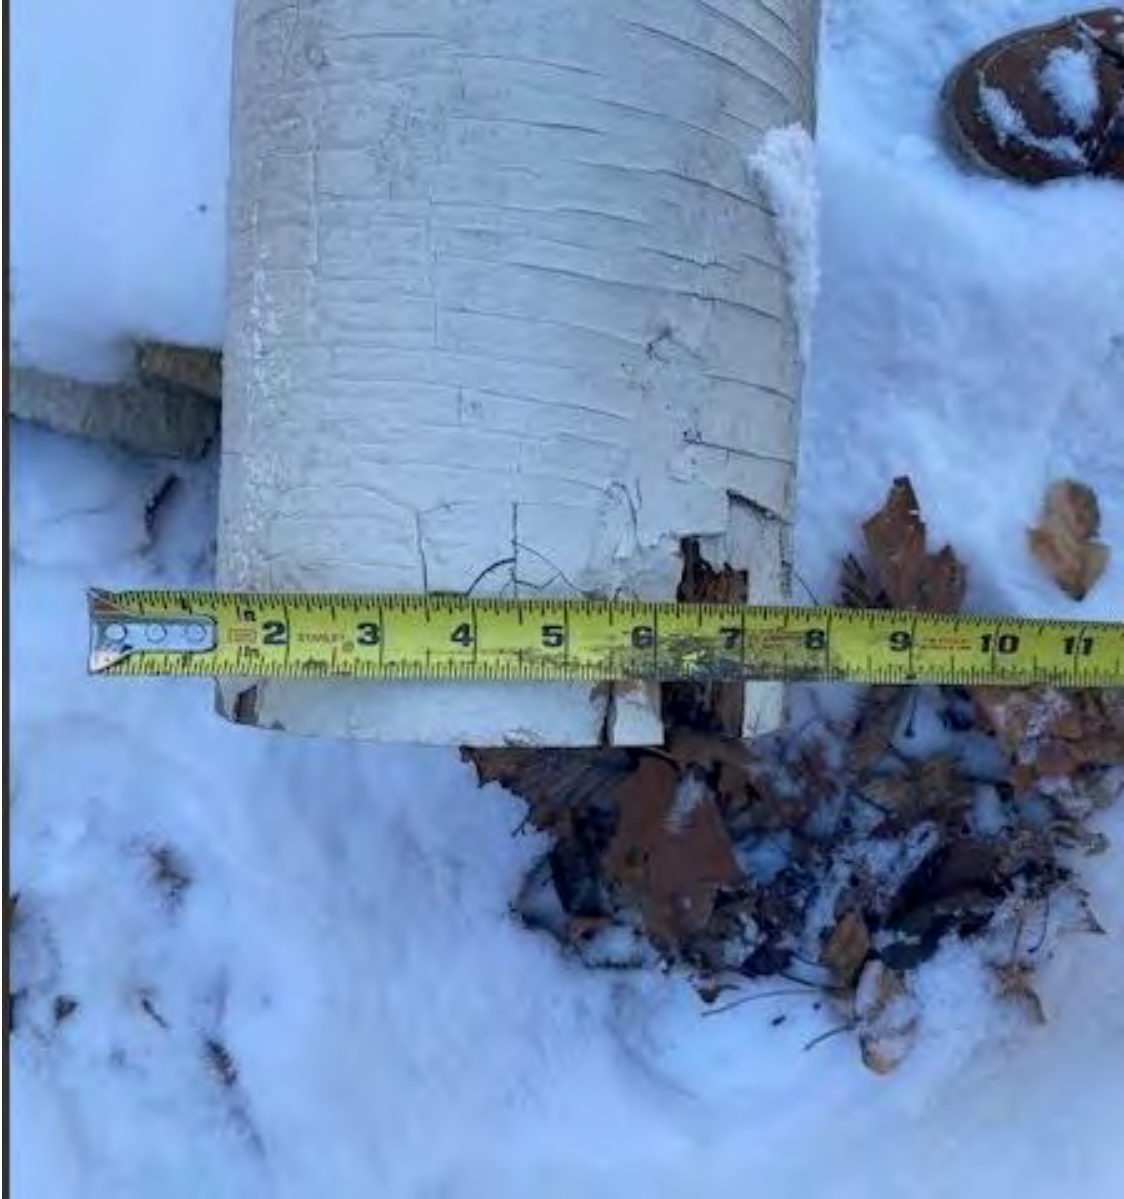
shaft bottom

Width of

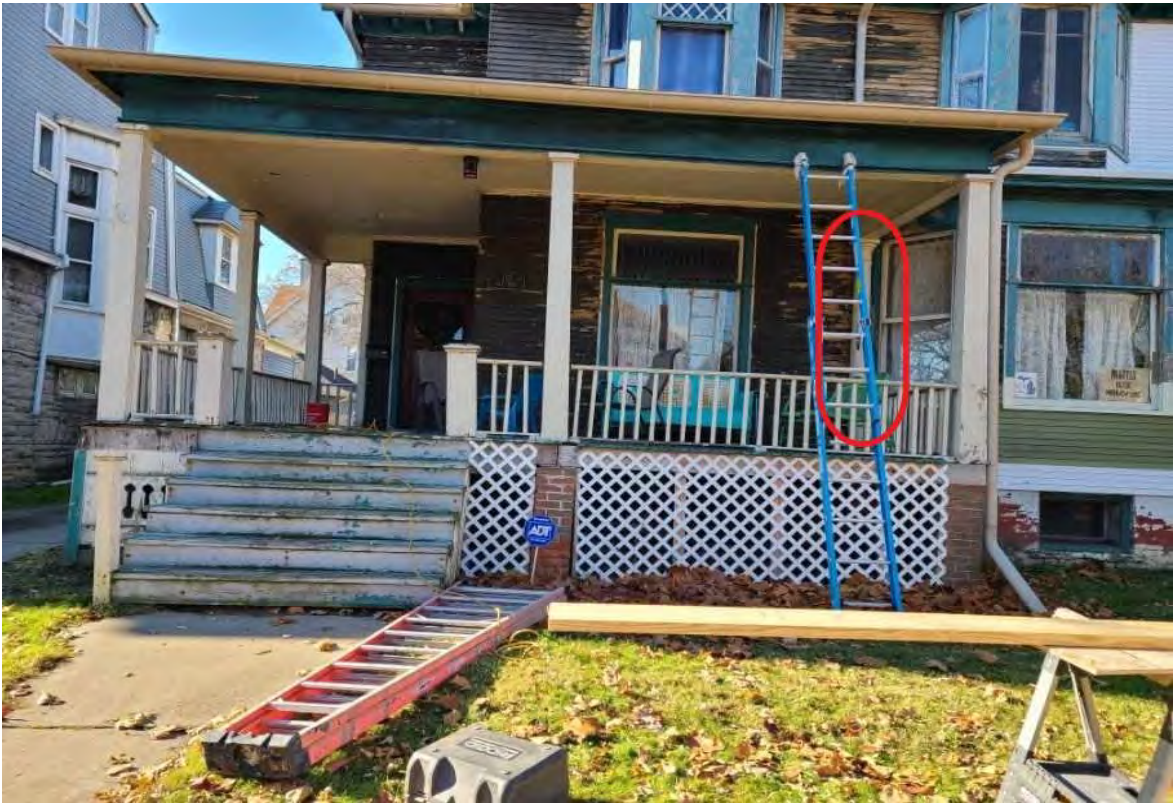
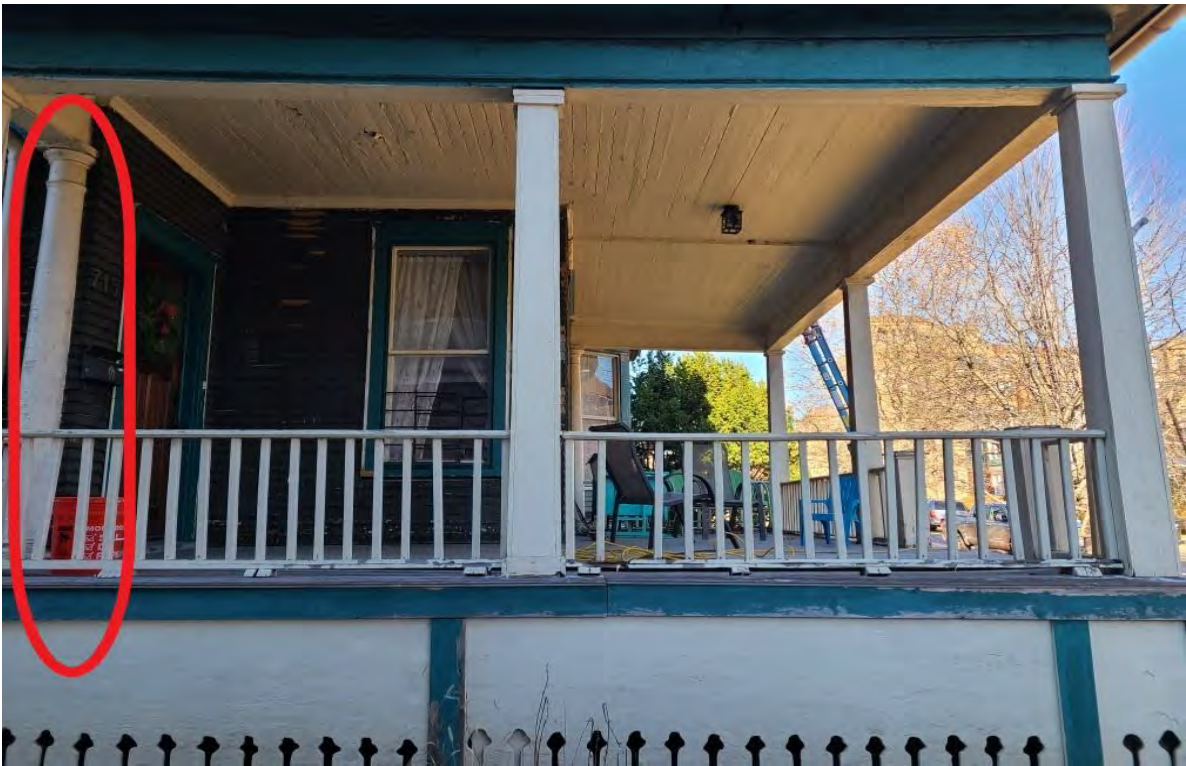
Locations of the rounds on the porch.
