STAFF REPORT: 10/12/2022 REGULAR MEETING

APPLICATION NUMBER: #22-8066

ADDRESS: 2011 LONGFELLOW

SCOPE: REPLACE WOOD WINDOWS WITH WOOD AND FIBERGLASS UNITS ALTER PORCH
(WORK COMPLETE WITHOUT APPROVAL)

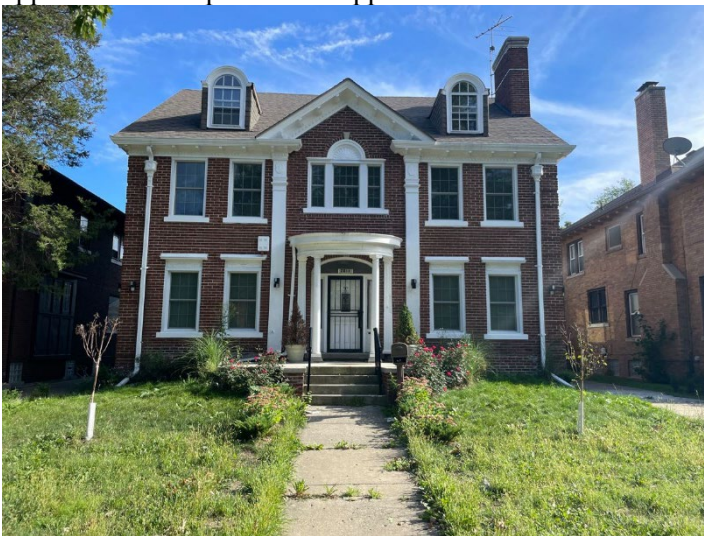
Site Photo 1, by Staff Sept. 19, 2022: (North) front elevation.
