# Elevated Blood Lead (EBL) Investigation Report

1772 Seyburn St.  
Detroit, MI 48214  
1912

Date of Inspection: 11/20/2020

Date of Report 11/30/2020

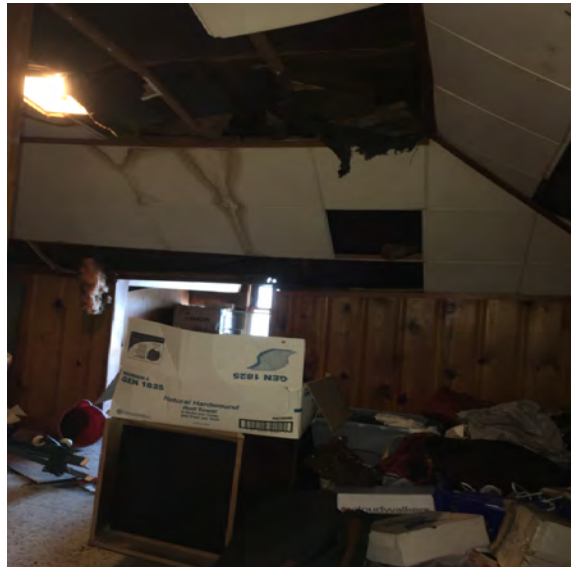
Attic (Not Painted) Pic 1

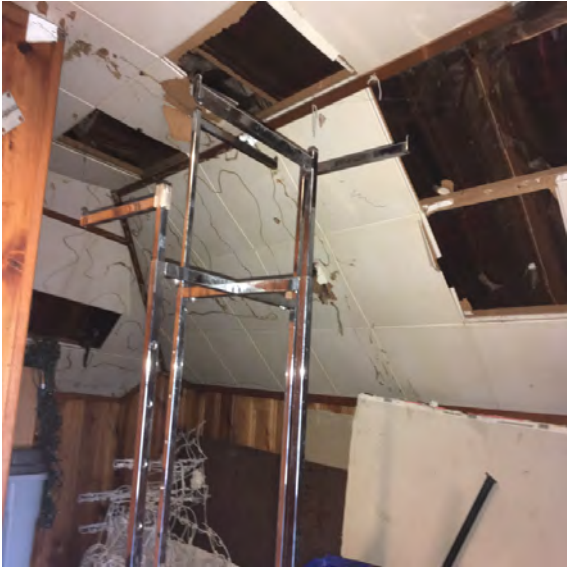
Attic (Not Painted) Pic 2

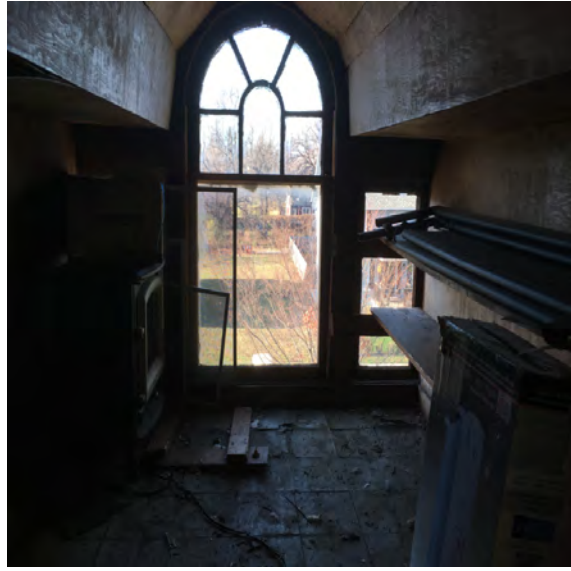
Attic (Not Painted) Pic 3

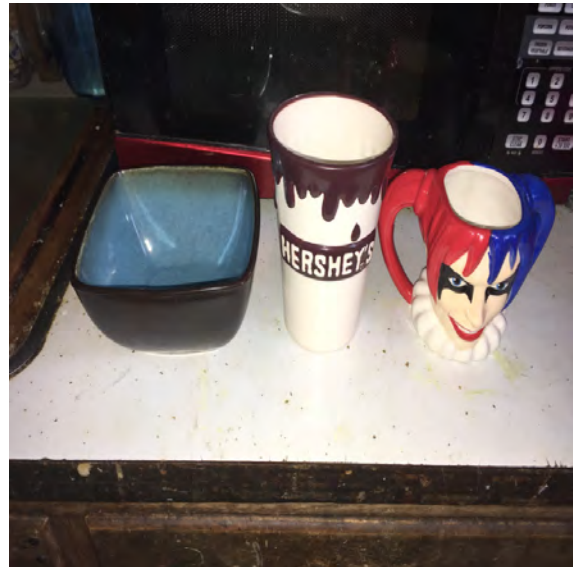
Bowl & Cups Tested

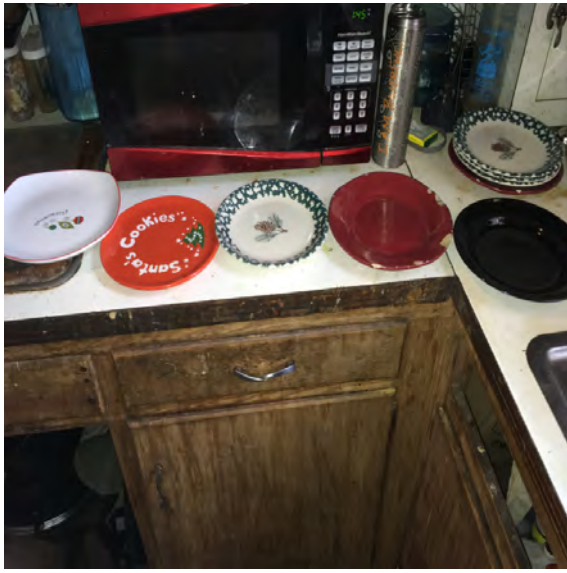
Plates Tested

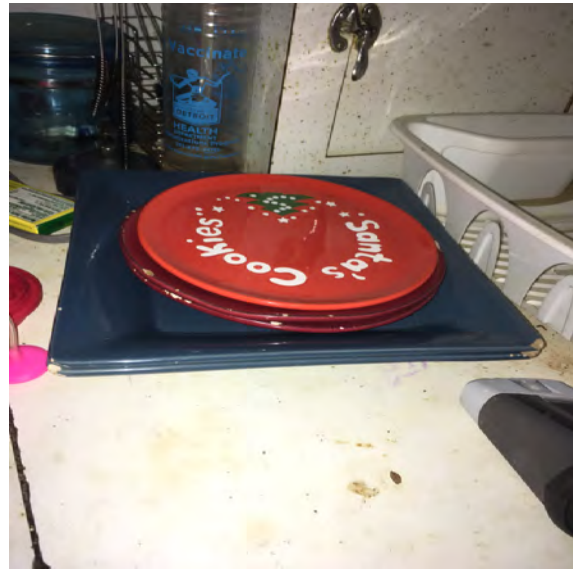
Dishes (Plates) Positive for Lead

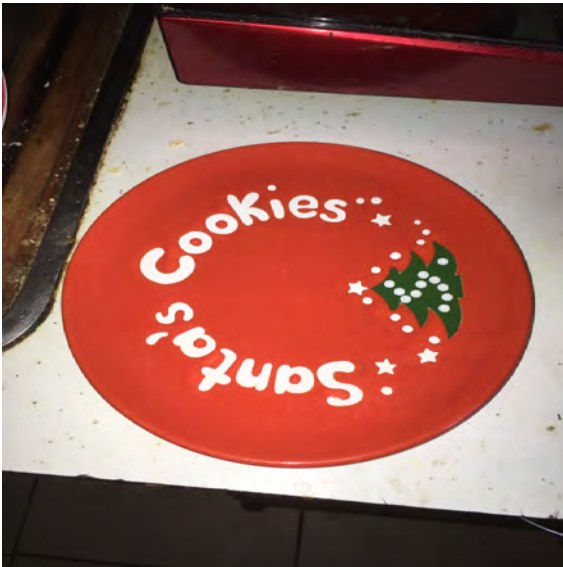
Plate Tested Positive (Dish 2)

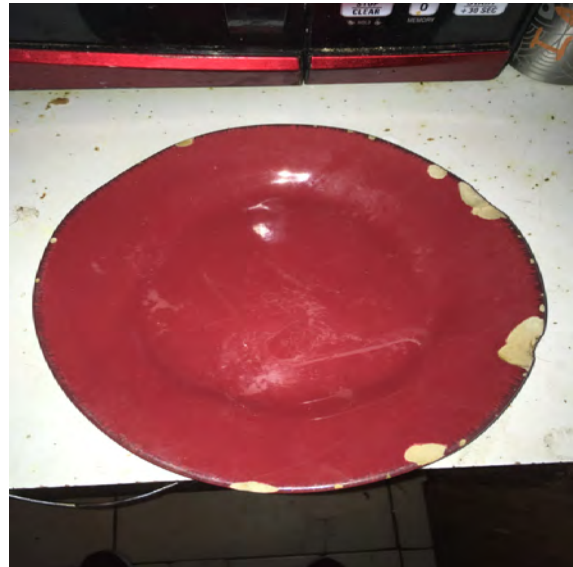
Plate Tested Positive (Dish 4)

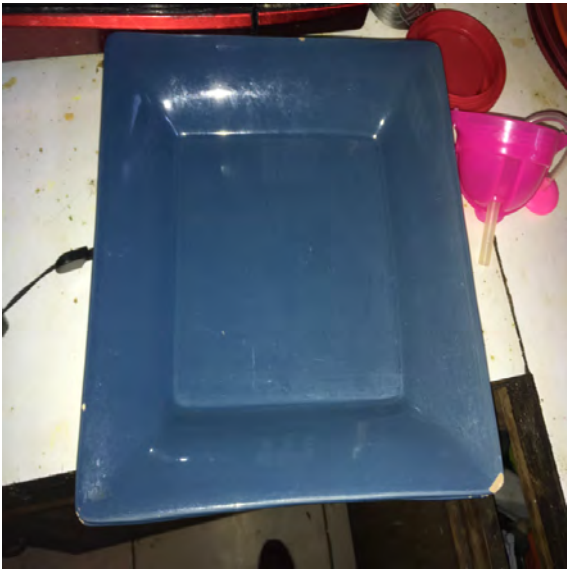
Plate Tested Positive (Dish 5)
