# HISTORIC DISTRICT COMMISSION PROJECT REVIEW REQUEST

ADDRESS(ES): 603 East Milwaukee AKA: Peerless Building

# EXTERIOR RENOVATION FOR PROJECT PEERLESS

**RE: 603-609 E. Milwaukee, Jam Handy/North End- East Grand  
Boulevard Historic District Window Replacement Request:  
Replace existing steel and wood windows**

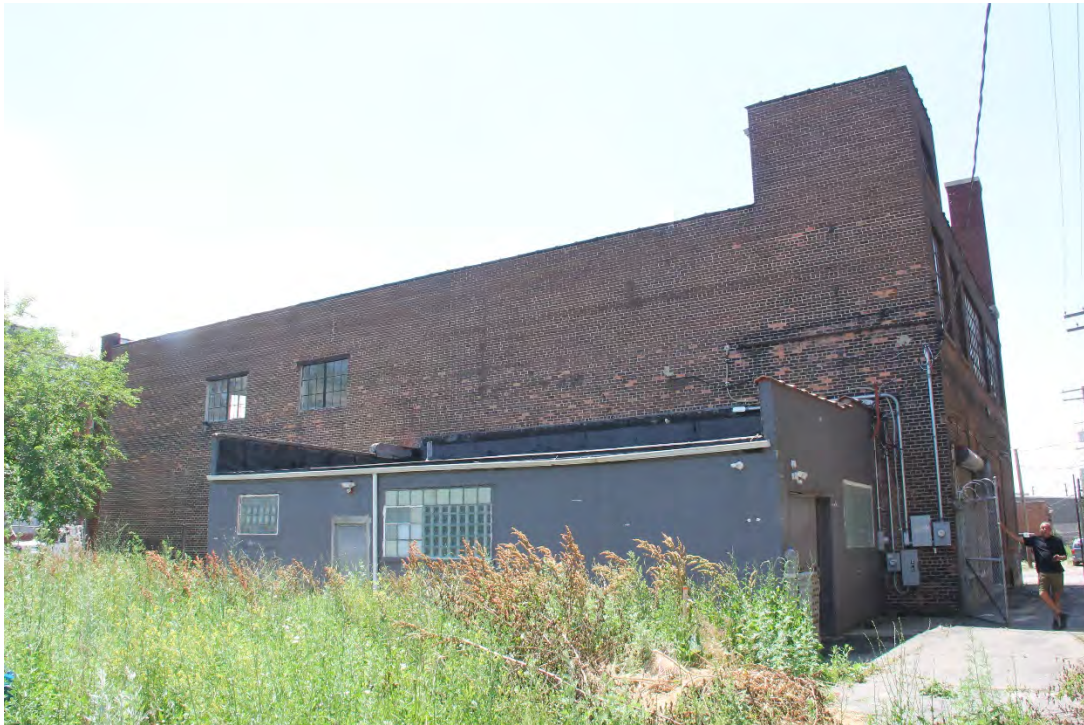
*South Elevation*

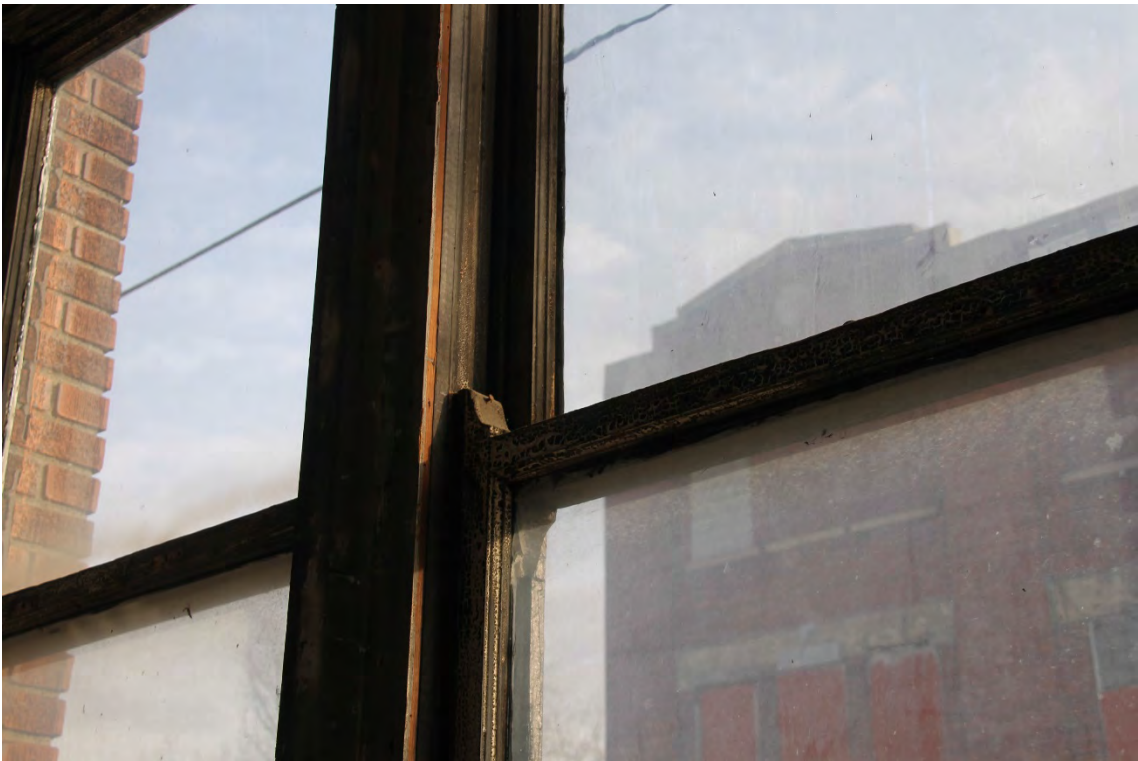
- All interior sash stops are missing.
- All glazing compound is failed and requires full replacement. This material most likely contains ACM. All painted surfaces mostly likely contain lead. Environmental testing should be completed prior to any work taking place.

*Interior View of Wood Double Hungs*
